# **GEO-ENVIRONMENTAL GROUND INVESTIGATION REPORT**

**FOR  
LAND OPPOSITE Nos. 6 & 7 SILVER STREET,  
GASTARD, CORSHAM, WILTSHIRE, SN13 9PY**

| <b>Report Production Record</b> | | |
|---|---|---|
| <b>Report on</b> | Geo-Environmental Ground Investigation Report | |

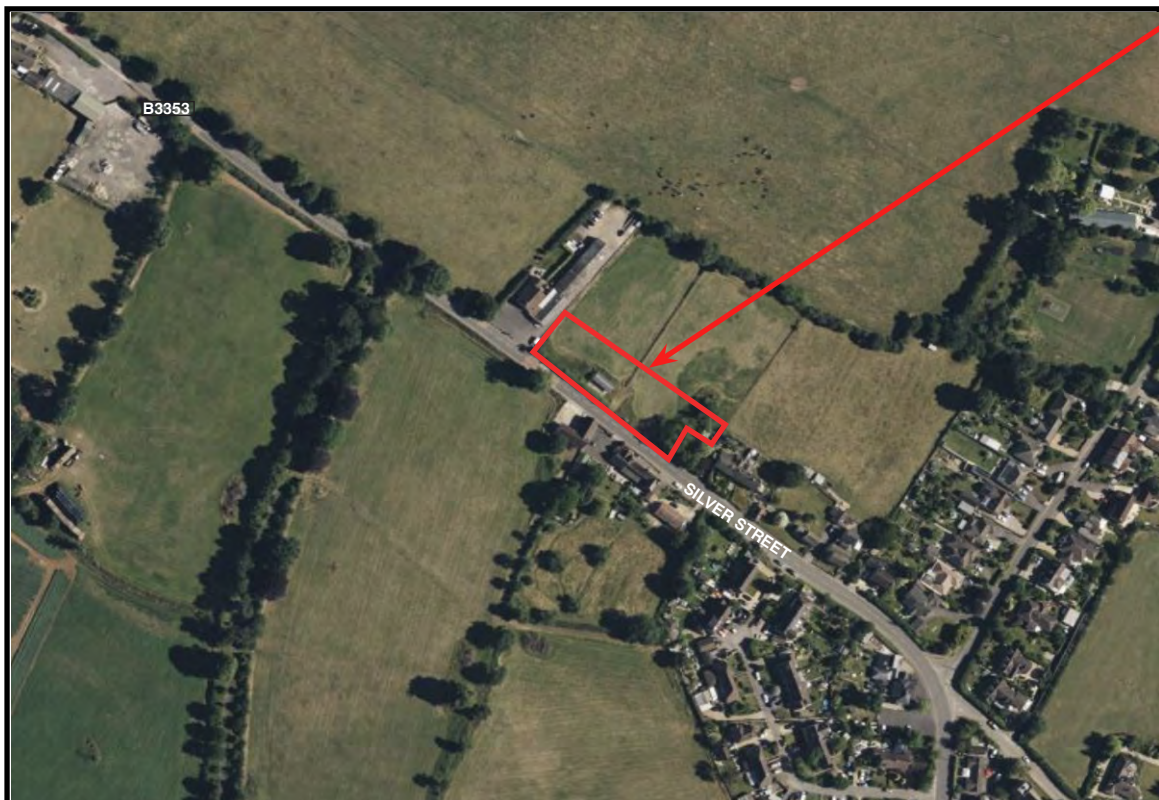
| Job No.<br>5710 | Drawing No.<br>5710/3 | Scale:<br>c1:250 @ A3 | Date:<br>10-06-26 |

THE  
SITE

PADDOCK A

P1  
Number and direction of photograph (Appendix 1)

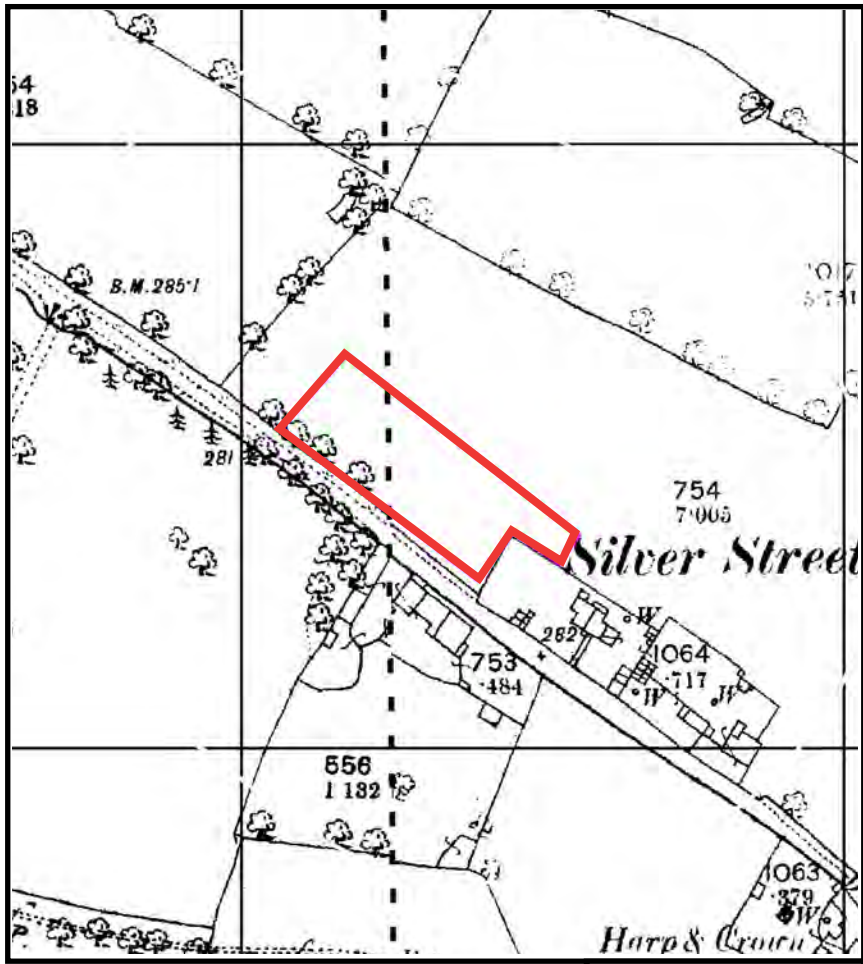
**1886**

(1:2500)

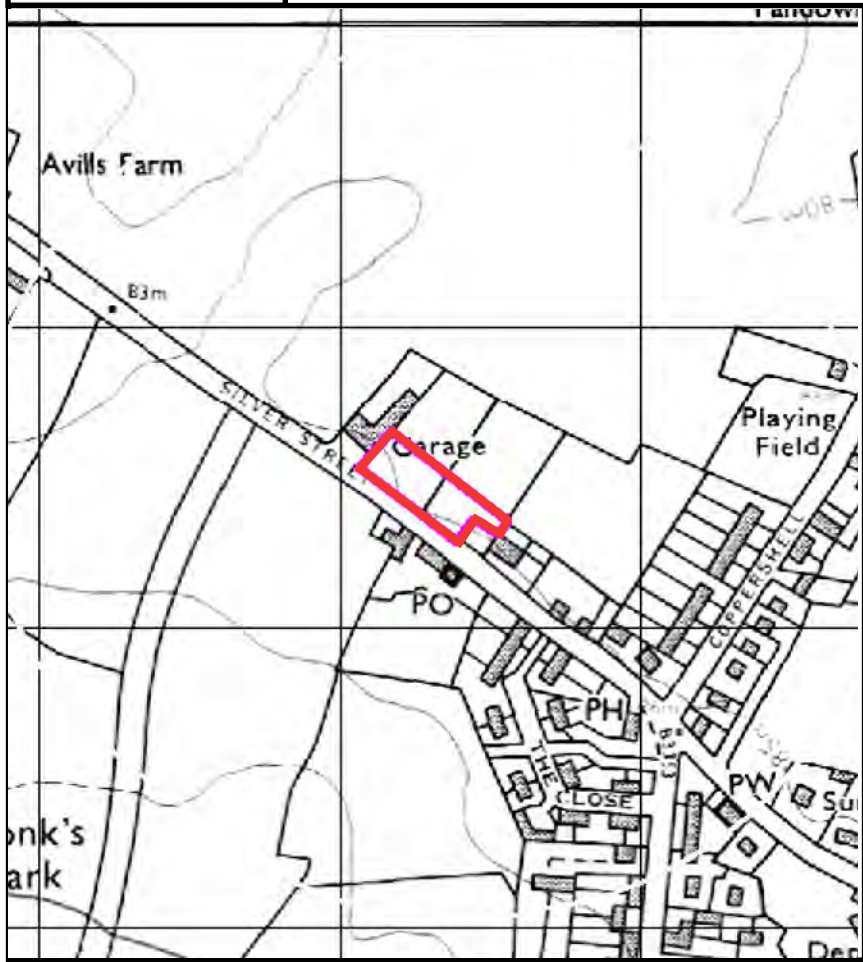
**1970**

(1:2500)

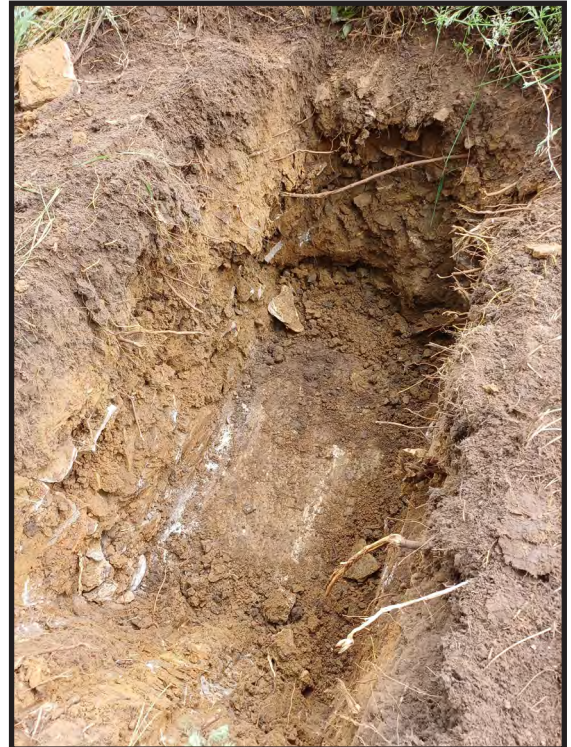
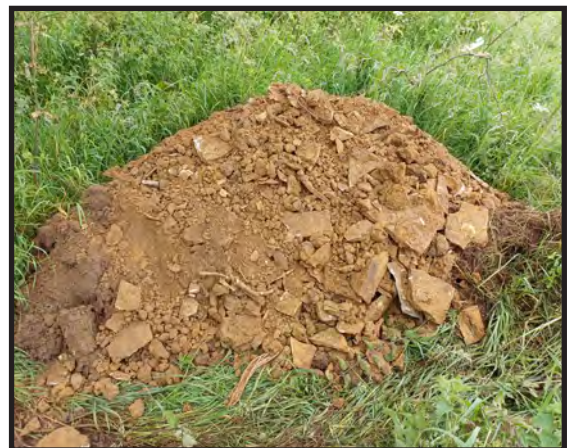
- A TOPSOIL: probable loose, dark brown, organic, slightly clayey, fine SAND, with many roots from overlying grass, weeds
- B CLAY: probable firm to stiff, light brown, gravelly, cobbly, locally sandy, plastic CLAY (gravel and cobbles are lenticular grey limestone), many live roots throughout, visually desiccated to 0.5m depth  
0.85m : refusal on limestone  
(*Forest Marble Formation (FMb) - limestone*)

- 1 Pit logged from surface; roots encountered to base
- 2 Pit dry and stable
- 3 Soil samples taken at 0.0-0.2m and 0.6m depth

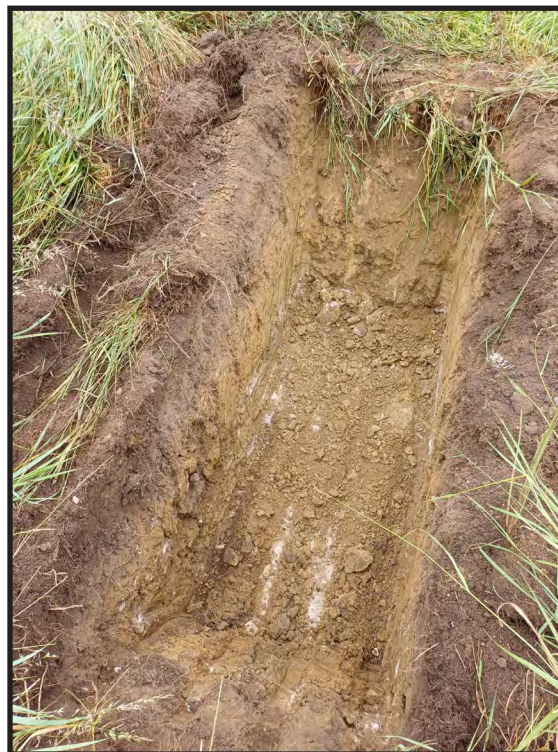
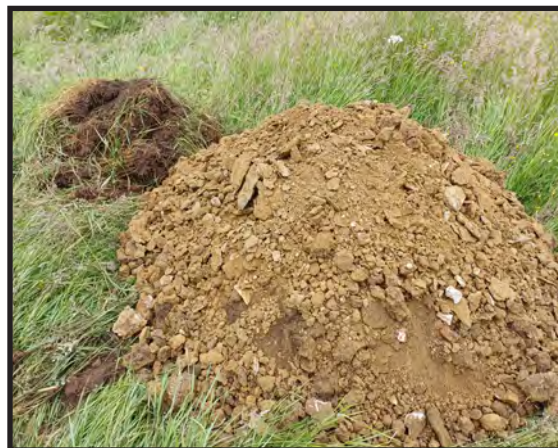
| Site: LAND OPPOSITE Nos 6 AND 7 SILVER STREET, GASTARD, CORSHAM, WILTS SN13 9PY | | | | TRIAL PIT No.<br><br><b>TP2</b> |

- A TOPSOIL: probable soft, dark brown, organic, clayey, fine SAND, with many roots from overlying grass
- B CLAY: probable firm to stiff, light brown, gravelly, sandy, dry and desiccated CLAY (gravel is medium to coarse, lenticular, subangular, crystalline grey limestone), many fine live roots throughout (*Forest Marble Formation - FMb*)

- Pit logged from surface
- Pit dry and stable
- Soil sample taken at 0.0-0.3m depth

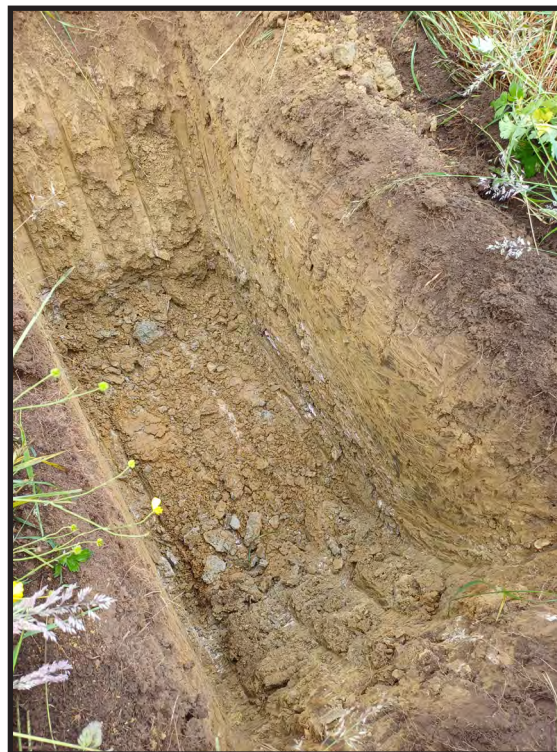
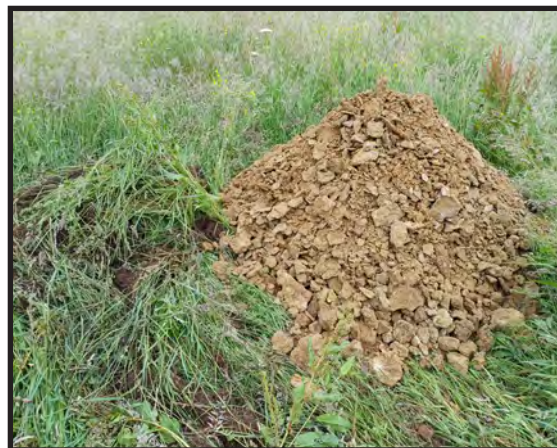
| <b>Site:</b> LAND OPPOSITE Nos 6 AND 7 SILVER STREET, GASTARD, CORSHAM, WILTS SN13 9PY | | | | <b>TRIAL PIT No.</b><br><br><b>TP4</b> |

- 1 Pit logged from surface
- 2 Pit dry and stable
- 3 Soil sample taken at 0.4m depth

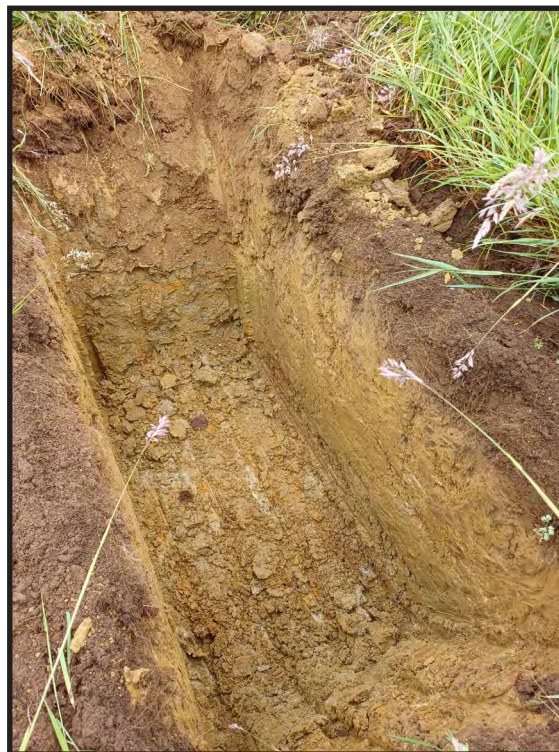
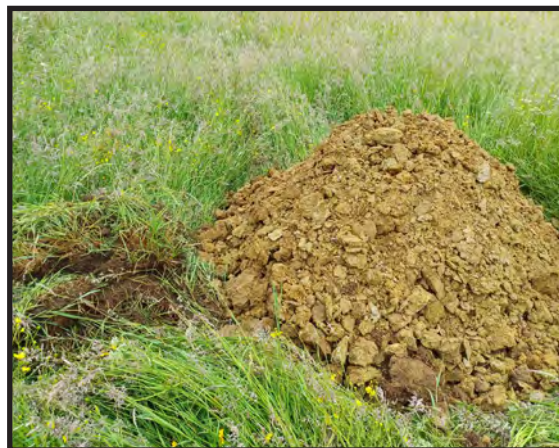
| <b>Site:</b><br>LAND OPPOSITE Nos 6 AND 7 SILVER STREET, GASTARD, CORSHAM, WILTS SN13 9PY | | | | <b>TRIAL PIT No.</b><br><br><b>TP5</b> |

- 1 Pit logged from surface
- 2 Pit dry and stable
- 3 Soil sample taken at 0.0-0.2m depth

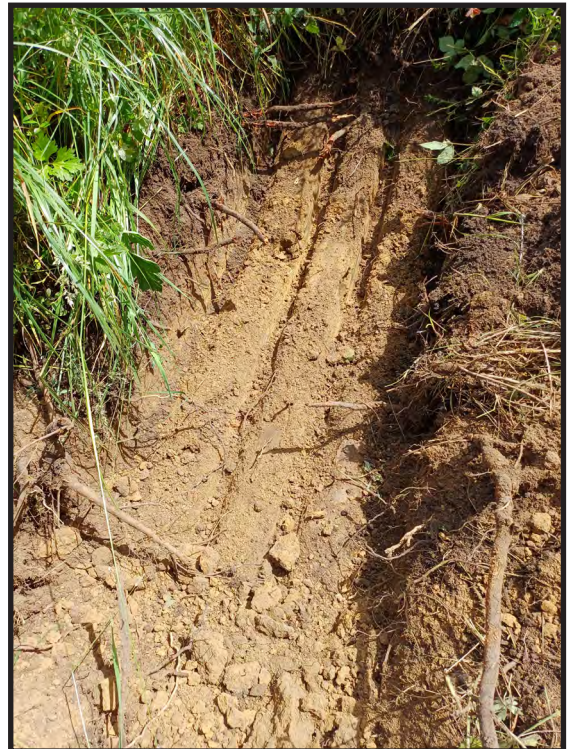
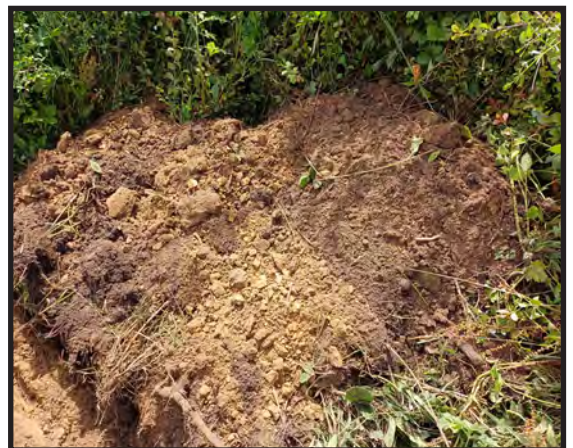
| Site: LAND OPPOSITE Nos 6 AND 7 SILVER STREET, GASTARD, CORSHAM, WILTS SN13 9PY | | | | TRIAL PIT No.<br><br><b>TP6</b> |

- 1 Pit logged from surface
- 2 Pit dry and stable
- 3 Soil sample taken at 0.0-0.2m depth

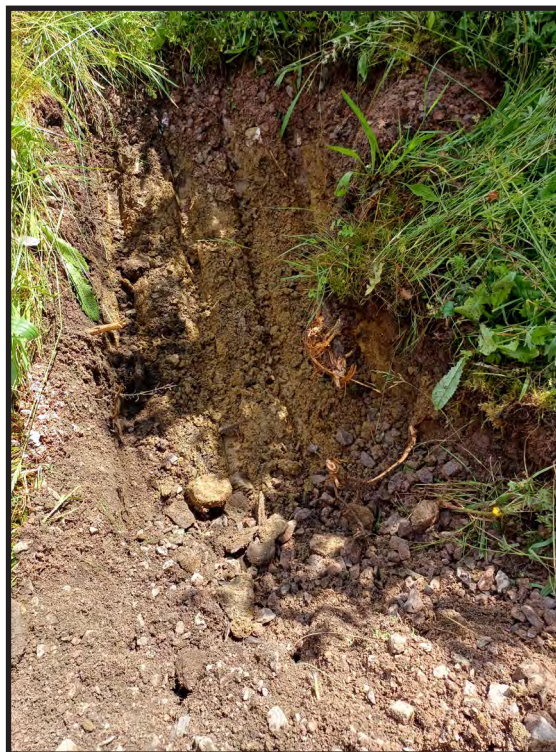
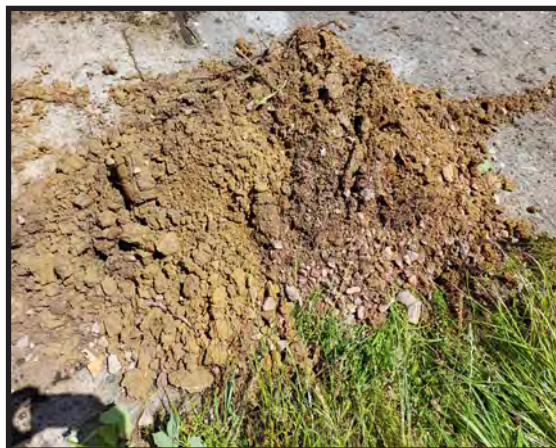
- A MADE GROUND: probable very loose, purplish-brown, sandy GRAVEL of fine to coarse, subangular to angular limestone
- B TOPSOIL: probable soft, dark brown, slightly sandy CLAY with many live roots from overlying grass and adjacent hedgerow
- C CLAY: probable stiff, light brown, slightly sandy, dry desiccated CLAY with many roots (*Forest Marble Formation - FMb*)

- 1 Pit logged from surface
- 2 Pit dry and stable
- 3 Soil sample taken at 0.0-0.05m depth

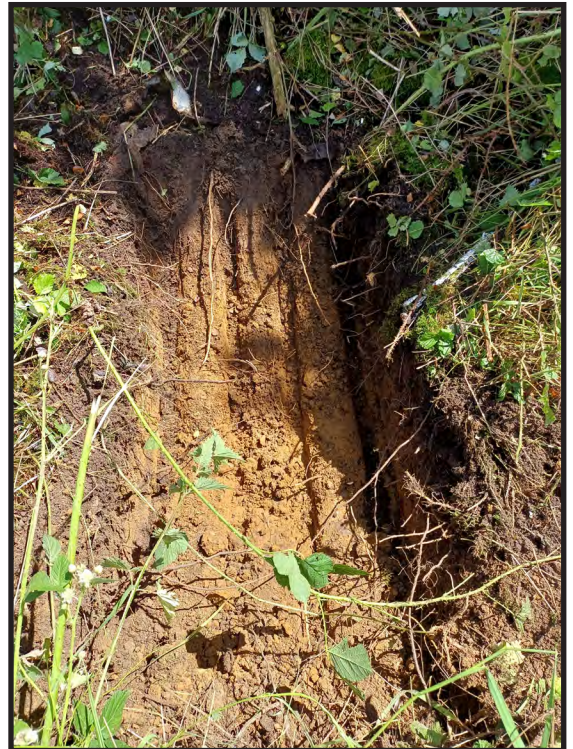
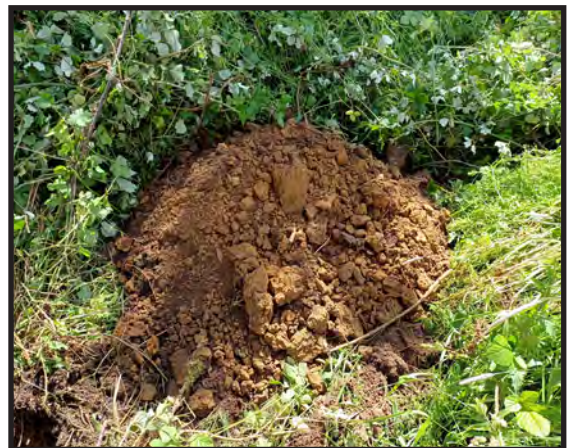
- 1 Pit logged from surface
- 2 Pit dry and stable
- 3 Soil sample taken at 0.0-0.2m depth
