## BAT SURVEY REPORT

WEST LODGE, BARFORD ST. MARTIN,  
WILTSHIRE

stark ecology<sup>ltd</sup>

JULY 2026

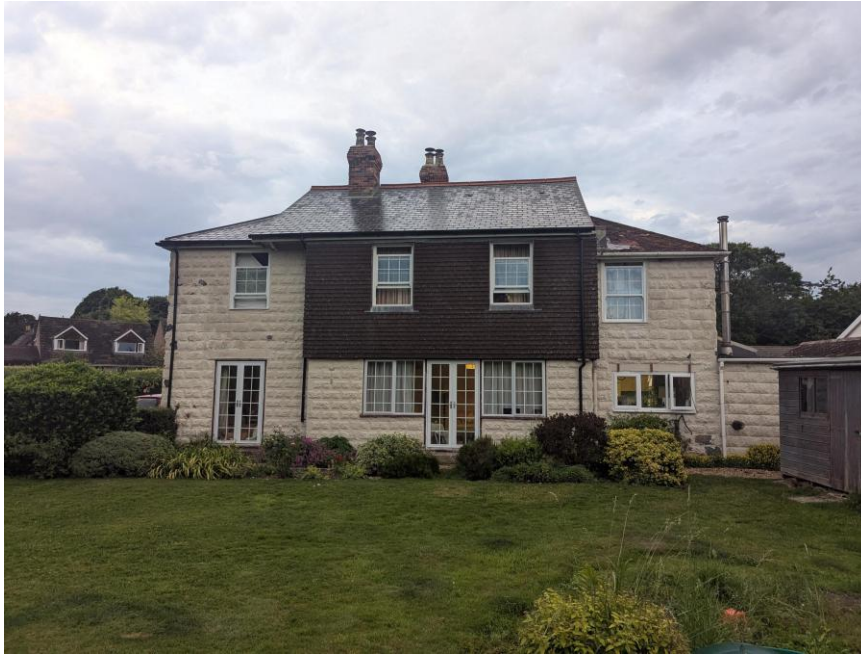
**Fig 2:** West Lodge.

West Lodge is a two storey property which has block walls with a painted stone facade. In 2024 the roof was asbestos tiles with decorative clay ridge tiles and there was one red brick chimney at the western end of the house and one on the north side of the roof. In 2026 the roof of the property had been replaced with slate (this work was carried out under licence from Natural England in 2025).

Part of the upper floor of the southern face of the house is covered with cement hanging tiles.

This photo taken from the south on 22<sup>nd</sup> June 2026.

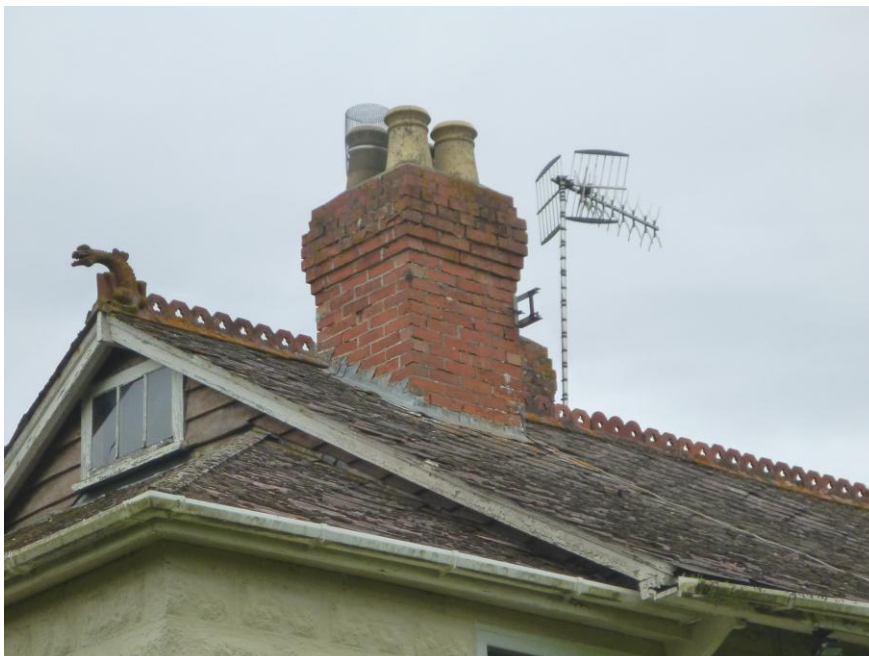
**Fig 3:** A lower roof ties in on the western gable which is clad with timber.

At the western end of the property is a two storey section of the house which has a lower, monopitch roof. This part of the roof ties into a timber clad part of the gable end wall and the asbestos tiles in this area of the property were also replaced with slate in 2025. Under the bat licence that was issued in 2025 the timber cladding has also been removed from this part of the property.

This photo taken from the southwest on 27<sup>th</sup> September 2023.

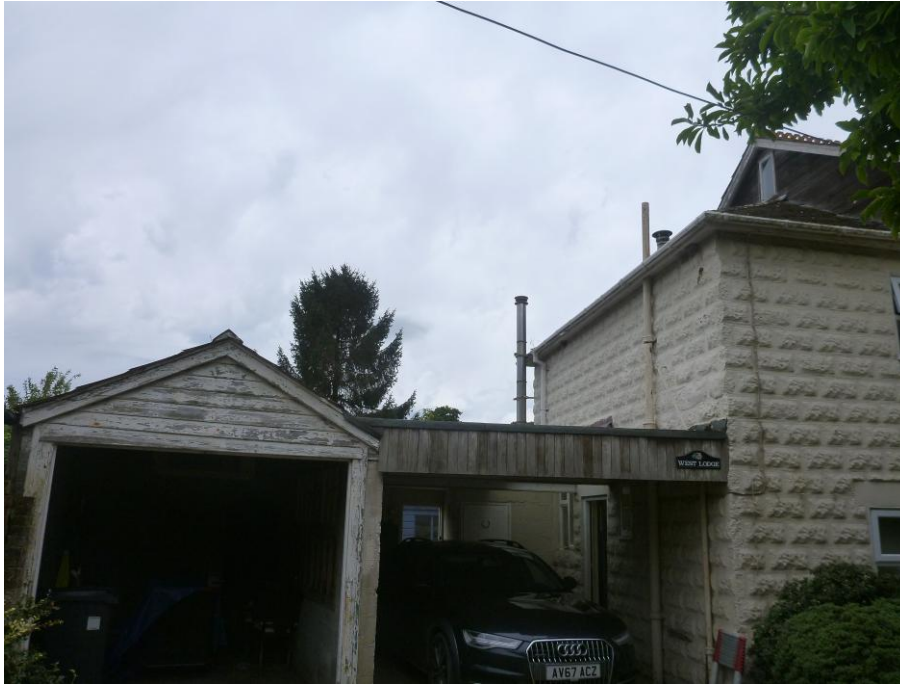
**Fig 4:** Single storey garage and car part attached to the east face of West Lodge.

At the eastern end of the house is an attached single storey garage of the same construction as the house. The door on the north face of the building is left open and the garage is attached to the house by a single storey car port structure which is also open on the north face.

This photo taken from the north on 27<sup>th</sup> September 2023.

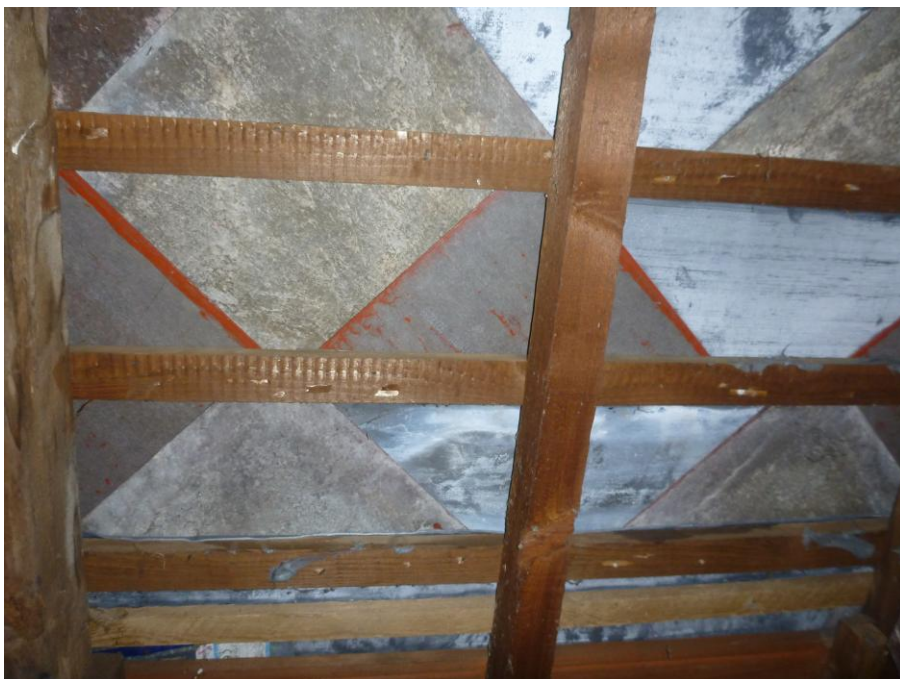
**Fig 5:** The asbestos roof tiles were unlined (and have since been replaced with slate).

There is a single loft space above the property which was all accessible to the surveyor on 27<sup>th</sup> September 2023. The asbestos roof tiles were unlined and the loft space insulated with fibreglass material.

This photo taken on 27<sup>th</sup> September 2023.

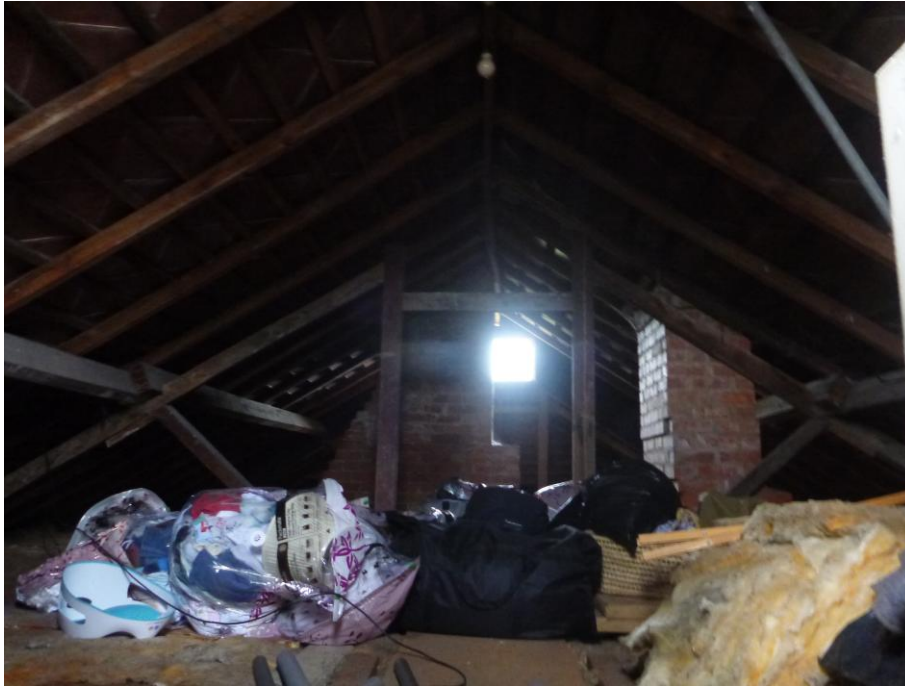
**Fig 6:** Windows in the gable ends allow daylight to penetrate the loft space.

There are windows in both gable ends of the loft space which allow daylight to penetrate large areas of this part of the property.

This photo taken on 27<sup>th</sup> September 2023.

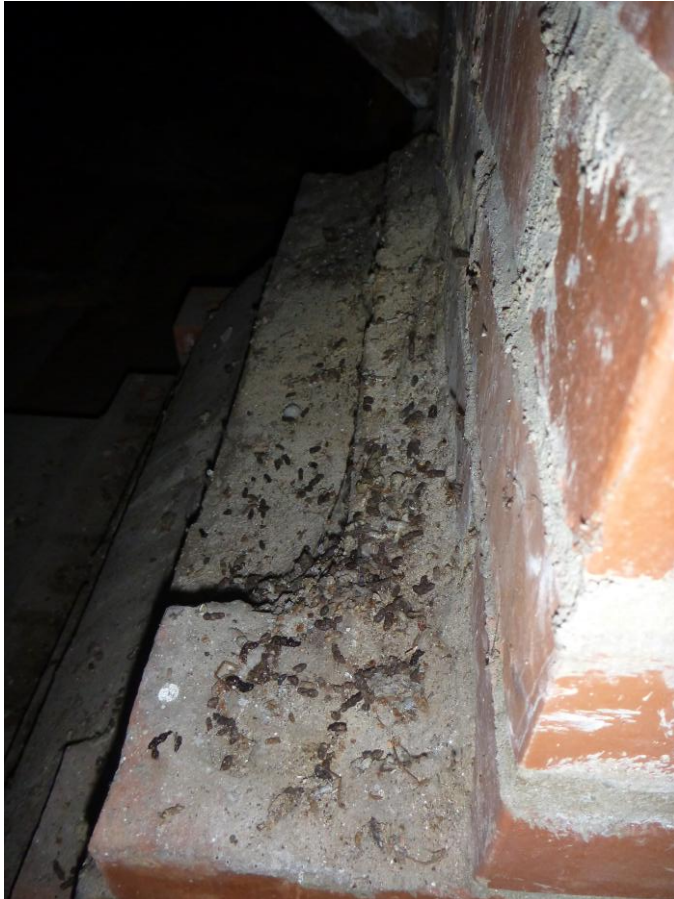
**Fig 7:** Bat droppings were noted at the base of both chimneys as they pass through the loft space of West Lodge.

Internally evidence of bats was found in the loft space with accumulations of bat droppings noted around both chimneys.

This photo taken 27<sup>th</sup> September 2023.

A sample of the droppings was collected and sent for DNA analysis to aid species identification which confirmed that the droppings were from brown long-eared *Plecotus auritus* and serotine *Eptesicus serotinus* bats.

The serotine and brown long-eared roosts in the loft space of the house were modified when this area of the property was re-roofed in 2025 (under bat licence from Natural England). Although no direct work to the hanging tiles or soffit on the south face of the property was proposed, there was the potential for this work to result in disturbance and possibly some damage to the soprano pipistrelle maternity roost and so the work was carried out in March/April, before the maternity period.

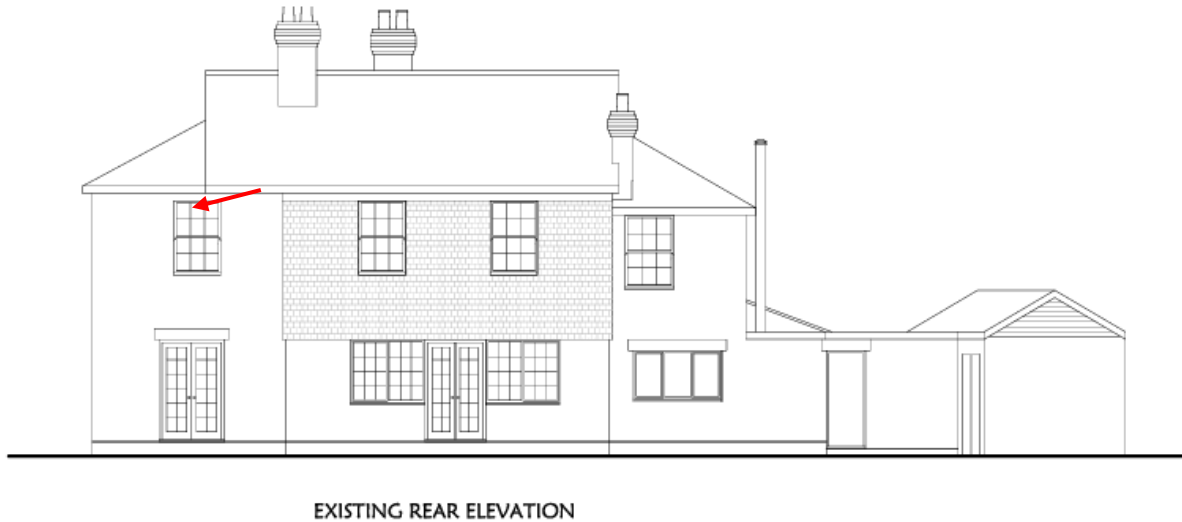
**Fig 10:** One serotine bat emerged from this area of the property on 24<sup>th</sup> June 2024.

At 2156 one serotine bat emerged from the western corner of the main part of the house, close to the eaves.

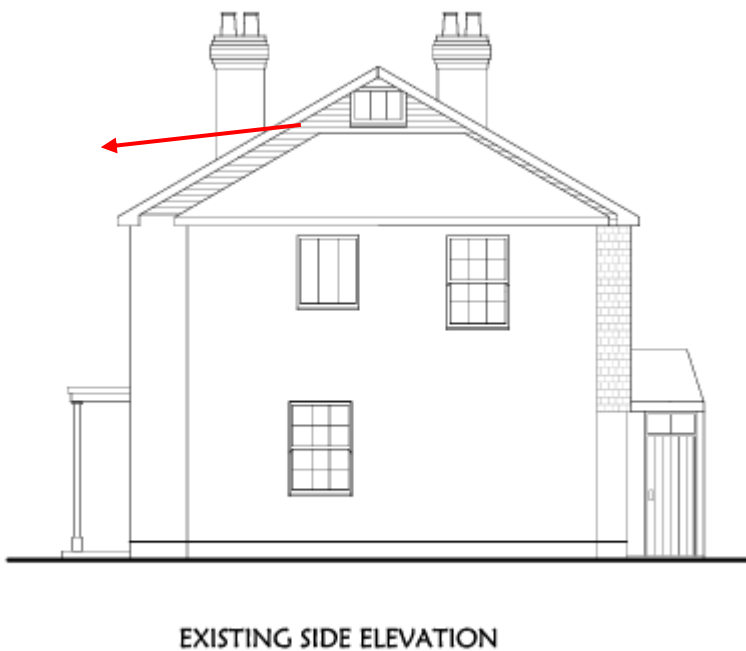
**Fig 11:** One common pipistrelle emerged from this area of the property on 24<sup>th</sup> June 2024.

At 2149 one common pipistrelle bat emerged from the timber cladding on the western gable of the house.

The updated plans to extend West Lodge in 2026 will now only result in impacts on the western face of the property, where no bat roosts have been identified in 2023, 2024 or 2026. As there will be no direct impacts on bats or their roosts there is no seasonal constraint on the work to tie in the new extension, and this work will not need to be carried out under licence from Natural England but as there are known to be bat roosts in other areas of the property, the following approach to work to remove roof materials will be adopted in order to avoid accidental disturbance:

- The removal of roof materials (to tie in the new extension) will be carried out under the supervision of a suitably licensed ecologist.
- Roof materials will be carefully removed by hand and will be lifted, not rolled, to prevent crushing any bats which may be present beneath. All materials will then be checked on all surfaces for bats before stacking or throwing.

- In the unlikely event that a bat is found during this work the ecologist will contact Natural England for advice and a licence will be obtained before work to remove the roof materials continues.
