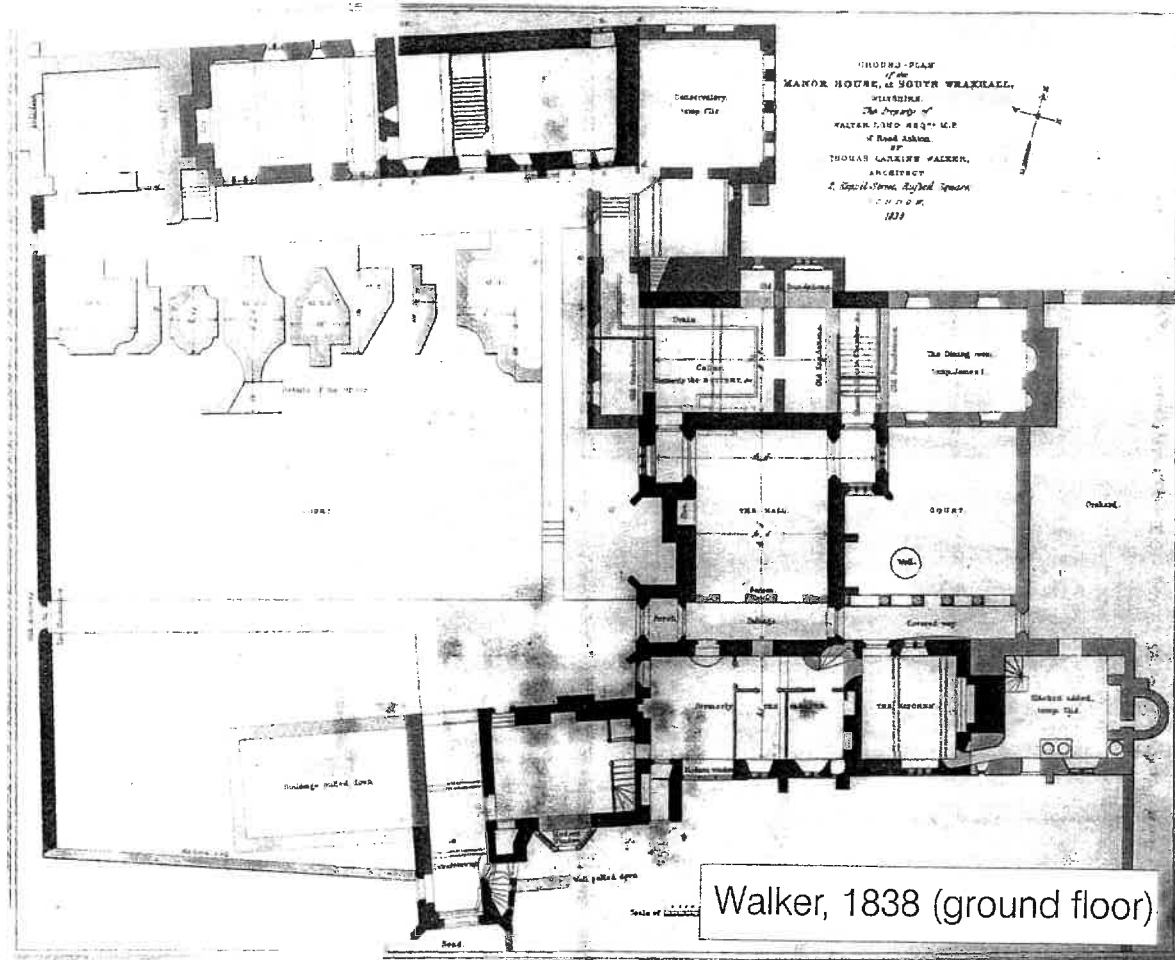
Figure 3. Walker's and Ponting's analyses

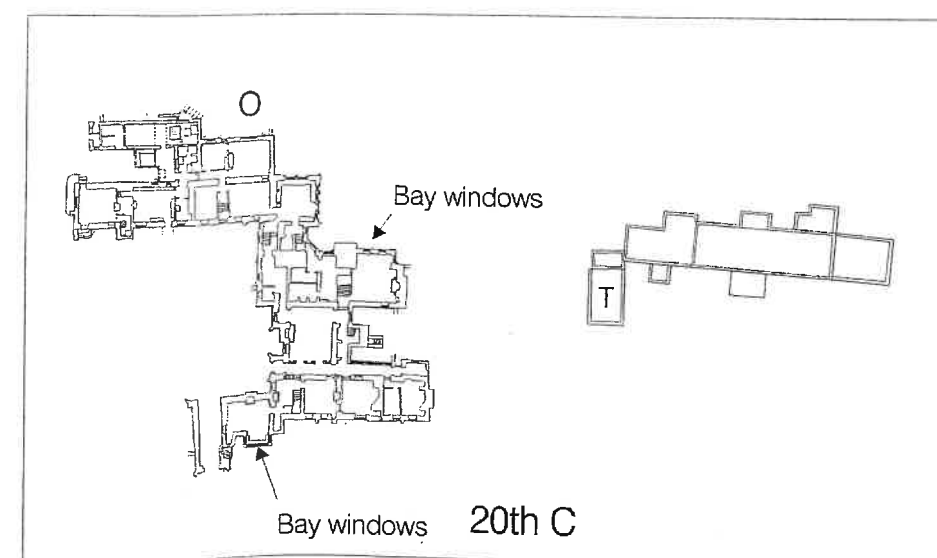
Figure 5. Received chronological development

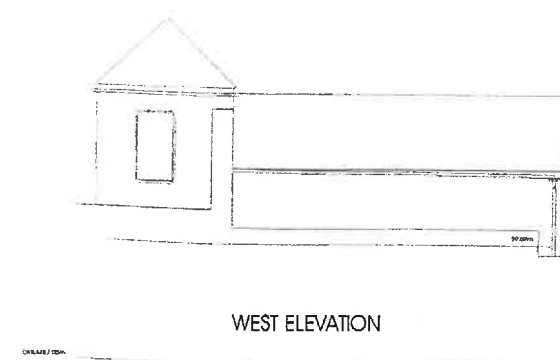
Figure 13. Implied and observed interventions

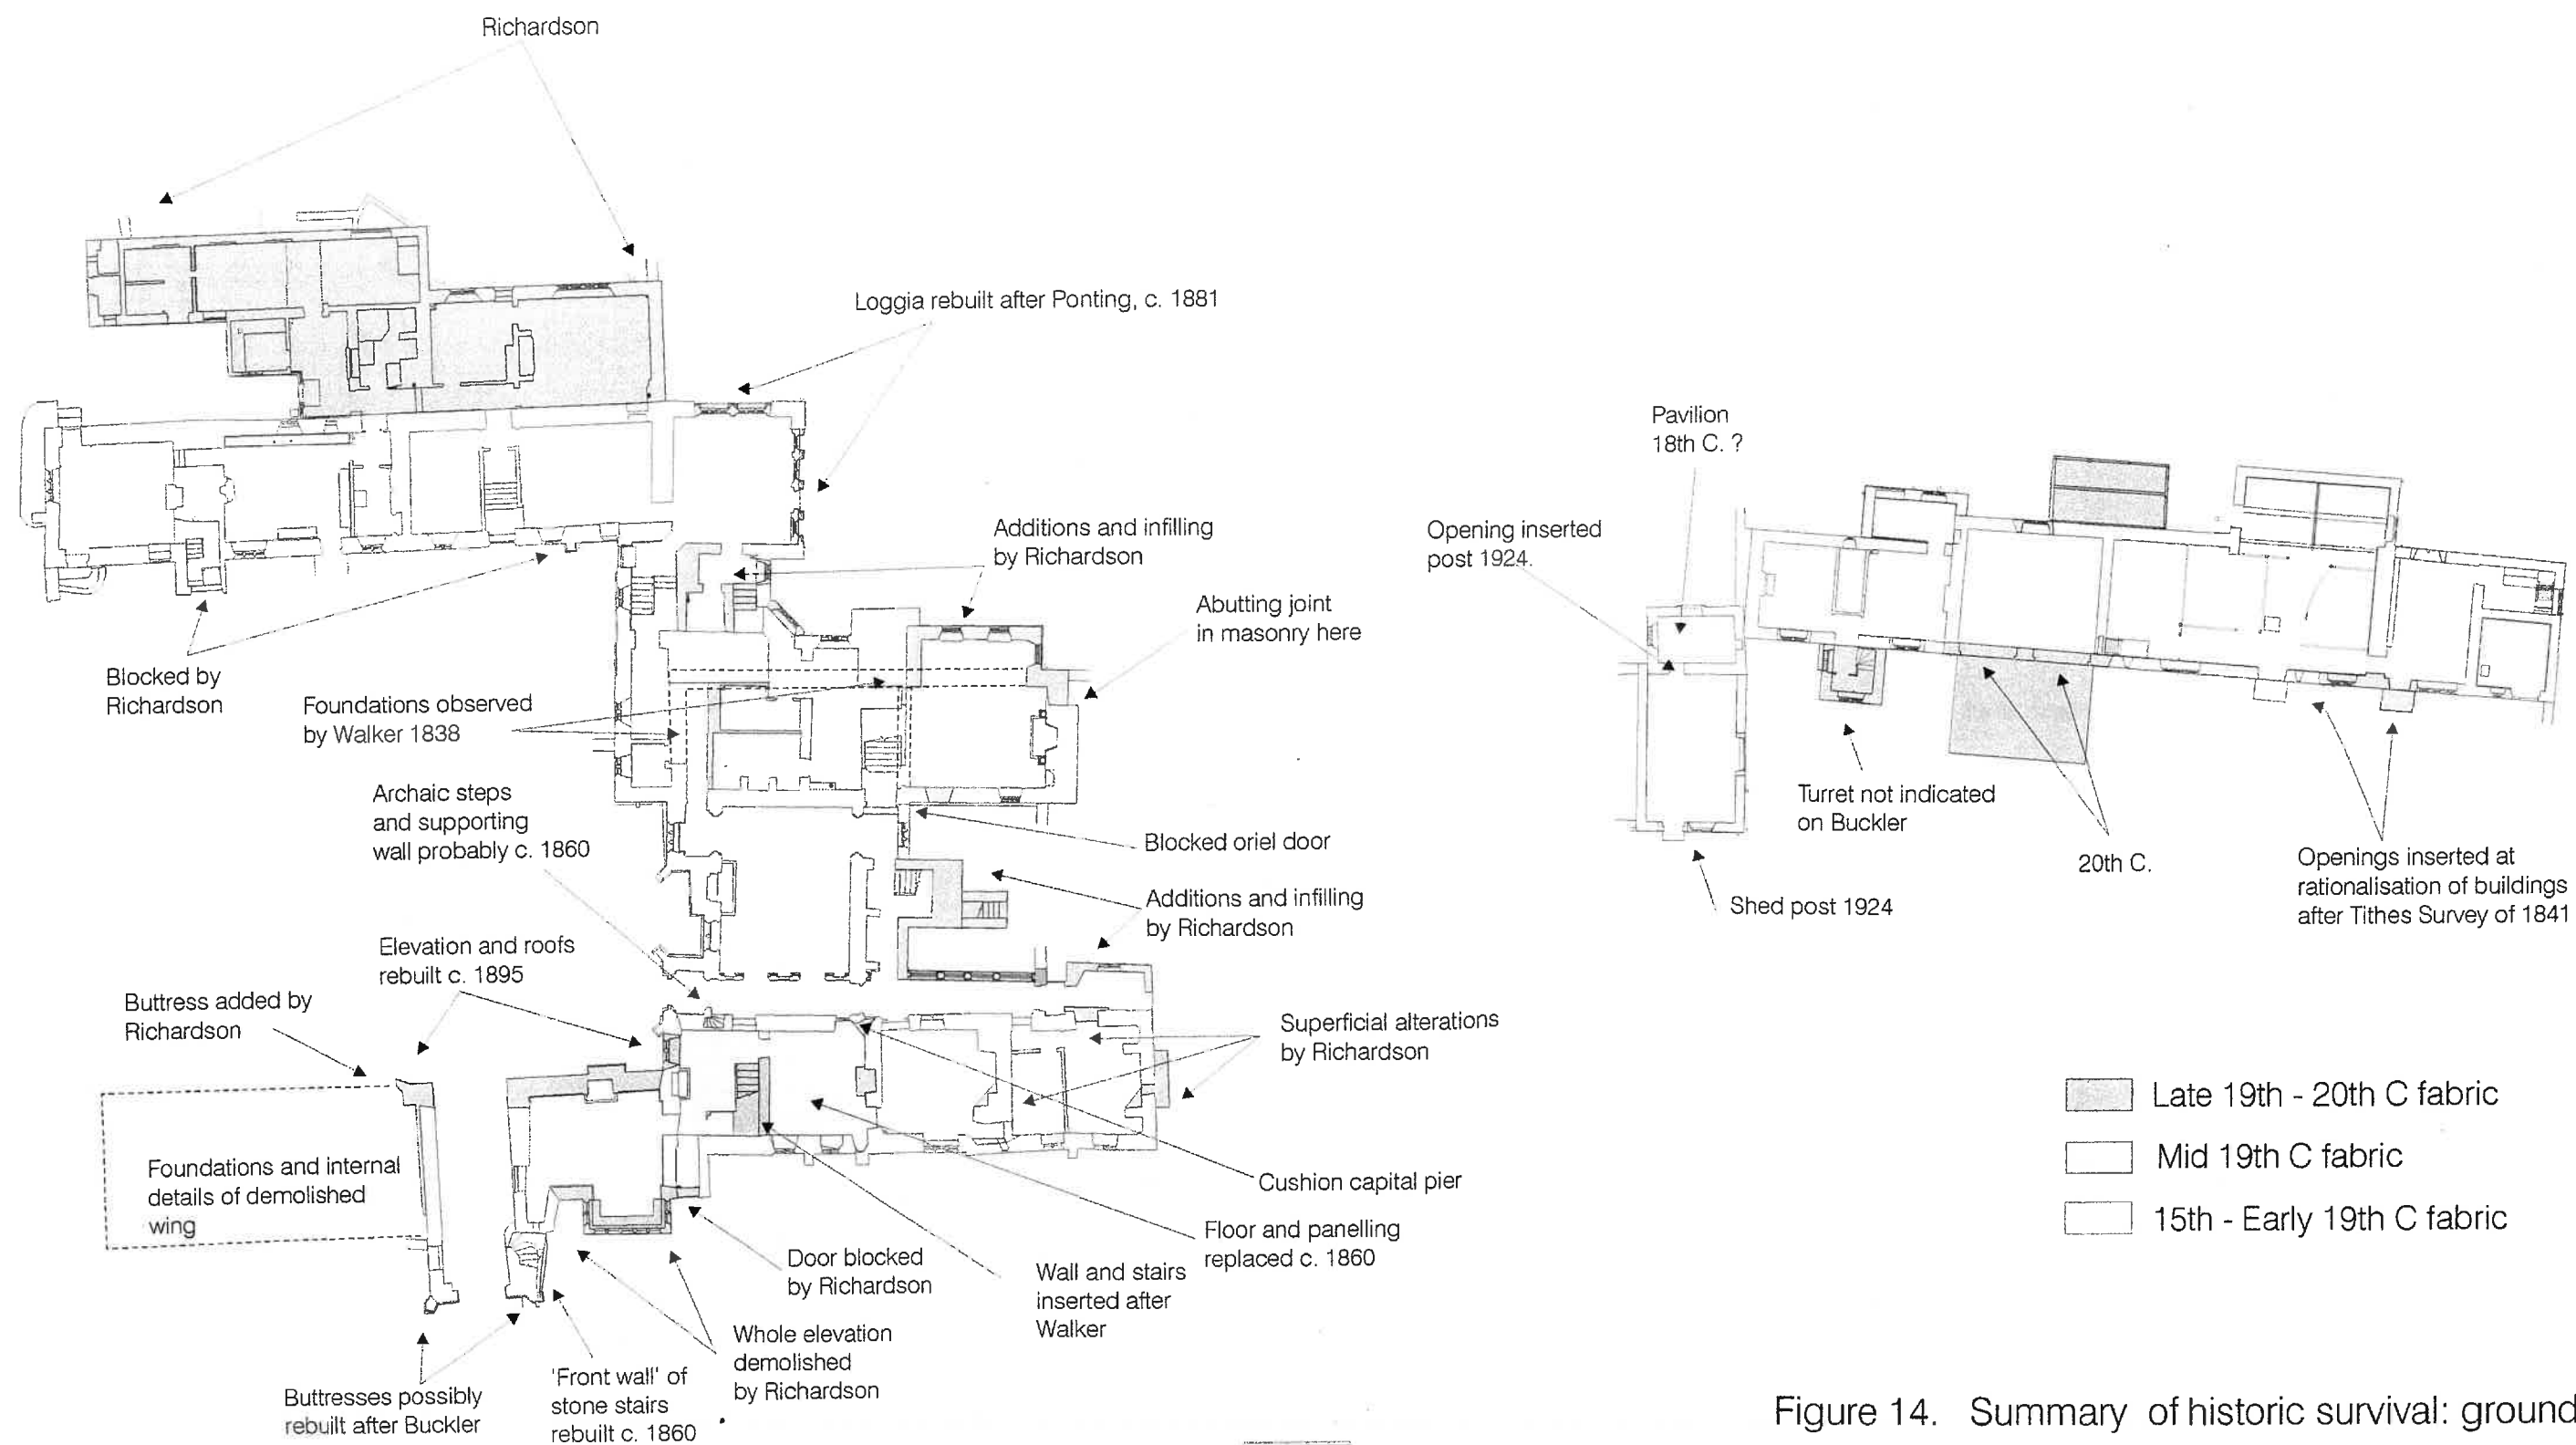
Figure 14. Summary of historic survival: ground floor

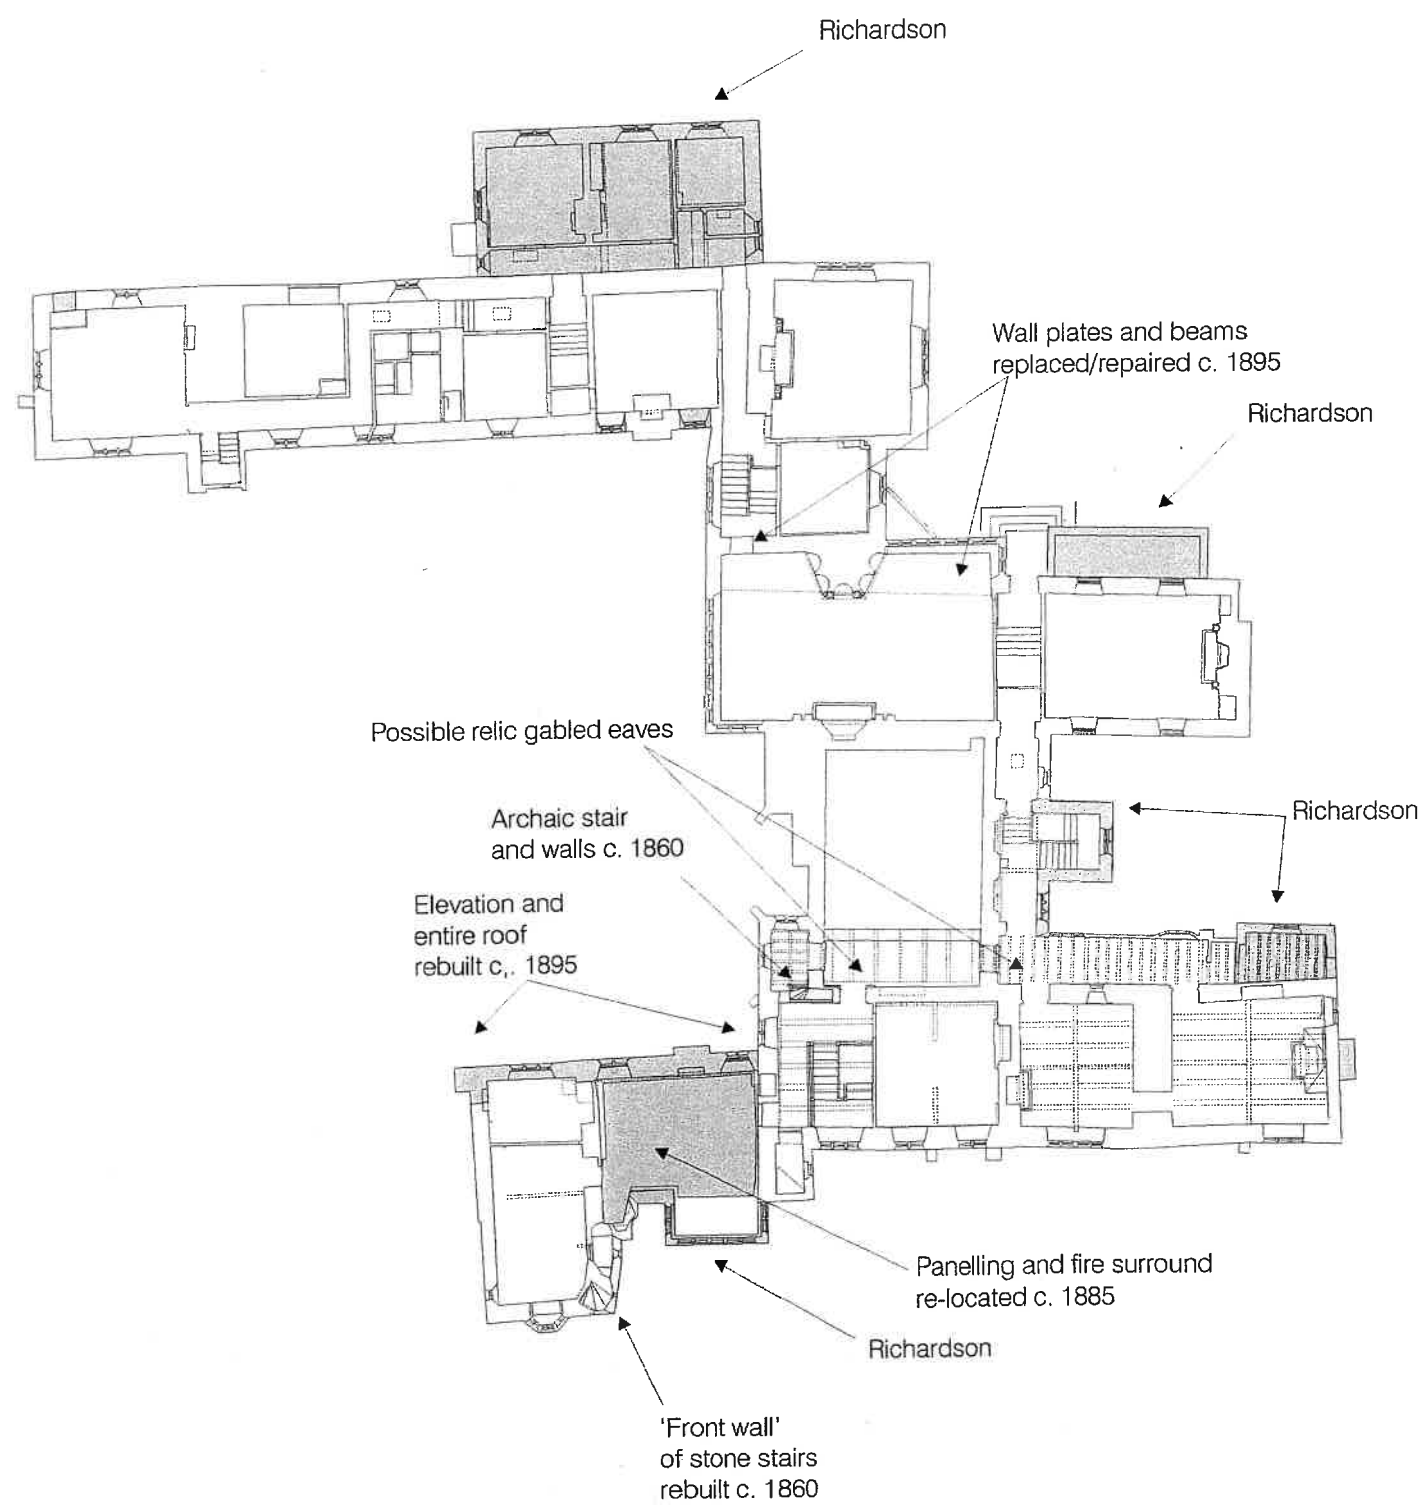
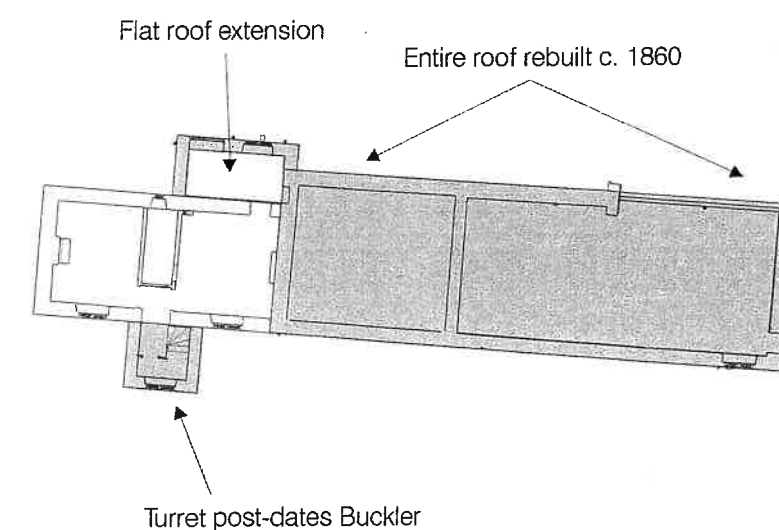
Figure 15. Summary of historic survival: first floor
