### **Stage II Bat Survey**

#### **Stableblock**

#### **South Wraxall Manor**

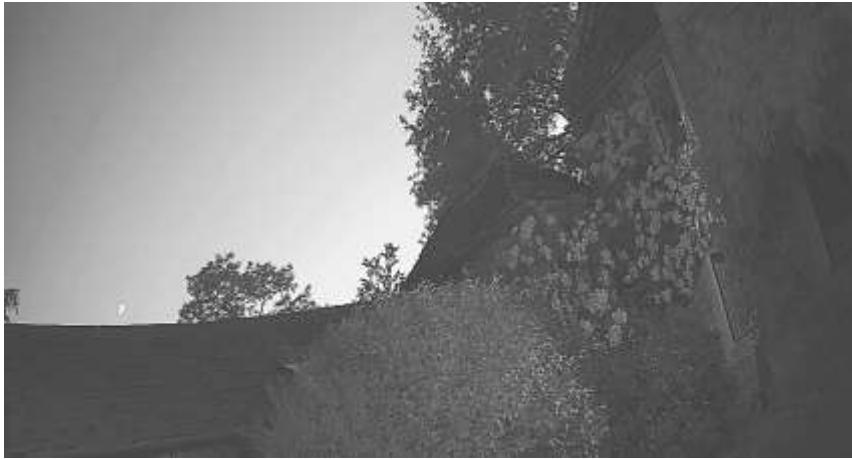
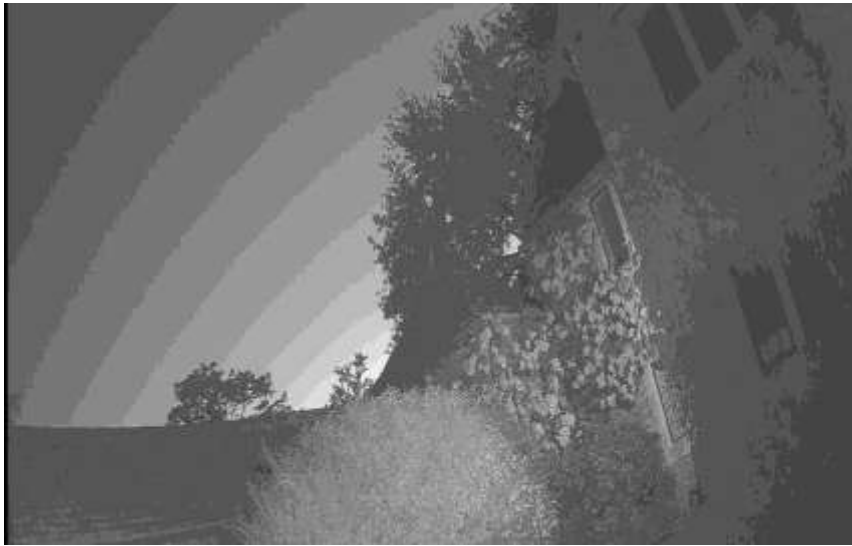
*1-2. Area 1- Workshop*

No bats were seen on the video footage of the workshop (Area 1) during the survey on the 20<sup>th</sup> of May 2026.

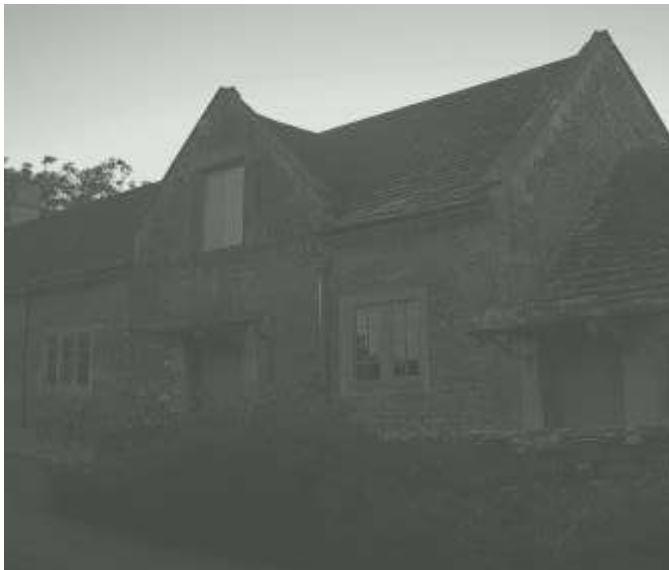
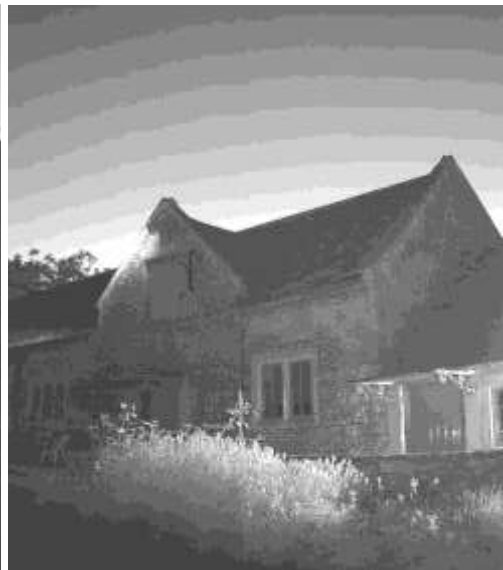
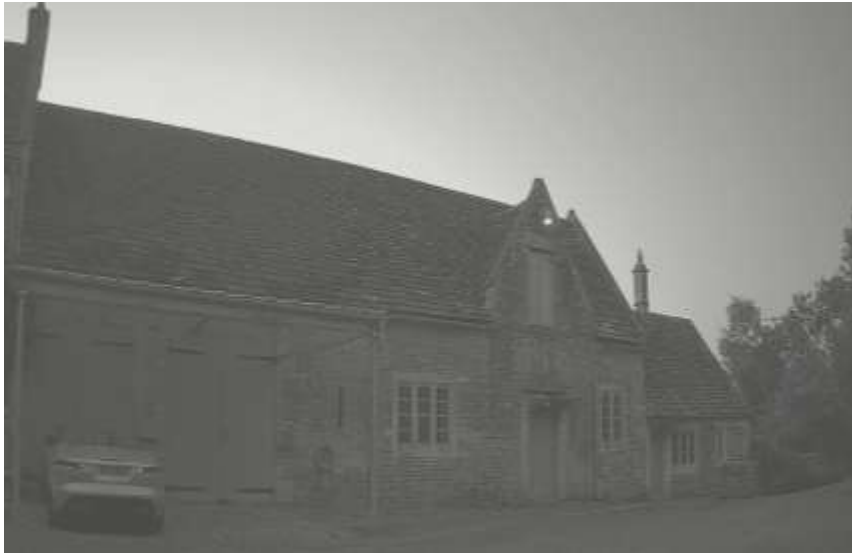
3-6. Area 2- Stable block

No bats were seen to emerge from south elevation of the stable block (Area 2) during the survey on the 20<sup>th</sup> of May 2026.

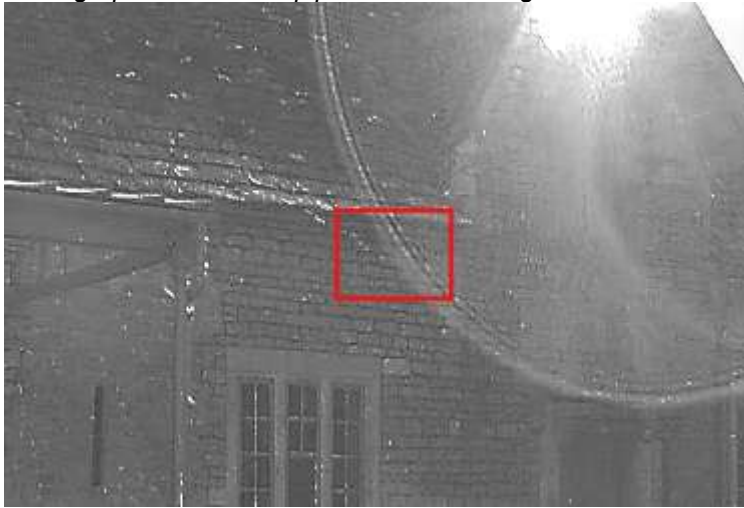
| Time | Recordings | Notes |
|---|---|---|
| <b>22:17</b> | 2 | S→N, Bat emerge under tile (Photograph 7) & wall crevice (Photograph 8) |

*Photograph 8: Common pipistrelle bat emerges from wall crevice*

Number of bats roosting in affected area and spread-out roosting areas indicate a male/ non breeding roost. As parts of affected site area is currently being used by bats a low impact licence through Natural England is required for works affecting areas used by bats on the south elevation of the stable block (Area 2).

- Obtain any relevant consents
- Obtain a low impact bat licence from Natural England
- Put up one bat box
- Toolbox talk and ecologist attend whilst potential roosting places removed
- Licence report

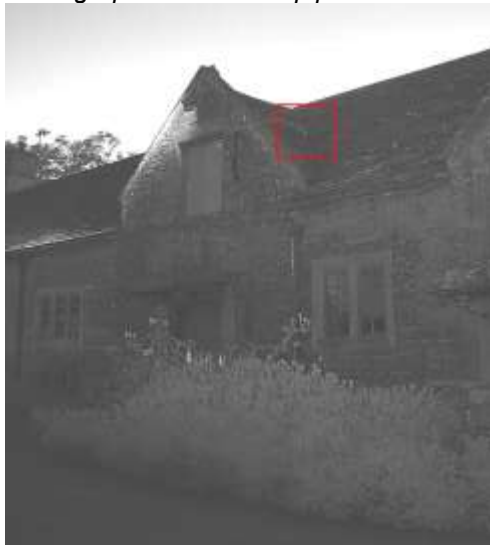
| Time | Recordings | Notes |
|---|---|---|
| <b>22:19</b> | 3 | W→E, E→W Bat emerge under tile (Photograph 9) |

*Photograph 9: Common pipistrelle bat emerges from tile by dormer*

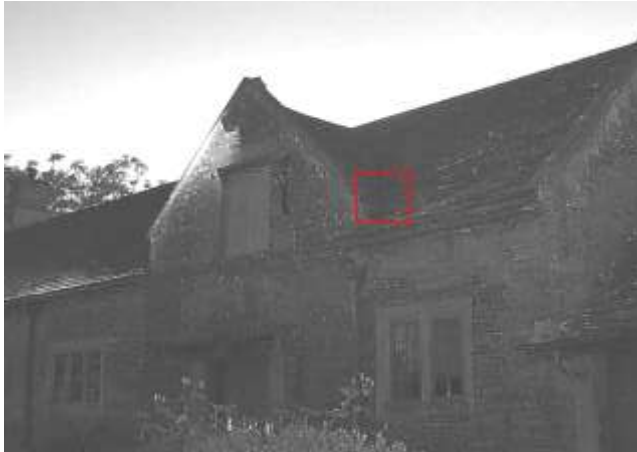
| Time | Recordings | Notes |
|---|---|---|
| <b>22:20</b> | 4 | 2x W→E, S→N & Bat emerge under tile (Photograph 10) |

A total of 4 common pipistrelle bats were seen to emerge from the south elevation of the stable block (Area 2) during the survey on the 18<sup>th</sup> of June 2026.

Photograph 10: Common pipistrelle bat emerges from tile by dormer
