# Unit 5 Wilton Shopping Village, Wilton, Salisbury, SP2 0HR.

## Preliminary Roost Assessment (PRA)

Date: 11/06/26

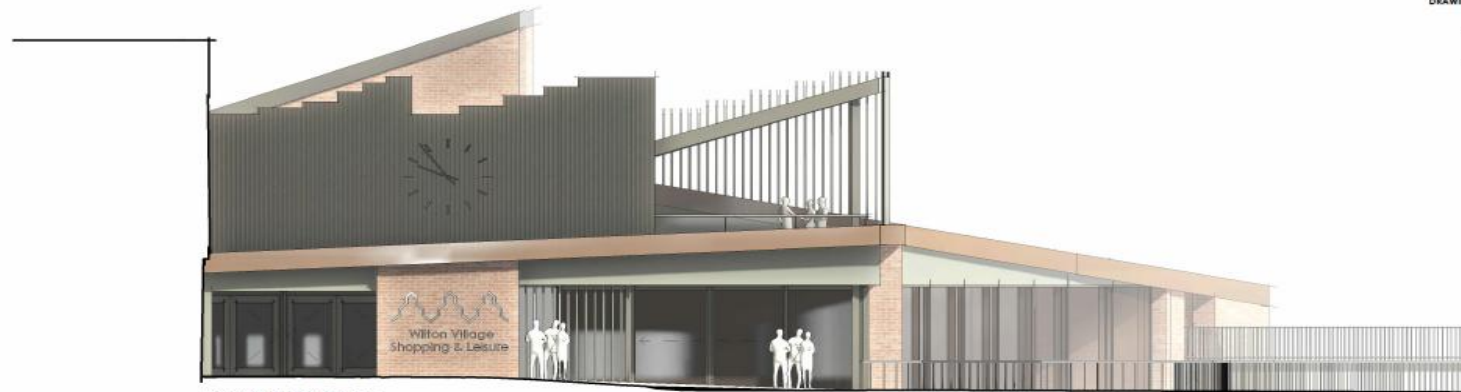
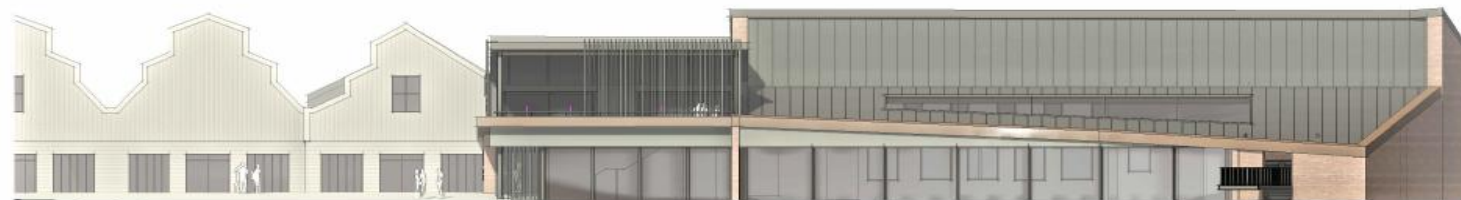
1 Front (South East) Elevation  
1 : 100

2 Side (North East) Elevation  
1 : 200

**Figure 2:** Showing the building as proposed

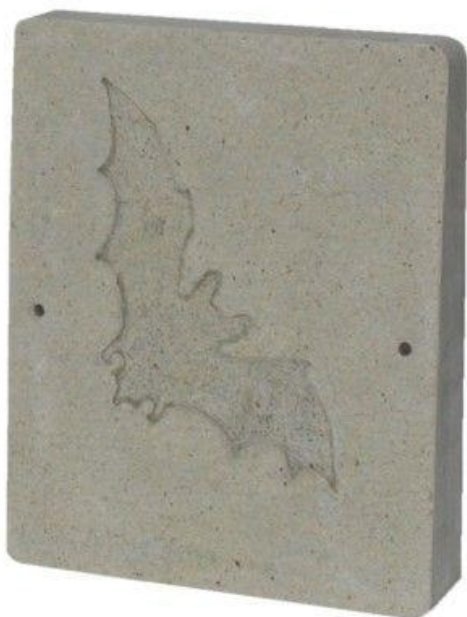
## Schwegler 2FE Wall-Mounted Bat Shelter

**MATERIAL:** Woodcrete

**DIMENSIONS (MM):** 250 x 300 x 30 to 50

**SITING:** Installing the 2FE is very easy using just two screws to fix it to a wood, brick, stone, or concrete wall. If the wall surface is uneven we recommend sealing the three edges of the 2FE with silicone, foam insulating tape, or a similar method. This will ensure it is free from draughts, which are preferred by bats.

For summer use, the 2FE should ideally be mounted on a wall with a southerly or easterly aspect. Final siting should be selected to provide a clear flight path, minimise disturbance and avoid direct illumination from external lighting.

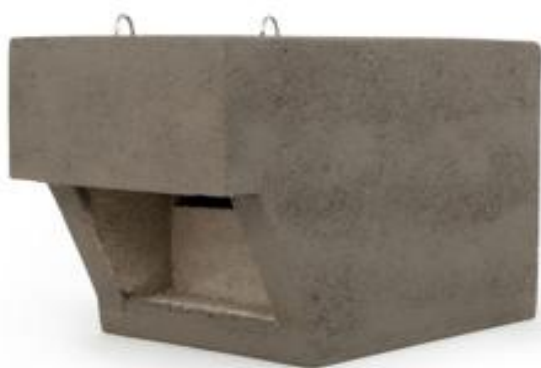
## **Vivara Pro WoodStone Wagtail/Dipper Nest Box**

**MATERIAL:** Woodstone - a mix of wood fibres and concrete. This robust material is environmentally sustainable and will last for decades.

**DIMENSIONS (MM):** 170 x 200 x 310

**SITING:** For the purposes of this scheme at Unit 5, the box should be installed beneath the walkway at the western end of the site, as shown indicatively on Figure 3. Final siting should avoid regular disturbance and should take account of safe access for installation and future maintenance.

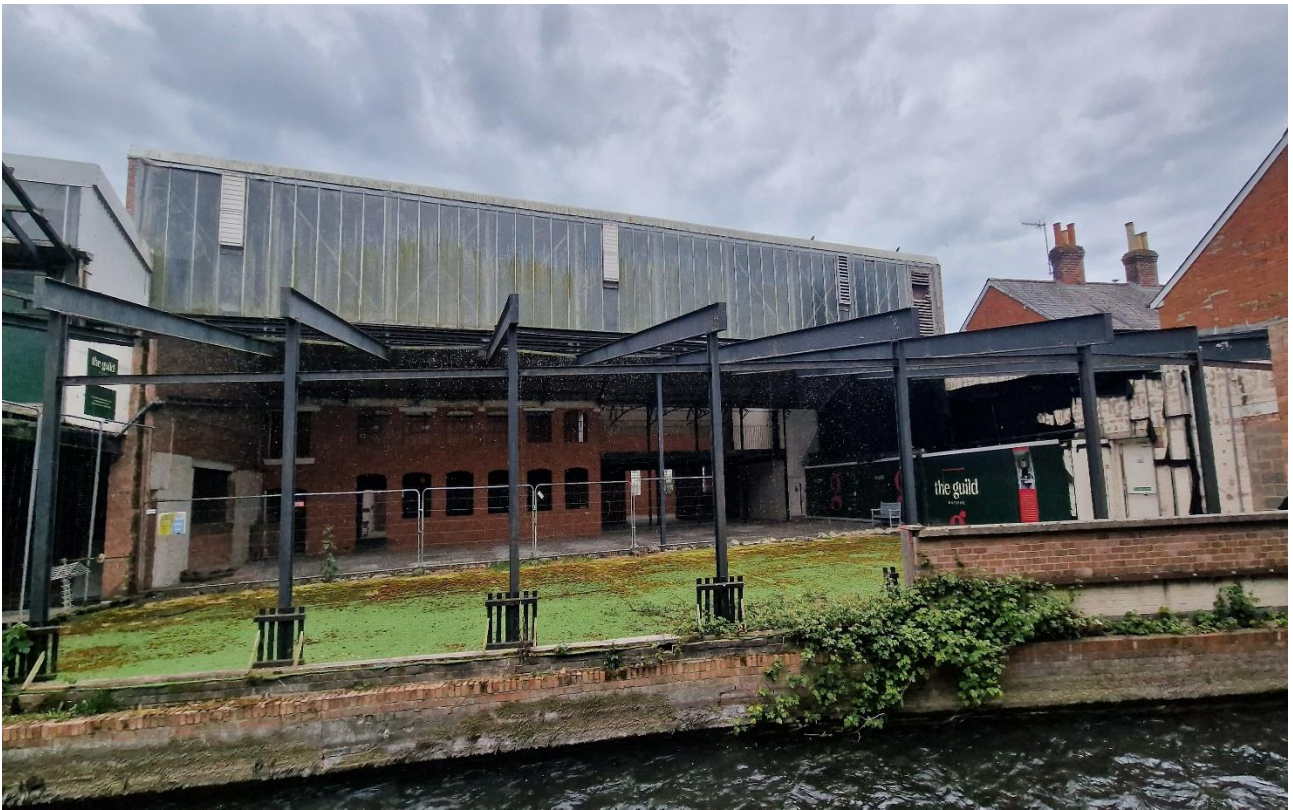
- 3.2 Unit 5 comprises a large commercial building with a sawtooth roof clad in corrugated steel and incorporating prominent north-west-facing roof windows. The principal external materials comprise a combination of exposed brickwork and corrugated sheet cladding, giving rise to a relatively simple and visually accessible building envelope.

- 3.3 Particular attention was given to junctions between cladding sheets, roof abutments, exposed edges, window surrounds and other features that can, in some circumstances, provide crevice roosting opportunities. Although the external fabric includes a mix of materials and construction joints, no features were identified that were considered capable of providing suitable shelter, depth, protection or microclimatic conditions for roosting bats within the parts of the building relevant to the proposed works.

- 3.4 In particular, the inspection did not identify any lifted sheets, open crevices, gaps of suitable dimension, sheltered recesses or other external features likely to function as viable bat roost access points or resting places. The exterior of the building therefore offered no evidence of roosting suitability beyond the low level of uncertainty inherently associated with a daytime Preliminary Roost Assessment.

- 3.5 No evidence of bat use was recorded during the external inspection. Specifically, no bats, droppings, staining, feeding remains or other field signs indicative of current or recent bat occupation were observed on the elevations, around potential access locations or beneath the inspected parts of the building.

**Picture 1:** The northern elevation of Unit 5

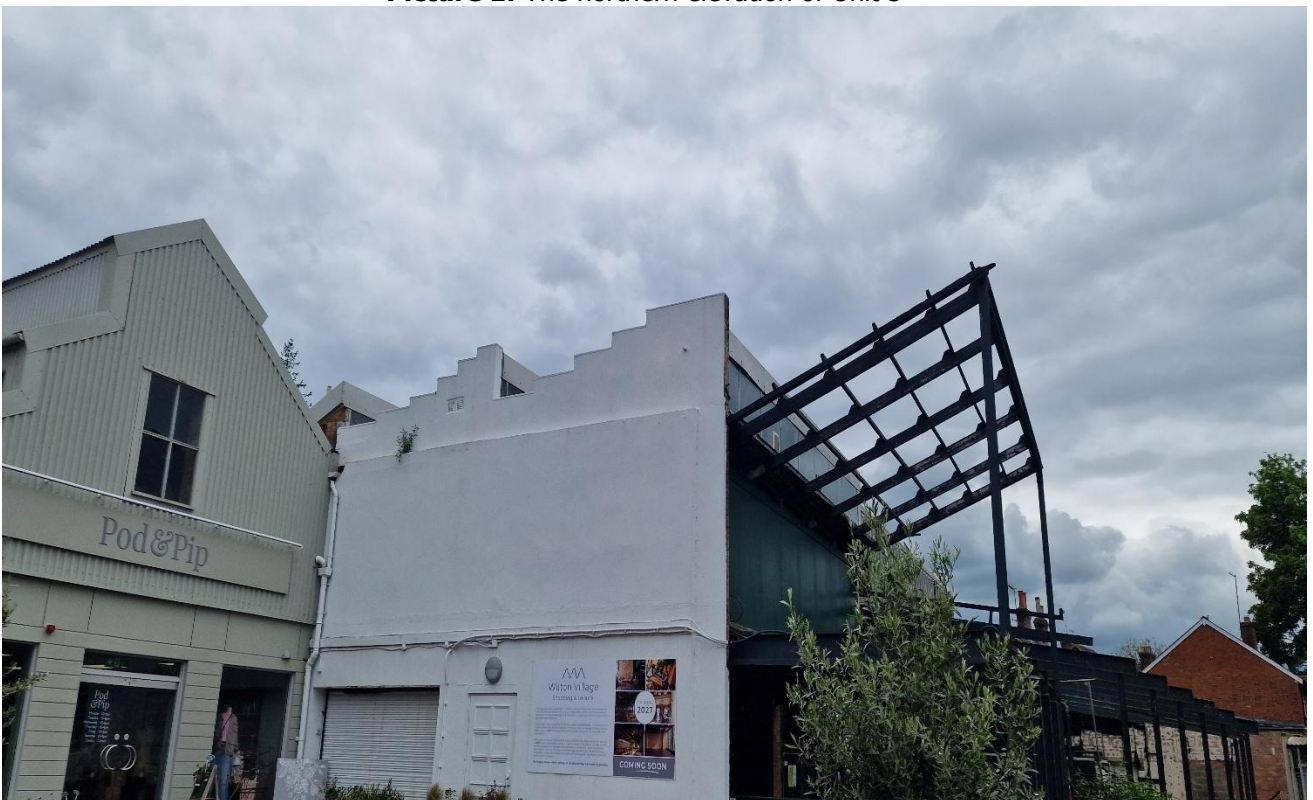
**Picture 2:** The eastern elevation of Unit 5

- 5.2 It is recommended that two wall-mounted **Schwegler 2FE Wall-Mounted Bat Shelters** are installed, one on the eastern elevation and one on the western elevation, as shown indicatively on Figure 3. It is also recommended that two **Vivara Pro WoodStone Wagtail/Dipper Nest Boxes** are installed beneath the walkway at the western end of the site, as shown indicatively on Figure 3.

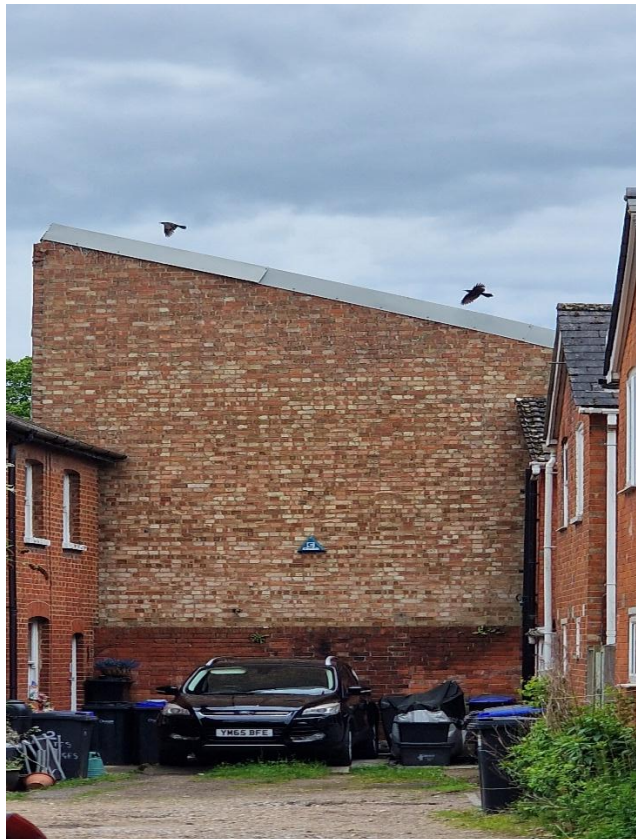
**Pictures 3 and 4:** Western elevation of Unit 5

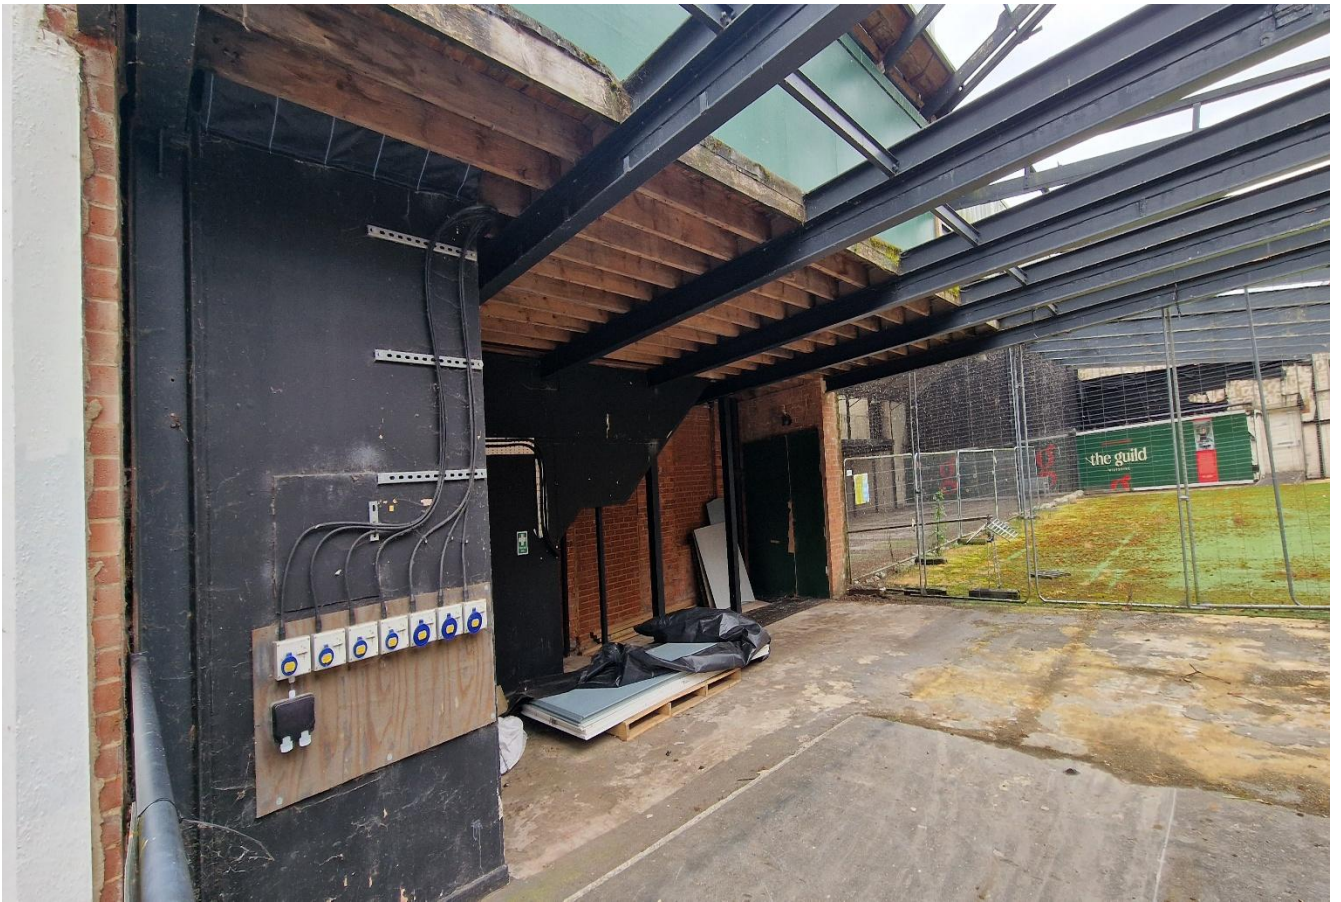
- 3.6 The internal inspection identified a large open-plan commercial unit with a substantial internal void beneath the sawtooth corrugated roof, which incorporates a series of rooflights/windows and is supported by exposed steel framing. The scale and openness of the internal space allowed a clear appraisal of the roof structure, internal wall surfaces and other features relevant to bat roost assessment.

- 3.7 The internal walls are formed predominantly of exposed red brick, and the northern elevation is partly open to the elements, with a combination of glazing and netting.

- 3.8 Notwithstanding the accessible nature of the building interior, the inspection did not identify any features considered suitable to support bat roosting within the parts of the structure relevant to the proposed works. In particular, no crevices, enclosed voids, lifted materials, sheltered junctions or other dark and undisturbed recesses of a type typically associated with roosting bats were identified during the survey.

- 3.9 No evidence of bat use was recorded during the internal inspection. Specifically, no bats, droppings, feeding remains, staining, scratch marks or other field signs indicative of current or recent bat occupation were observed in the areas inspected at the time of survey.

**Picture 5:** Internal view of Unit 5

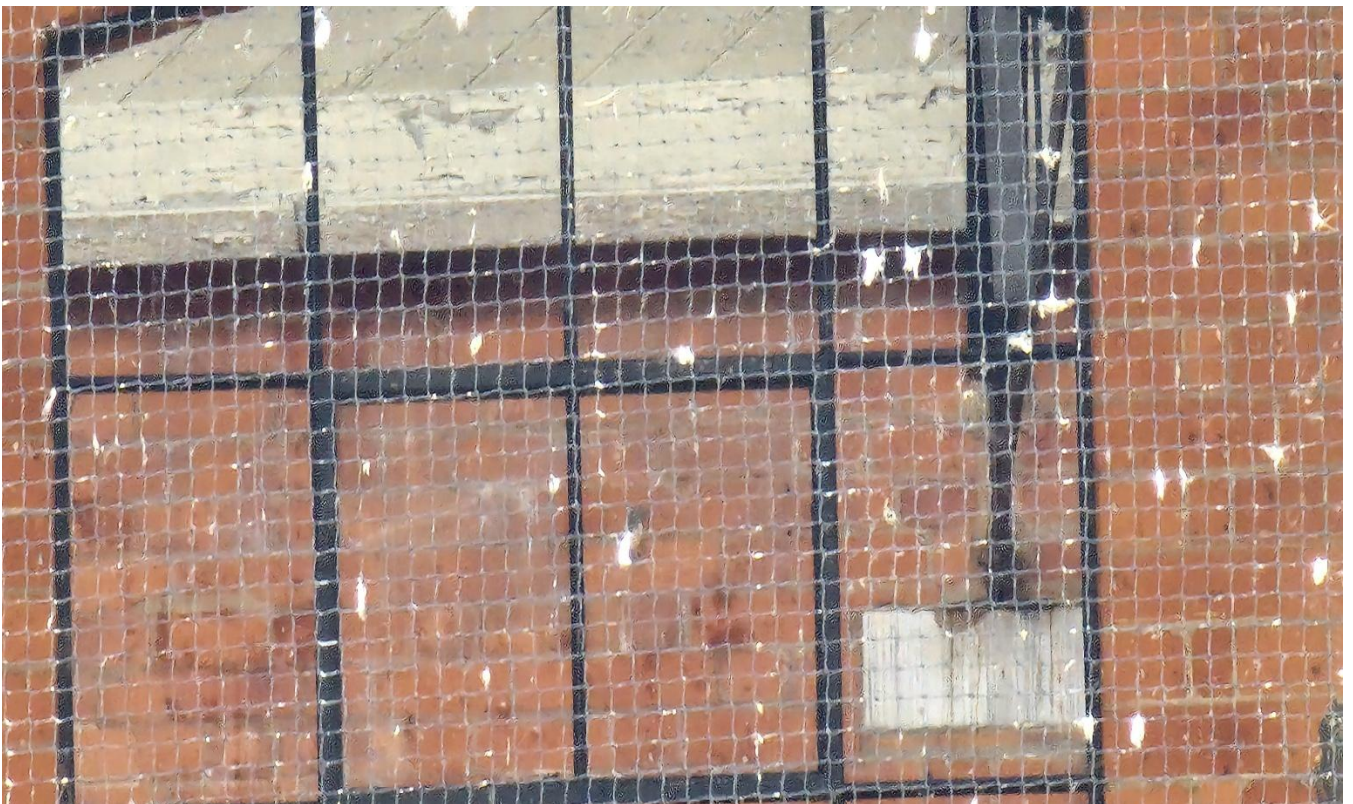
**Picture 6:** Internal view of Unit 5

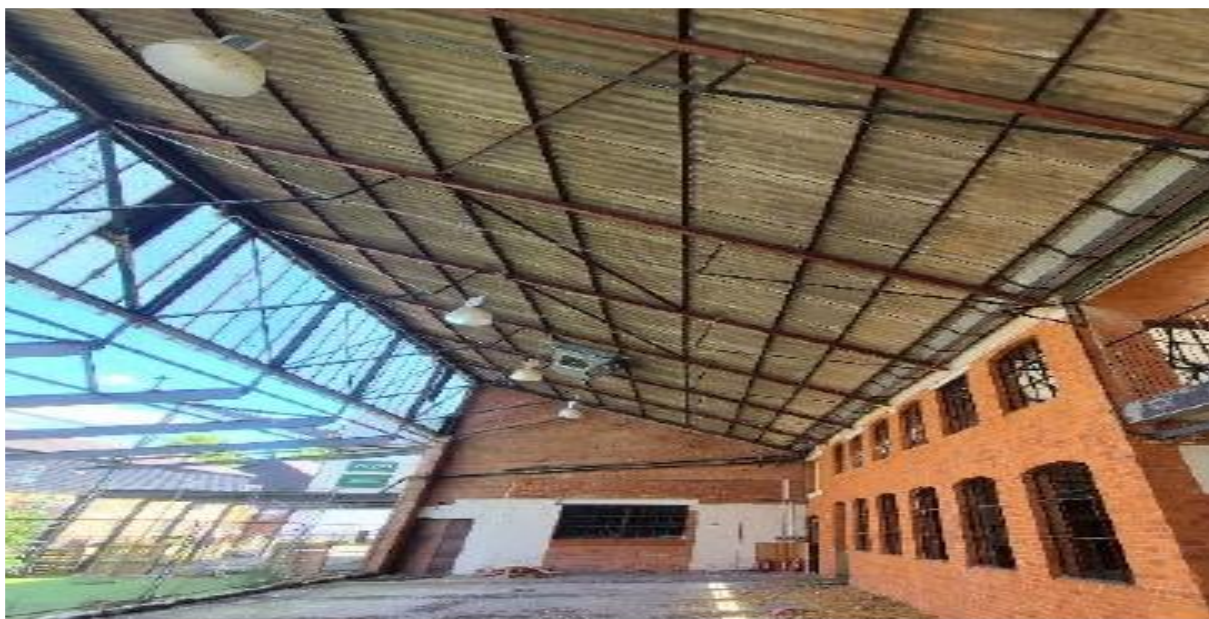
**Picture 7:** Internal view of Unit 5
