# GROUND TESTING LTD

## INSITU TESTING REPORT

| <b>Report No.</b> | 1476 - R.01(00) | <b>Date</b> | 23 March 2026 |
| <b>Contract</b> | Kings Arms, Trowbridge | | |

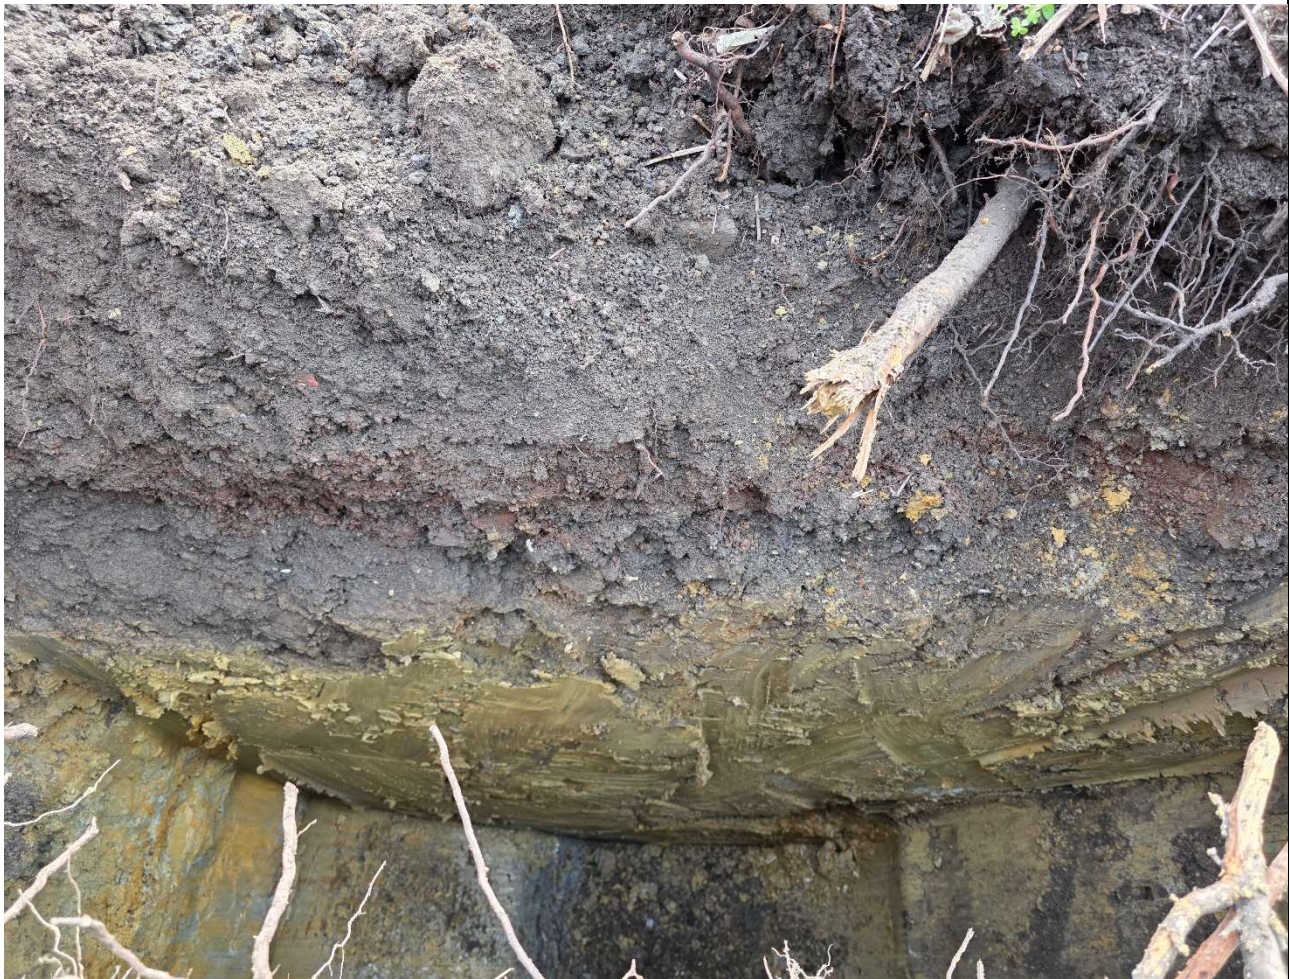
| <b>Comment</b><br>GW Pit<br><br>Slight ingress of water.<br><br>0.00-0.40m Brown slightly sandy gravelly CLAY many roots and rootlets (TOPSOIL)<br><br>0.40-1.80 Orangish greyish brown slightly sandy silty CLAY<br><br>1.80-2.30 Orangish brownish grey very sandy silty CLAY<br><br>Weather was sunny.<br>Pit was dug with a 8T JCB<br>Pit dimensions: <b>L 2.40m x W 0.40m x D 2.30m</b><br>NGR: <b>ST 86086 60164</b> | <b>Project</b><br>Kings Arms, Trowbridge |
