**Buildings at Teffont House Hotel, Teffont Evias  
Preliminary Roost Assessment  
July 2026**

**Report Title:** Buildings at Teffont House Hotel:  
Preliminary Roost Assessment

**Report reference:** THH26.02

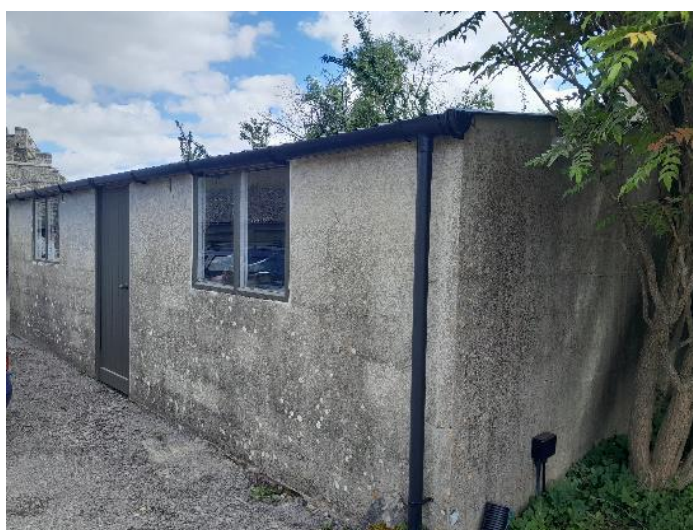
Photo 1. B1 northern and western elevations

Building 1 (B1) is a storage building with a corrugated metal mono pitch roof and three stone walls, the fourth wall which adjoins building 2 (B2) is fibrous cement. B1 only has one door on the northern elevation and two large windows, on the same elevation. There were gaps between the tops of the walls and the roof structure but the building material and high levels of light penetration make it unsuitable for roosting bats. No signs of bats were found inside or outside of the building.

The buildings are largely constructed of material not suitable for bat roosting, with considerable drafts and high internal light levels. Therefore, the buildings are considered to have **negligible** suitability for roosting bats.

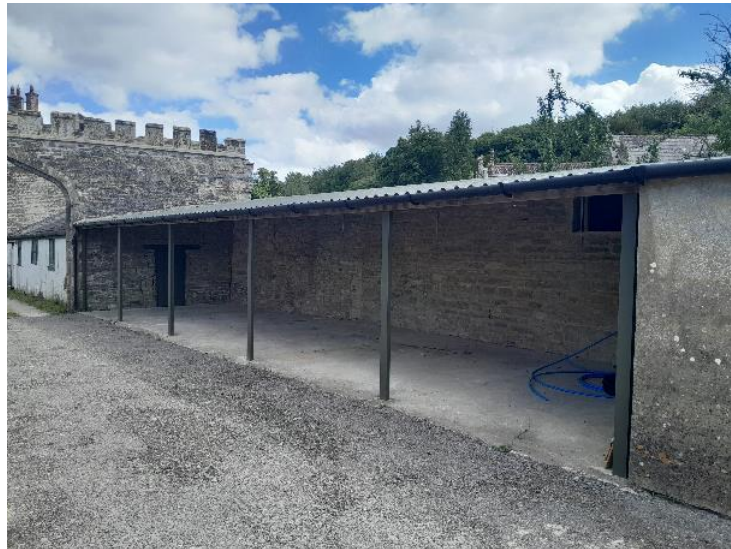
Photo 4. Northern elevation of B2

Building 2 is connected to B1 on the western elevation. It has a stone and mortar rear (southern) wall, which was in good condition and a mono pitch roof which matches B1 and is also corrugated metal. The northern elevation is open fronted. The eastern end connects directly to the house gateway arch. The building is open, light and drafty and is constructed from materials largely unsuitable for roosting bats. Whilst natural stone walls are suitable for roosting bats, the barn wall was in very good condition, with no gaps or voids. No signs of bats were found inside or outside of the building.
