**Historic Wall Condition Appraisal**

**Gateway Adjacent to 207 Boreham Road, Warminster**

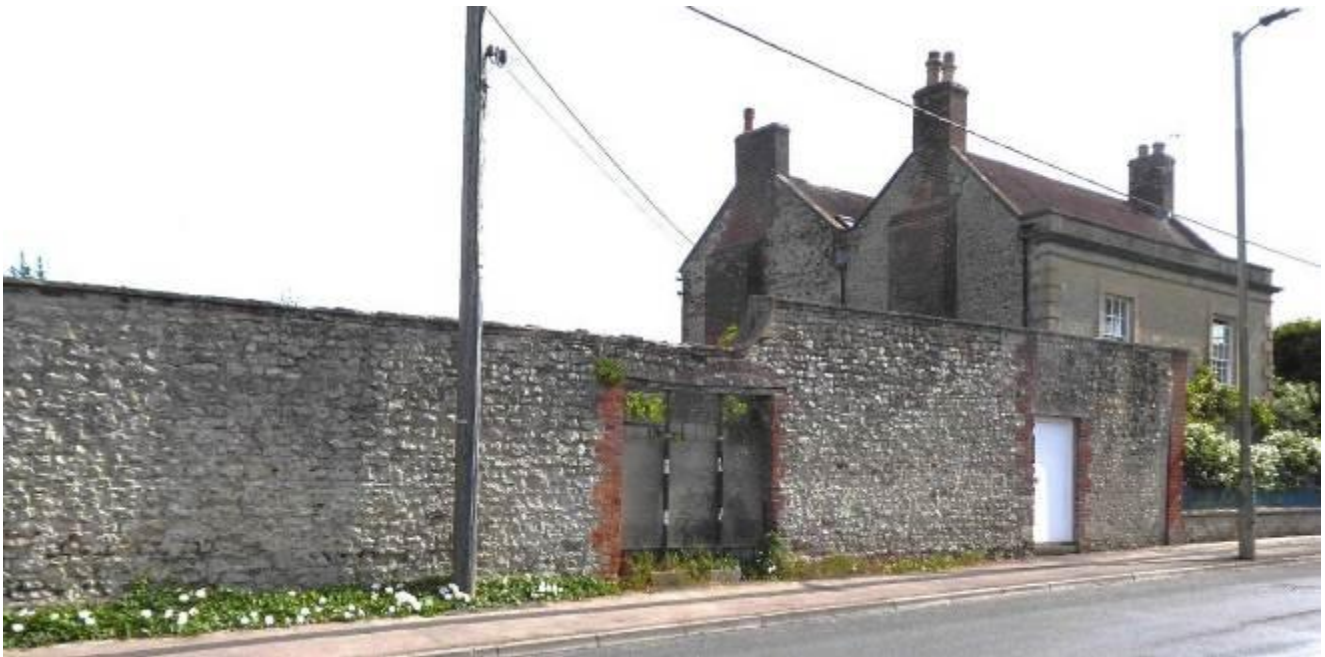
This is to consider a gateway in the wall to the south side of the land that is proposed to be developed and which abuts to the north side of Boreham Road. In this location the gateway is just to the west of the west boundary wall to 207 Boreham Road, Warminster, Wiltshire.

Gateway to the west of 207 Boreham Road

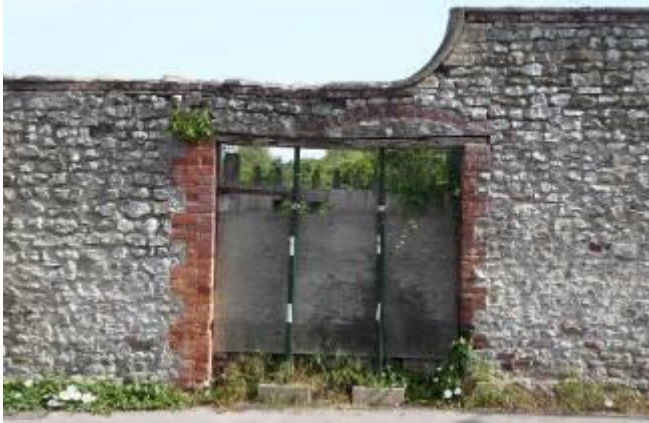
The wall is effectively upright and overall in a fair condition for its apparent age and form of construction, which from the road side is approximately 2.74 m high over the west end (left looking from the road) and 3.36 m over the east side, but where on the field side the ground

is about 0.65 – 0.75 m higher. From ground level to the shoulder of the opening the wall is 0.48 m thick, which to that point is approximately 2.2 m and which produces a slenderness ratio of 4.58, which is well inside Eurocode 6 ratio of 12. Above the shoulder of the arch the wall reduces in thickness to 0.38 m.

Gateway from the front (road)

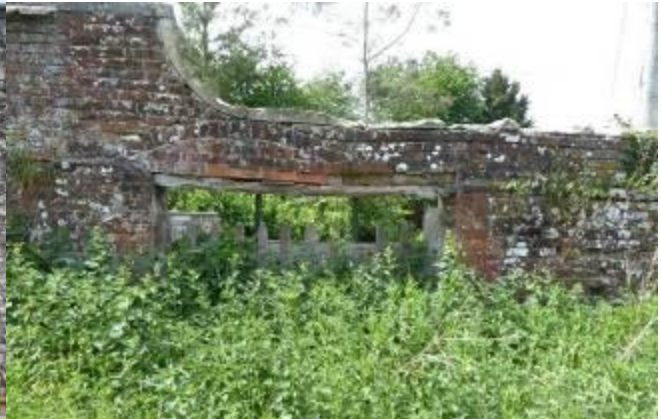
Gateway from the rear (field)

The main fabric to the road side face of the wall is a local high silicate chert sandstone type of material laid as random rubble or roughly squared blocks in lime mortar that has been much pointed with modern cement type mortar, which shows much sign of general surface erosion, but largely stable. The field side of the wall, where visible above high nettles, is largely of brickwork that is laid as a form of English garden wall bond, with a great deal of erosion of the mortar joints as well as brick faces, mostly due to historic frost spalling of similar.

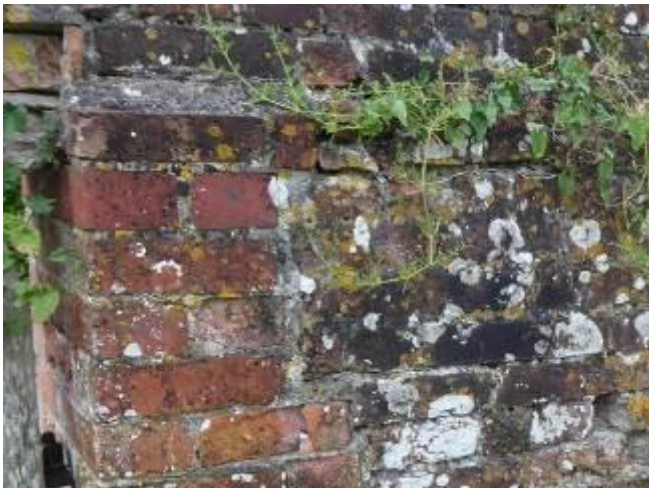
West side rear jamb

The mass of the brickwork employed in the wall, including the east quoining to the gateway is a handmade brick of a size suggesting a dating, for this area, to the early – mid 19th C, where this has a textured face and of a red / brown colour, that has weathered on the sheltered rear face almost to a red / purple. In comparison the bricks used to dress the west side of the opening are of larger format and appear to be an extruded or wirecut type of an orangey / red colour, which could suggest a date to the second quarter of the 20th C. The use of this latter brick would also suggest when the original opening in the wall, as indicated by the remnant cambered brick arch over, it was enlarged to its present configuration.

In consolidating this opening there will be a need for some general stabilisation work to the road side stone face, extending a minimum of 2.0 m on either side, which can be undertaken by carefully raking out and repointing this in an appropriately coloured and textured lime mortar to match that of the original fabric. On the rear face of the wall there will be a need for comprehensive raking out and repointing of the brickwork, as well as cutting out and replacement of excessively eroded or defective bricks with new matching coloured, textured and sized bricks.

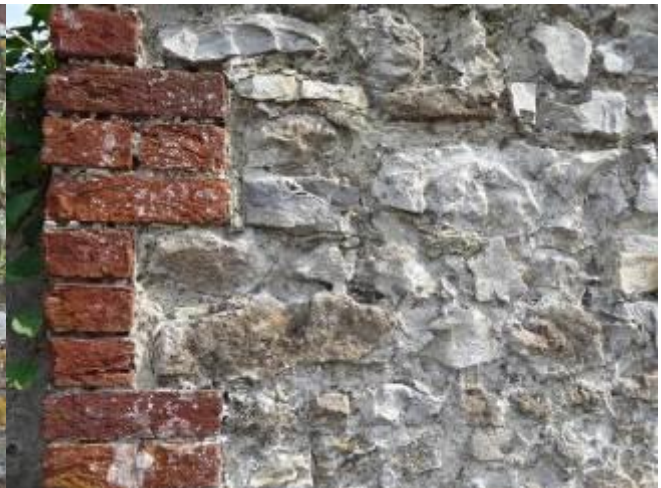
East side front jamb

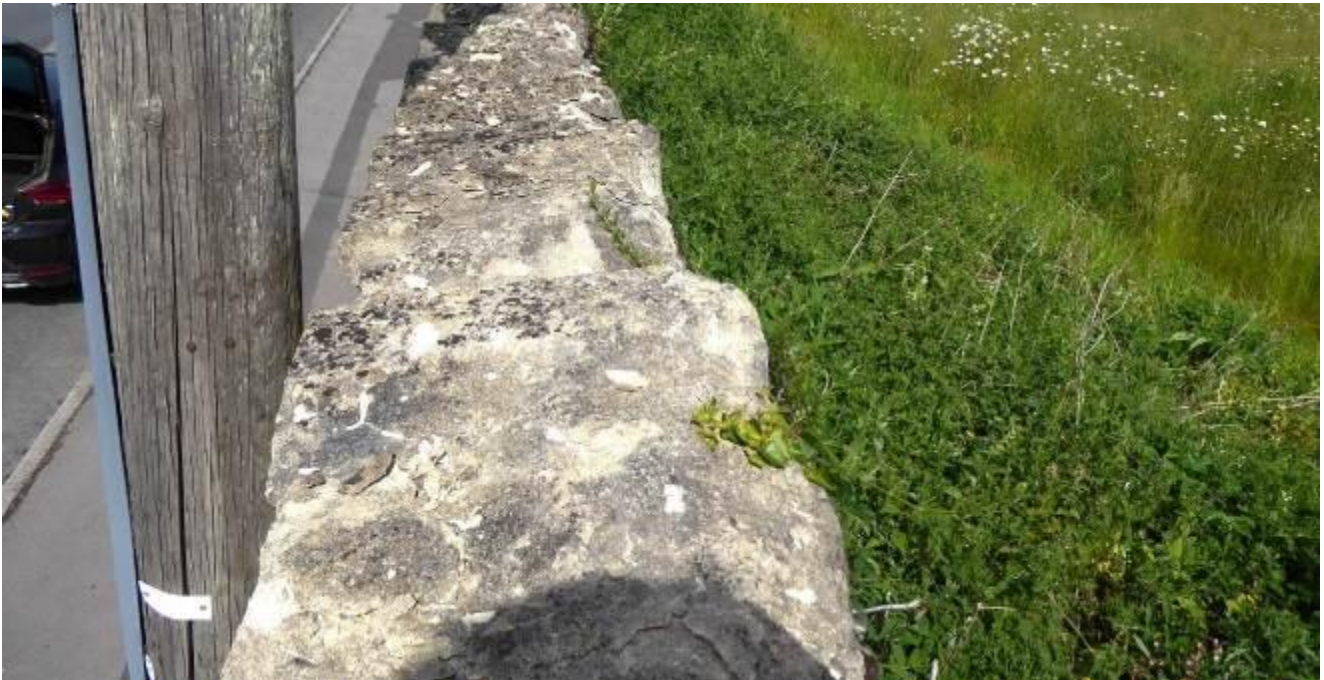
The wall is capped with natural stone coping stones, of a Bath type, which are set flush to the back face, where they are about 130 mm thick, and then taper down to an overhang at the front of about 25 mm and have a thickness of about 40 mm. These are all very severely eroded, with little or no taper and open joints between them so that water has easy access in to the head of the wall and which is likely to be resulting in further disruption and stabilisation of the fabric.

Severely eroded wall copings

At the same time as any stabilisation and repointing of the main wall fabric, the top of the wall will require new coping stones along the same length that is reconstructed, if not the whole wall. This should all be in new matching stone with a profile to match the existing, including the curving sections to the wall top level change for fully replicate that element. Pointing

mortar will need to be in lime and match in colour and texture to the stone and have a flush or only very slightly recessed joint.
