# Heritage, Design and Access Statement

High House Farmhouse, Corsley, Warminster, BA12 7NS

Longleat Estate – July 2026

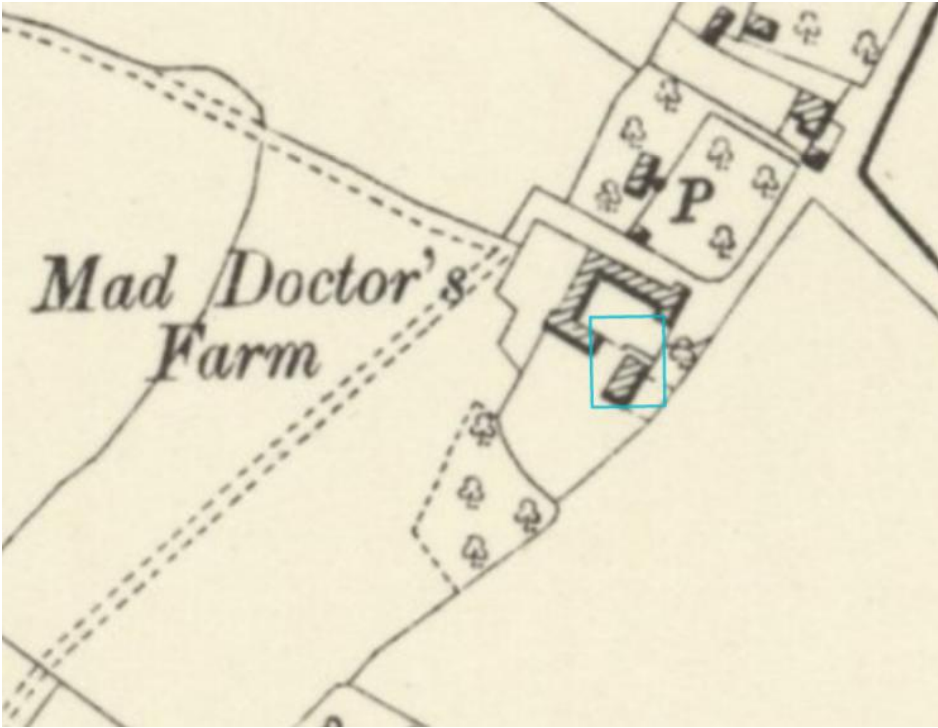
Figure 2: High House Farm Circa 1844 (Source: National Library for Scotland)

The embellishments in the architectural detailing and its subtle presence of grandeur suggest the building may have had a slightly elevated status in the community. The period of construction aligns with the enclosing of the land and formation of larger farms in the area, and these details suggest that High House would have been a prominent new farm at the time, and would likely have taken many of the local former small holders into its employment. A building can be seen on this site on maps from 1844 and the farm house appears close to its current form suggesting its development may have been minimal over time.

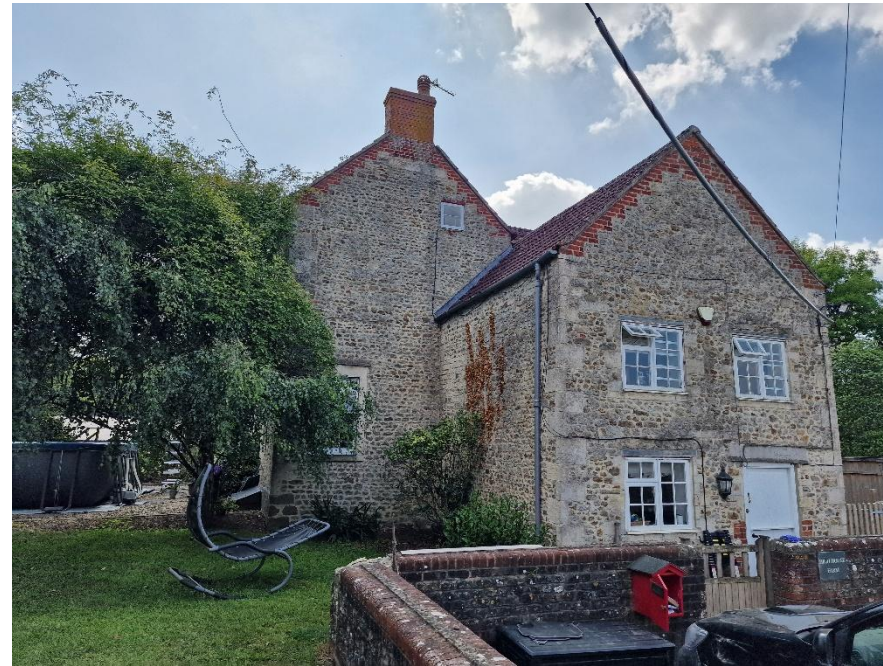
Figure 3: North elevation.

The building has a main range running approximately North to South with gabled out shoots to the West side likely being part of the original structure. A lower outshoot appears to have been added to the north and the western Gable structures have been linked the western extension between them.

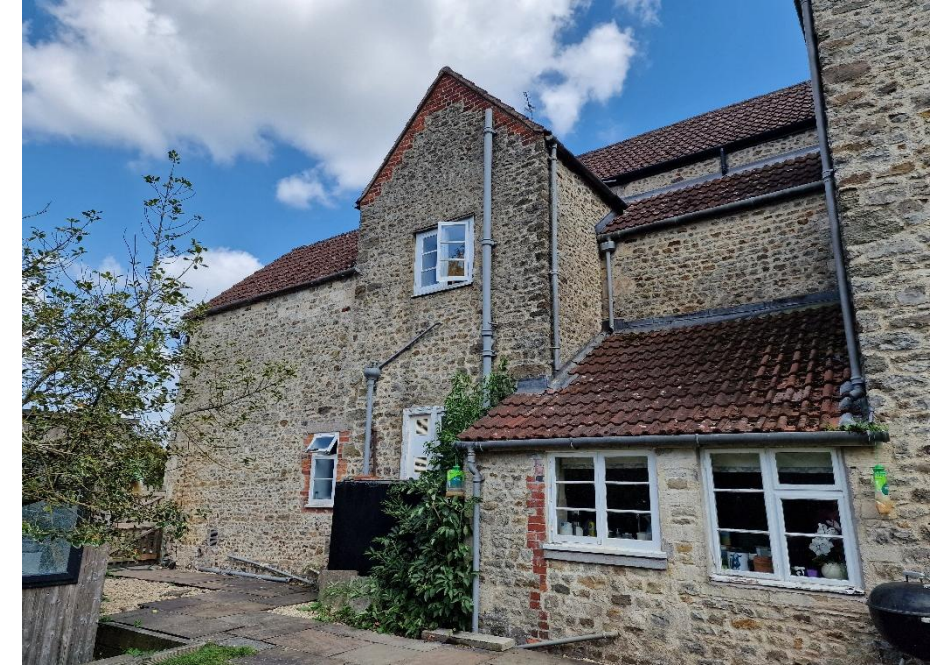
Figure 4: West elevation.

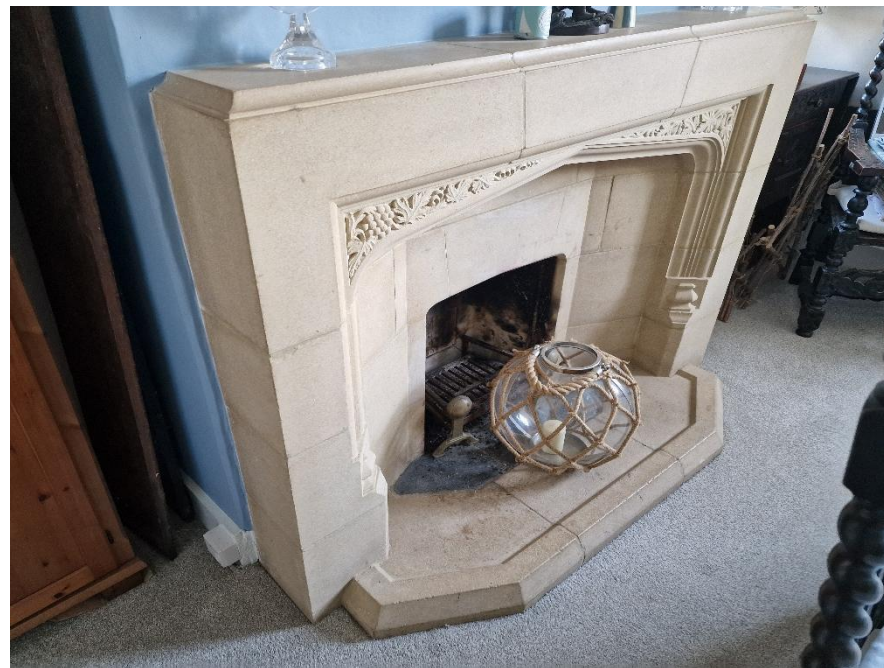
Figure 5: Dining room fireplace

The scale of the internal space gives some impression of grandeur with large floor areas and high ceilings. Modest but prominent carved stone fireplaces are the focal points of each of the main reception rooms.

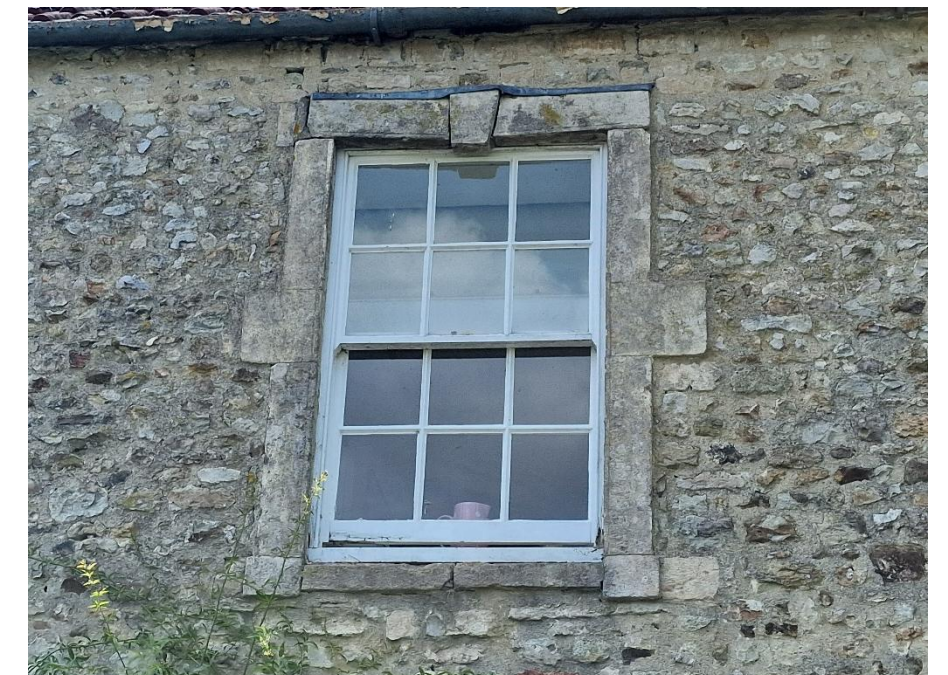
Figure 6: Main elevation boxed sliding sash windows.

The raised quoin details to the front walls and the box-sash windows with flat stone arches over on the main elevation provide an embellishment over basic architectural detailing of this vernacular style, and contrast to the more simple rear and side elevations.

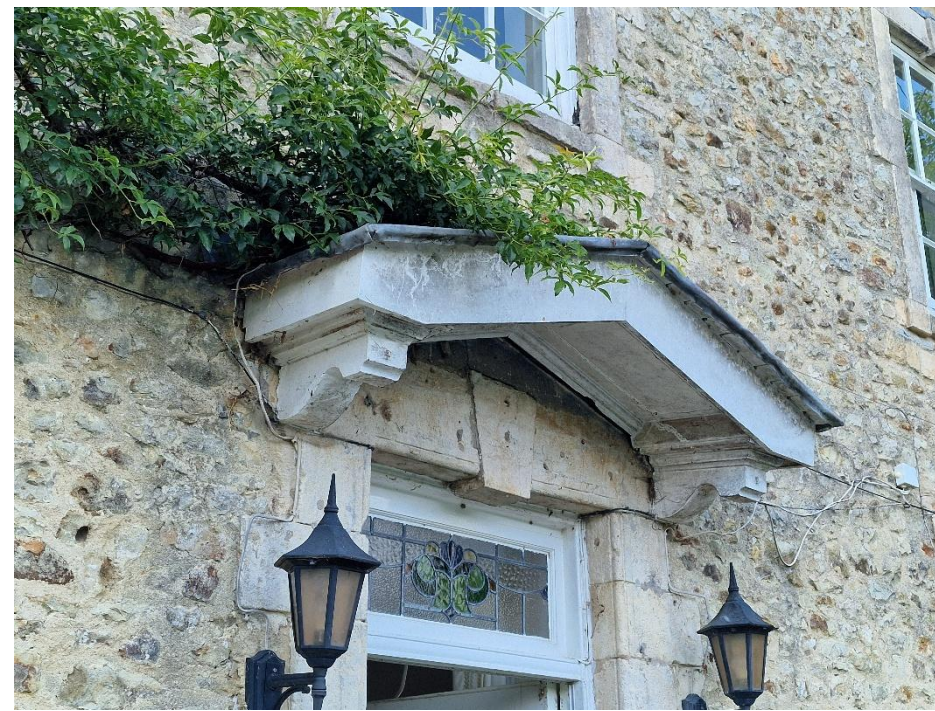
Figure 8: Timber and lead front door cover
