## PHASE 2 GROUND INVESTIGATION REPORT

**FOR  
HAWKE RIDGE BUSINESS PARK, MILL  
LANE, WESTBURY, WILTSHIRE  
BA13 4LD**

**Report No. 5636/3**

| Report Production Record | | |
|---|---|---|
| Report on | Phase 2 Ground Investigation | |

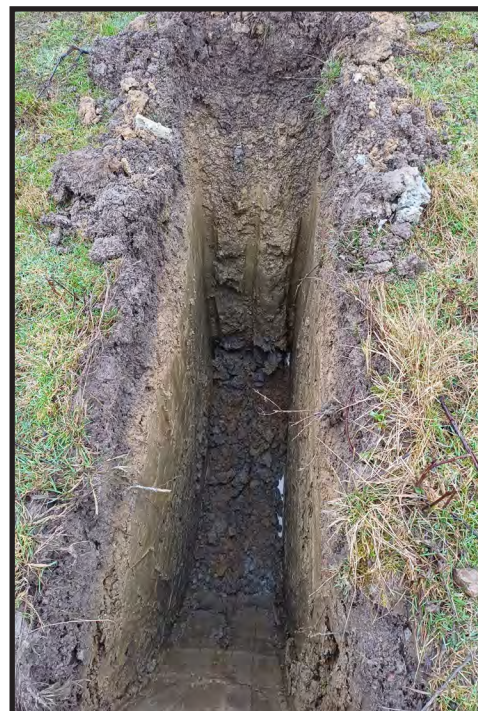
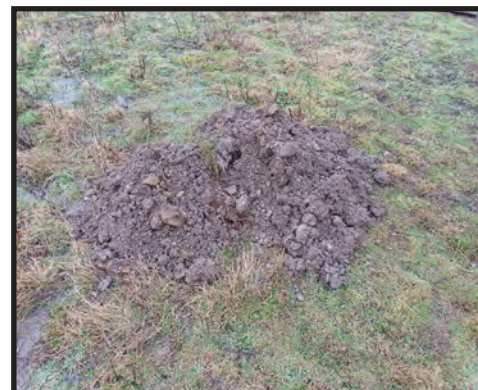
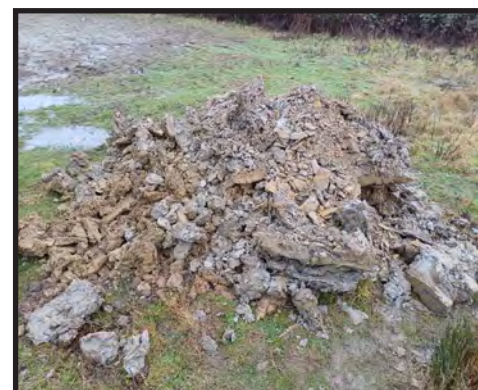
| <b>Site:</b> HAWKE RIDGE BUSINESS PARK, MILL LANE, WESTBURY, WILTS BA13 4LD | | | | <b>TRIAL PIT No.</b><br><br><b>TP1</b> |

- A** TOPSOIL: probable soft, dark brown, organic, saturated, slightly gravelly, plastic CLAY with many roots from over lying grass
- B** CLAY: probable firm, light brown, slightly gravelly, plastic CLAY; roots and desiccation evident to 1.6m (gravel is fine limestone)  
1.2m : becoming mottled light grey  
1.6m : recovered as coarse gravel of probable extremely weak mudstone, with occasional gypsum crystals  
(OXFORD CLAY FORMATION)

- Pit logged from surface
- Pit dry and stable
- Soil samples taken at 0.05m and 0.5m depth

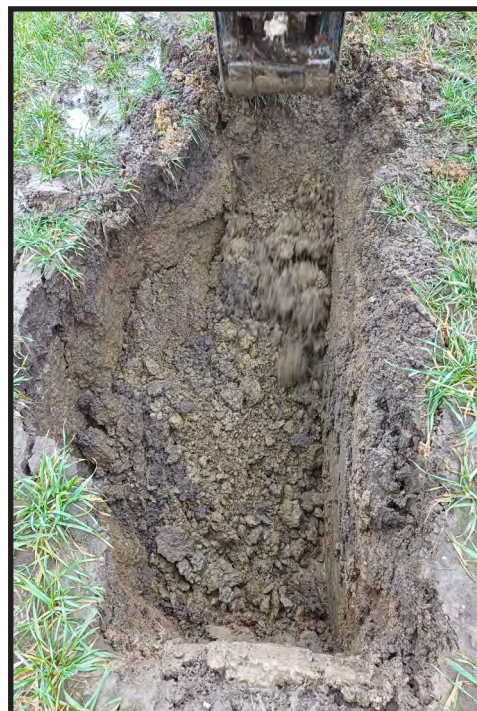
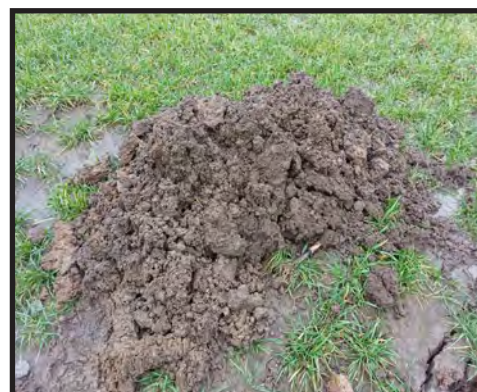
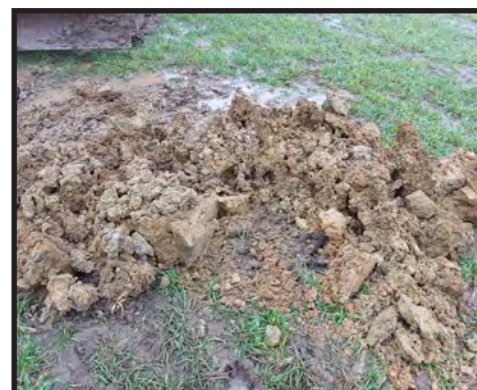
| <b>Site:</b><br>HAWKE RIDGE BUSINESS PARK, MILL LANE, WESTBURY, WILTS BA13 4LD | | | | <b>TRIAL PIT No.</b><br><br><b>TP2</b> |

- A TOPSOIL: probable soft, dark brown, organic, saturated, slightly gravelly, plastic CLAY with many roots from over lying grass and former crop (gravel is marlstone)
- B CLAY: probable soft, light orangish-brown, plastic CLAY with rare roots; wet and unstable (*ALLUVIUM*)
- C CLAY: probable firm, mottled light grey and orangish-brown, plastic CLAY with rare fine gravel of limestone; occasional gypsum crystals (*OXFORD CLAY FORMATION*)

- 1 Pit logged from surface; terminated due to side instability
- 2 Pit wet to 1.0m depth but stable
- 3 Soil samples taken at 0.25m and 0.4m depth

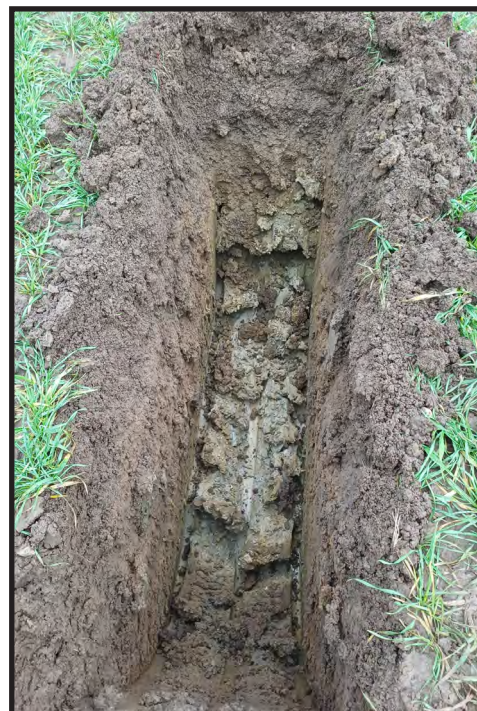
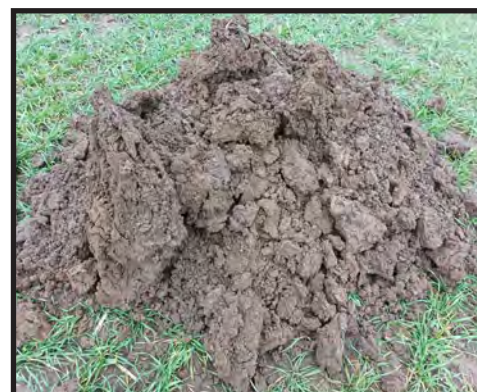
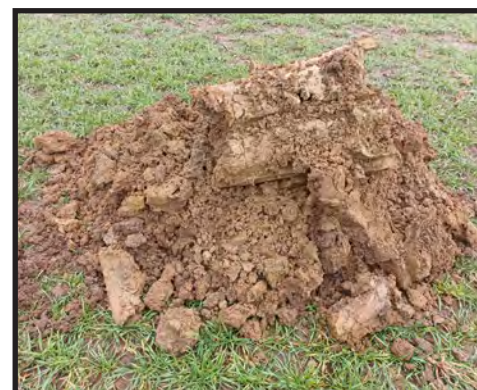
| <b>Site:</b> HAWKE RIDGE BUSINESS PARK, MILL LANE, WESTBURY, WILTS BA13 4LD | | | | <b>TRIAL PIT No.</b><br><br><b>TP3</b> |

- A TOPSOIL: probable very soft, dark brown, organic, plastic CLAY with profuse roots from former crops
- B CLAY: probable firm, orangish-brown, plastic CLAY with rare roots (ALLUVIUM ?)
- C CLAY: probable soft to firm, light brown, slightly gravelly plastic CLAY (gravel is fine limestone)  
1.0m : becoming probable firm, mottled light grey and orangish-brown (OXFORD CLAY FORMATION)

- 1 Pit logged from surface
- 2 Pit dry and stable
- 3 Soil samples taken at 0.0-0.2m, 0.4m and 0.8m depth

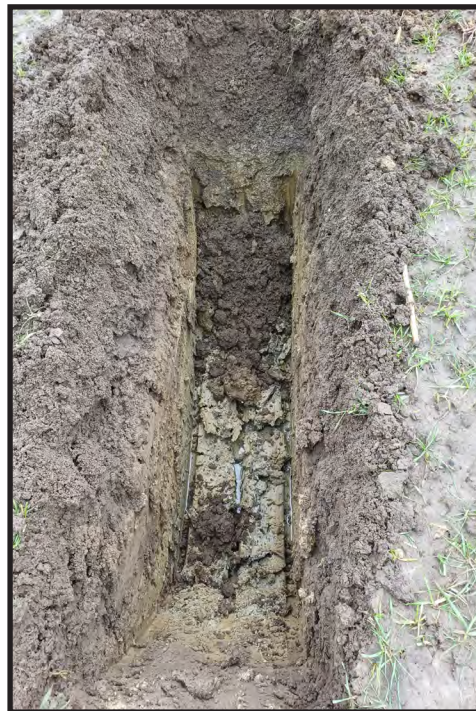
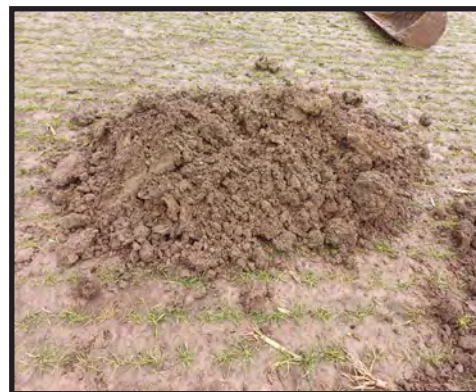
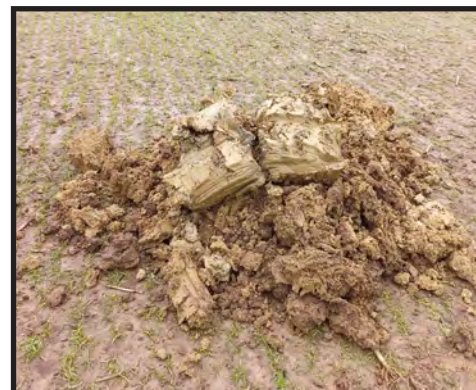
| Site: HAWKE RIDGE BUSINESS PARK, MILL LANE, WESTBURY, WILTS BA13 4LD | | | | TRIAL PIT No.<br><b>TP4</b> |

- A TOPSOIL: probable very soft, dark brown, organic, plastic CLAY with many roots from former crops; water seepage at base
- B CLAY: probable soft to firm, light brown, slightly gravelly plastic CLAY  
1.0m : becoming mottled light grey and light blue with occasional gravel of limestone  
(OXFORD CLAY FORMATION)

- Pit logged from surface
- Pit dry and stable
- Soil samples taken at 0.0-0.35m and 0.35-0.7m depth

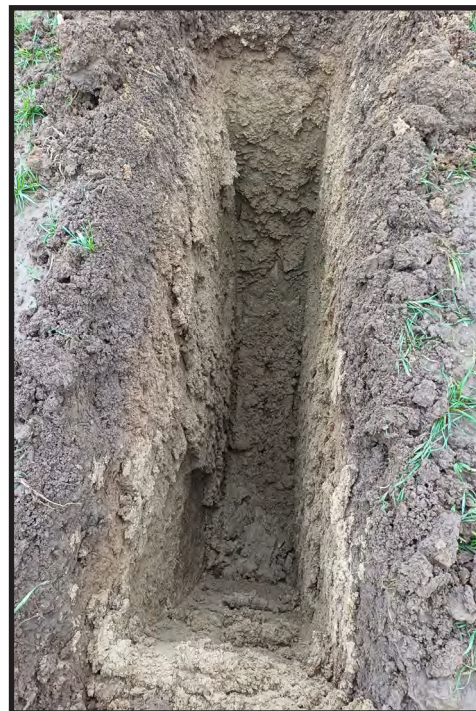
| <b>Site:</b> HAWKE RIDGE BUSINESS PARK, MILL LANE, WESTBURY, WILTS BA13 4LD | | | | <b>TRIAL PIT No.</b><br><br><b>TP5</b> |

- A TOPSOIL: probable very soft, dark brown, organic, plastic CLAY with many roots from former crop and localised desiccation
- B SILT/CLAY: probable soft light brown locally mottled grey, slightly sandy SILT/CLAY  
1.0m : water seepage and unstable below  
(ALLUVIUM)

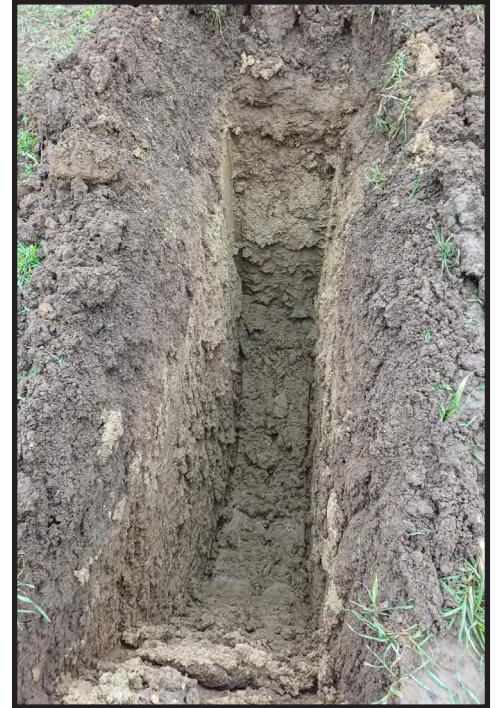
| <b>Site:</b><br>HAWKE RIDGE BUSINESS PARK, MILL LANE, WESTBURY, WILTS BA13 4LD | | | | <b>TRIAL PIT No.</b><br><br><b>TP6</b> |

- A TOPSOIL: probable very soft, dark brown, organic, plastic CLAY; locally desiccated; rare to medium fragments of brick
- B SILT/CLAY: probable very soft to soft, light brown, slightly sandy, plastic SILT/CLAY  
1.6m : water seepage, causing instability  
(ALLUVIUM)

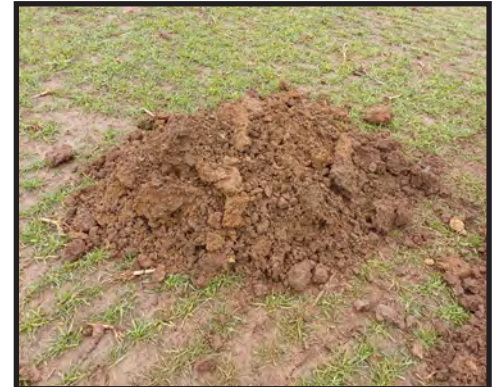
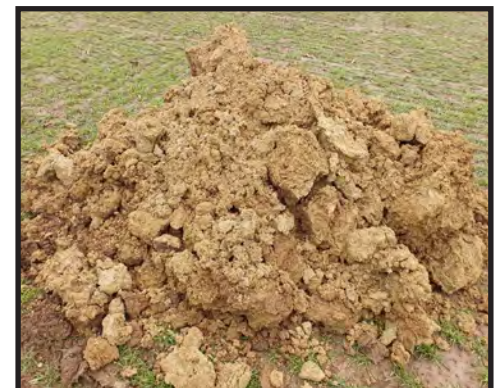
- Pit logged from surface; terminated at 1.7m due to instability
- Water seepage at 1.6m
- Soil samples taken at 0.0-0.3m depth

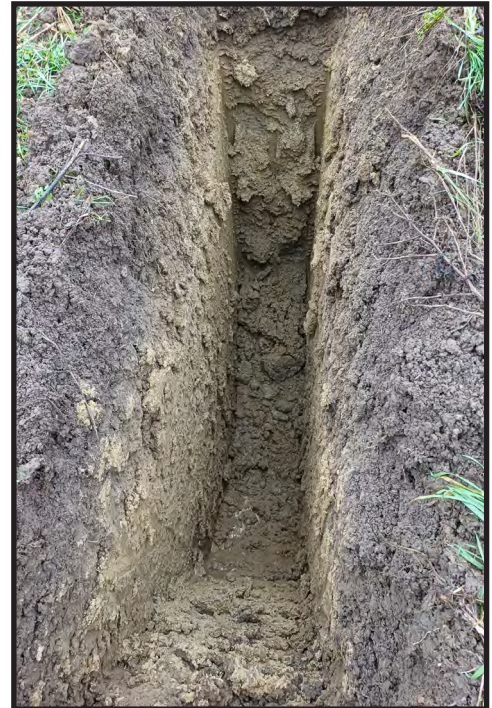
| <b>Site:</b><br>HAWKE RIDGE BUSINESS PARK, MILL LANE, WESTBURY, WILTS BA13 4LD | | | | <b>TRIAL PIT No.</b><br><br><b>TP7</b> |

- A TOPSOIL: probable very soft, dark brown, organic, slightly gravelly, plastic CLAY with many roots from overlying grass and weeds (gravel is medium to coarse brick, limestone of fine charcoal)
- B SILT/CLAY: probable soft, light brown/light orangish-brown, slightly sandy SILT/CLAY  
1.0 and 1.4m : water entering, stating to cause pit instability (ALLUVIUM)

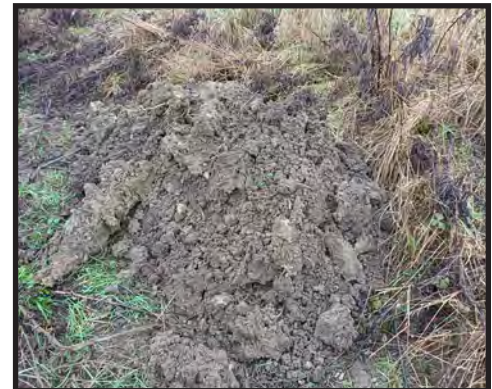
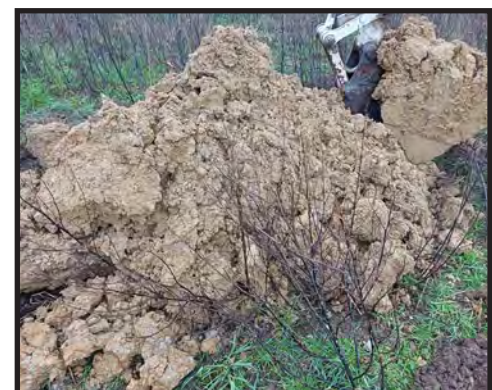
- Pit logged from surface
- Water entry at 1.0m and 1.4m. Pit unstable
- Soil samples taken at 0.0-0.2m and 0.75m depth

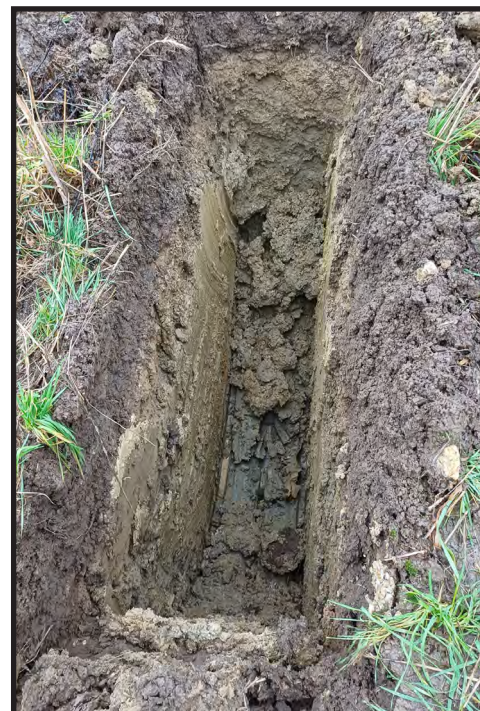
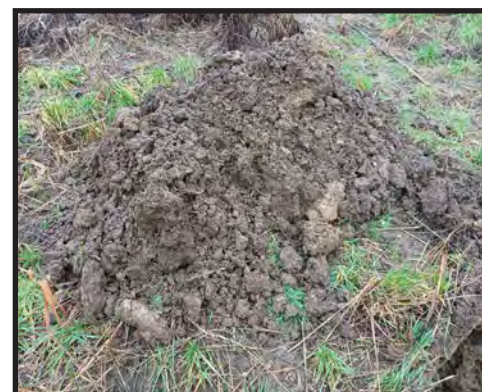
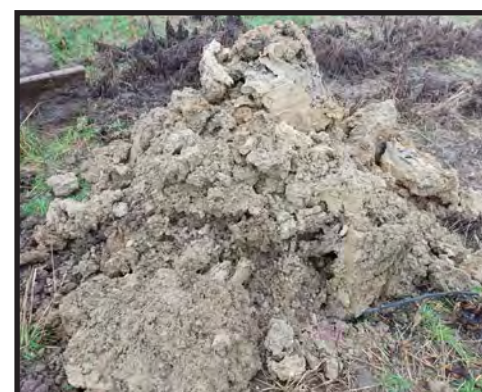
| <b>Site:</b> HAWKE RIDGE BUSINESS PARK, MILL LANE, WESTBURY, WILTS BA13 4LD | | | | <b>TRIAL PIT No.</b><br><br><b>TP8</b> |

- A TOPSOIL: probable soft, dark brown, organic, gravelly plastic CLAY (gravel is limestone)
- B SILT/CLAY: probable soft, light brown, slightly sandy, slightly gravelly, plastic SILT/CLAY (gravel is fine limestone)  
1.5m: water entering pit (ALLUVIUM)
- C CLAY: probable firm, mottled light brown and grey, slightly gravelly plastic CLAY (gravel is fine limestone)  
(OXFORD CLAY FORMATION)

- 1 Pit logged from surface
- 2 Water entry at 1.5m depth
- 3 Soil samples taken at 0.0-0.3m and 0.5m depth

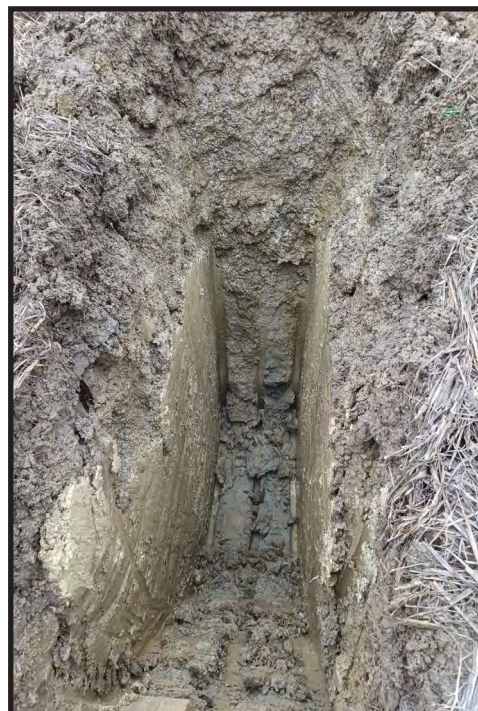
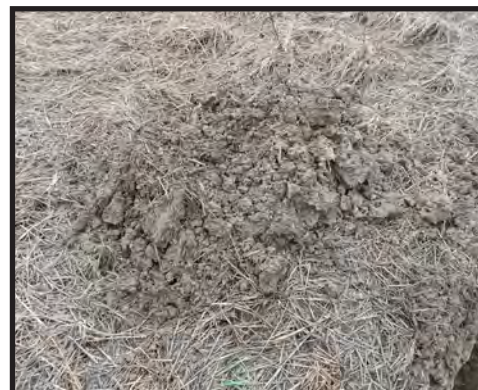
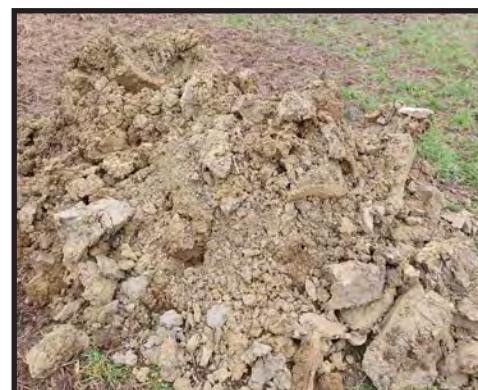
| <b>Site:</b> HAWKE RIDGE BUSINESS PARK, MILL LANE, WESTBURY, WILTS BA13 4LD | | | | <b>TRIAL PIT No.</b><br><br><b>TP10</b> |

- A TOPSOIL: probable very soft, dark brown, organic, very saturated, plastic CLAY (gravel is limestone)
- B CLAY: probable very soft, wet, brown, slightly gravelly, plastic CLAY (*ALLUVIUM*)
- C CLAY: probable soft to firm, light brown, plastic CLAY (*ALLUVIUM*)
- D CLAY: probable firm, mottled light brown and light grey, plastic CLAY; possible desiccation to 2.0m (*OXFORD CLAY FORMATION*)

- 1 Pit logged from surface
- 2 Pit wet to 0.5m depth
- 3 No samples taken

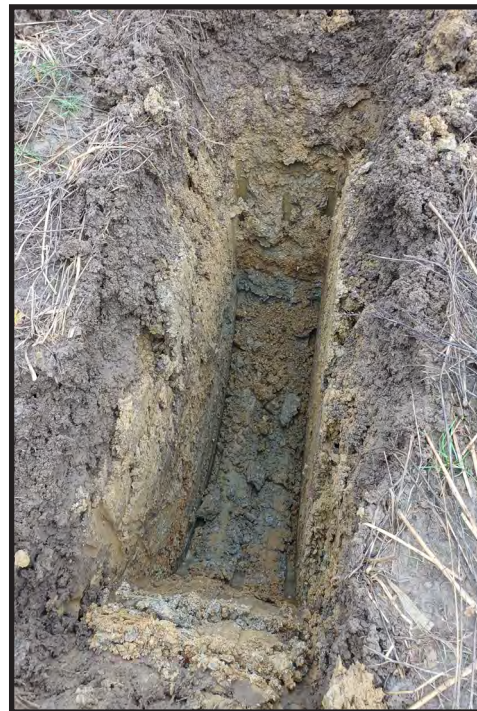
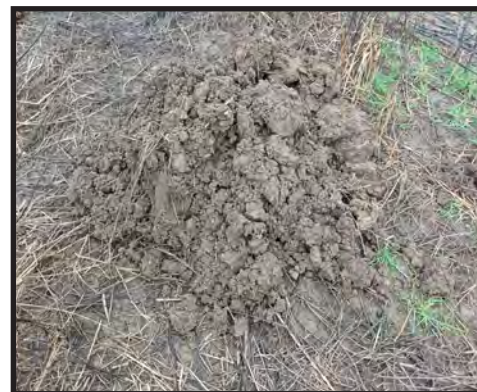
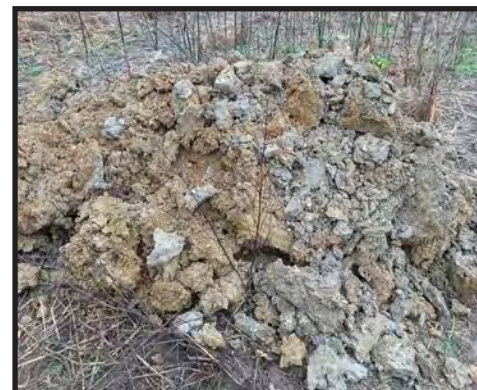
| <b>Site:</b> HAWKE RIDGE BUSINESS PARK, MILL LANE, WESTBURY, WILTS BA13 4LD | | | | <b>TRIAL PIT No.</b><br><br><b>TP11</b> |

- A TOPSOIL: probable very soft, dark brown, organic, saturated plastic SILT/CLAY, with many roots from overlying grass; water seepage at base
- B CLAY: probable firm to stiff, light brown, desiccated CLAY  
0.9m : becoming firm, mottled light brown and light grey plastic clay  
(OXFORD CLAY FORMATION)

- Pit logged from surface
- Pit dry and stable (water seepage at base of topsoil only)
- Soil samples taken at 0.0-0.3m and 0.6m depth
- Hand shear vane testing carried out:

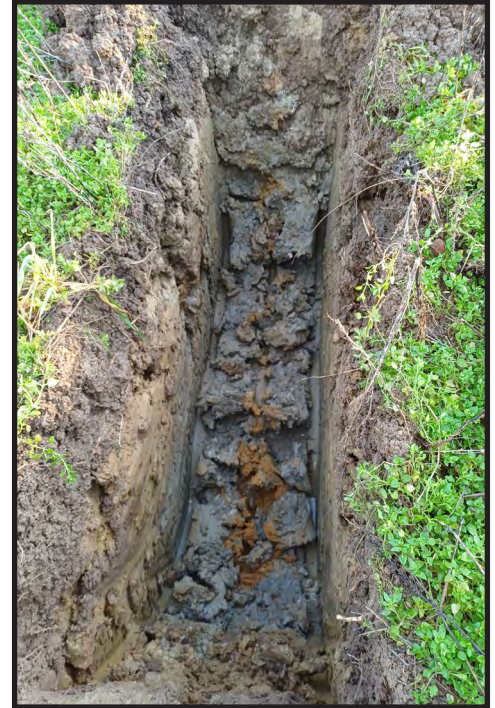
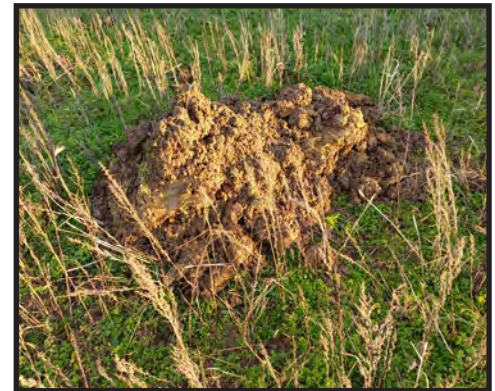
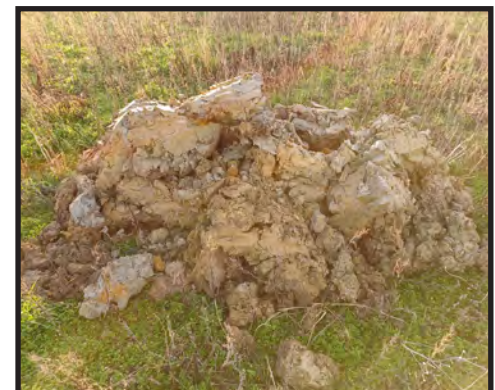
| <b>Site:</b><br>HAWKE RIDGE BUSINESS PARK, MILL LANE, WESTBURY, WILTS BA13 4LD | | | | <b>TRIAL PIT No.</b><br><br><b>TP12</b> |

- A TOPSOIL: probable very soft, dark brown, organic, slightly gravelly, plastic CLAY
- B CLAY: probable firm to stiff, light brown, plastic CLAY; rare roots and desiccation evident  
 0.7m : becoming mottled light brown and light grey, slightly gravelly, plastic CLAY (gravel is fine limestone and shell)  
 1.5m : appears normally hydrated with no relic desiccation below  
 1.7 - 1.8m : fine gypsum crystals  
 (OXFORD CLAY FORMATION)

- Pit logged from surface; roots encountered to 1.5m depth
- Pit dry and stable
- Soil samples taken at 0.0-0.25m and 1.0m depth
- Hand shear vane testing carried out:

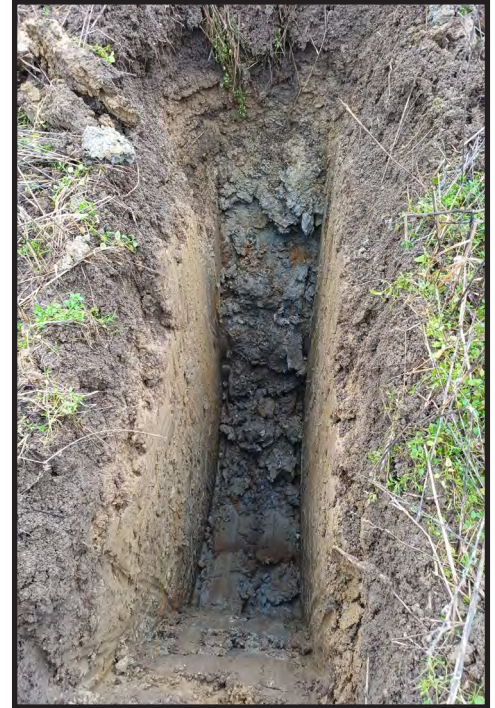
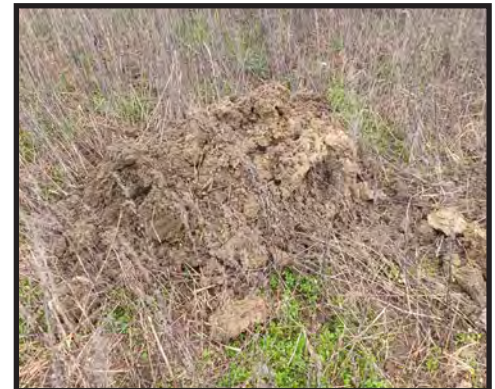
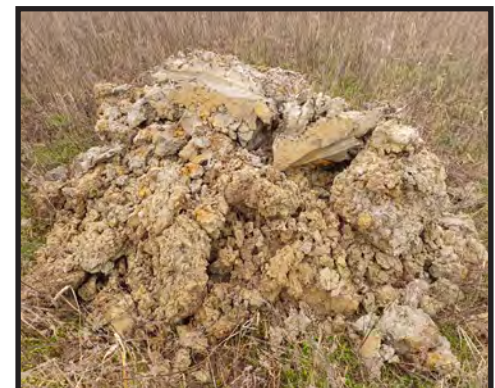
| <b>Site:</b><br>HAWKE RIDGE BUSINESS PARK, MILL LANE, WESTBURY, WILTS BA13 4LD | | | | <b>TRIAL PIT No.</b><br><br><b>TP13</b> |

- A TOPSOIL: probable very soft, dark brown, organic, saturated, plastic SILT/CLAY with profuse roots from overlying grass and adjacent hedgerow; water seepage at base
- B CLAY: probable firm to stiff, light brown, desiccated CLAY, with many roots  
 0.9m : becoming mottled light brown and light grey, desiccated CLAY, with occasional pockets of orange-brown CLAY  
 1.5m : showing relict mudstone structure and much fine gypsum crystals; appears normally hydrated  
 (OXFORD CLAY FORMATION)

- Pit logged from surface; possible hawthorn hedgerow cropped to 1.5-2.0m
- Pit dry and stable Water seepage at base of topsoil only
- Soil samples taken at 0.0-0.25m and 0.4m depth
- Hand shear vane testing carried out:

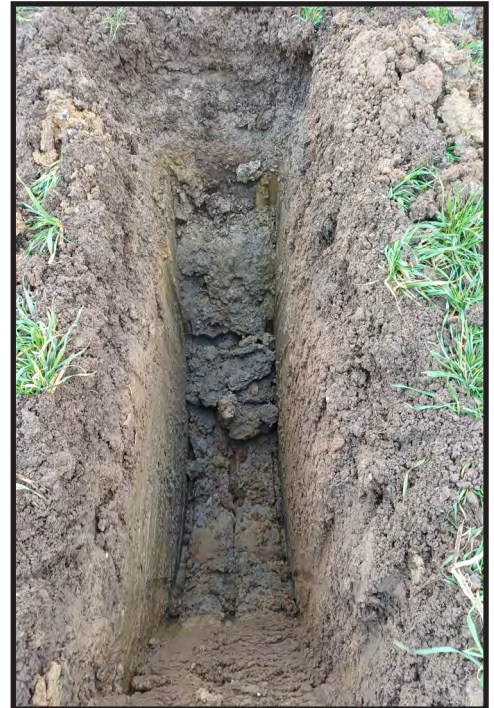
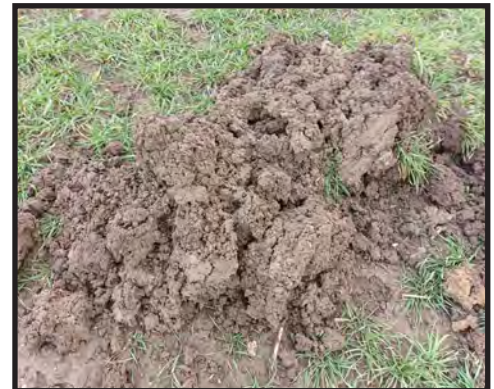
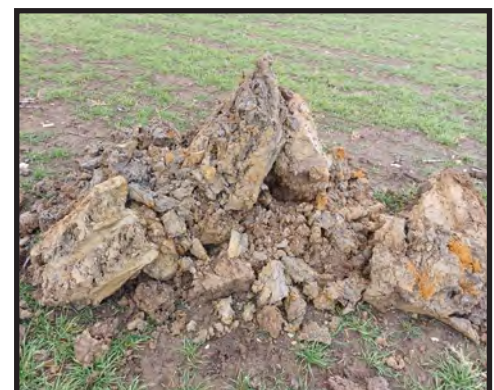
| <b>Site:</b> HAWKE RIDGE BUSINESS PARK, MILL LANE, WESTBURY, WILTS BA13 4LD | | | | <b>TRIAL PIT No.</b><br><br><b>TP14</b> |

- A TOPSOIL: probable very soft, dark brown, organic, plastic CLAY with occasional roots throughout
- B MADE GROUND: firm, light brown, plastic CLAY, with rare roots and rare charcoal; slight water seepage at base
- C CLAY: light brown, slightly gravelly, plastic CLAY (gravel is fine limestone)  
0.8m : becoming mottled light brown and light grey; roots encountered to 1.1m depth  
1.1m : showing relict mudstone structure (OXFORD CLAY FORMATION)

- 1 Pit logged from surface
- 2 Pit stable. Water seepage at base of made ground
- 3 Soil samples taken at 0.0-0.25m and 0.25-0.55m depth
- 4 Hand shear vane testing carried out:

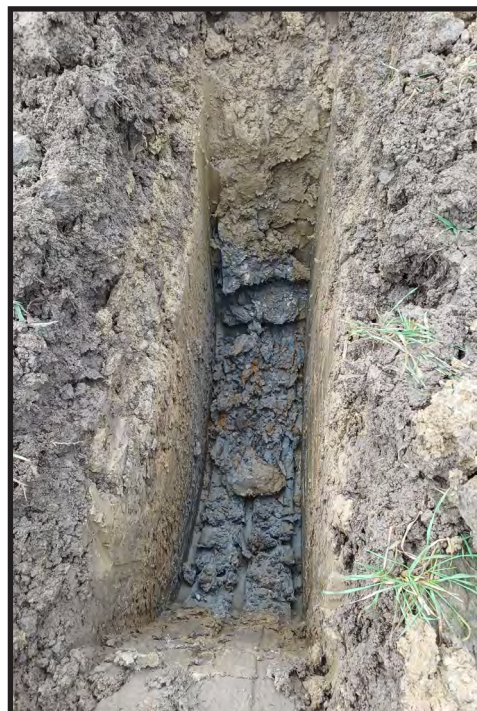
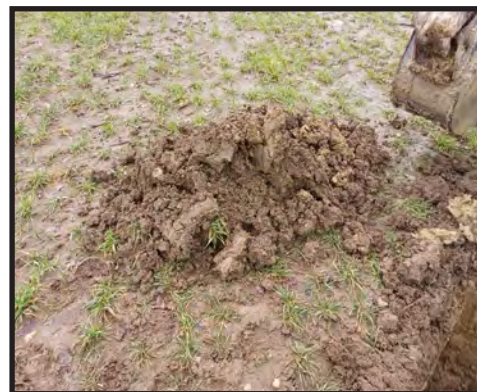
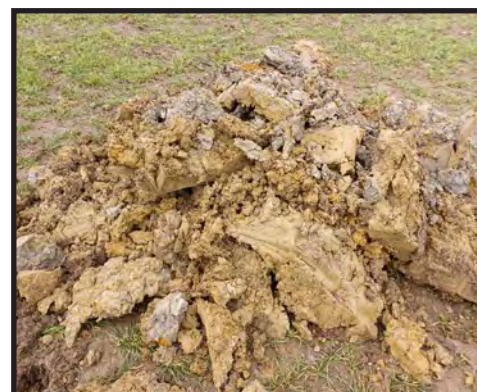
- A TOPSOIL: probable very soft, dark brown, wet, organic, plastic CLAY
- B CLAY: probable stiff, light brown, slightly gravelly, plastic CLAY  
1.0m : becoming mottled light brown and light grey (gravel is fine limestone and shell)  
(OXFORD CLAY FORMATION)

- Pit logged from surface
- Pit dry and stable
- Soil samples taken at 0.0-0.25m and 0.75m depth
- Hand shear vane testing carried out:

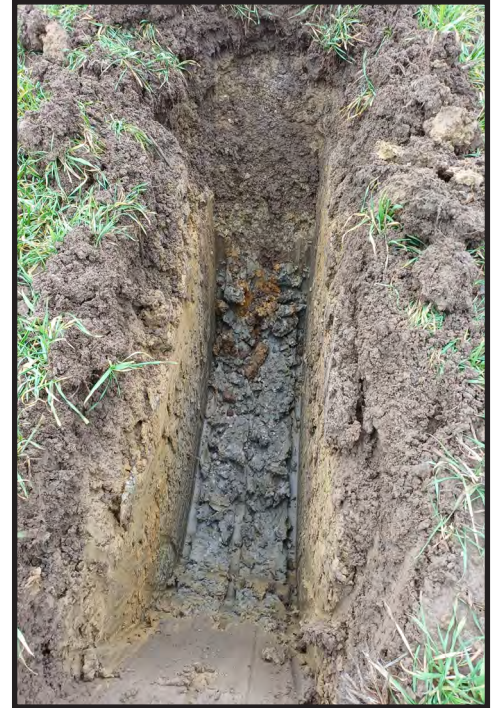
| <b>Site:</b><br>HAWKE RIDGE BUSINESS PARK, MILL LANE, WESTBURY, WILTS BA13 4LD | | | | <b>TRIAL PIT No.</b><br><br><b>TP16</b> |

- A TOPSOIL: probable very soft, dark brown, organic, plastic CLAY
- B CLAY: stiff, light brown, slightly gravelly to gravelly, plastic CLAY (gravel is fine to medium limestone)  
0.8m : becoming mottled light brown and light grey, plastic CLAY, with rare pockets of orange-brown clay  
(OXFORD CLAY FORMATION)

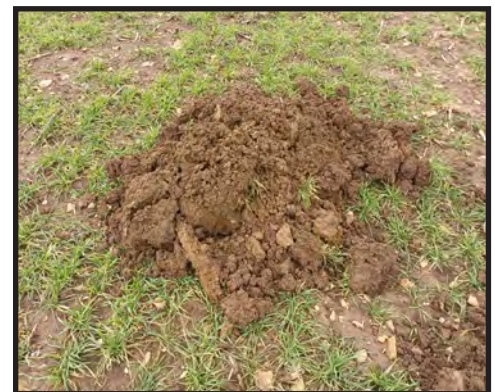
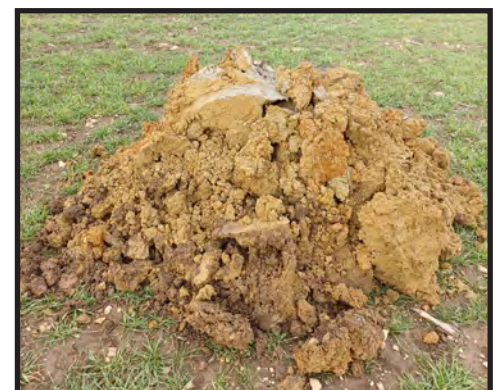
- A TOPSOIL: probable very soft, dark brown, organic, plastic CLAY with many roots
- B MADE GROUND: probable firm, brown, slightly gravelly, plastic CLAY (gravel is fine limestone, brick and charcoal); slight water seepage at base
- C CLAY: firm, light brown slightly gravelly, plastic CLAY (gravel if fine limestone), roots encountered to 1.0m  
1.2m : becoming stiff, with occasional pockets of orange clay (*OXFORD CLAY FORMATION*)

- 1 Pit logged from surface
- 2 Slight water seepage at base of stratum B; stable
- 3 Soil samples taken at 0.0-0.25m and 0.25-0.4m depth
- 4 Hand shear vane testing carried out:

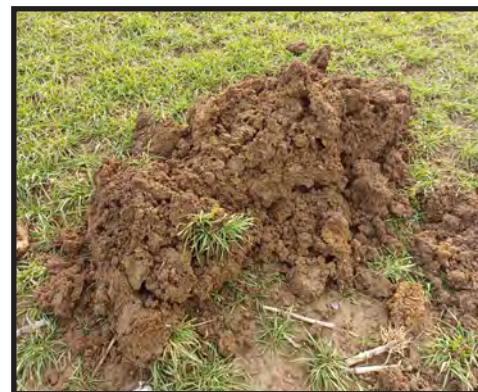
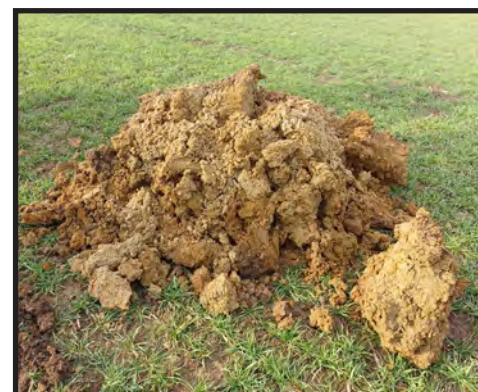
- A TOPSOIL: probable very soft, dark brown, organic, plastic CLAY
- B SILT/CLAY: probable soft, light brown mottled light grey, slightly sandy, slightly gravelly, plastic SILT/CLAY (gravel is fine to medium limestone and flint) (*ALLUVIUM*)
- C SAND/GRAVEL: probable loose, greyish-brown, very sandy, very clayey, fine to medium GRAVEL of limestone/very gravelly fine SAND; significant water entry leading to instability in stratum C only (*ALLUVIUM*)

- 1 Pit logged from surface
- 2 Significant water entry leading to instability in stratum C only
- 3 Soil sample taken at 0.0-0.2m depth

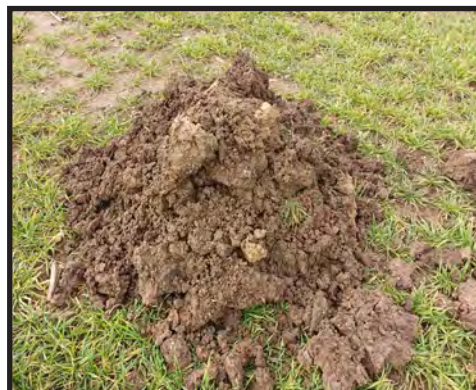
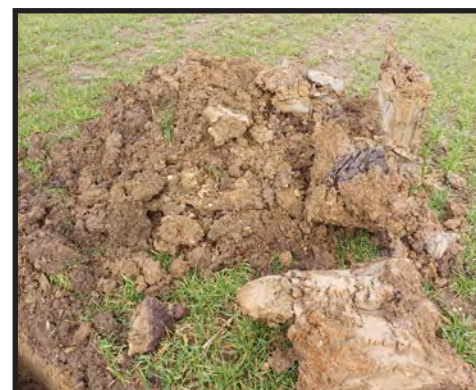
- A TOPSOIL: probable very soft, dark brown, organic, slightly gravelly, plastic CLAY (gravel is fine to medium limestone, brick, flint, charcoal)
- B CLAY: firm, dull greyish-brown, slightly gravelly, slightly sandy to sandy plastic CLAY (gravel is fine to medium limestone, occasional wood (former tree branch); water seepage at base leading to local instability (*ALLUVIUM*))
- C CLAY: stiff, initially light brown rapidly becoming mottled light brown and light grey, slightly gravelly plastic CLAY (gravel is fine limestone and shell (*OXFORD CLAY FORMATION*))

- 1 Pit logged from surface
- 2 Water seepage at base of stratum B, leading to local instability
- 3 Soil sample taken at 0.0-0.2m depth
- 4 Hand shear vane testing carried out:
