| Project | Date | Drawing |
|---|---|---|
| West Barn Farmhouse<br>West Yatton, Wiltshire | Aug 26 | Replacement Timbers Plan |
| Scale<br>1:100 @ A2 | | Rev: 2<br>Ref: WBF-211 |

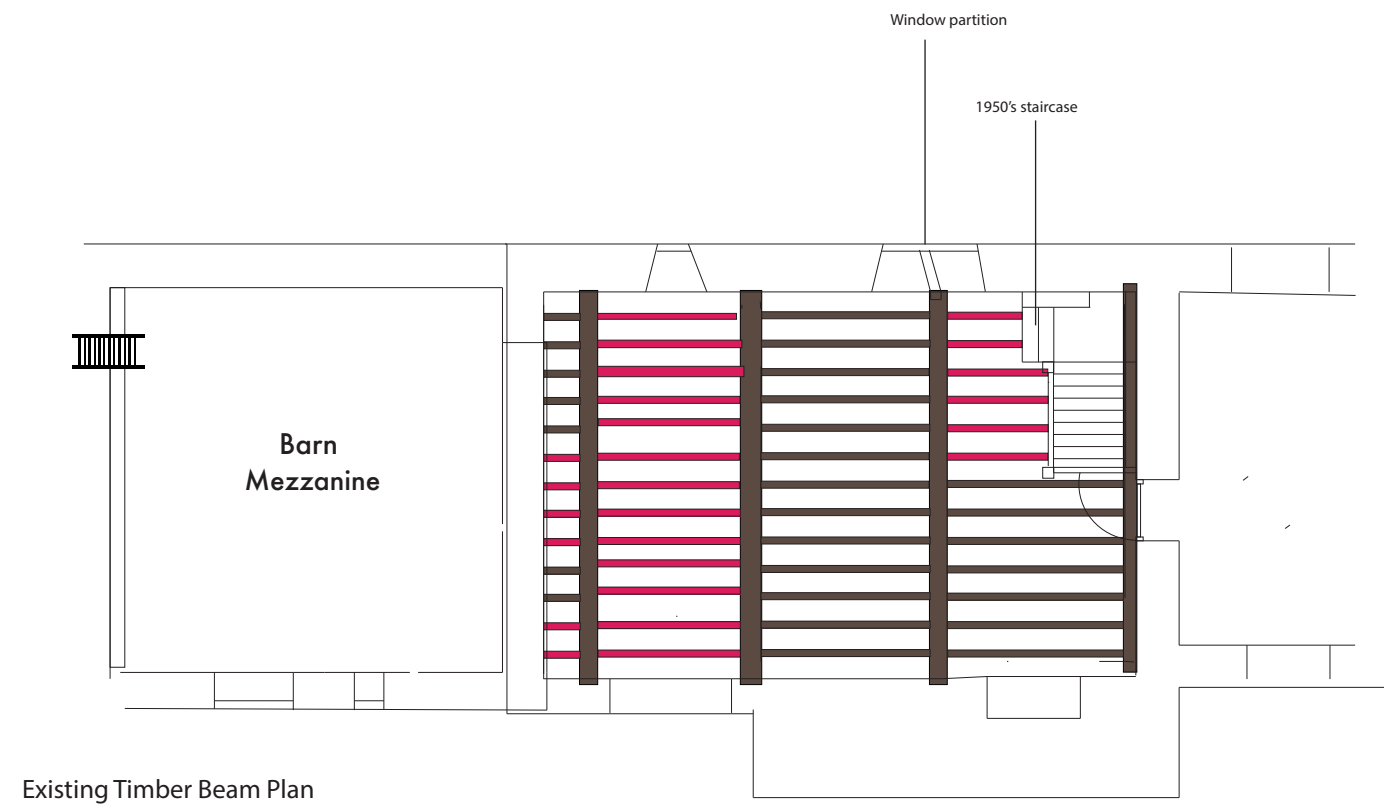
Existing Timber Beam Plan

Decayed beams /cut requiring replacement
