# STRUCTURAL REPORT (revision 25293-02d)

BARNs 4 AND 6  
PICKER PALMER FARM, CAPP LANE, HEYWOOD  
Prepared for:  
Mr J Buck  
Acorn Architectural  
Office 107  
8 The Bridge  
Chippenham  
SN15 1FY

3rd August 2026

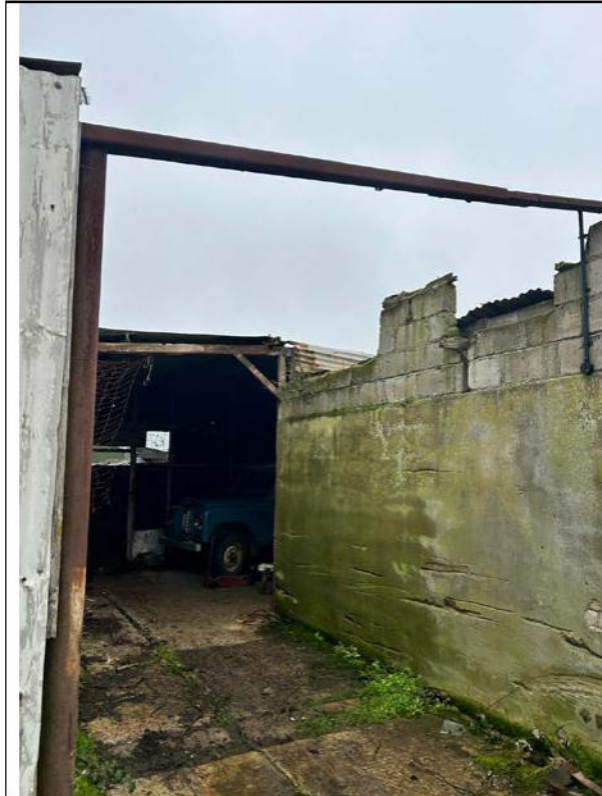
Barn 4 Front (Northern) Elevation

4.1.1 Barn 4 comprises a single-storey blockwork structure measuring approximately 9m x 3.3m in plan.

4.1.2 The building is constructed with single skin dense block external and internal walls.

4.1.3 The roof is of lean-to construction formed with timber purlins supporting single skin corrugated steel sheeting.

4.1.6 While the roof covering, purlins and walls would benefit from some upgrading works as part of the conversion - typical of a building of this age and agricultural history - the core structure is sound and well suited for conversion.

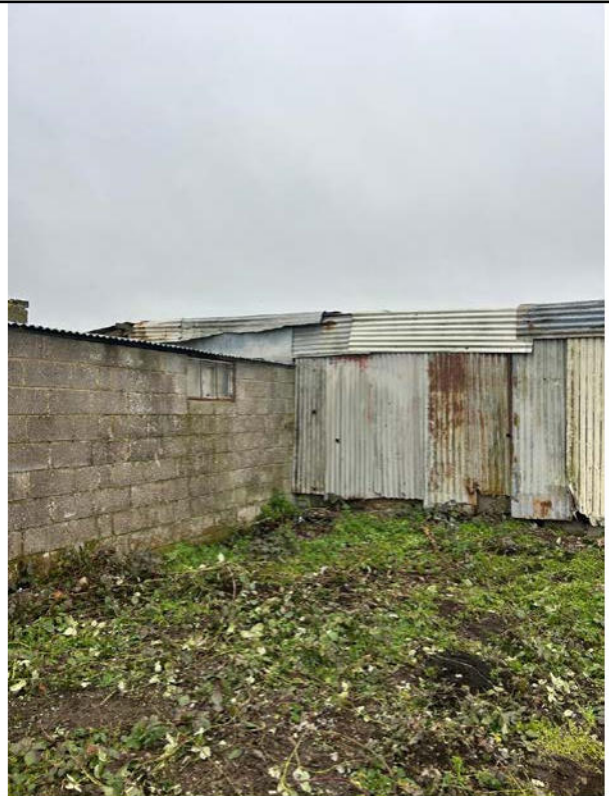
Barn 4 Rear (Southern) Elevation

4.2.8 The southern external wall has partially collapsed in one bay. Looks like it may have been struck with the top few courses coming off. Refer to Acorn Architectural drawing 2645-601 for location noted as “Partial wall collapsed”.

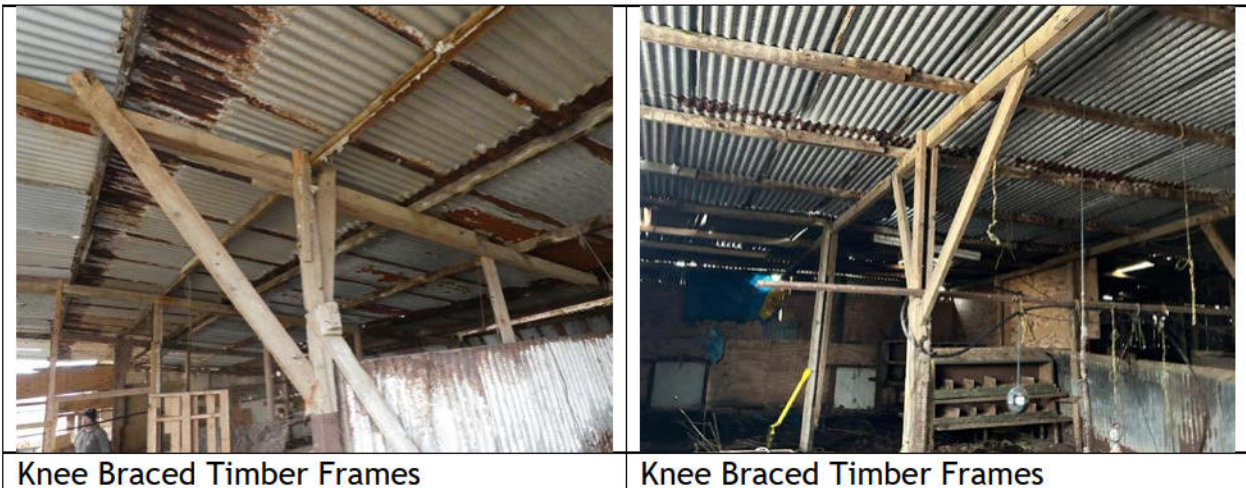
4.2.7 These frames incorporate knee braces (cruxes), a robust traditional detail which provides strong primary structural stability to the building.

Knee Braced Timber Frames

4.3.3 The timber frames are in good condition, structurally sound, and well suited for incorporation into the proposed conversion.

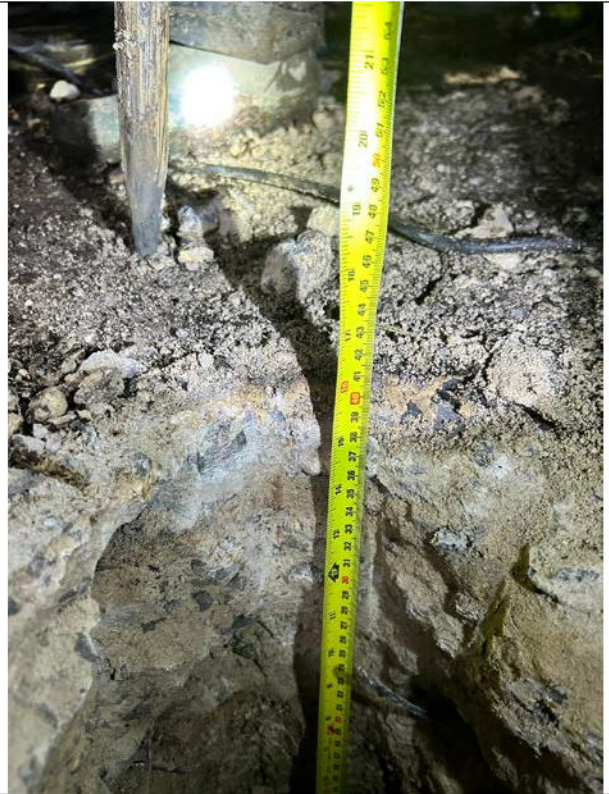
4.4.2 The slab was recorded as being approximately 400-500mm thick. Further investigations show the slab extends beyond the face of the external walls.

4.4.3 The building has historically been used for agricultural purposes, and the existing slab is generously proportioned and considered more than adequate for the proposed domestic loading; wind & snow loading will remain the same as the building has already successfully withstood.

Ground Bearing Slab 400-500mm
