ENVIRONMENTAL DESK STUDY  
AND  
PRELIMINARY  
RISK ASSESSMENT

Oak Tree Farm  
Crawlboys Lane  
Ludgershall  
SP11 9PL

September 2019

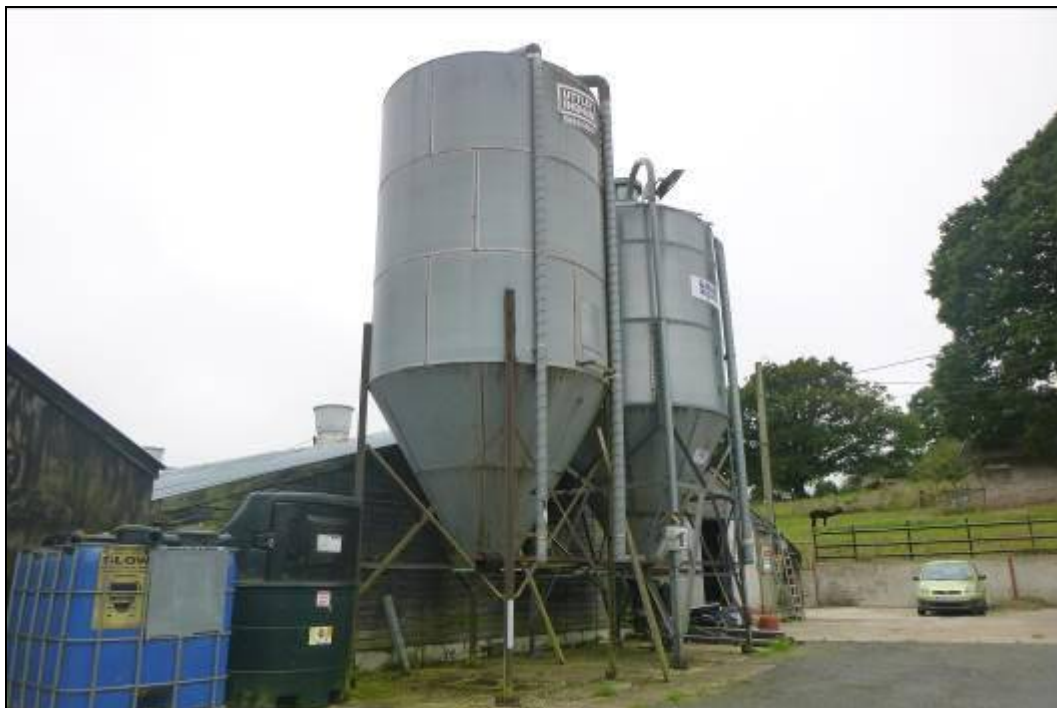
This northern section comprises a tarmacadam surfaced entrance way which extends into a concrete parking area. Adjacent to the parking area is the remaining poultry shed, in front of which there are two grain silos, an oil tank and an IBC containing liquid for vehicle disinfection. These are each positioned upon concrete plinths. There was no ground staining evident.

**Photograph 2** Showing the concrete parking area with the grain silos, oil tank and vehicle disinfectant outside the northern end of the existing poultry shed

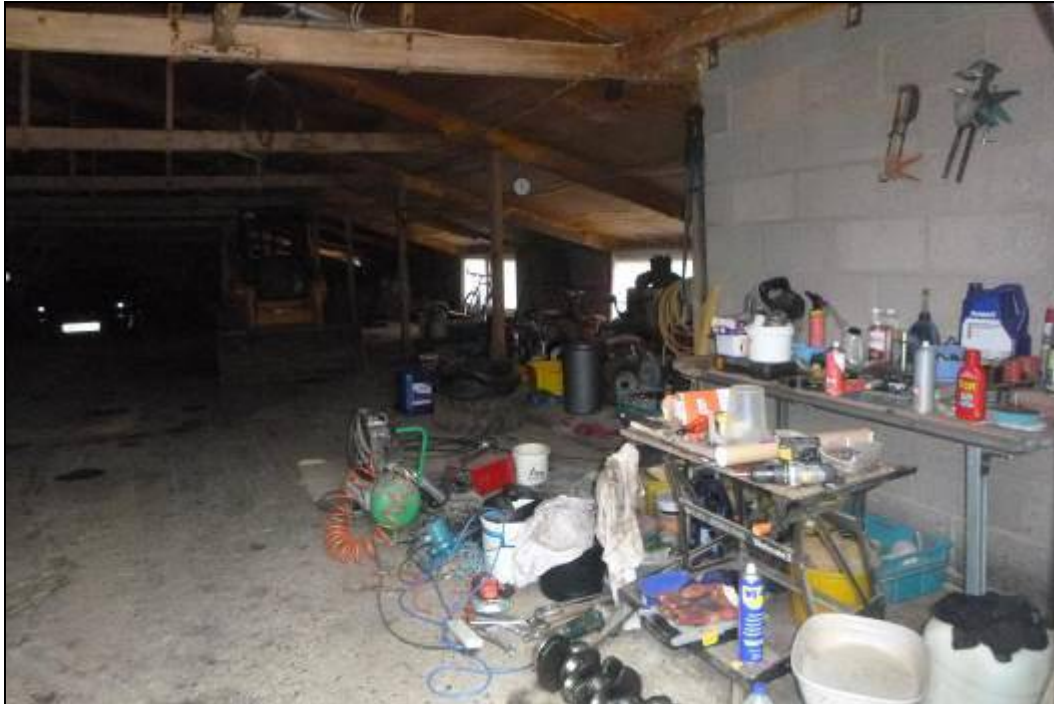
The remaining poultry shed is constructed from timber with steel panelled roofing, lined internally with hardboard. The flooring within the shed is of concrete construction, and is generally in a good state of repair. The shed is now used for the storage of vehicles, plant, tools, other machinery, and oil.

**Photograph 3** Showing the storage inside the existing poultry shed

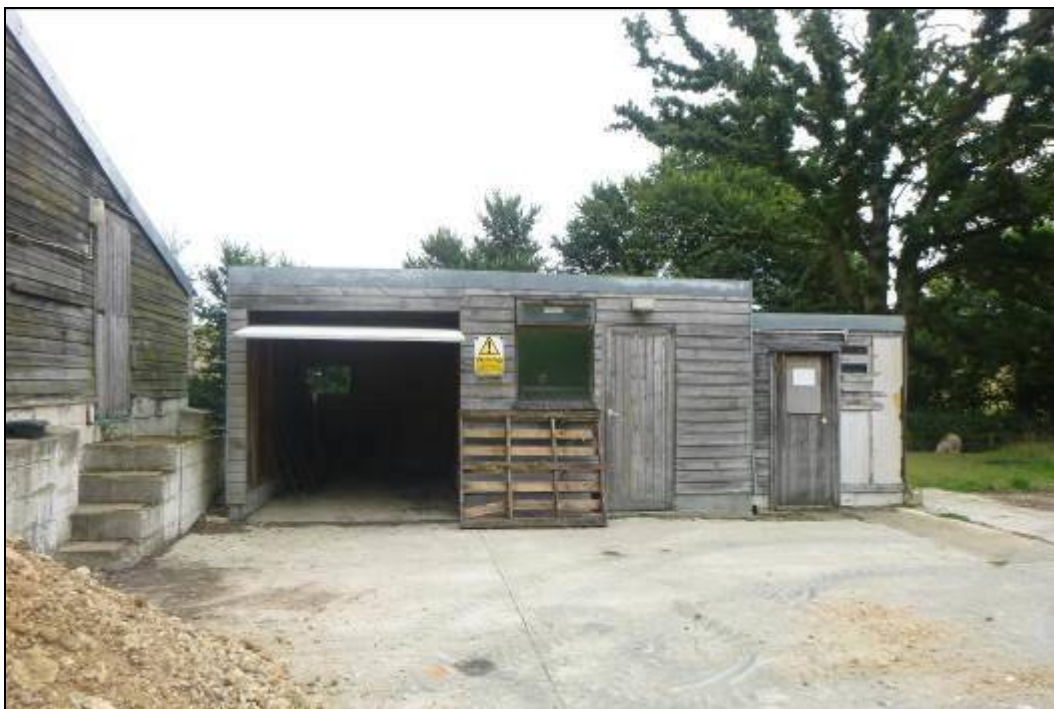
Adjacent to the southern end of the existing poultry barn there is a concrete courtyard which is not expected to have seen any specific use, other than the parking of agricultural vehicles. It is in a reasonable state of repair, with grated drainage present. The concrete cover of the courtyard merges with the concrete base that remains from the demolished shed. The base is in poor condition and removal of the concrete has begun at the southern end, exposing the ground beneath, where hardcore and made-ground was visible. To the south of the demolished shed footprint there are two more grain silos.

**Photograph 6** Showing the courtyard and stable to the south of the existing poultry shed

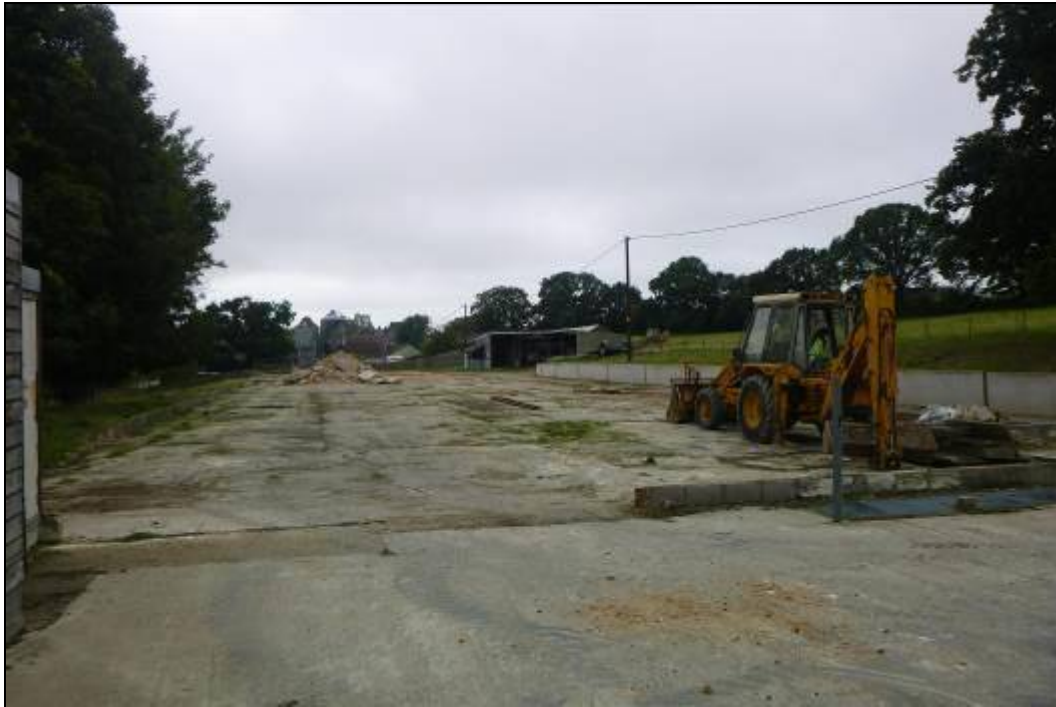
**Photograph 7** Showing the concrete base of the demolished poultry shed from the northern end

The concrete base from the demolished poultry shed largely remains in-situ and is currently in a poor state of repair. This remaining hard surface has seen recent use for the general parking of vehicles and machinery. The process of removing the concrete base has started at the southern-most point, exposing underlying hardcore and possible made-ground.

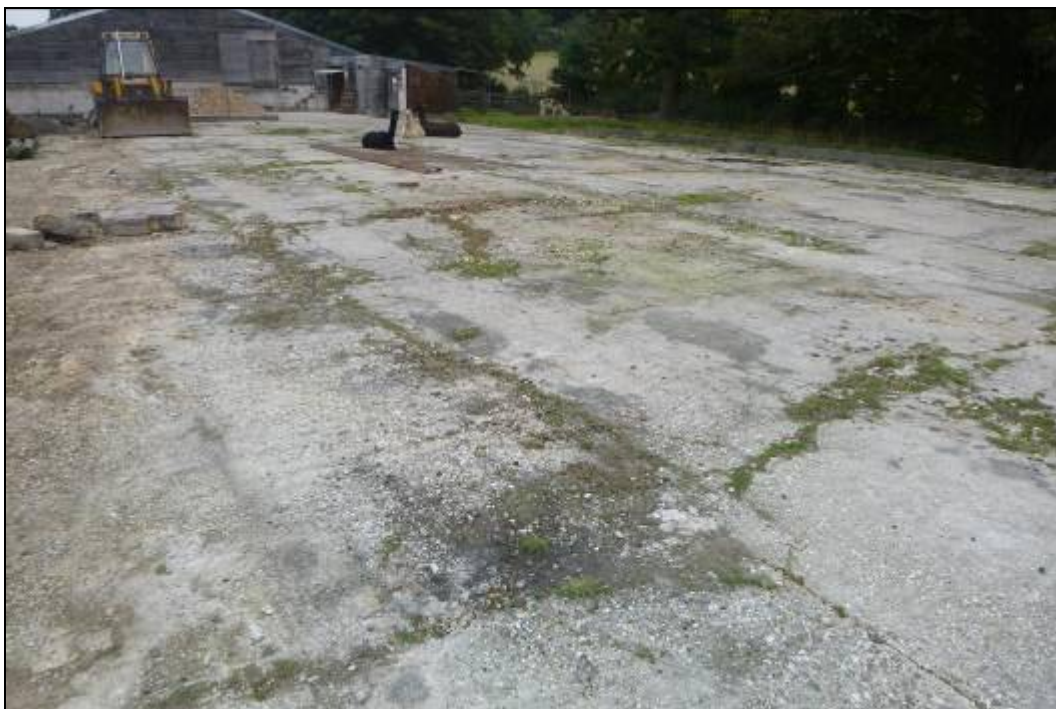
**Photograph 8** Showing the condition of the concrete base

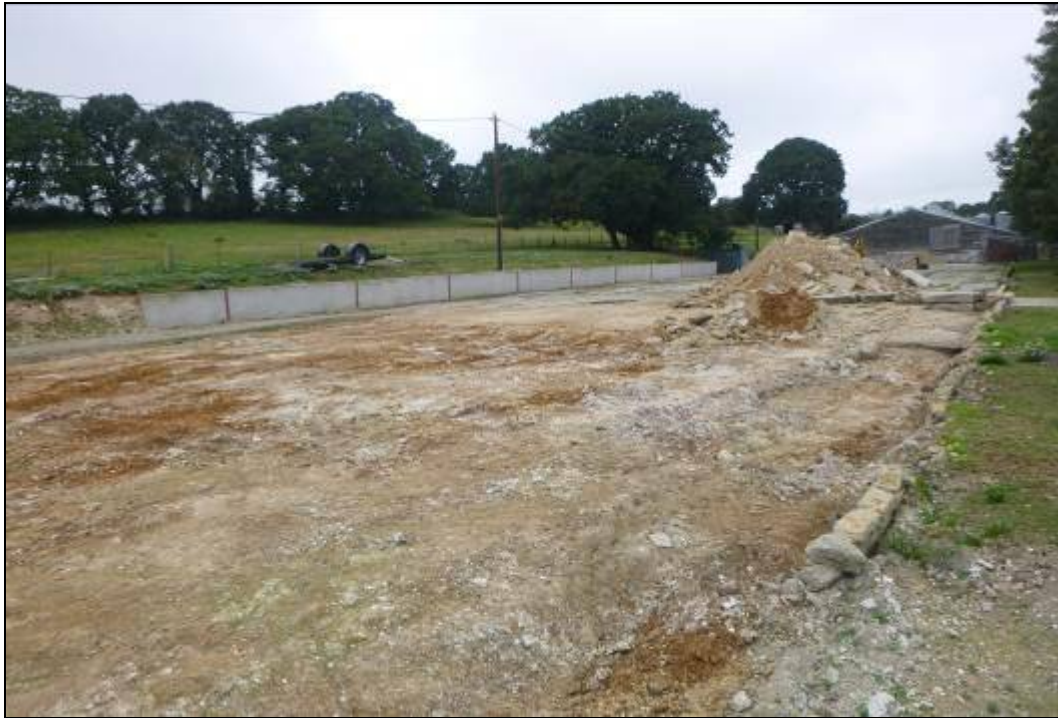
**Photograph 9** Showing the southern section of the concrete base where concrete removal has begun
