## **Design Access & Heritage Statement:**

Dam Leakage Repairs at  
Wilton Water Reservoir, Kennet &  
Avon Canal.

### **Repairs and maintenance to dam headwall and culverts east of the bank of sluices at Wilton Water, Kennet & Avon Canal, SN8 3DW**

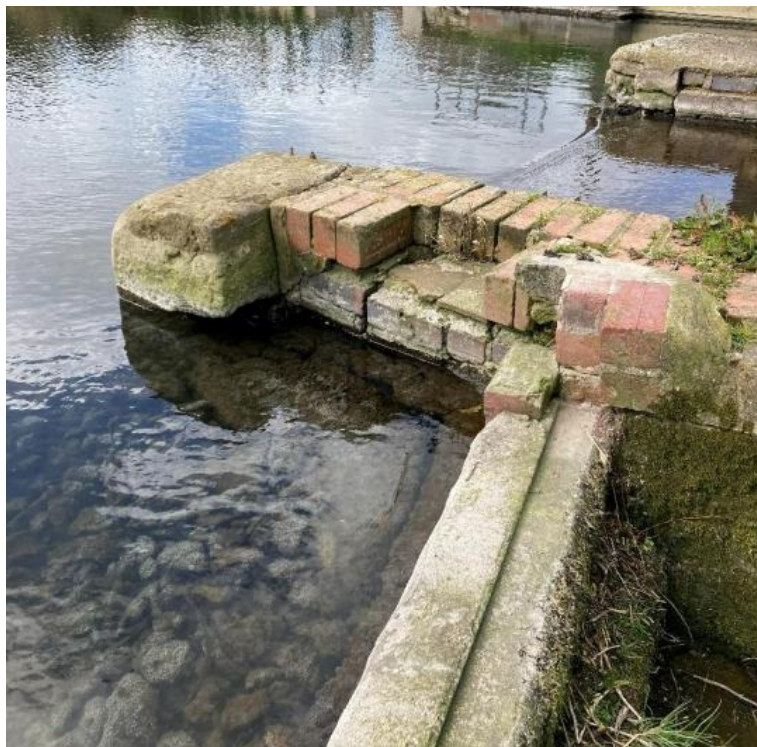
*Figure 3: Area of dam head wall to be rebuilt*

A minimum intervention approach is to be taken, only the areas that require repair (bulging brickwork, masonry damage, hungry joints) shall be considered.

Repairs to the dam masonry structure will involve some localised sections of rebuilding the true extent of works here is unknown until the area has been dewatered.

Repaired section will be tied into the existing masonry wall. Any localised failed areas will be rebuilt, any lost or loose masonry units will be reinstated, and any missing mortar repointed.

All repairs shall be of a `like for like` nature using matching traditional materials that have been previously consented for use on several Listed Structures on the K&A canal.

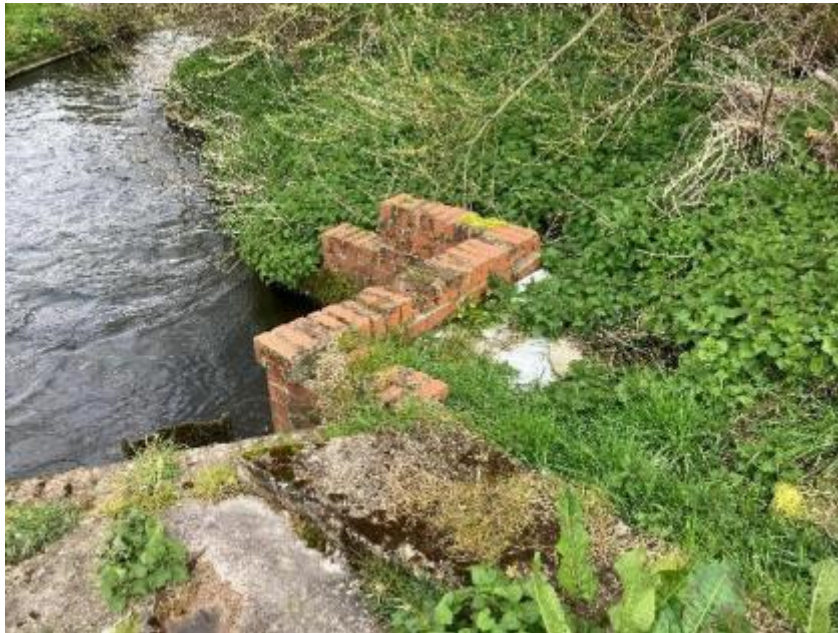
*Figure 4: Section of Headwall to be repaired and missing bricks replaced like-for-like.*

*Voiding behind to be infilled*

The total length of wall requiring repair is approximately 12m, depth of masonry wall, ranging from 0.5m – 1m. Void at back of headwall to be filled.

Re-pointing and replaced missing bricks these shall be carried out using the previously LBC approved lime mortar mix for the K&A Canal:

Limestone Aggregate shall be Crushed Bath stone with a particle range from 150mc up to 2mm.

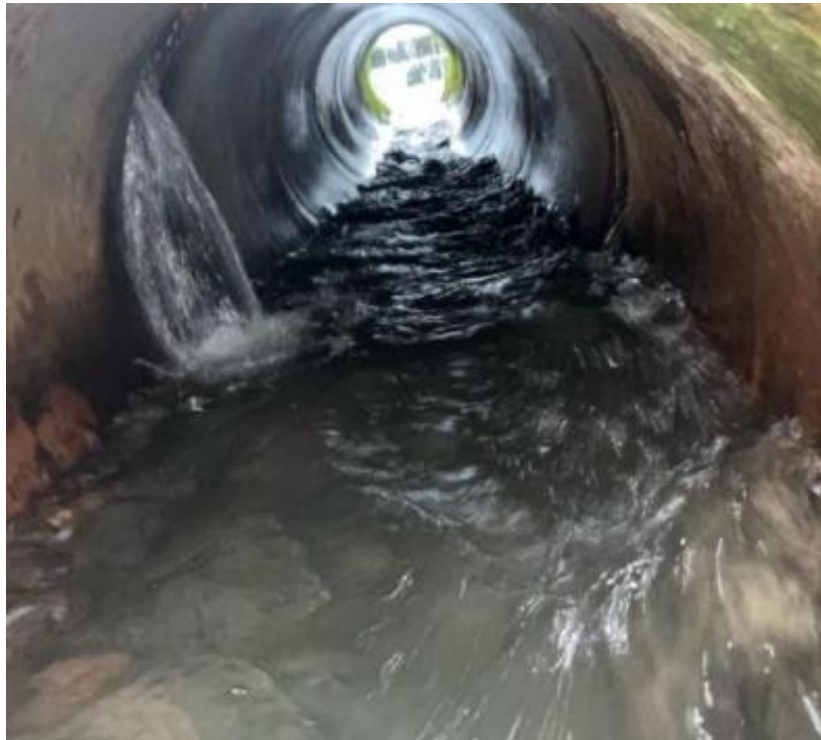
*Figure 5: Leak within the culvert through culvert barrel jointing*

There is a collection of 3 weir outlet culverts running behind the wave wall and from the overflow weirs. Leakage pathways through the dam headwall (wave wall) flow under the concrete dam slab and into the 3 culverts at their joints. This is a result of leakage through the dam wall causing settlement and unevenness of the concrete slab capping leading to leakage into the culverts. Further leak pathways exist in the earth embankment portion of the dam to the east of the slab which also requires sealing.

Installation of grouting to concrete slab and culvert barrel jointing below slab, to prevent current continuous leakage through wall and slab into culverts.

The proposal is to use cementitious grouting to fill leak pathways and voids below concrete slab to address current leakage to culvert structure.

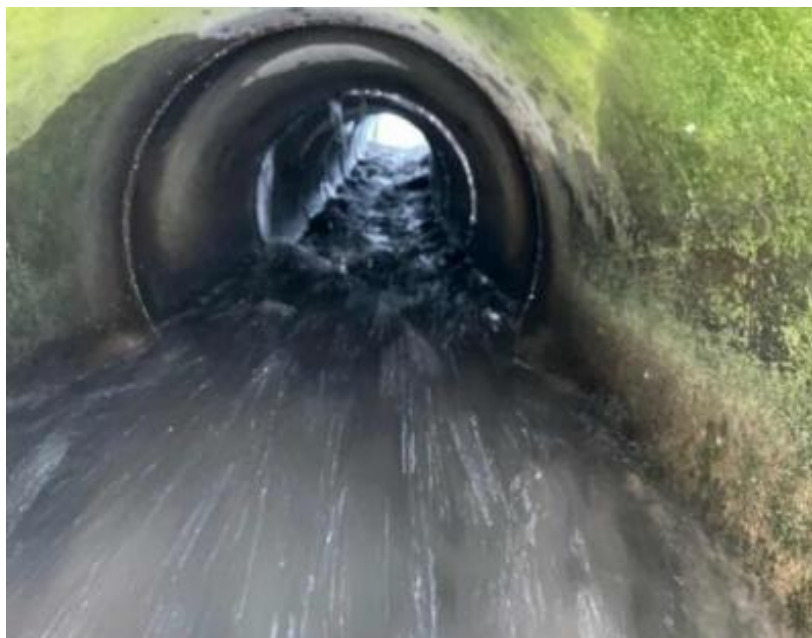
*Figure 6: Multiple leaks through culver barrel jointing*

Behind the dam wall a large concrete slab covering the earth bank and culverts also requires repairs to prevent leakage entering the culverts. Leakage through the dam wall has caused settlement to occur resulting in the slab becoming uneven and causing fractures in the culvert barrel jointing allowing leakage into the culverts.
