# Bat Emergence and Re-Entry Survey

**The Old Vicarage, Wilsford, Pewsey,  
Wiltshire  
SN9 6HB**

**This report is prepared to inform a planning application for the proposal described as a single-storey extension to the main dwelling and the conversion/remodelling of the garage.**

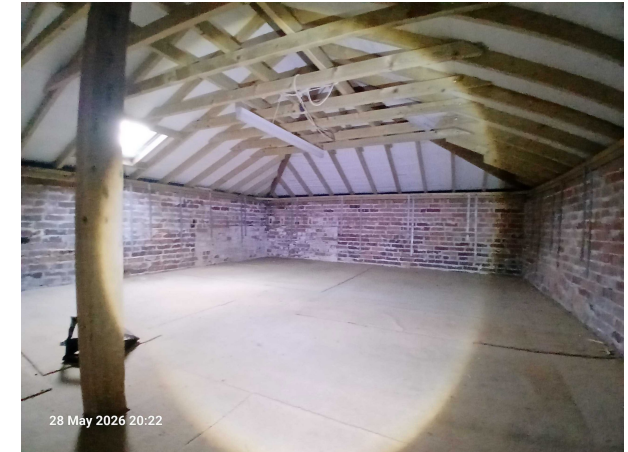
Figure 1a: Loft void of B2 taken from the northeastern corner.

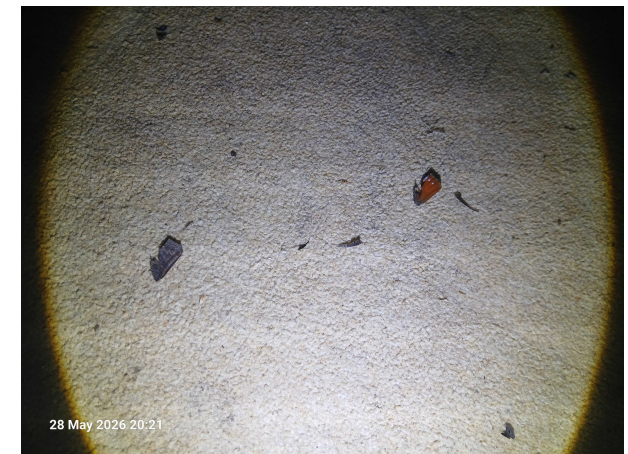
An updated internal inspection was completed prior to the second emergence survey by Keira Horman (Accredited Agent on Natural England Bat Licence Number:2025-85589-CL18-BAT) on the 18th June 2026. The loft space was assessed for any material changes since the previous inspection, with no alterations to the structure, access points, or suitability for roosting bats identified. The conclusions of the original PRA (Arbtech, April 2026) are therefore considered to remain valid. Notably, a similar number of droppings were identified scattered within the loft space, indicating recurring use. Size and morphology of the droppings appeared similar to as previously identified during the PRA. Additionally, two torn Peacock butterfly wings were identified within the northeastern corner of the first floor/void of B2. Due to the absence of significant cobwebbing and torn appearance these are likely associated with feeding as opposed to Araneae, although evidence of feeding is considered new.

Figure 1b: Scattered butterfly wings in the northwestern corner of B2's loft void.

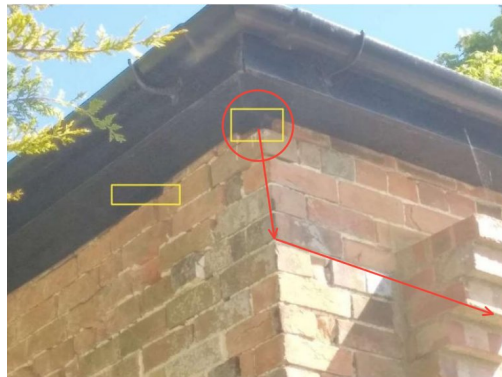
| Roost | Location | Access Point | Type | Species | Count | Impact Level | Impact Scale |
|---|---|---|---|---|---|---|---|
| 1 - B2 | Southwestern corner of B2. | Gap under bargeboard/missing brick. | Day roost | Common pipistrelle | 1 | Damaged | Site |

**Roost 1 (B2):** The roost has been characterised by a single emergence each survey (3no. total) from a gap under the lifted/missing brick. This feature was identified within the original PRA (April, 2026). No evidence of bats was identified in association with the roost. It is noted that during a bout of foraging during the first survey, an individual briefly rested on the wall top before continue to foraging around the site indicating consistent use of the roost in line with the roost type. No external works are proposed. However, this roost will be damaged when the building is converted as this will involve sealing the internal walls and roof space to facilitate new living areas.

**Figure 3a:** Roost 1 (B2) - Common pipistrelle day roost (red)

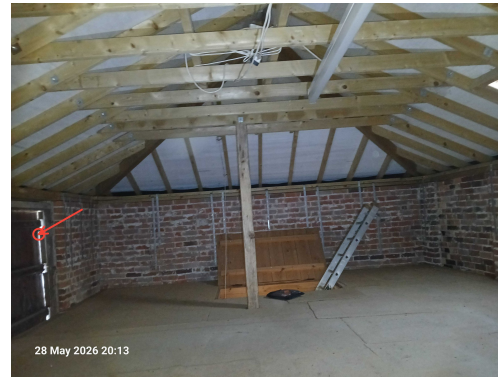
| Roost | Location | Access Point | Type | Species | Count | Impact Level | Impact Scale |
|---|---|---|---|---|---|---|---|
| 2 - B2 | Loft/void of B2 | Gap between timber door and frame on the northern elevation of B2 | Day roost | Serotine | 1 | Destruction | Site |

**Roost 2 (B2):** The roost has been characterised by a single emergence from a gap between the timber door and door frame on the northern elevation of B2, as well as droppings (~40no.) which were found scattered on the floor and walls of the first floor/void of B2. As identified during the original PRA, the timber door leads directly into the first floor/void area where all evidence has been identified. Owing to the low number of droppings and emergences identified, the roost is likely limited to a single individual and used on an occasional basis. Serotine bats utilise roosting habitats that provide a combination of crevices and open void spaces. Suitable internal crevice features within B2 void were identified in the form of a crevice under lifted timber above where bat droppings were identified on the internal wall, as well as dark corners at the ridge line behind the ridge beam which indicate likely

roosting locations. The roost is unlikely to be connected to the presence of feeding remains as the Serotine was confirmed exiting the building, and due to the lack of brown long eared emergences. This roost will be destroyed when the void is converted into living spaces as part of the works.

**Figure 3b:** Roost 2 (B2) - Serotine day roost, access point (red)

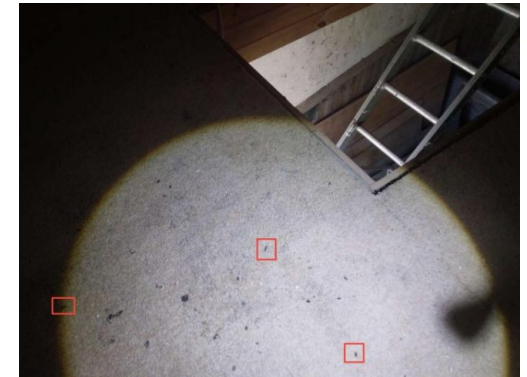
| Roost | Location | Access Point | Type | Species | Count | Impact Level | Impact Scale |
|---|---|---|---|---|---|---|---|
| 3 - B2 | B2 void/first floor | - | Transitiona l/occasion al roost | Brown long-eared bat | - | Destruction | Site |

**Roost 3 (B2):** The roost has been characterised by droppings only (~40no.) which were found scattered on the floor and walls of the first floor/void of B2. Owing to the number of droppings found it is likely a single individual. Owing to the absence of emergences or re-entries, number of droppings which were also identified as serotine, the roost is likely used occasionally. The presence of a low number of torn feeding remains (peacock butterfly wings) which are typically hunted by this species, indicates occasional (recent) foraging. This roost will be destroyed when the void is converted into living spaces as part of the works.

**Figure 3c:** Roost 3 (B2) - Brown long eared feeding roost (occasional)

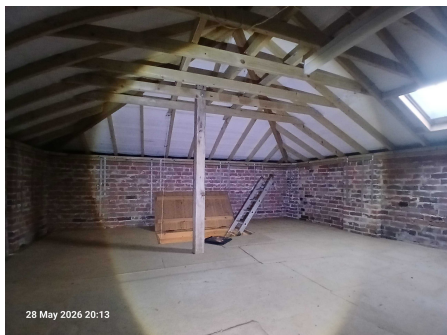
Loft void of B2 taken from the northwestern corner.
