## Bat Scoping Survey and Nesting Bird Report:

Arndown House, 7 Elm Hill, Warminster, Wiltshire, BA12 0AU

Client: Mr and Mrs S Butt

August 2026

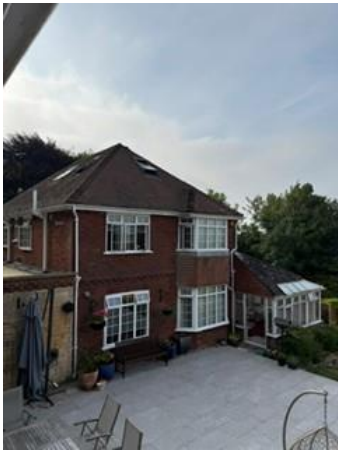
| Photographs | Description |
|---|---|
| | <p>This aspect of the building shows a side view two skylights can be seen in the roof of the main house with modern windows soffits and gutters. Under inspection there are no sufficient crevices or egresses for breeding birds or roosting bats relating to any of the features.</p> |

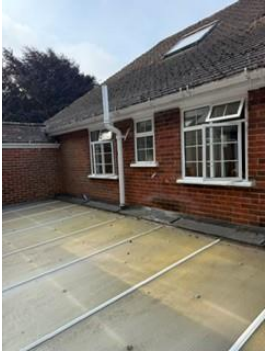
| | <p>This is a photograph of the annex with the link structure seen perpendicular in the right of the photograph. The soffits gutters and windows are all of modern construction and a skylight can also be seen on the roof of the annex.</p> <p>No obvious gaps or crevices could be found in relation to these features or the roof tiles.</p> |

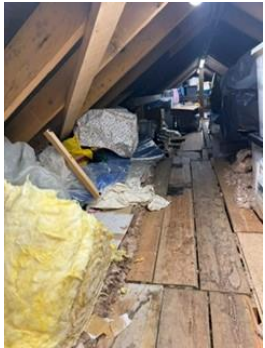
| | <p>This is a photograph of the roof void with significant light penetration no historic or current evidence was found of roosting bats or nesting birds.</p> |

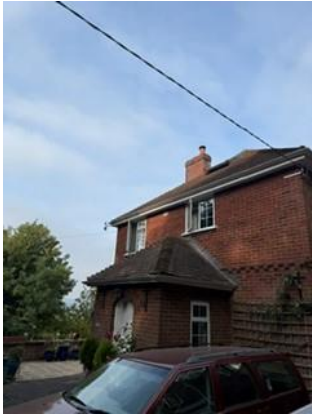
| | <p>The is photograph of the front of the property. No significant features associated with roosting bats was identified on this aspect of the building and no heat signatures were present under inspection.</p> |

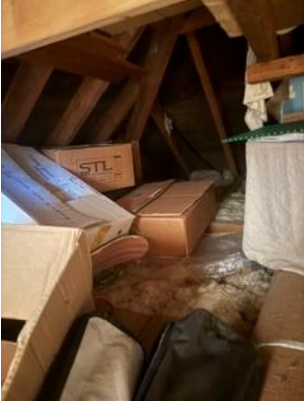
| | <p>This photograph shows one of the roof voids and the natural light from the skylights. No evidence either historic or current was found within the void.</p> |

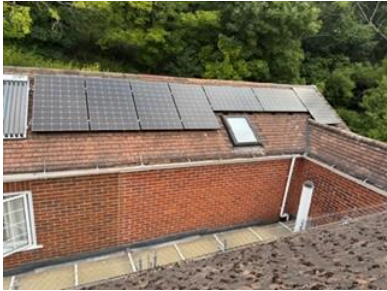
| | <p>The photograph taken from the main house shows the annex and a skylight and the link structure and the tiled roofs which are in good condition with no damaged or missing tiles.</p> |

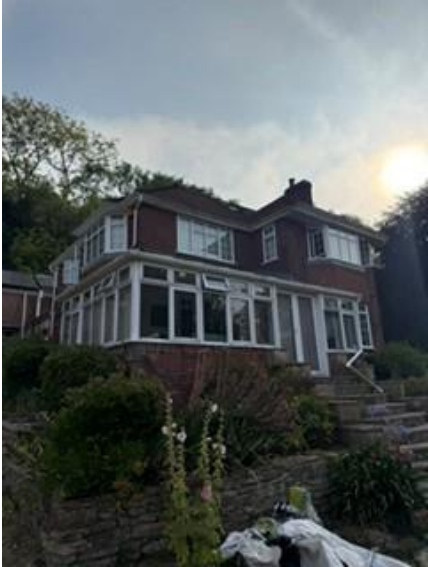
| | <p>This photograph is of the rear aspect of the main house. No evidence was found in relation to the brickwork, soffits or roof tiles of the structure and no thermal images were identified either under inspection.</p> |
