**Lodge Farm, Poulshot  
Preliminary Roost Assessment  
July 2026**

**Report Title:** Lodge Farm, Poulshot: Preliminary Roost Assessment

**Report reference:** LFP26.01

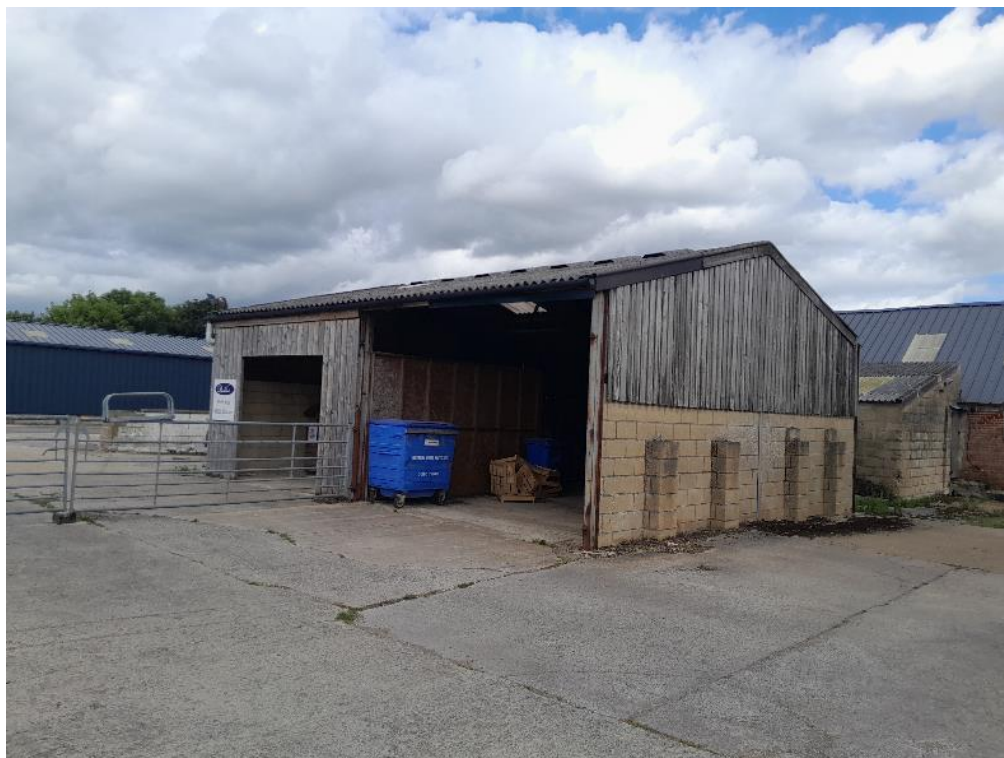
| Building | Composition | Comments | Risk Rating |
|---|---|---|---|
| 1 | Block lower walls, wooden cladding upper walls. Fibrous cement roof over a metal frame | Modern building. In good condition. Open fronted on western side. Light, open and drafty. Birds nest on structural beam | Bats – negligible<br><br>Birds – moderate (confirmed) |

Photo 1. Southern and eastern elevation of B1

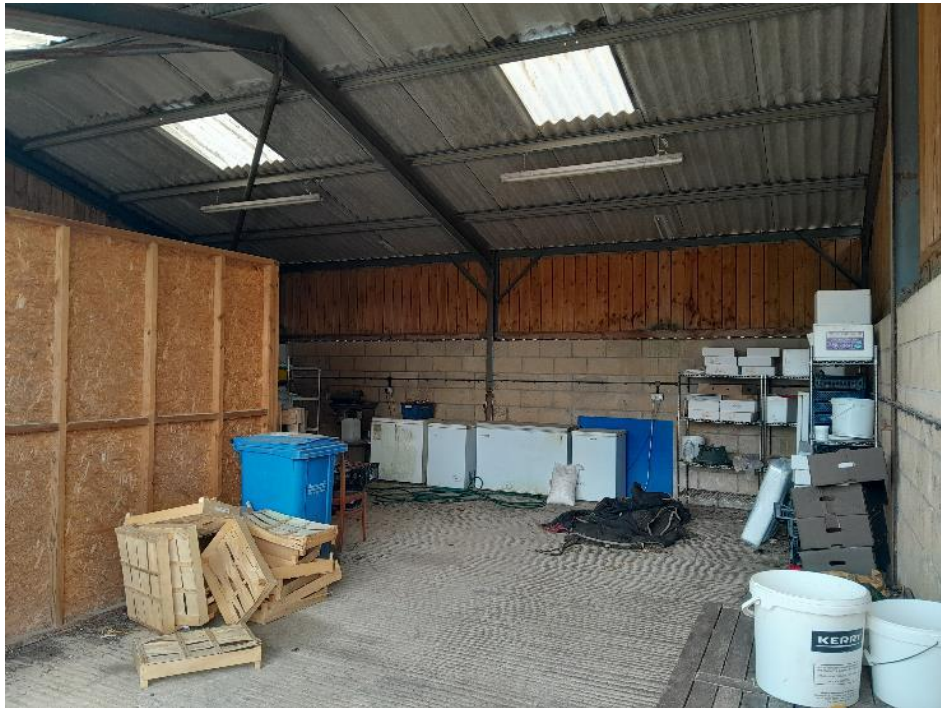
Photo 2. Inside of B1

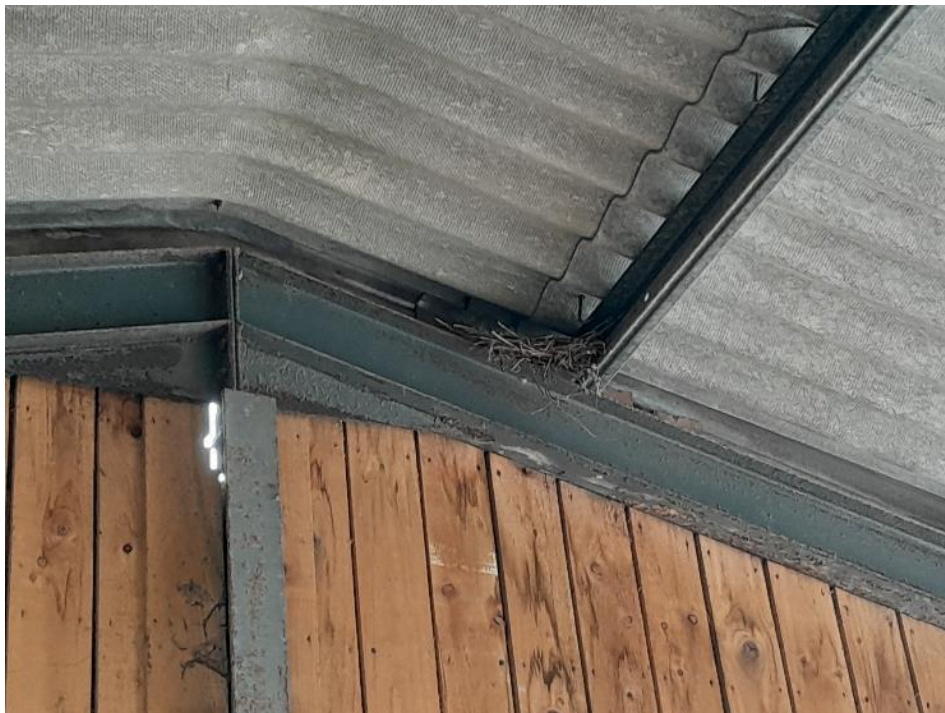
Photo 3. Birds nest inside of B1

Buildings 1, 2, 4 and 8 had evidence of nesting birds with other buildings also having some suitability. Where possible construction should start outside of the nesting season (March – August, inclusive). If this is not possible then a nesting bird check must be completed prior to work commencing. If an active nest is discovered then site works will stop and the nest be monitored by the site ecologist until the chicks have fledged or the nest has been naturally abandoned.

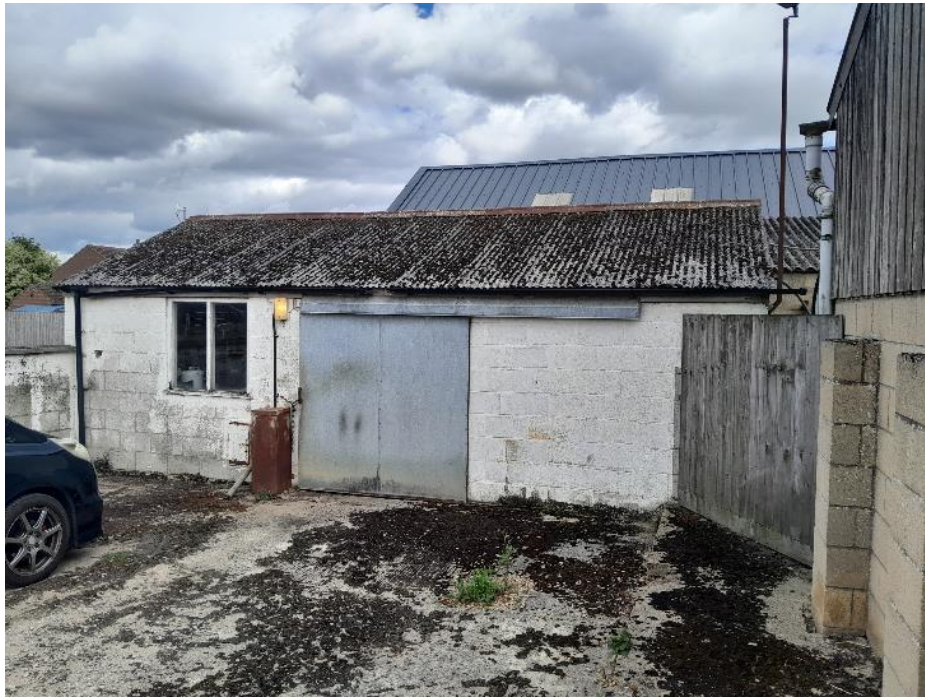
| Building | Composition | Comments | Risk Rating |
|---|---|---|---|
| 2 | Block walls with fibrous cement roof. Sliding metal door at front | Old building. Rear door left open. Materials not suitable for bats. Moderately open and drafty. Birds nest on electrical switch | Bats – negligible<br><br>Birds – moderate (confirmed) |

Photo 4. Western elevation of B2

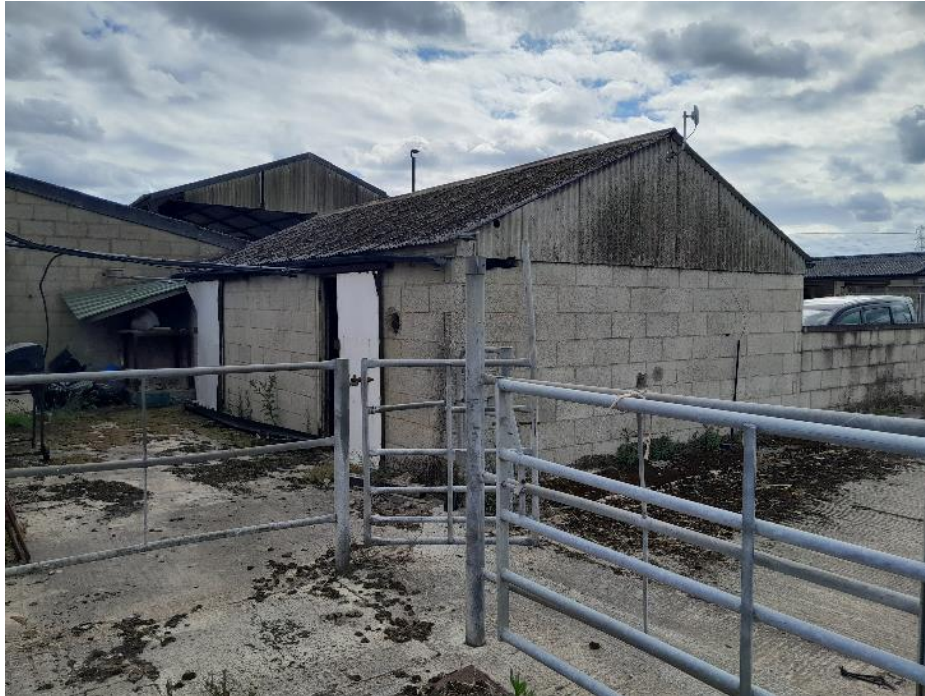
Photo 5. Northern and eastern elevation of B2

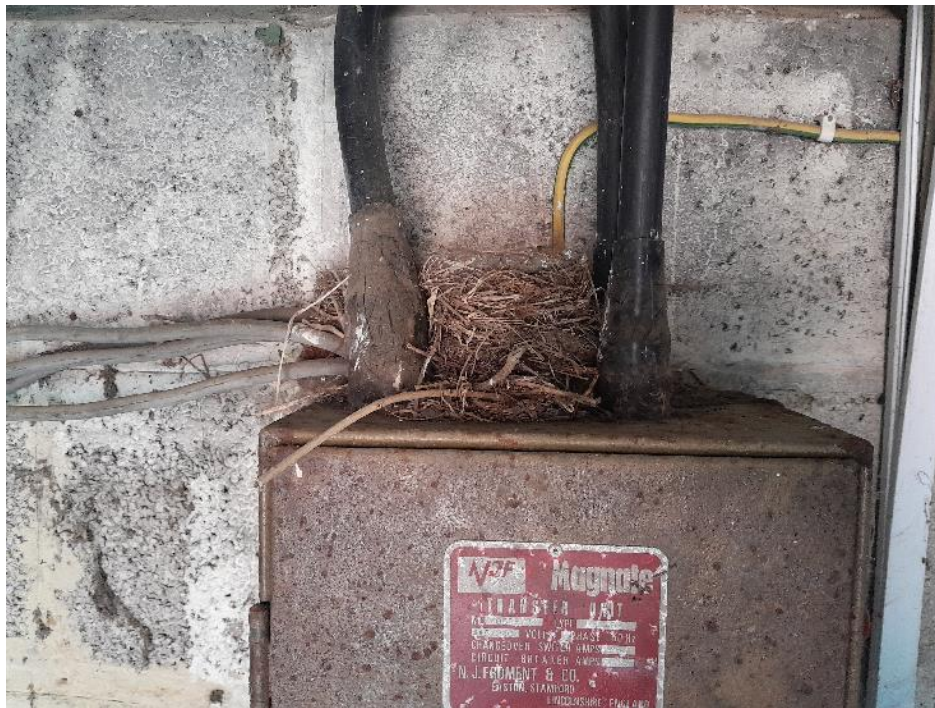
Photo 6. Birds nest within B2

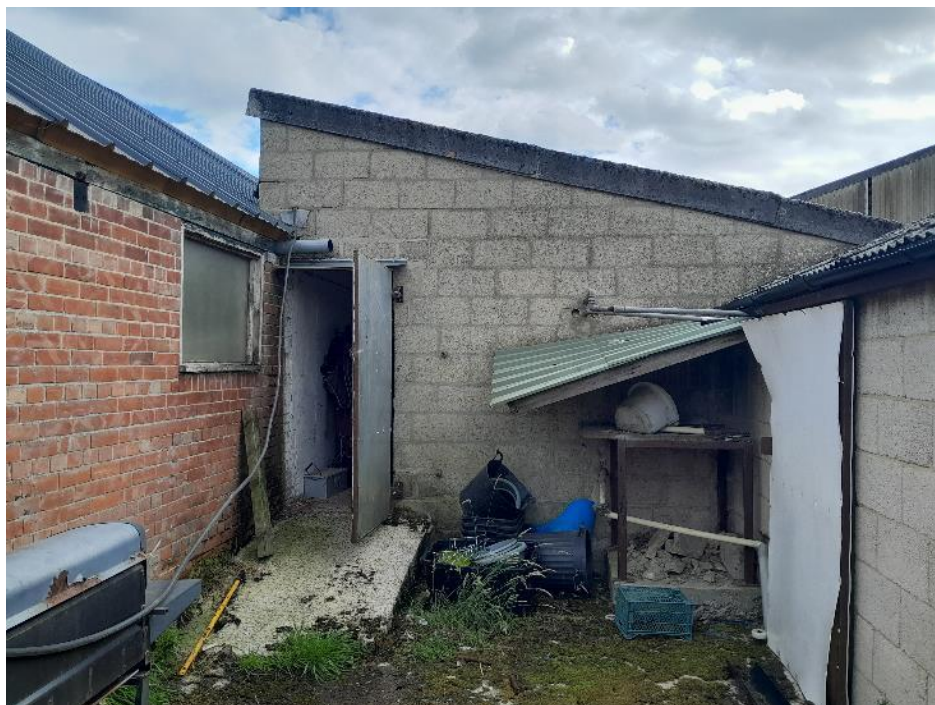
| Building | Composition | Comments | Risk Rating |
|---|---|---|---|
| 3 | Block walls with fibrous cement roof. Large roof lightpanels | Old building. Materials not suitable for bats. Very light inside. Highly disturbed by human activity | Bats – negligible<br><br>Birds - negligible |

Photo 7. Northern elevation of B3

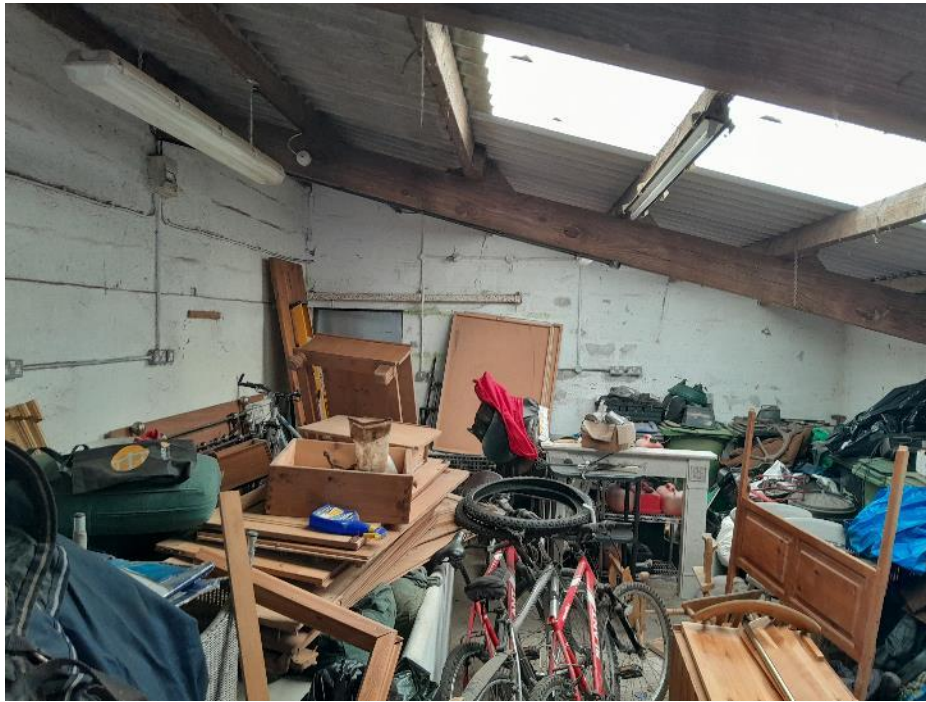
Photo 8. Inside of B3

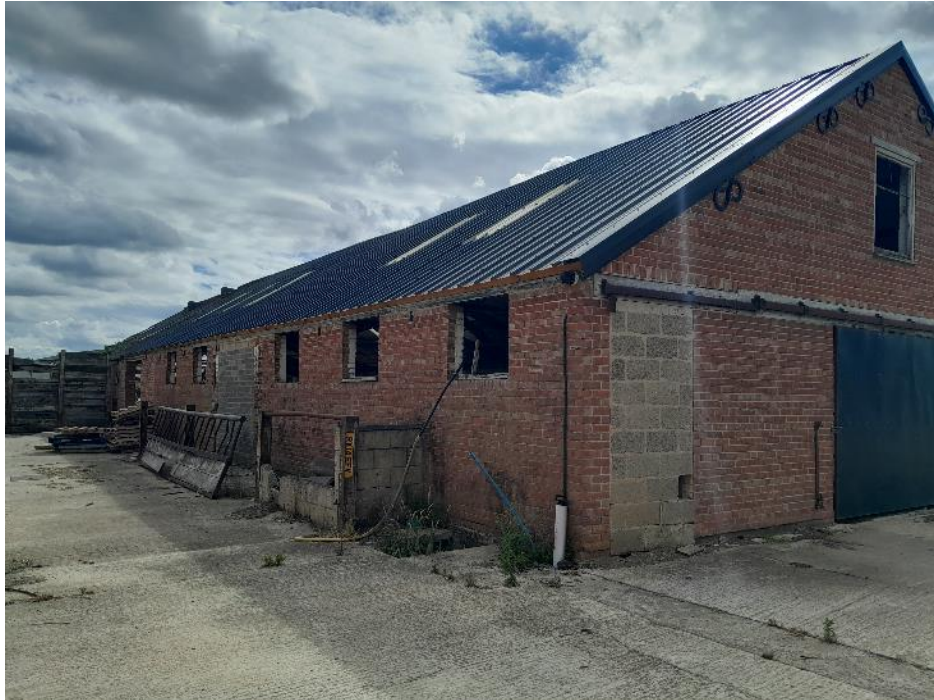
| Building | Composition | Comments | Risk Rating |
|---|---|---|---|
| 4 | Red brick walls, with a metal roof and wooden beams. Large roof lightpanels | Missing windows on the eastern elevation and open in the middle. Light, open and drafty. Birds nest on structural beam | Bats – negligible<br><br>Birds – moderate (confirmed) |

Photo 9. Northern and eastern elevations of B4

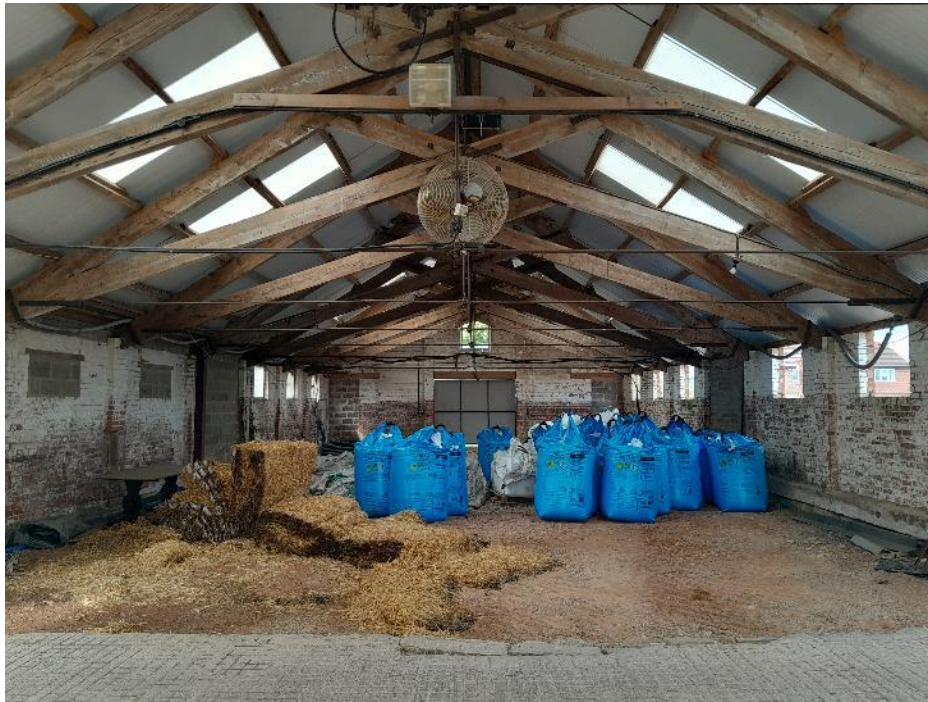
Photo 10. Inside of B4

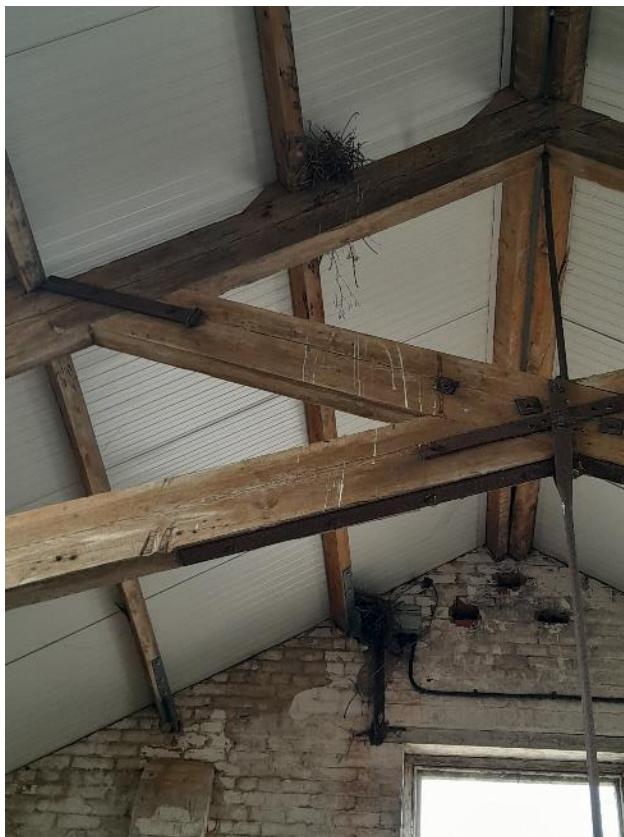
Photo 11. Two birds nests within B4

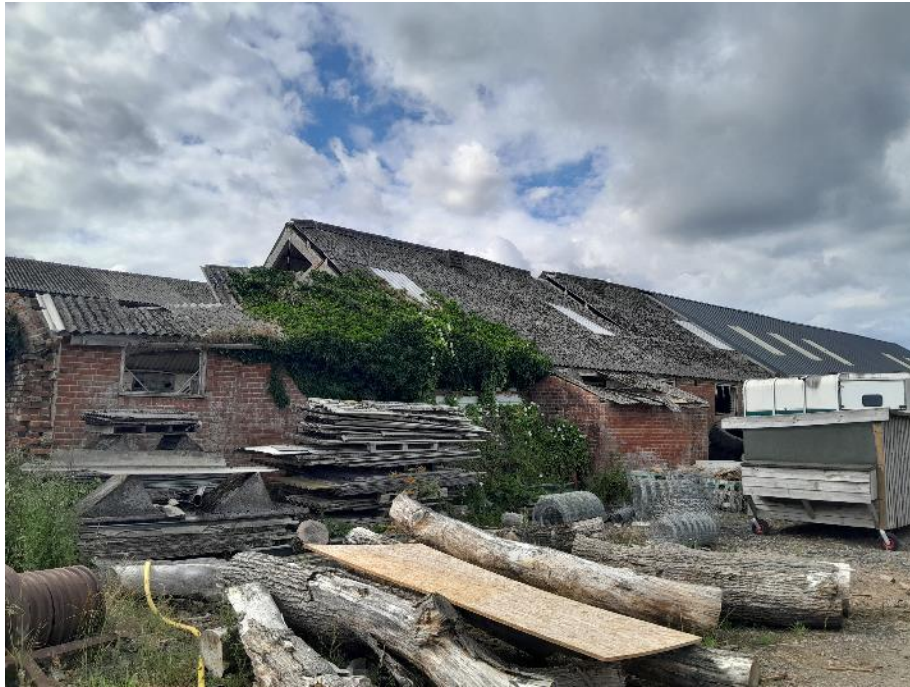
| Building | Composition | Comments | Risk Rating |
|---|---|---|---|
| 5 | Red brick walls, with a fibrous cement roof and wooden beams. Large roof light panels. | Missing windows on the eastern elevation and open in the middle. Light, open and drafty. Partial collapse at southern end | Bats – negligible<br><br>Birds - low |

Photo 12. Eastern elevation of B5 and B9

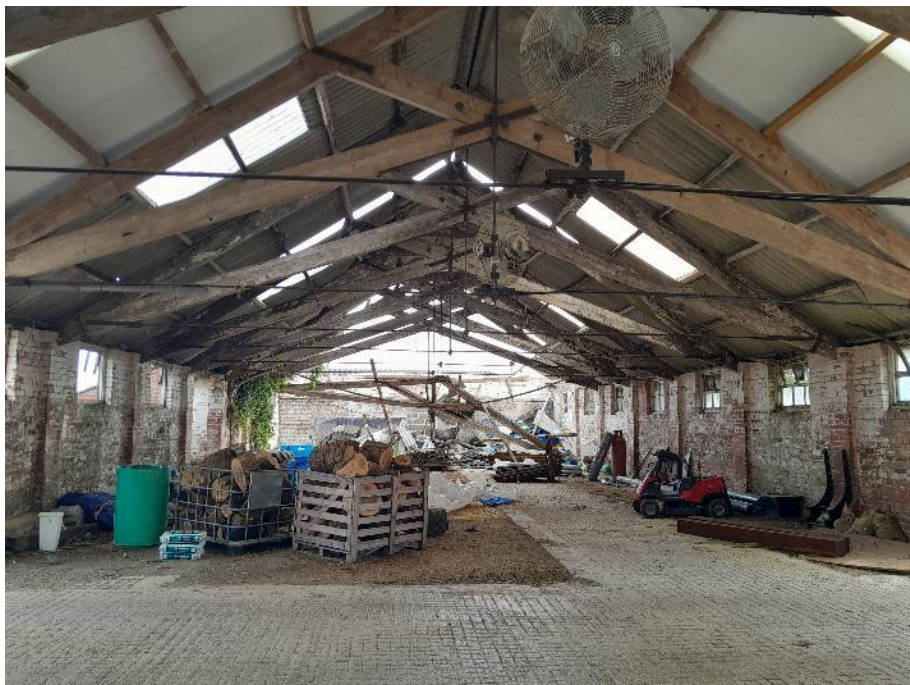
Photo 13. Inside of B5

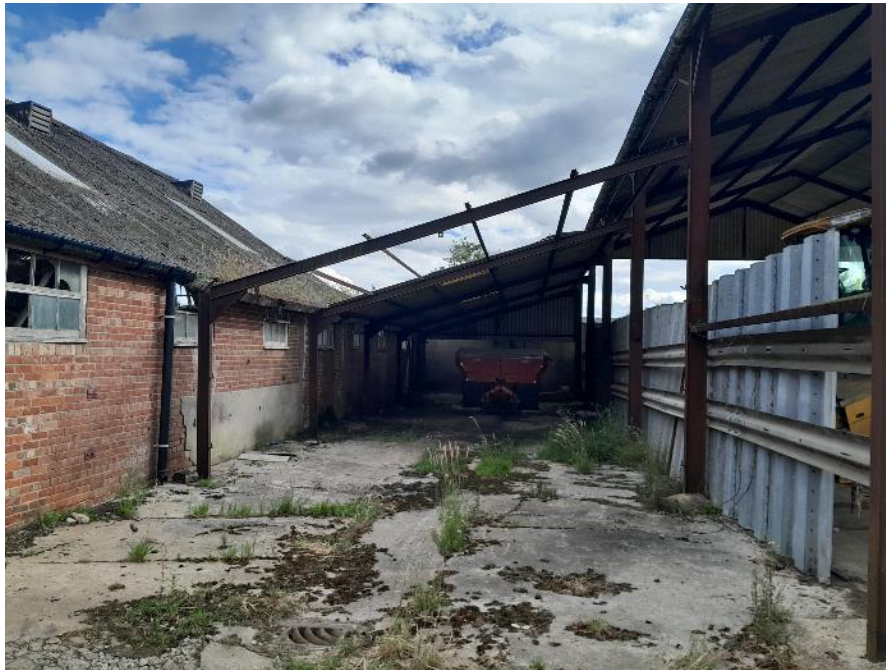
| Building | Composition | Comments | Risk Rating |
|---|---|---|---|
| 6 | Metal framed lean-to building with fibrous cement roof, with light panels. | Fully open at the northern end with some roof panels missing. Open, light and drafty. | Bats – negligible<br><br>Birds - negligible |

Photo 14. Looking south into B6

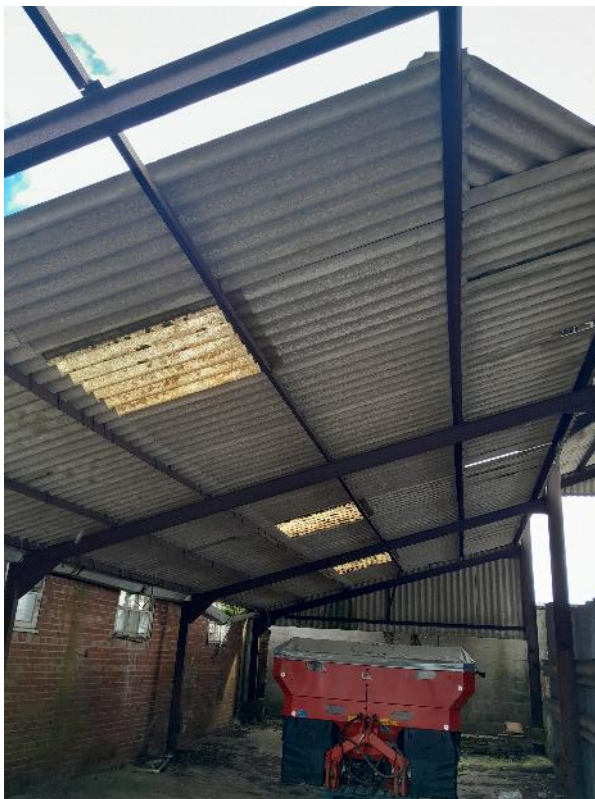
Photo 15. Roof structure of B6

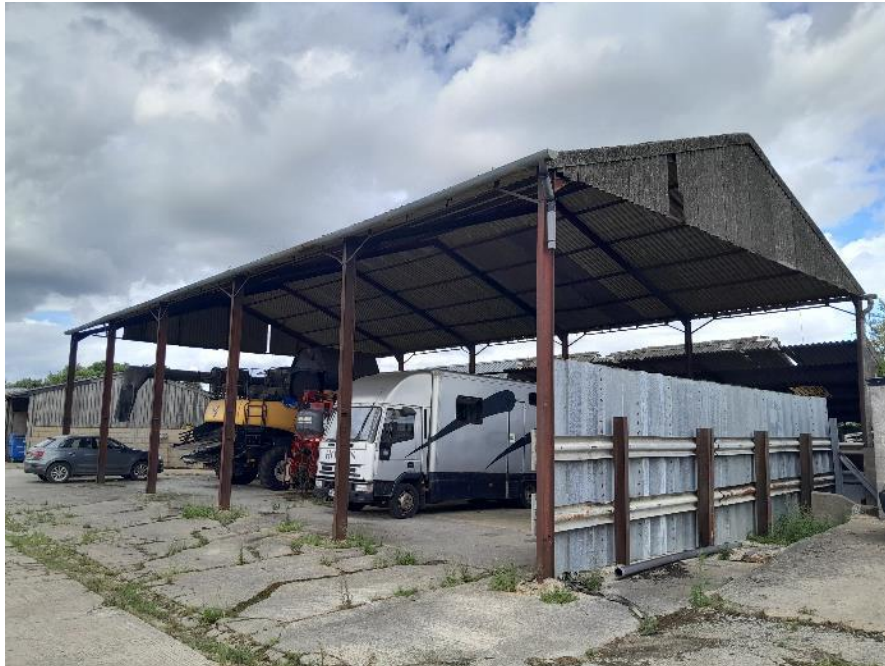
| 7 | Metal frame, open sided barn with fibrous cement roof. | Materials not suitable for bats. Very open, light and drafty | Bats – negligible<br>Birds - negligible |

Photo 16. Western and southern elevations of B7

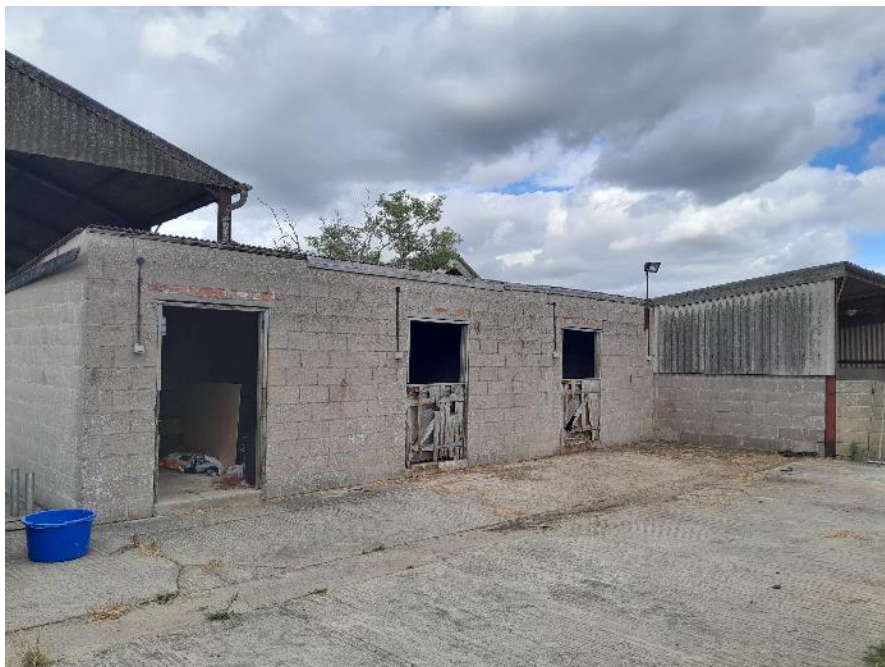
| 8 | Block walls, with a fibrous cement roof and wooden beams. Three stable doors on southern elevation | Materials not suitable for bats. Very open, light and drafty. Highly disturbed. Three birds nests recorded. | Bats – negligible<br>Birds – moderate (confirmed) |

Photo 17. Southern elevation of B8

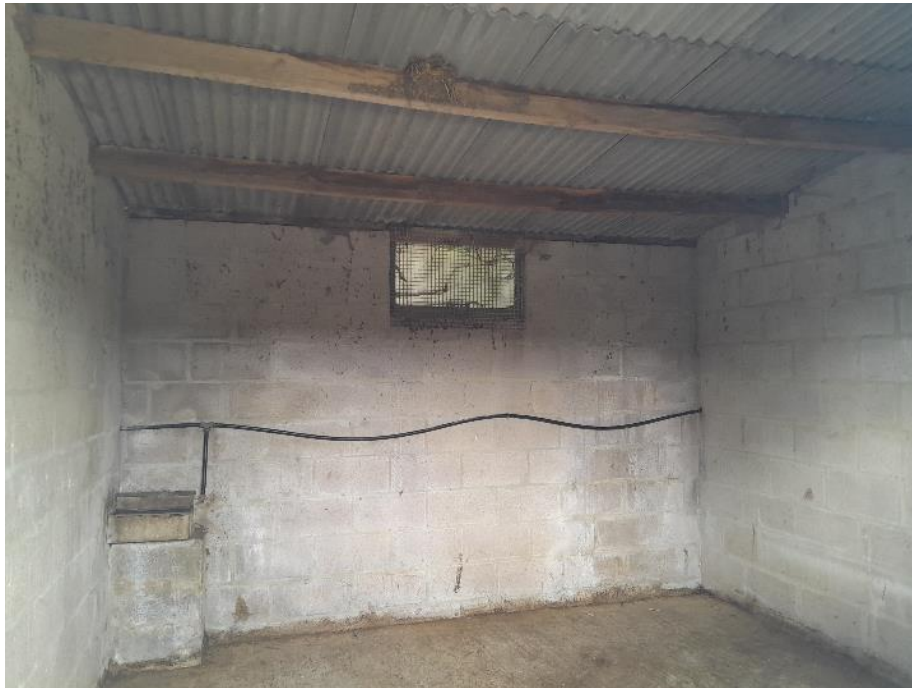
Photo 18. Inside of B8 with birds nest

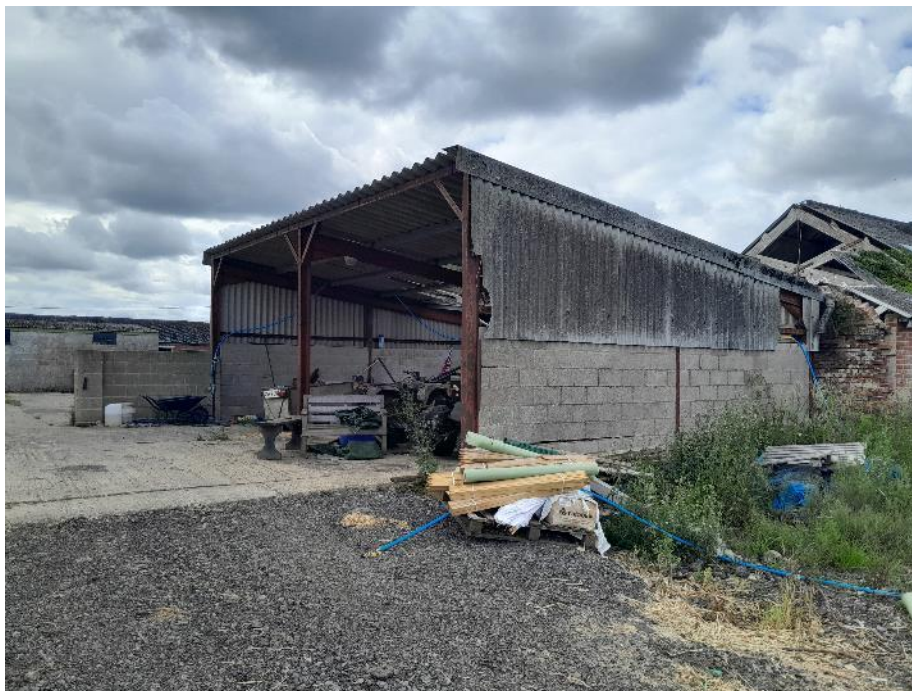
| 9 | Block lower walls with fibrous cement upper walls and roof over a metal frame. Open fronted on southern elevation | Materials not suitable for bats. Very open, light and drafty. Partial collapse of roof | Bats – negligible<br>Birds - negligible |

Photo 19. Southern and eastern elevations of B9

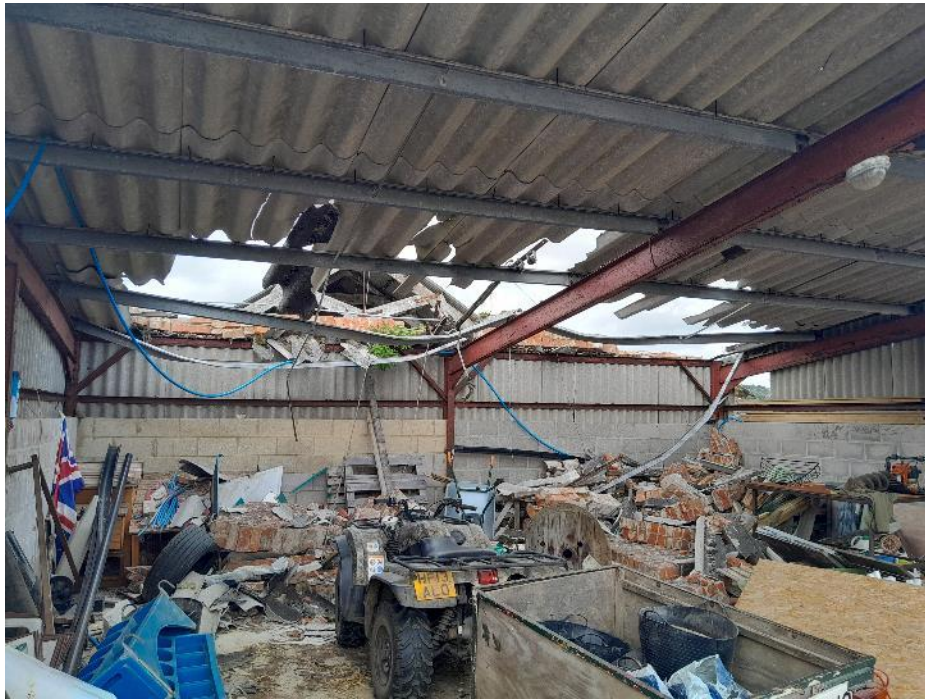
Photo 20. Inside B9, showing partial roof collapse.
