PROJECT  
TURNPIKE CLOSE  
SEMINGTON

## Topographical Land Survey

## **Re: Turnpike Close, Semington – Infiltration Testing Results**

DRAWING TITLE  
EXPLORATORY HOLE LOCATION PLAN

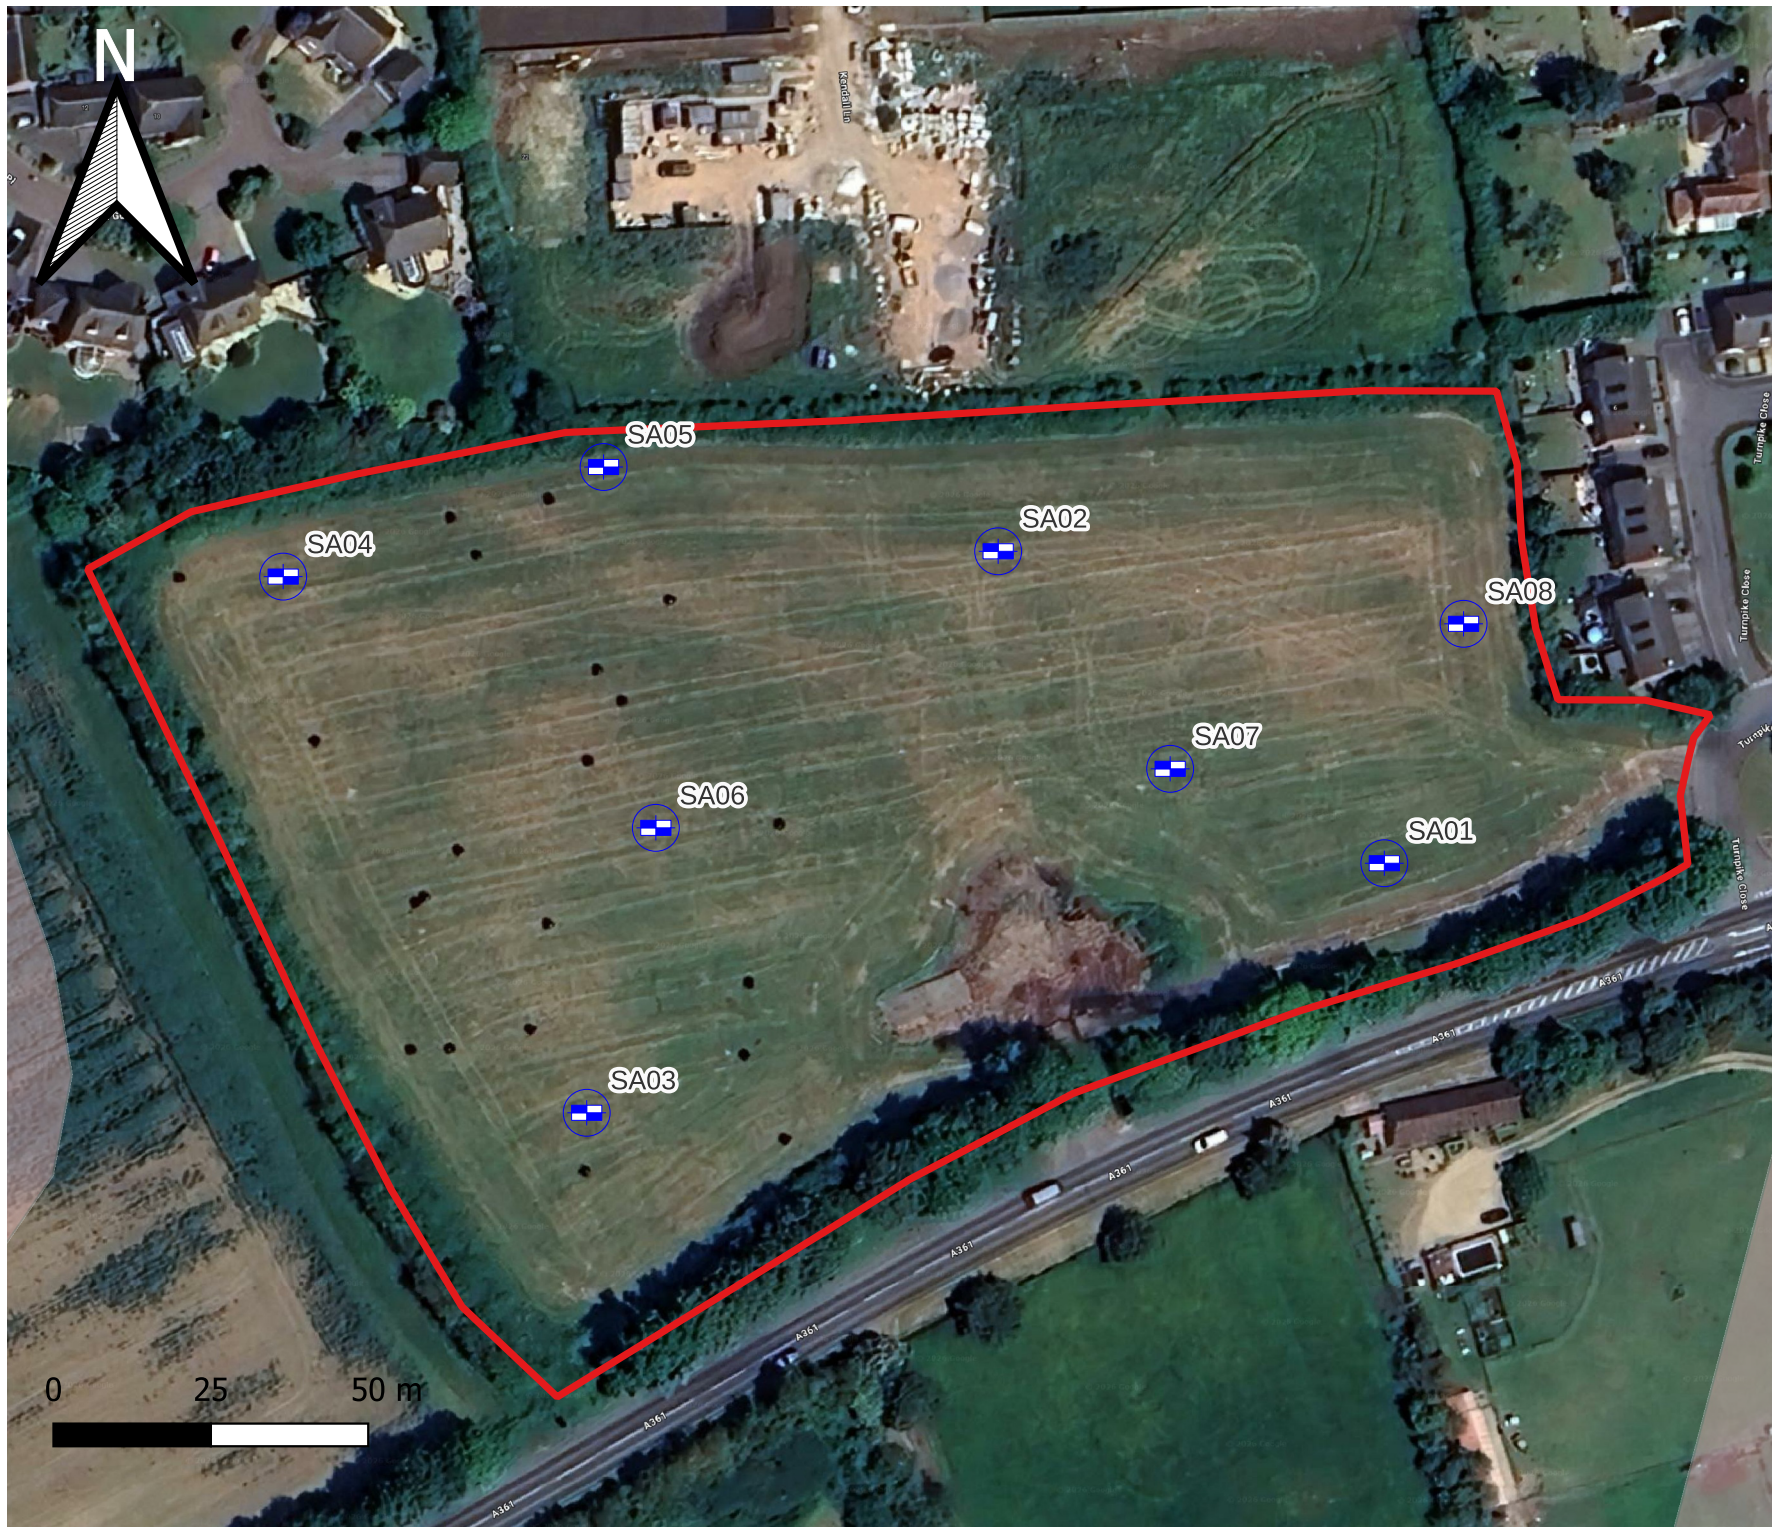
SOAKAWAYS

Eight trial pits (SA01 to SA08) were excavated to depths of between 1.80m and 2.80m bgl using a tracked excavator between the dates of 27<sup>th</sup> and 28<sup>th</sup> May 2026. The locations and depths of the tests were originally provided by the Client, and were completed in order to get an appropriate spread of information across the entire site. The locations of the trial pits are shown on the attached Exploratory Hole Location Plan (Drawing No. C6161/03).

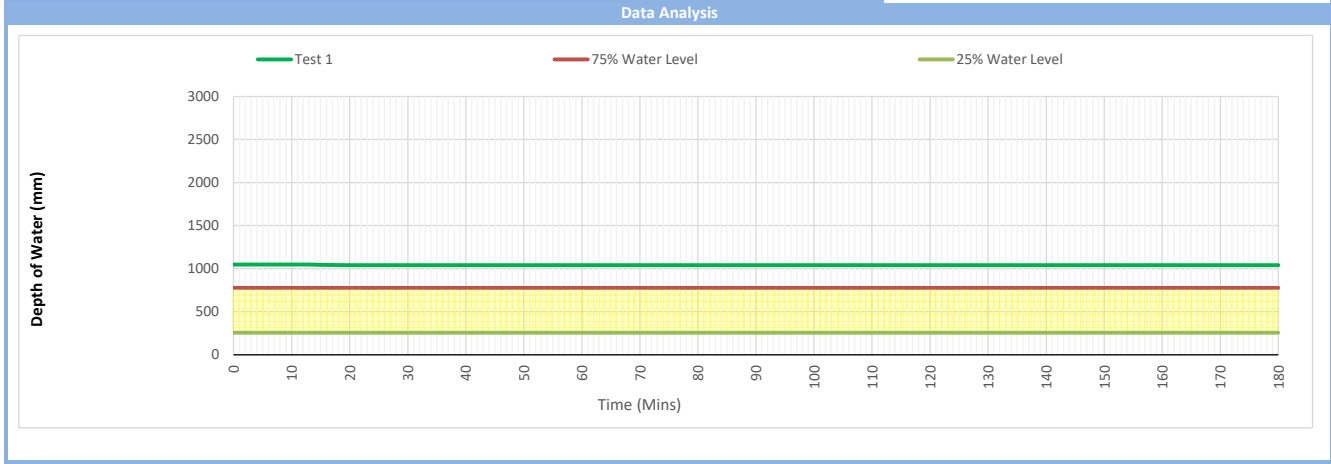
Soil Infiltration Rate Calculation

| | Test 1 | Test 2 | Test 3 |
|---|---|---|---|
| Soil Infiltration Rate (m/sec) | 1.49E-07 | | |

| Location | Infiltration Rate (m/s) |
|---|---|
| SA02 | $1.49 \times 10^{-7}$ |
