Project: Land at Turnpike Close, Semington, Wiltshire

## **APPENDIX H: FLOW ACCUMULATION PLAN - SCALGO**

## **APPENDIX J: GROUND INVESTIGATIONS– BROWNFIELD SOLUTION**

## **Re: Turnpike Close, Semington – Infiltration Testing Results**

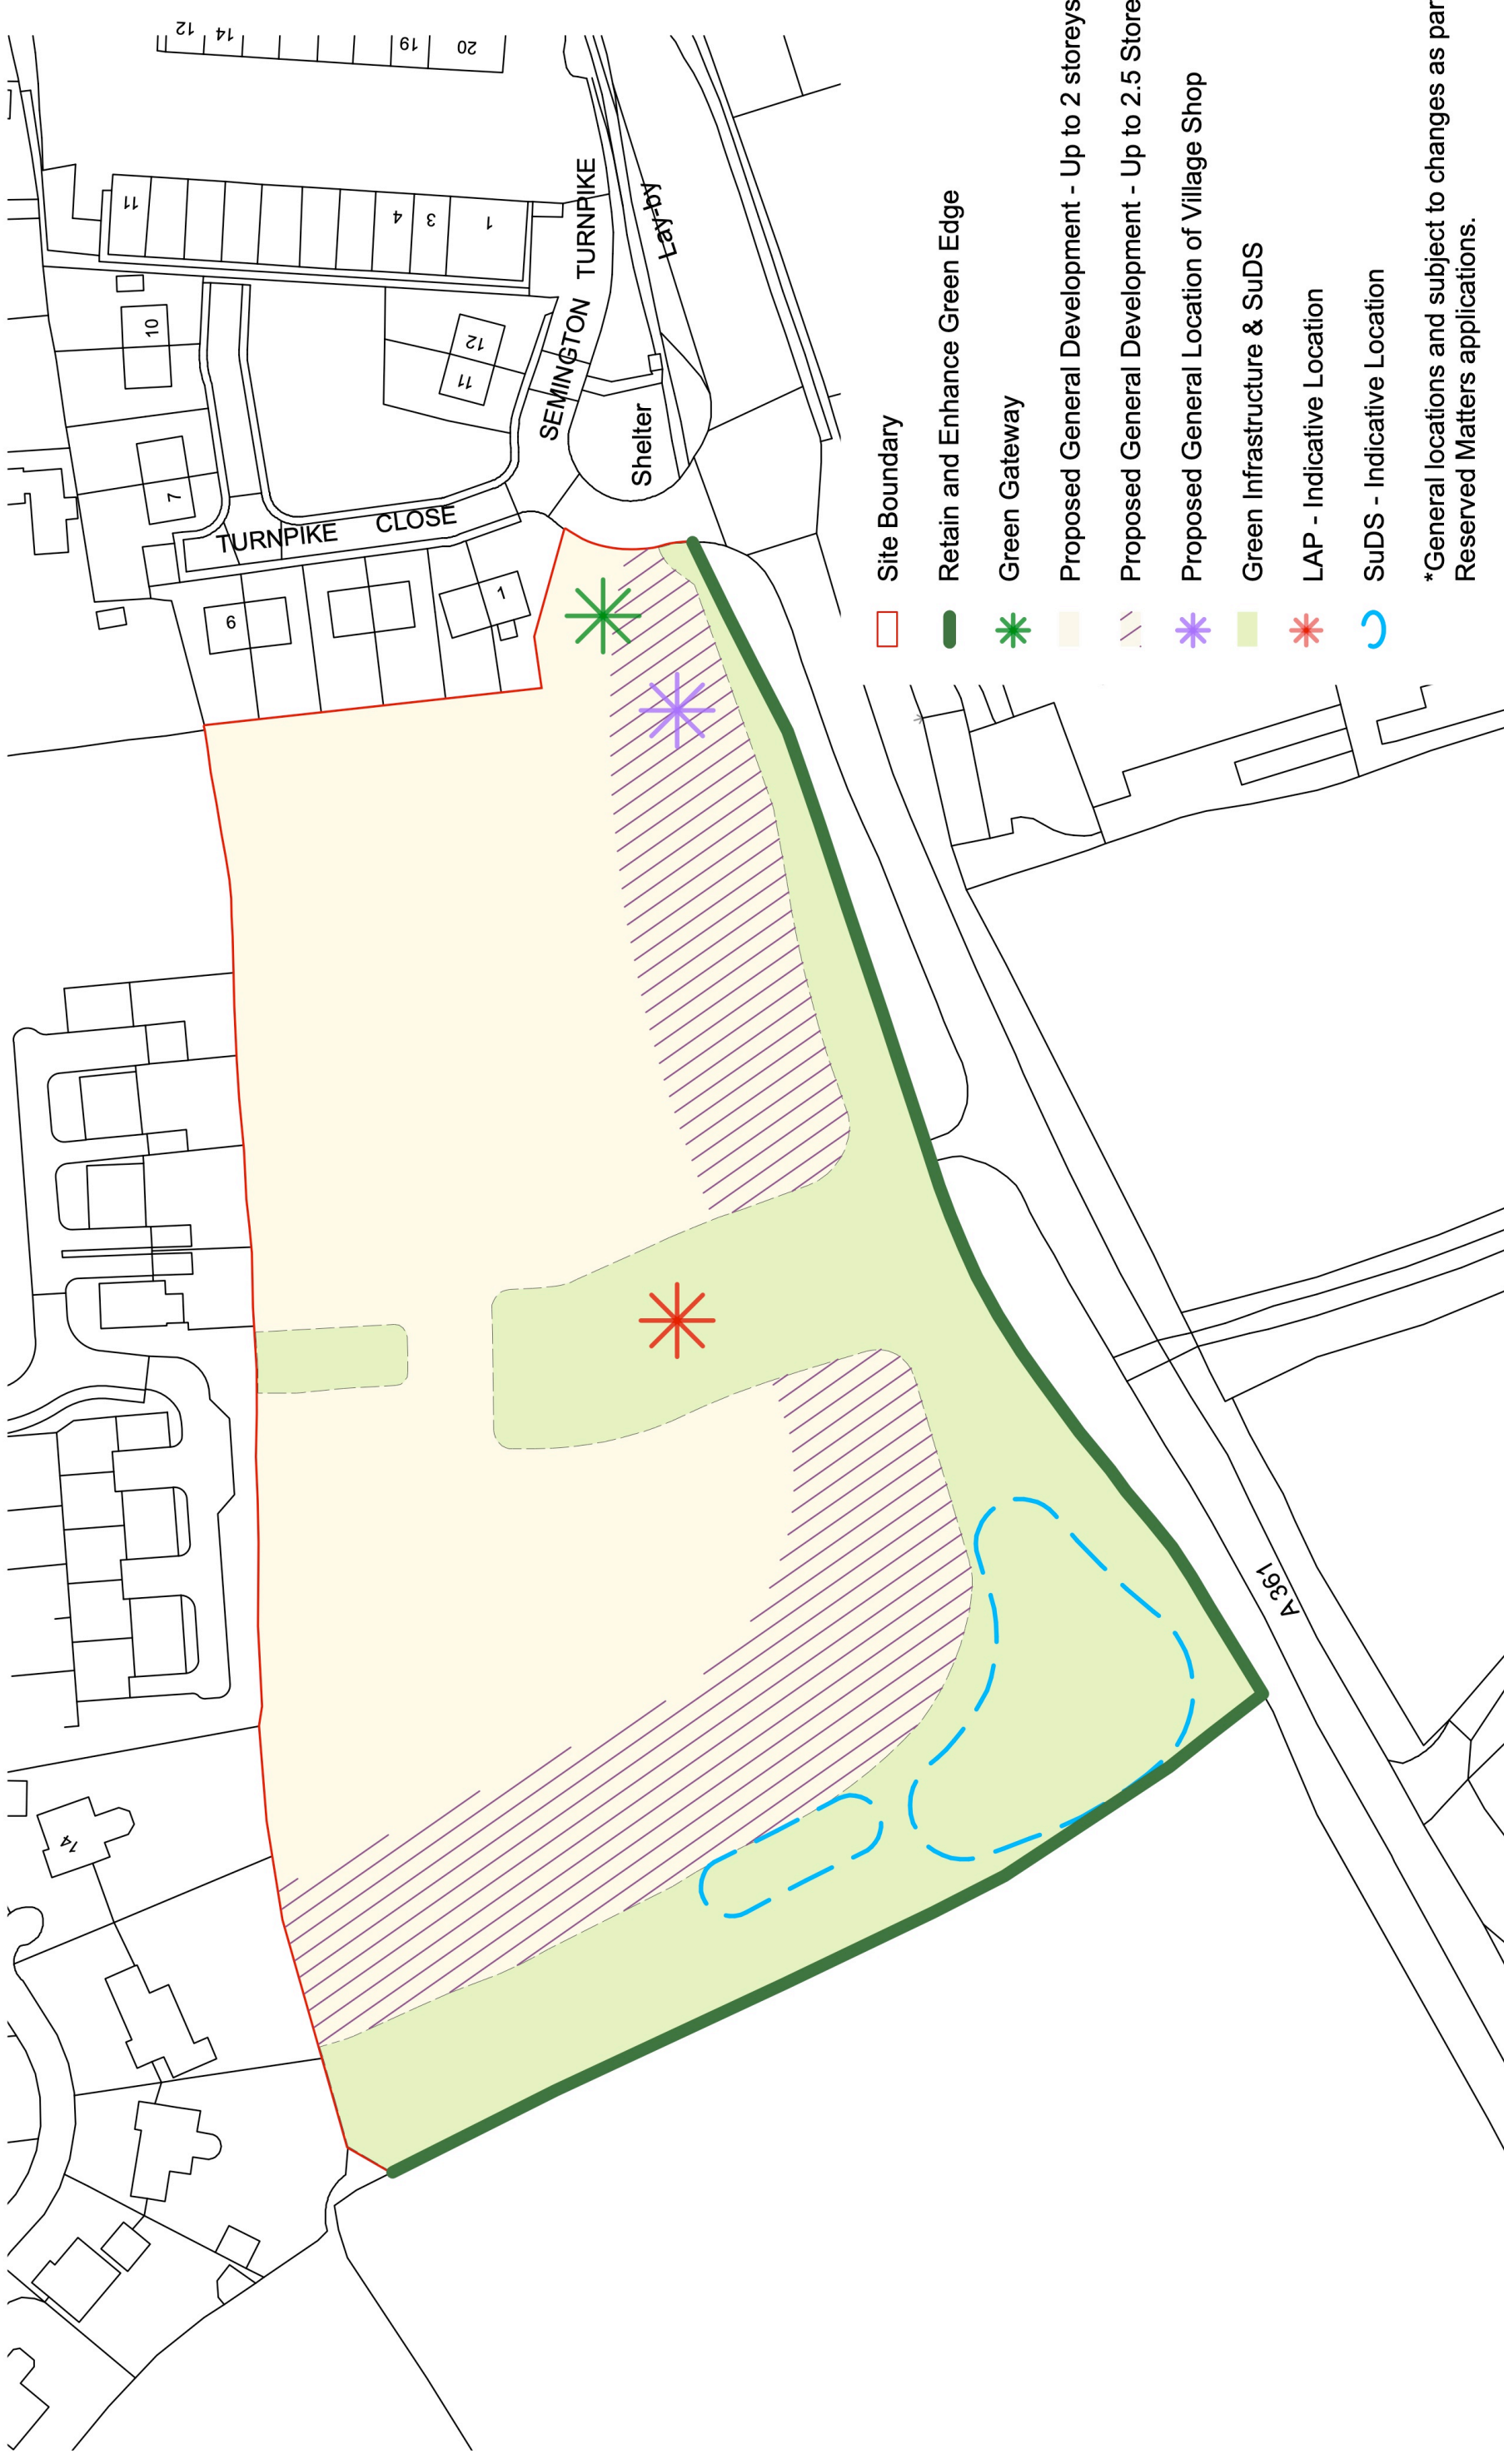
Drawing Title: Parameter Plan

Site Boundary

Proposed General Development - Up to 2 storeys

Proposed General Development - Up to 2.5 Storeys

Proposed General Location of Village Shop

Green Infrastructure & SuDS

LAP - Indicative Location

SuDS - Indicative Location

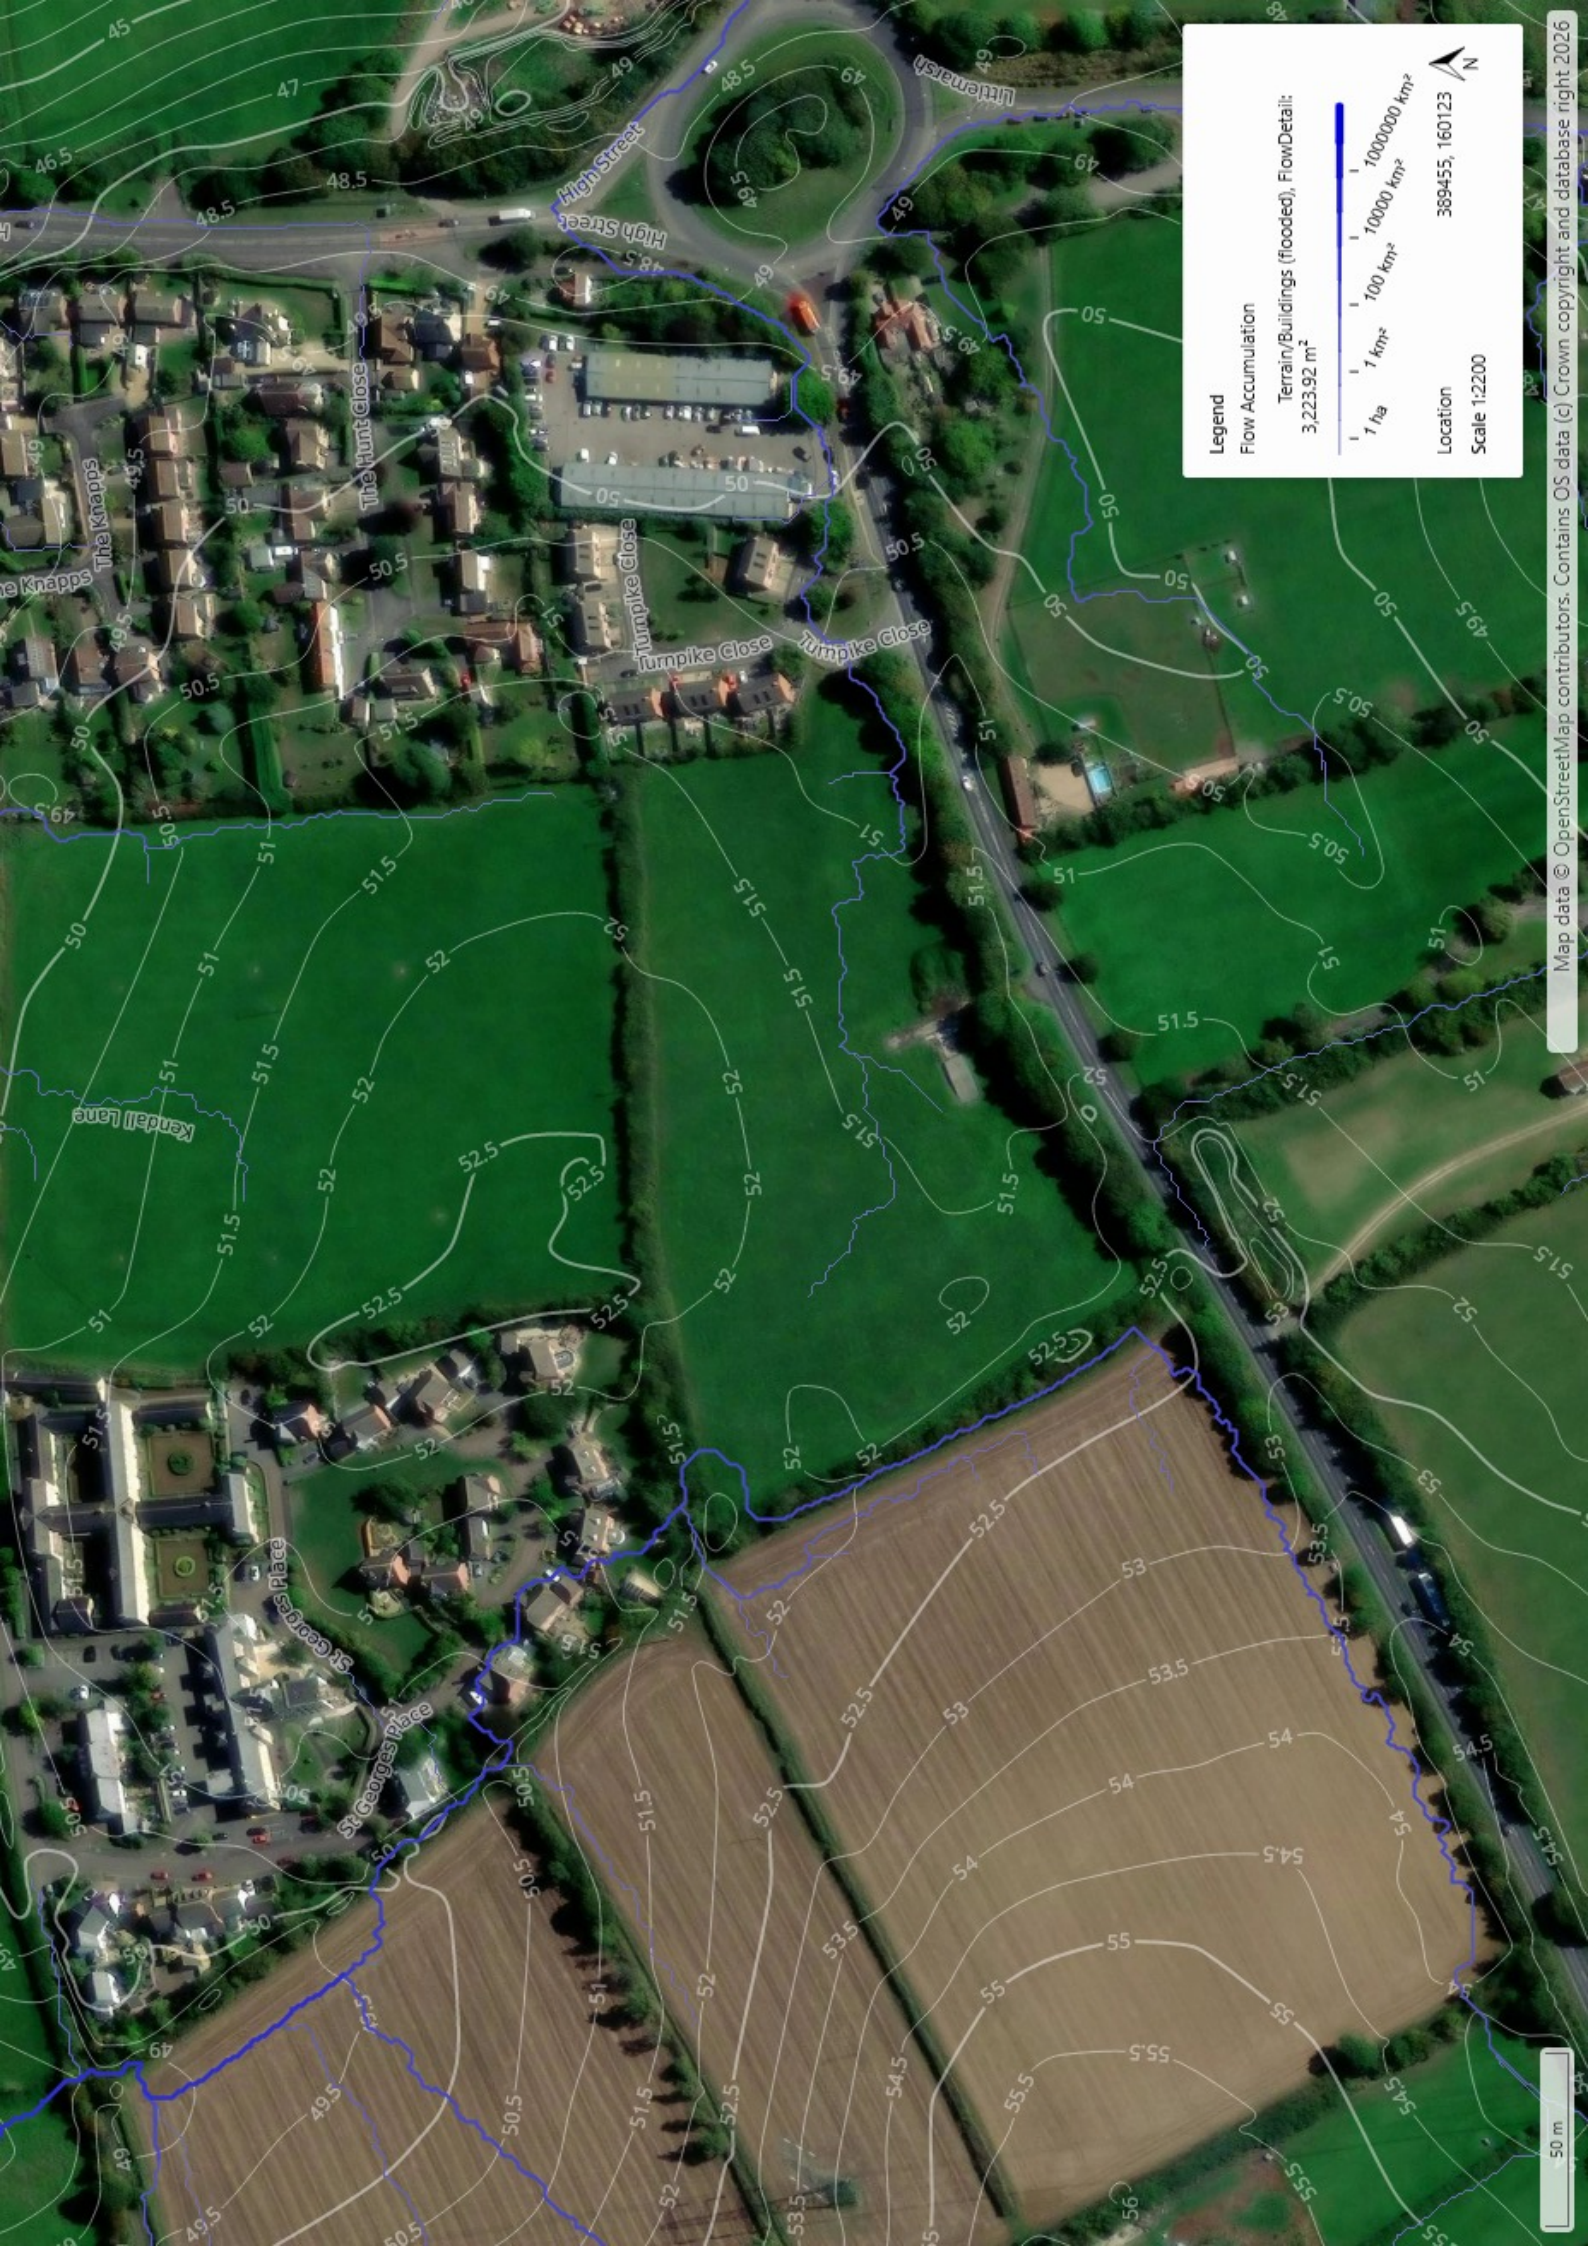
Flow Accumulation

Terrain/Buildings (flooded), FlowDetail:

3,223.92 m<sup>2</sup>
