**REMEDIATION STRATEGY & VERIFICATION PLAN**  
**of a site at**  
**LAND AT THE OLD FIRE STATION, WARMINSTER**  
**for**  
**A AND P PROPERTY SERVICES**

**Project No 2419**  
**Report ref: 2419-P3E-1-D**  
**Issued: 12 August 2026**  
**Revision: D**

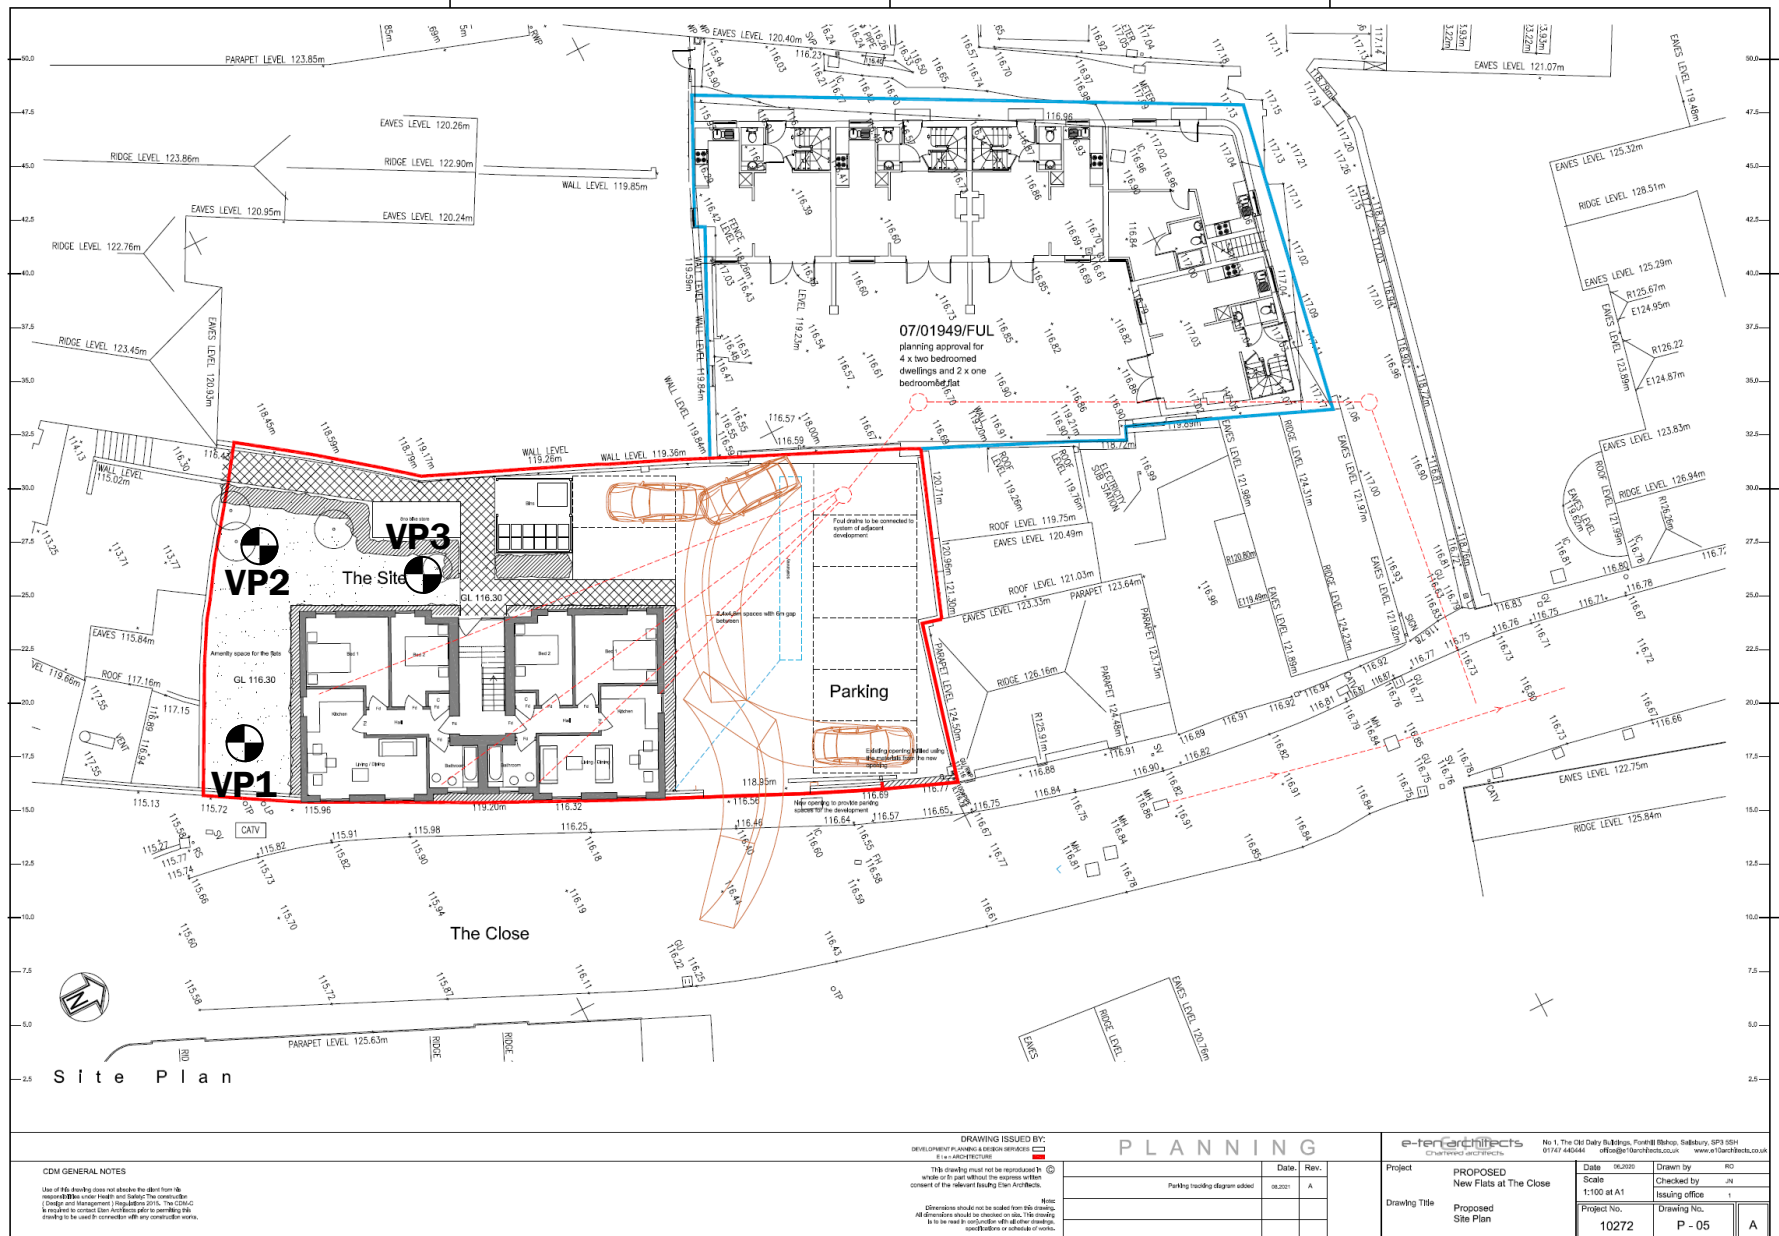
## **Appendix B – Indicative Verification Sampling Plan**

An indicative plan of the proposed sample locations and verification pits is contained in appendix B. The actual locations will be determined during the verification visit.

After placing of the topsoil verification samples will be taken and tested. The clean fill for gardens and landscaped areas should comply with the requirements set out in appendix E. Verification samples will be taken in accordance with the plan in appendix B.

Verification pits will be excavated to a minimum depth of 600mm to confirm the thickness of the capping layer.

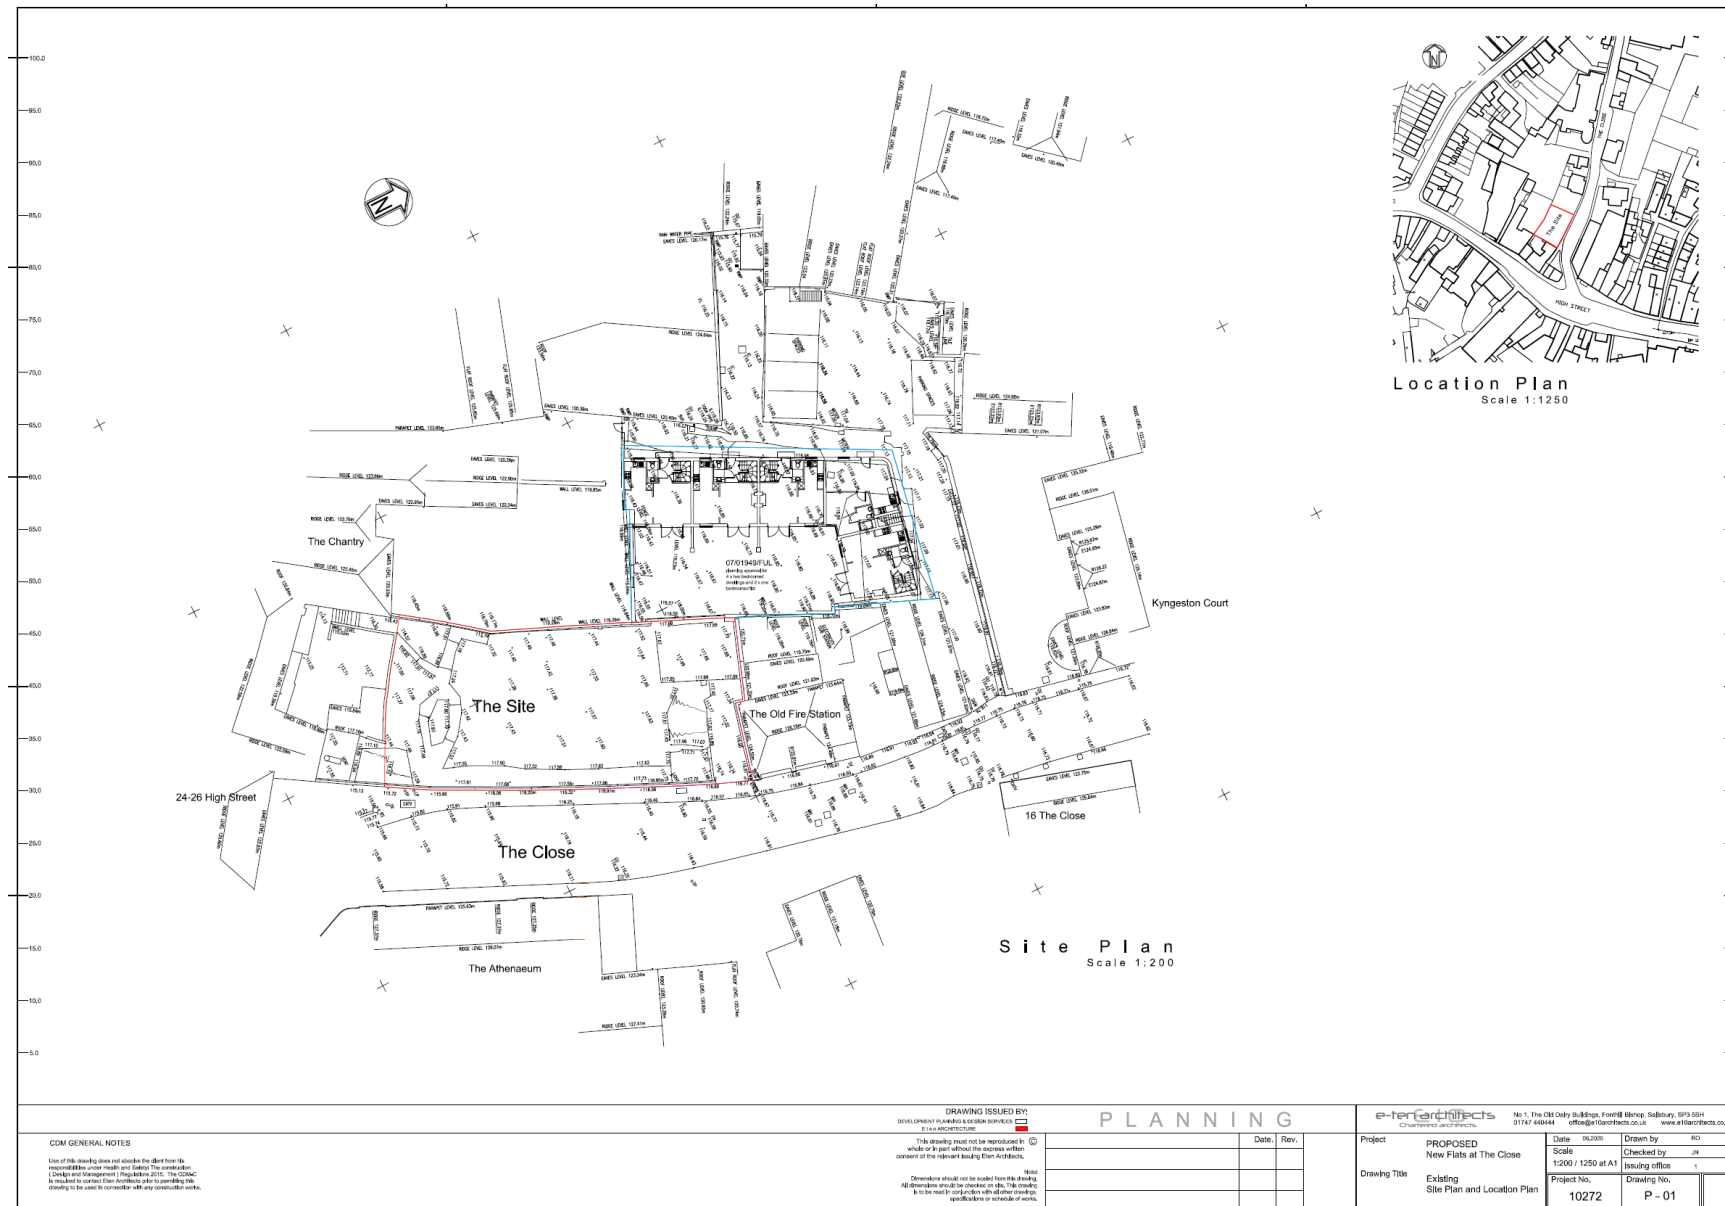
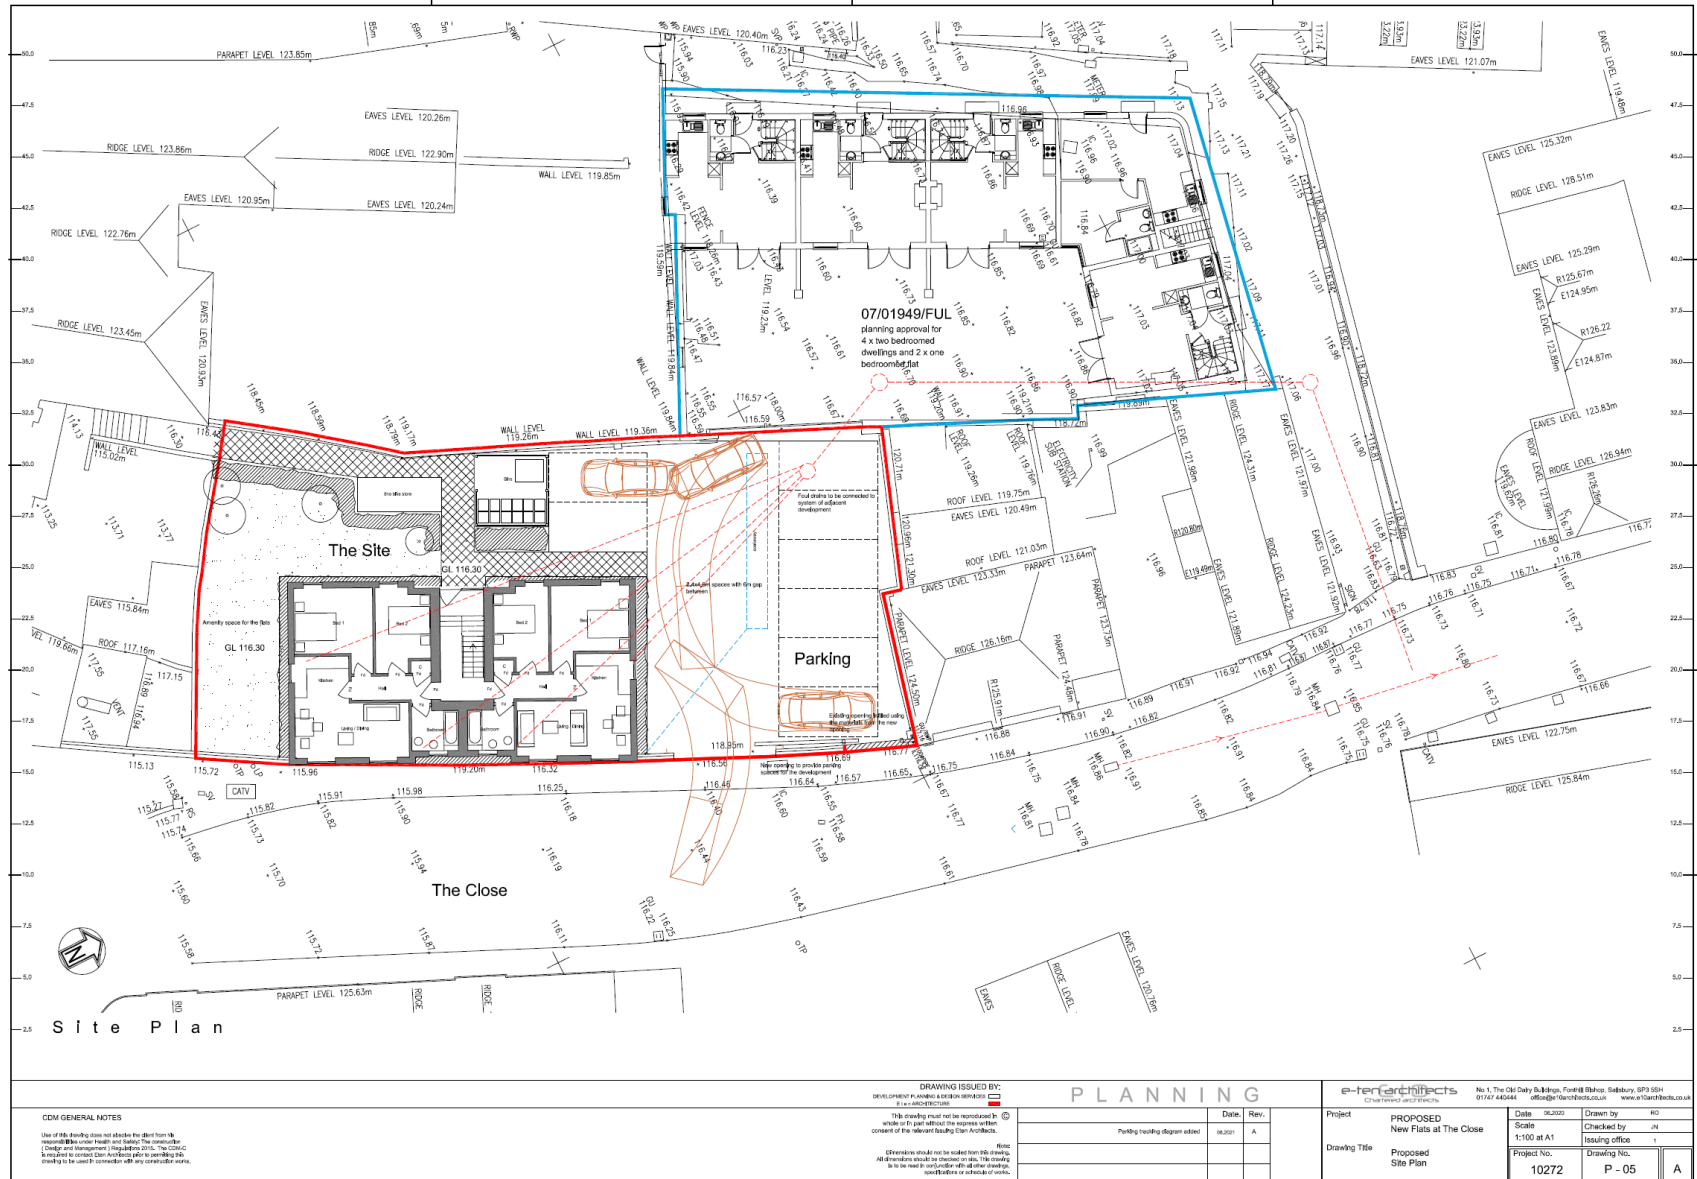
## **Appendix C – Existing and Proposed Site Plan**

Plan details for the proposed redevelopment of the site are shown on the E-ten Architects drawing contained in appendix C.

The drawings shows the development split into two elements.

One element comprising a block of flats including parking facilities, cycle and bin storage, communal soft landscaping and the partial demolition of a listed wall to facilitate the proposed development.

In the area of the communal soft landscaping the site level has been reduced by approximately 1m.

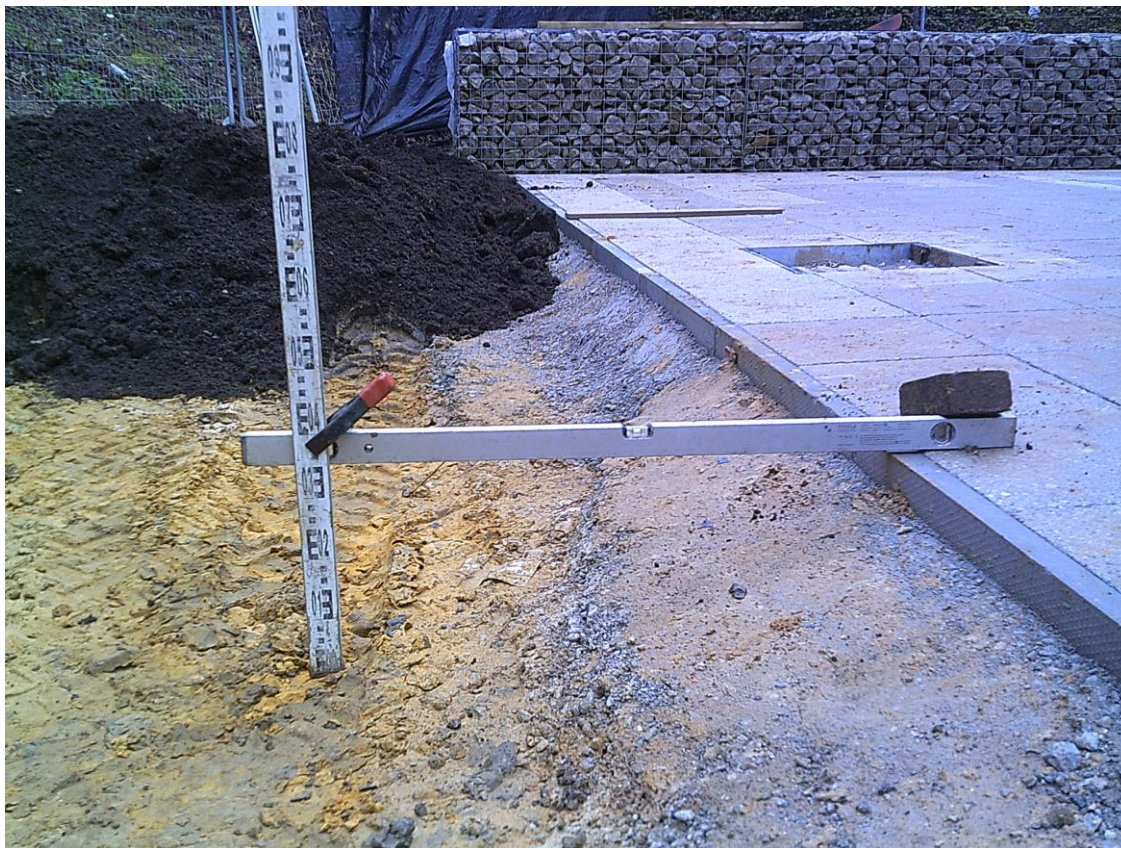
Example A: Close up, showing the depth clearly.

To demonstrate that the made ground within the soft landscape area has been removed to a depth of 600mm, photographs will be taken of the proposed soft landscaped areas following removal of made ground. Examples of how to take photographs showing depth and locations are contained in appendix I. A plan showing the locations of the photographs will be prepared.

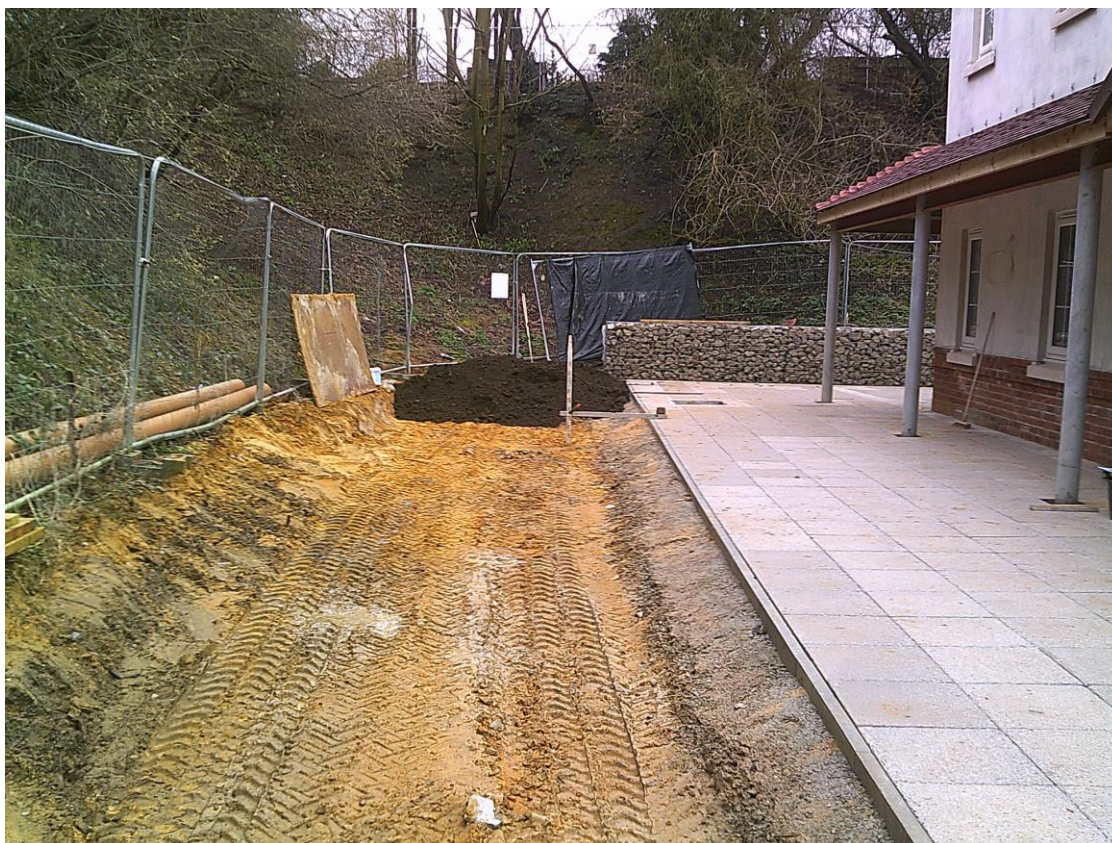
Example A: Showing the location of the close up

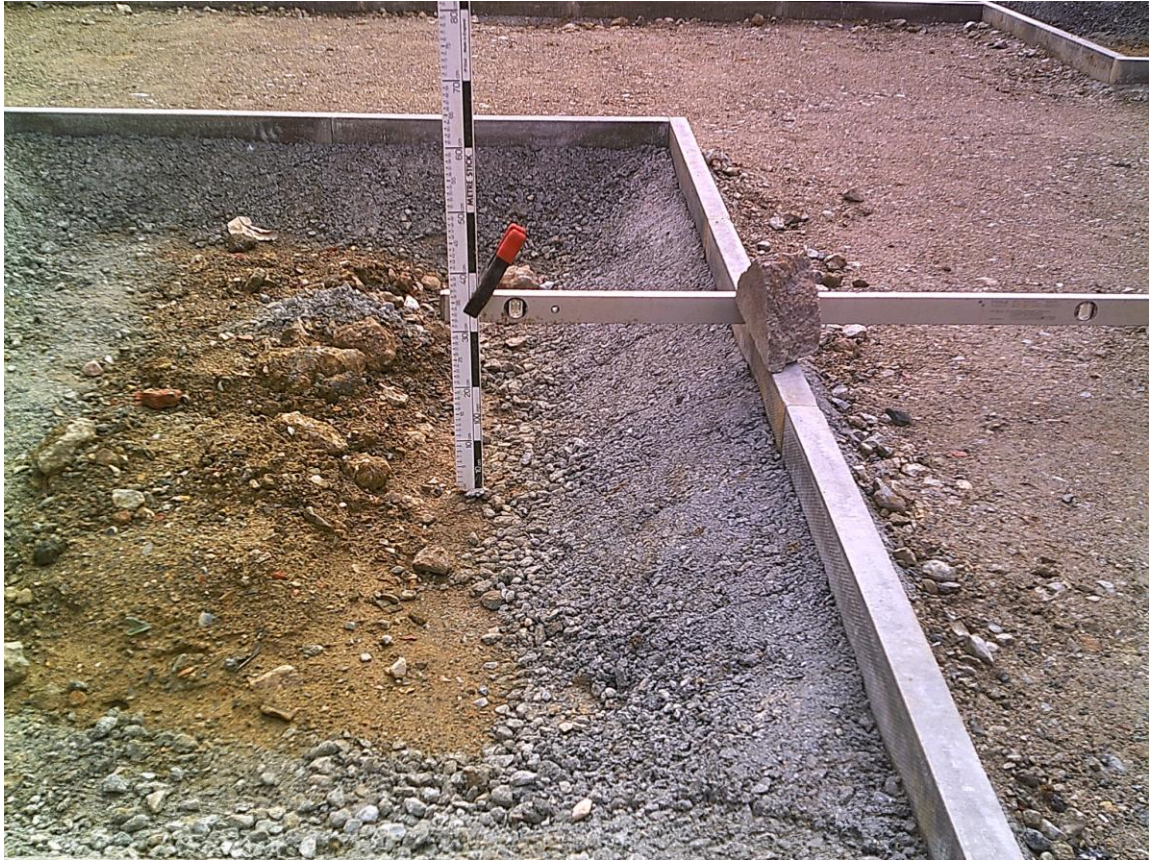
Example B: Close up, showing the depth clearly

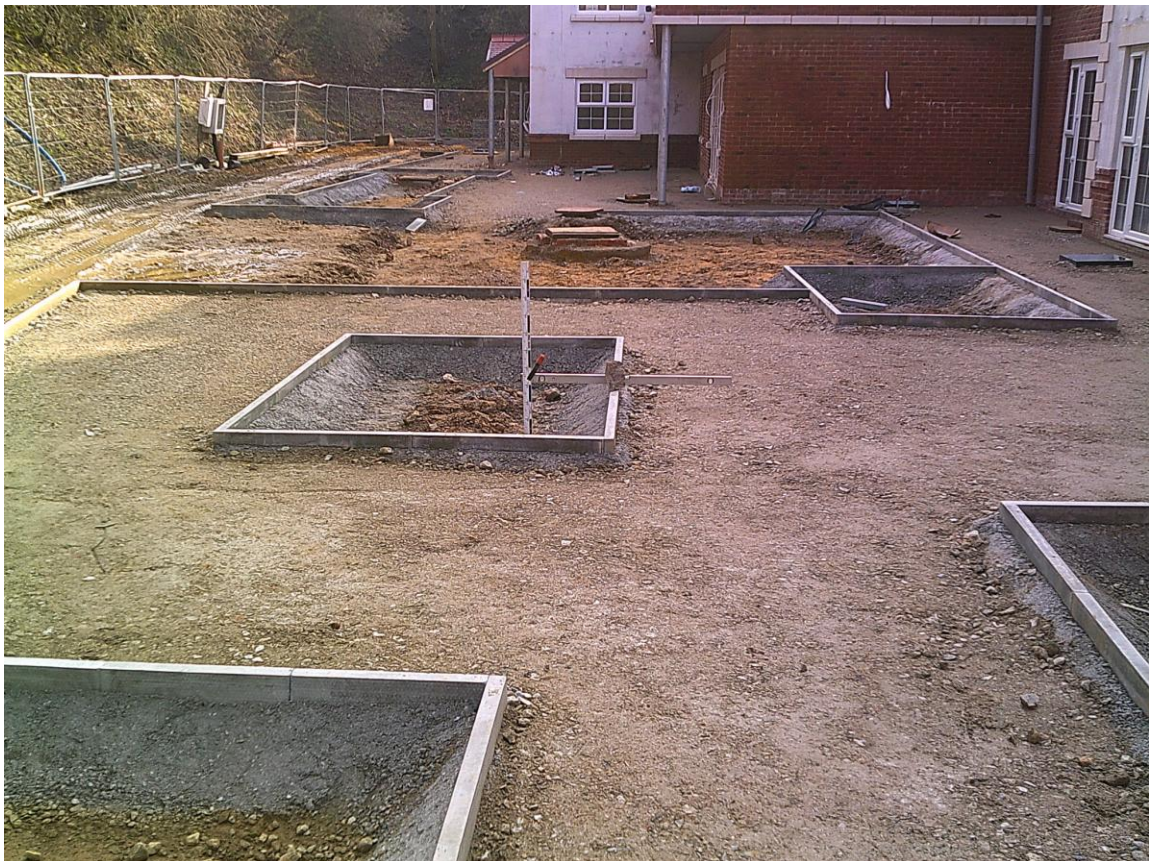
Example B: Showing the location of the close up
