**PHASE 2 ENVIRONMENTAL INVESTIGATION**  
**of a site at**  
**LAND AT THE OLD FIRE STATION, WARMINSTER**  
**for**  
**A AND P PROPERTY SERVICES**

**Project No 2419**  
**Report ref: 2419-P2E-1-B**  
**Issued: 7 August 2026**  
**Revision: B**

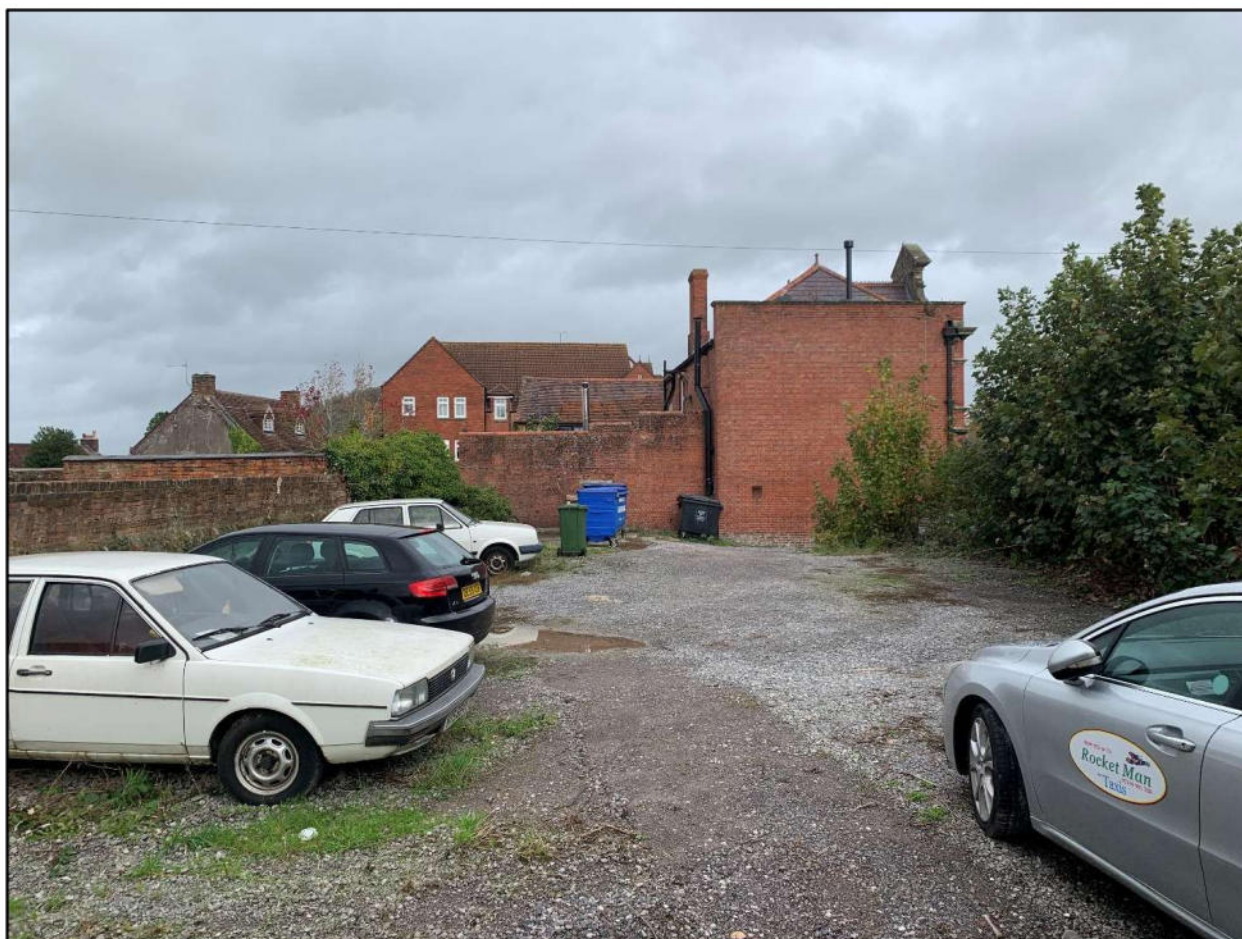
**Photograph 1: View looking north across from the southern boundary**

The site is rectangular shaped in plan and occupies 0.1ha. The site is generally flat with a downward gradient from north to south.

At the time of the visit the site was being used as a car park.

Several commercial waste bins were identified on site. Evidence of fly tipping was also identified along the southern site boundary including garden waste, brick, metal and small amounts of domestic waste.

The majority of the site is hard surfaced comprising concrete, paving and gravel. The condition of the hard standing is poor with vegetation growing through cracks in the concrete.

No significant visual or olfactory evidence of contamination was noted during the visit.

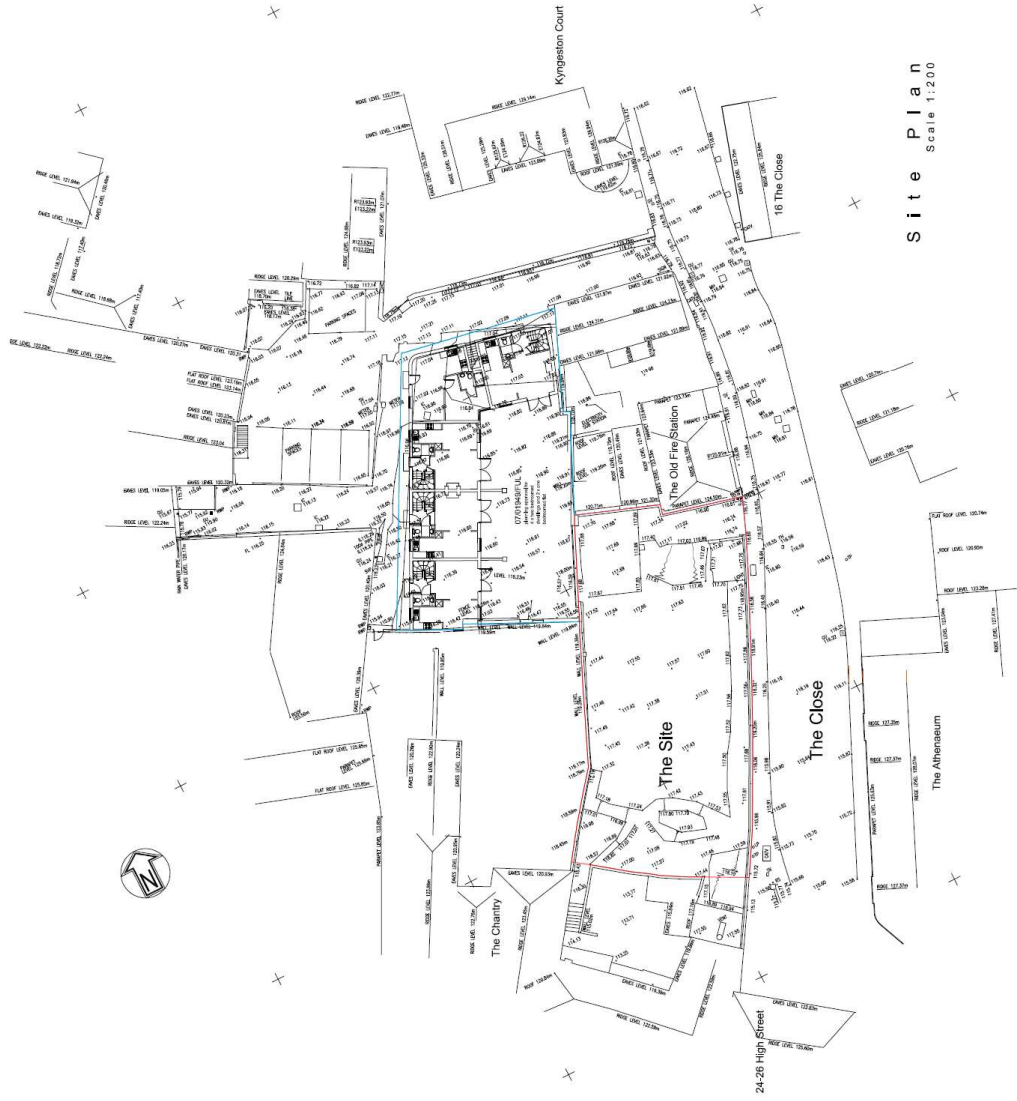
Site Plan  
Scale 1:200

Plan details for the proposed redevelopment of the site are shown on the E-ten Architects drawing contained in appendix C.

The drawings shows the development split into two elements.

One element comprising a block of flats including parking facilities, cycle and bin storage, communal soft landscaping and the partial demolition of a listed wall to facilitate the proposed development.

In the area of the communal soft landscaping it is proposed to lower the site by approximately 1m.

The second element comprising residential dwellings without private gardens or communal soft landscaping.
