# 1. Introduction and Methodology

**1.1.1** This Heritage Statement has been prepared to describe and assess the significance of the heritage assets at Nonsuch Estate and to consider how the proposed works for their restoration and reuse may affect that significance. It supports a planning and listed building consent application to Wiltshire Council and provides a proportionate, evidence-based account of the site's architectural, historic and landscape interest in accordance with national and local policy.

**1.1.2** Nonsuch Estate includes Nonsuch House (Grade II\*), the Stable Block and Coach House (Grade II), the Walled Garden (Grade II) and the Garden Walls and Gate Piers (Grade II), together with other associated curtilage structures and the designed parkland that forms their setting. The purpose of this assessment is to describe the development of these buildings and spaces, to identify their individual and collective significance, and to evaluate the degree to which the proposed works might affect them. It also seeks to demonstrate how potential harm has been avoided or reduced through design and how the project will secure the long-term conservation and viable reuse of the

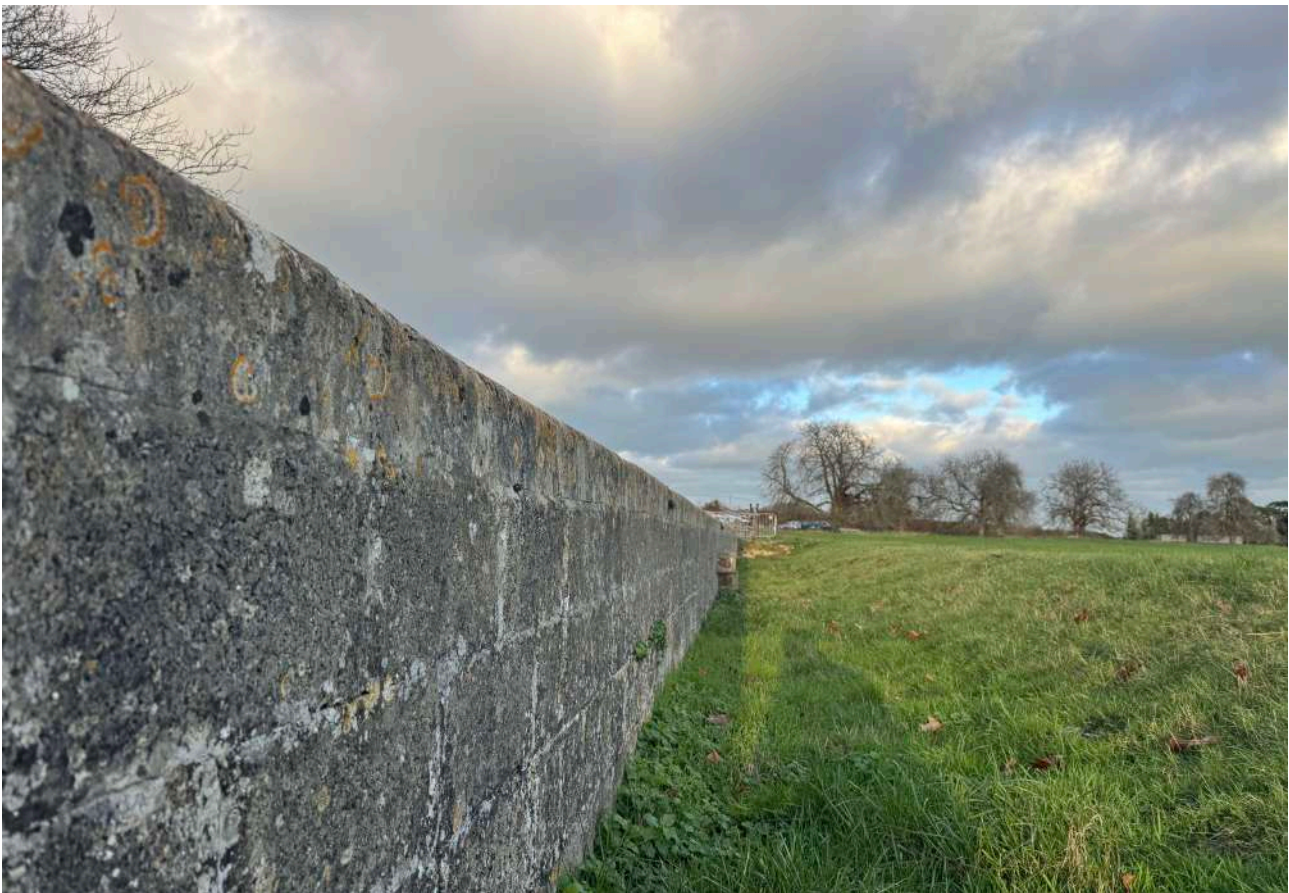
Figure 3.9: Modern concrete ha-ha forming southern garden edge

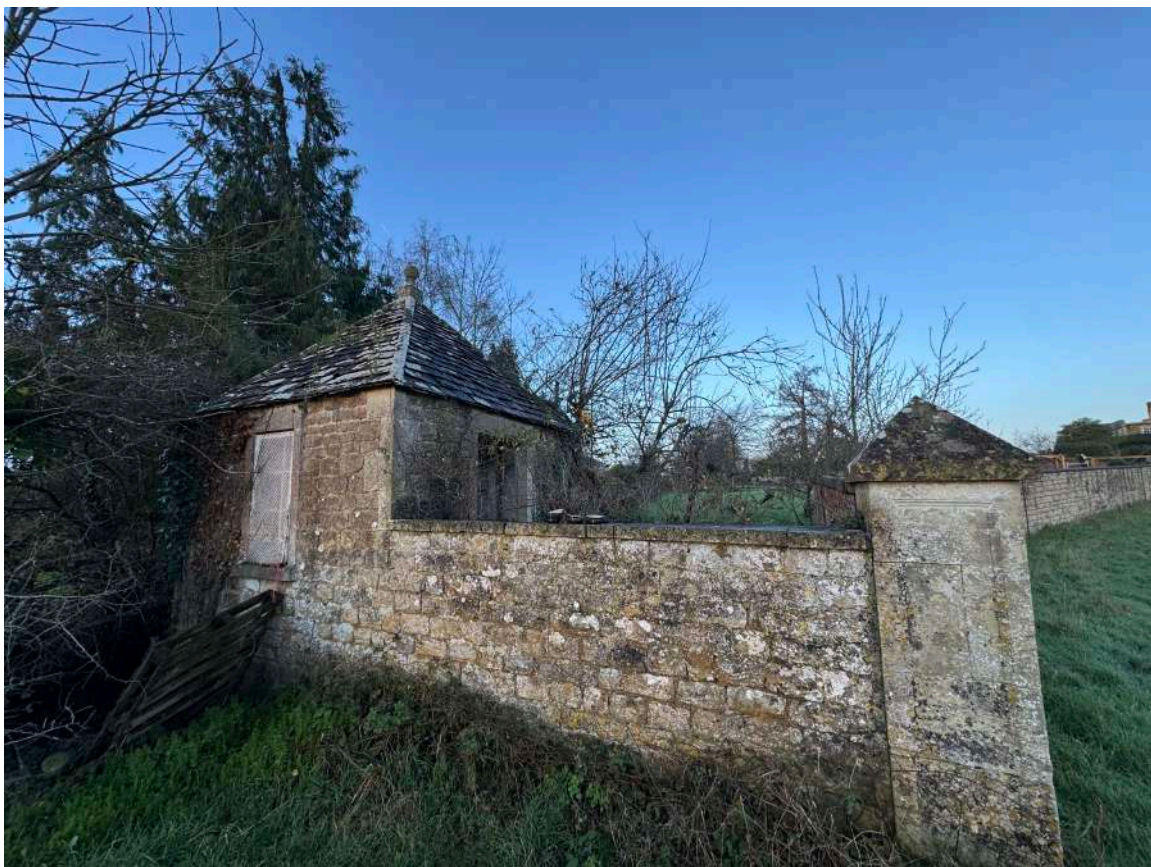
Figure 3.13: Relationship between Summerhouse and the wall of the Walled Garden

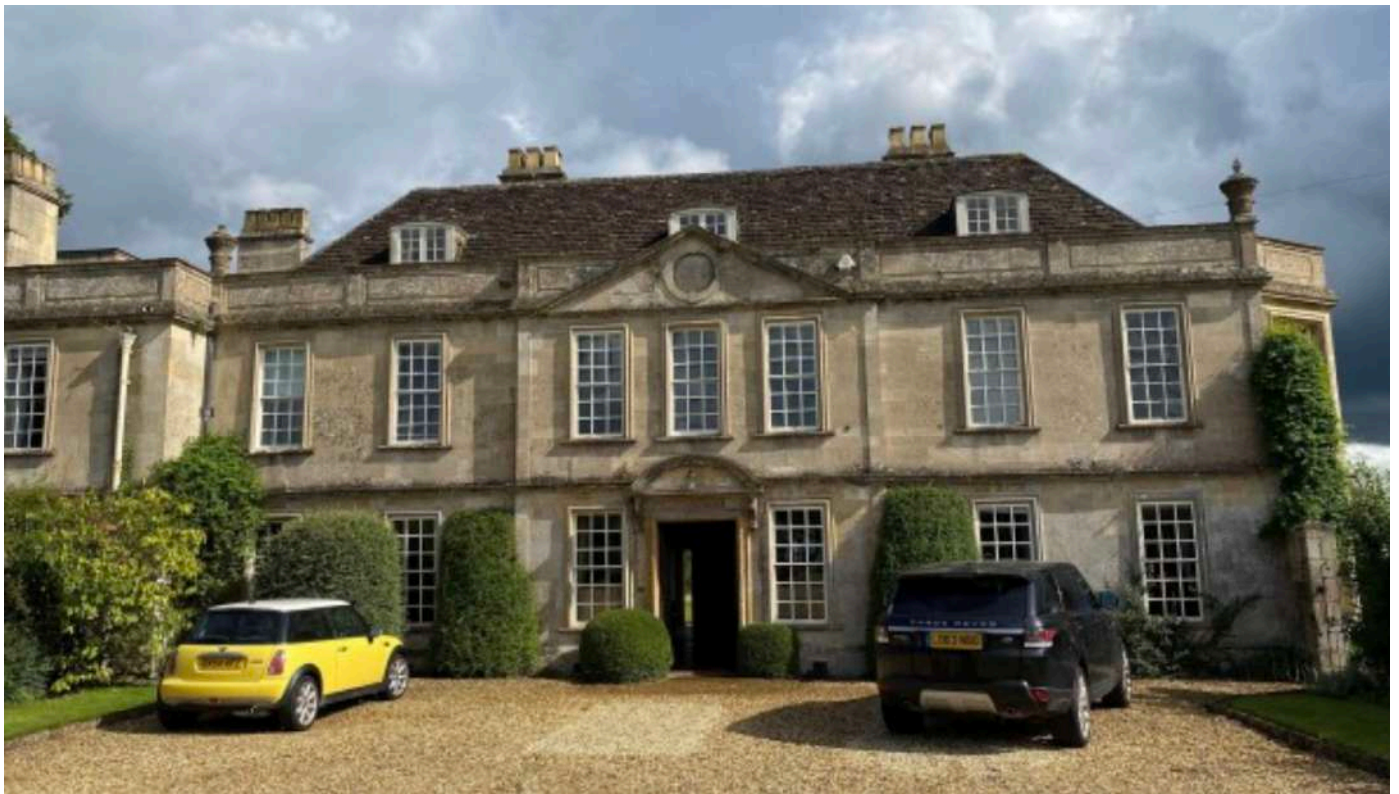
Figure 5.1: North ashlar elevation of Nonsuch House (pre-fire)

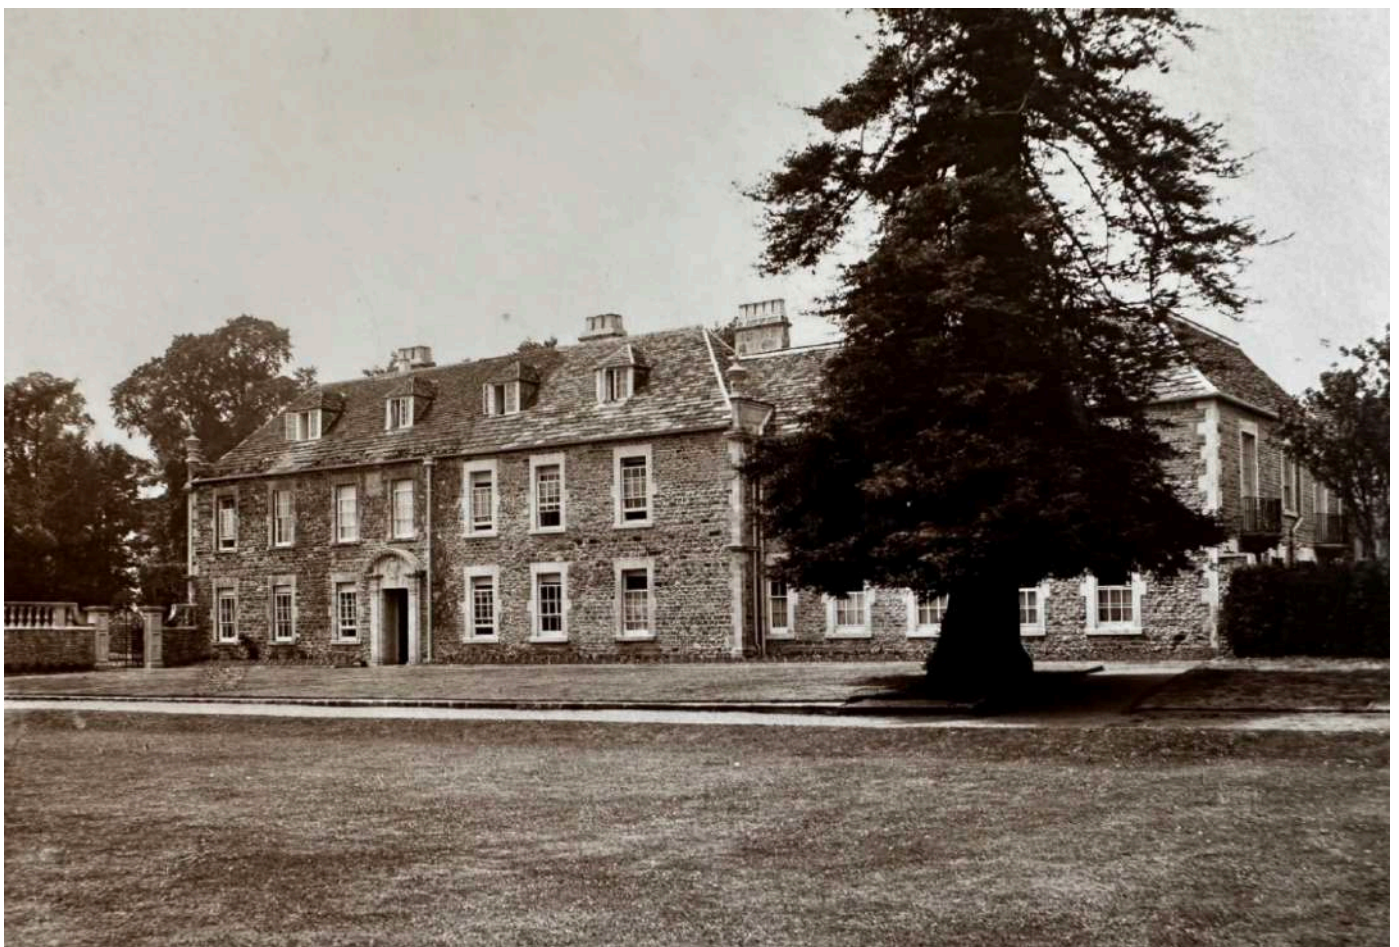
Figure 5.2: South elevation of Nonsuch House (pre-fire)

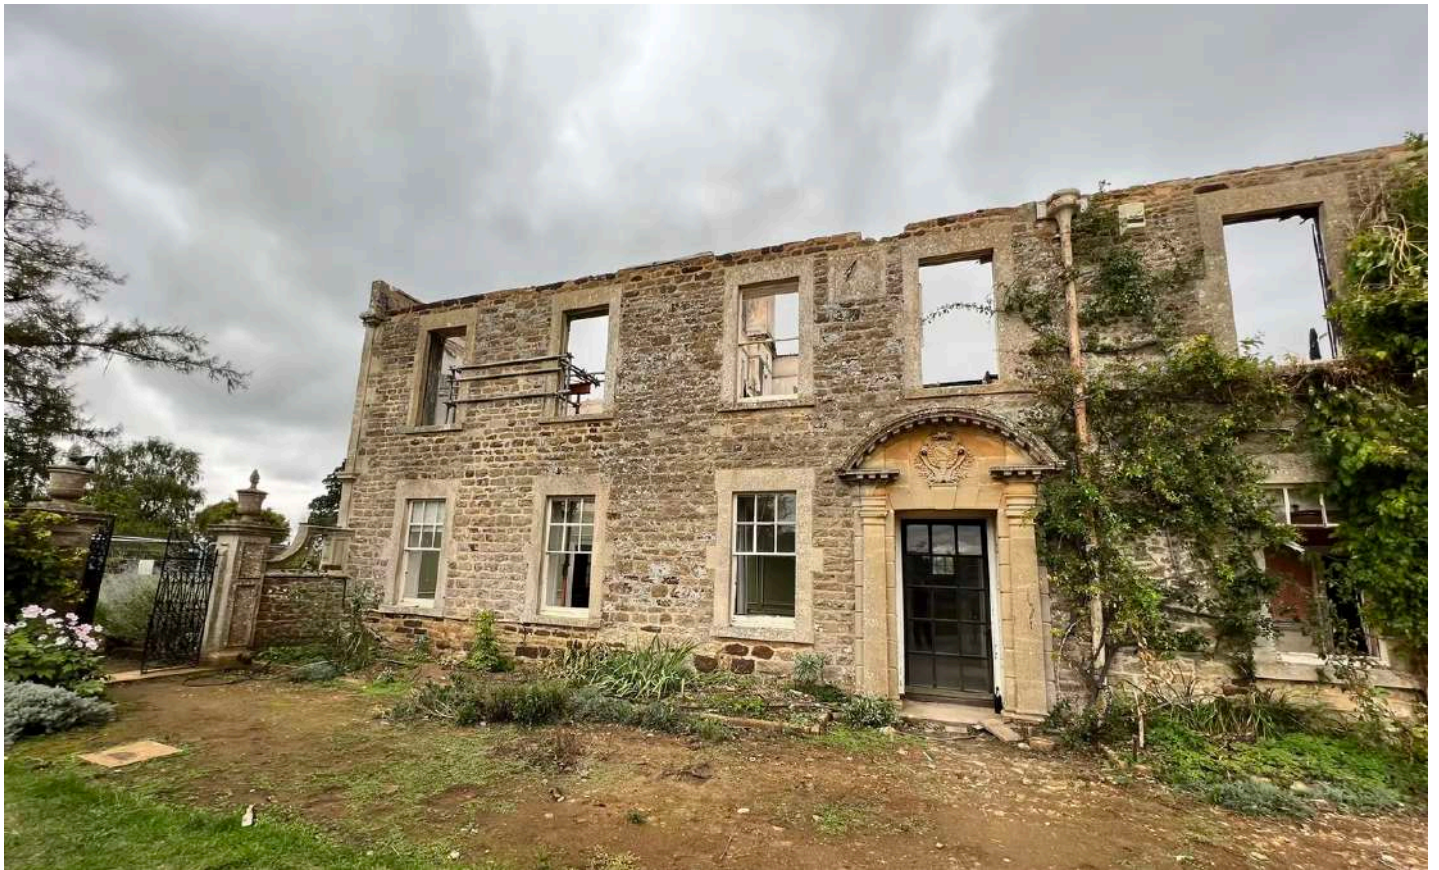
Figure 5.3: Nonsuch House, South Elevation. Fire-damaged shell

**6.3.8** The major fire in 2022 caused severe and extensive damage to Nonsuch House. Almost all of the first-floor structure, the entire attic level and the whole roof were lost. The fire caused substantial damage to parts of the ground floor, and the months that followed, during which the house remained exposed, resulted in significant water penetration, deterioration of finishes and progressive decay of the upper wall heads. Most of the masonry envelope survives, although areas adjacent to the lost roof structure show water-induced deterioration. A temporary roof has now stabilised the condition, but some water ingress persists and will require further management and repair.

**8.4.1** The 2022 fire has had a profound and far-reaching effect on the condition of Nonsuch House. The entire roof structure, together with the attic floor and almost all of the first floor, was lost. Significant areas of the surviving ground floor were directly affected by heat and smoke, and subsequent exposure to the weather allowed prolonged water ingress into the remaining fabric. For an extended period of approximately seven to twelve months the building stood open to the elements, and substantial rainwater penetration occurred through the charred wall-heads and compromised floor structures. The damage is now expressed in decayed timbers, displaced masonry, collapsing internal partitions, disintegrated plasterwork, damaged masonry fireplaces, salt disturbance, mould growth and the failure of surviving finishes. Although the ground-floor plan form remains legible, its material condition has been materially eroded.

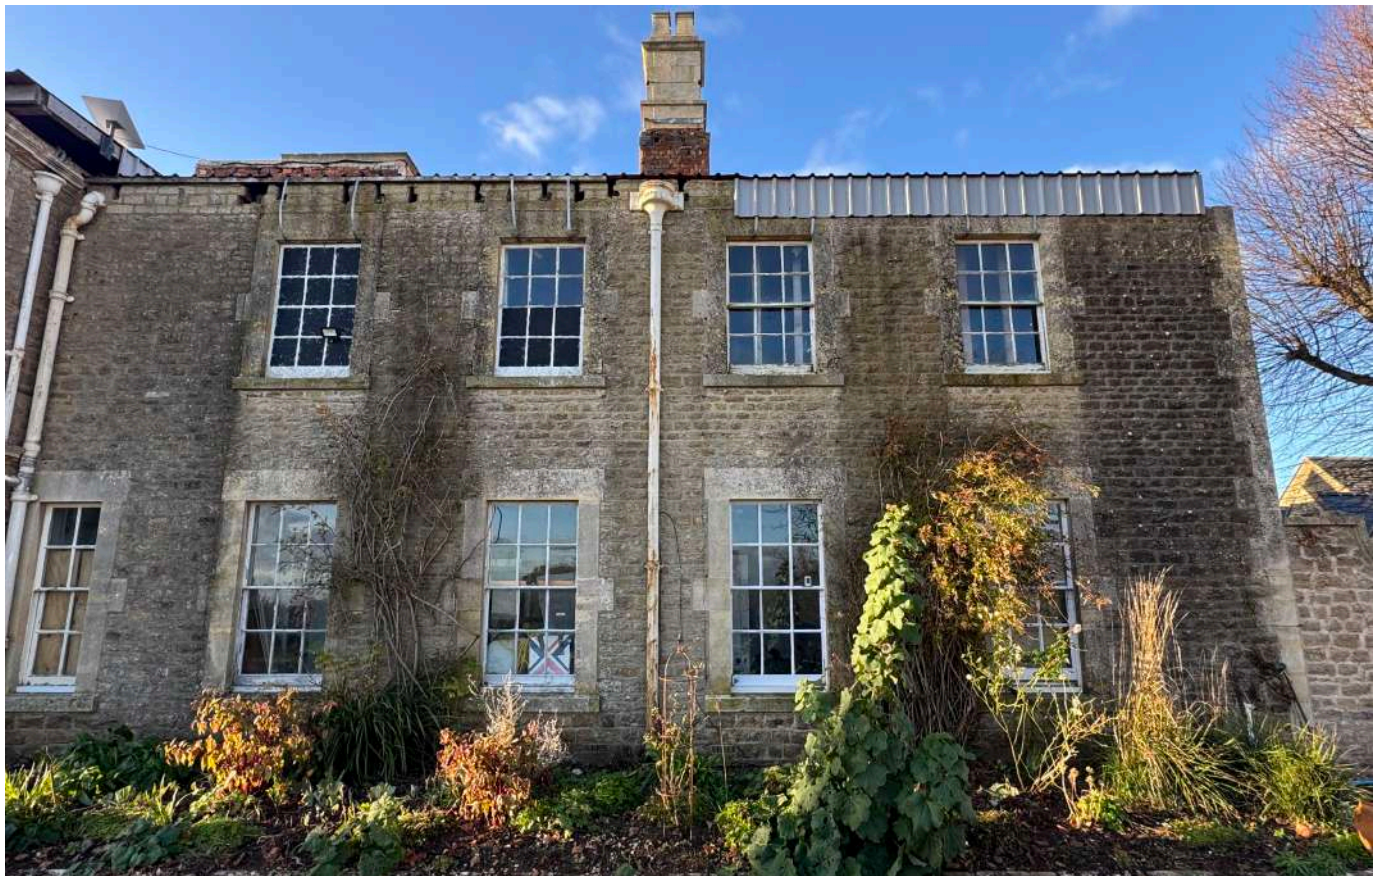
Figure 5.4: East Wing South Elevation, post-fire

**8.4.3** The East Wing has also suffered extensive damage. Although the pattern of destruction differs from that of the main house, the loss of the roof and the entire attic storey has left the upper fabric exposed. Fire spread into parts of the first floor and, in places, into the ground floor, charring timbers and degrading internal finishes. Prolonged water ingress, combined with poor ventilation, has resulted in widespread mould growth and the deterioration of joinery and plaster surfaces. The form and alignment of the range remain clearly understood, but the condition of the fabric now necessitates a sustained programme of intervention.

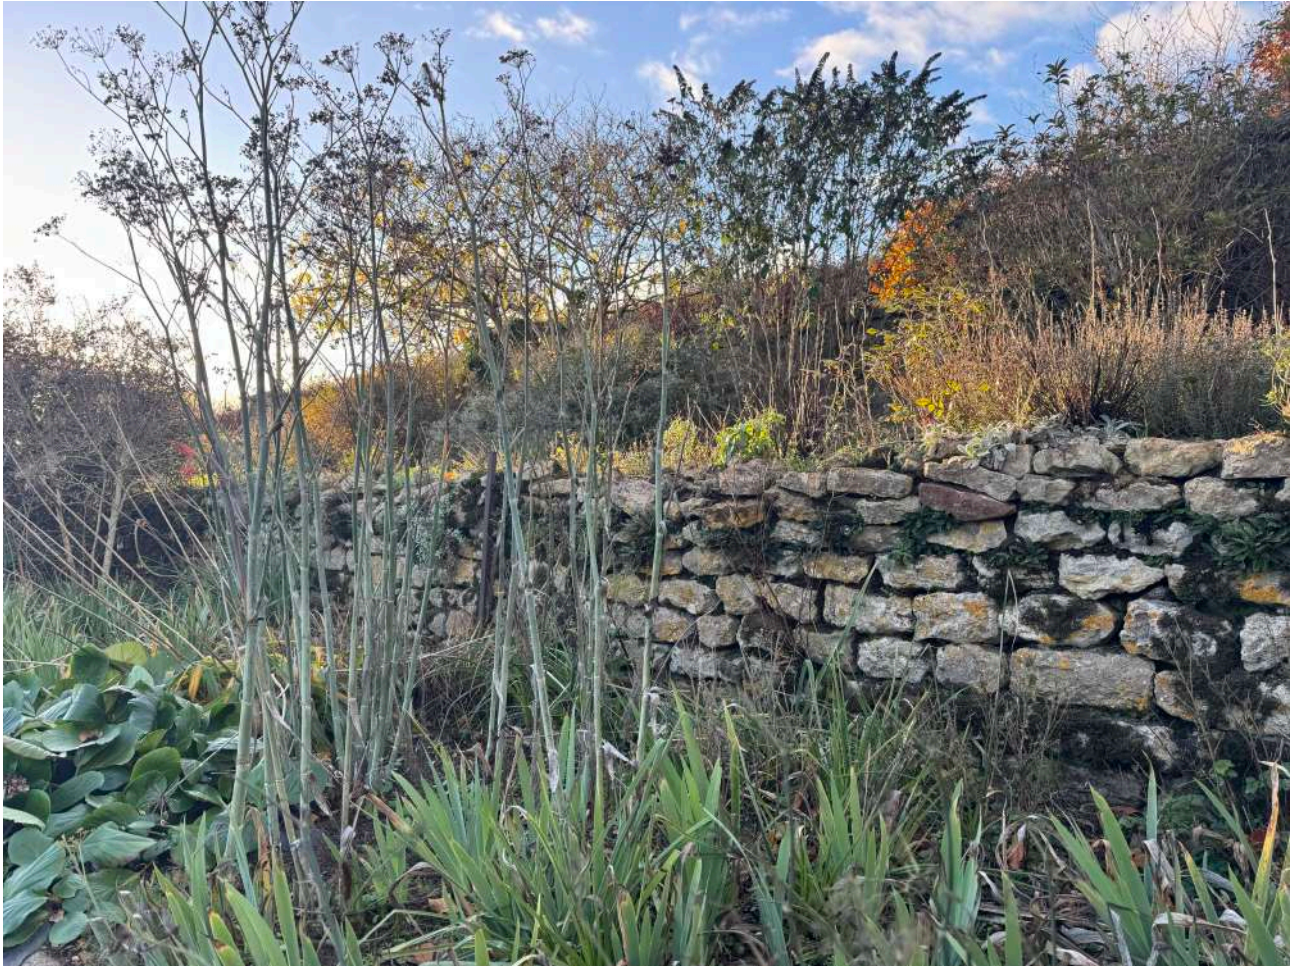
Figure 5.9: Raised terrace in Larch Garden - condition of wall

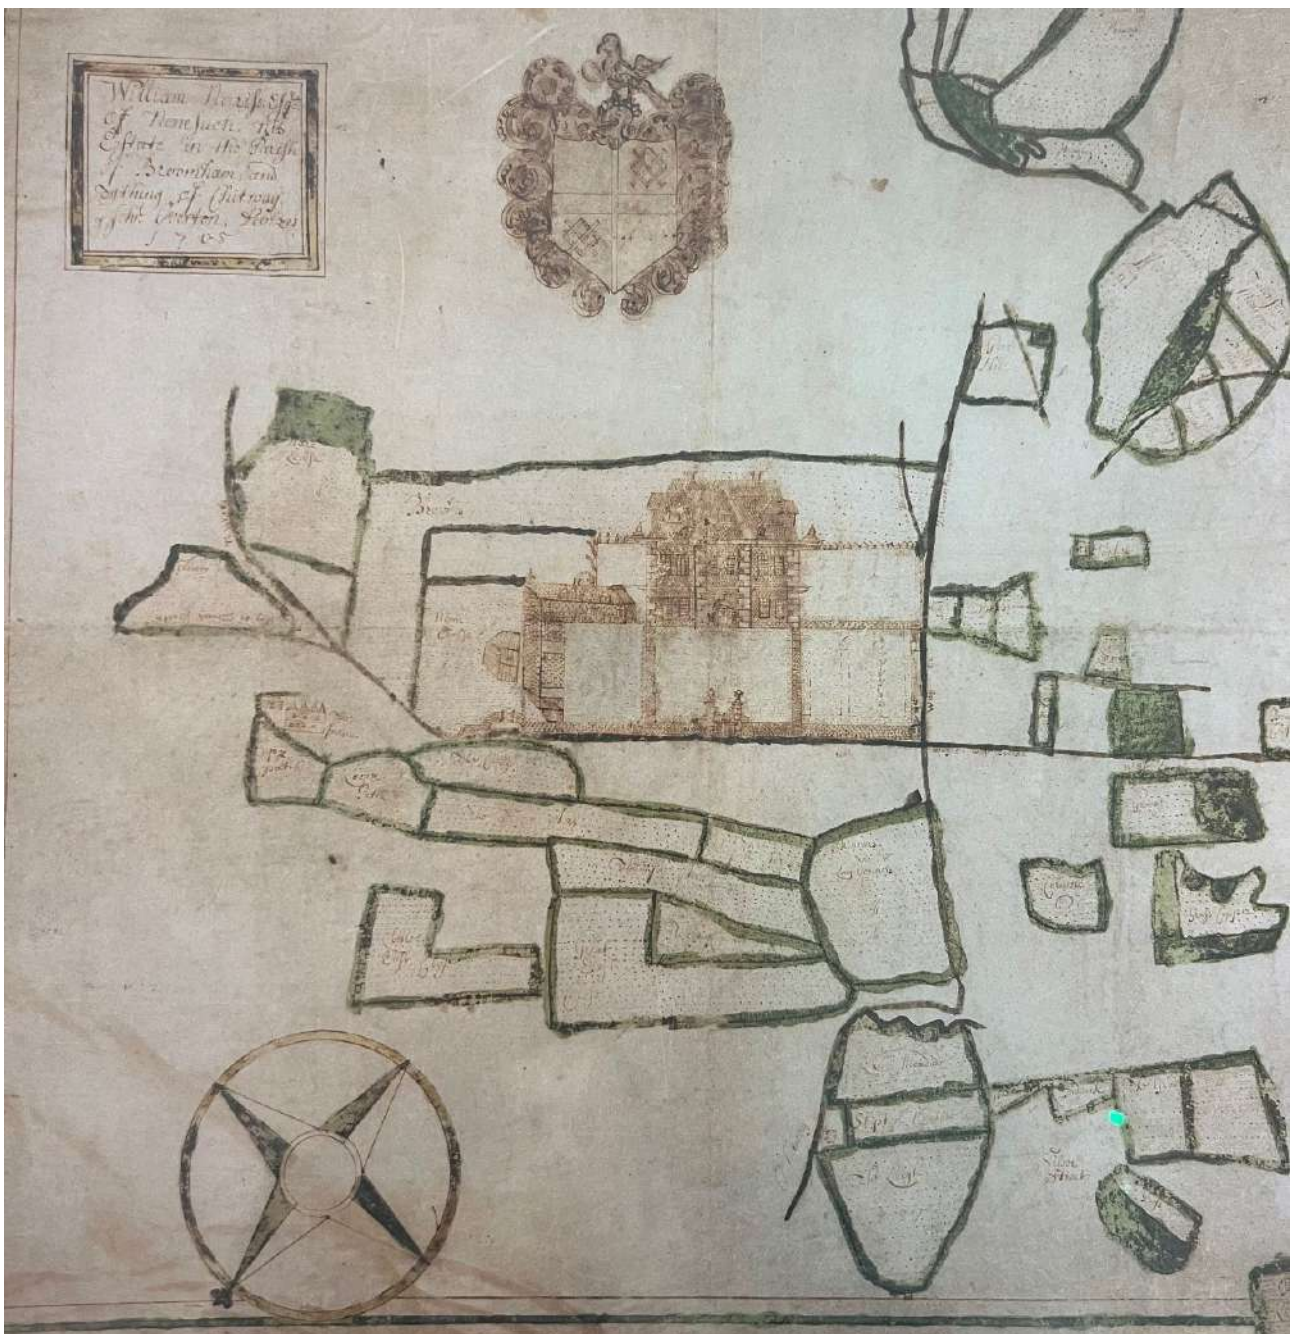
**7.3.1** The drawing below is the first known depiction of Nonsuch House which was at the time under the ownership of William Norris Esq. Just as the lodge that came before it, the house in the form depicted below is no longer standing and was extended and adapted at some point after 1705 by the Norris family who owned the estate until 1835. The elevation below before building was rebuilt. The house is shown as the original symmetrical William & Mary style house. The front façade of the house was most likely built out of pennant stone with sandstone quoins to the corners. The roof has a different form, being pitched on all sides and the center has a central hipped end over the front entrance. The roof also has pitched dormers on the East and West elevations. The Stable Block is present in the drawing below although the building wraps around where the East Wing currently stands to connect to Nonsuch House

Figure 7.5: 1705 William Norris Esq Parchment . John Overton

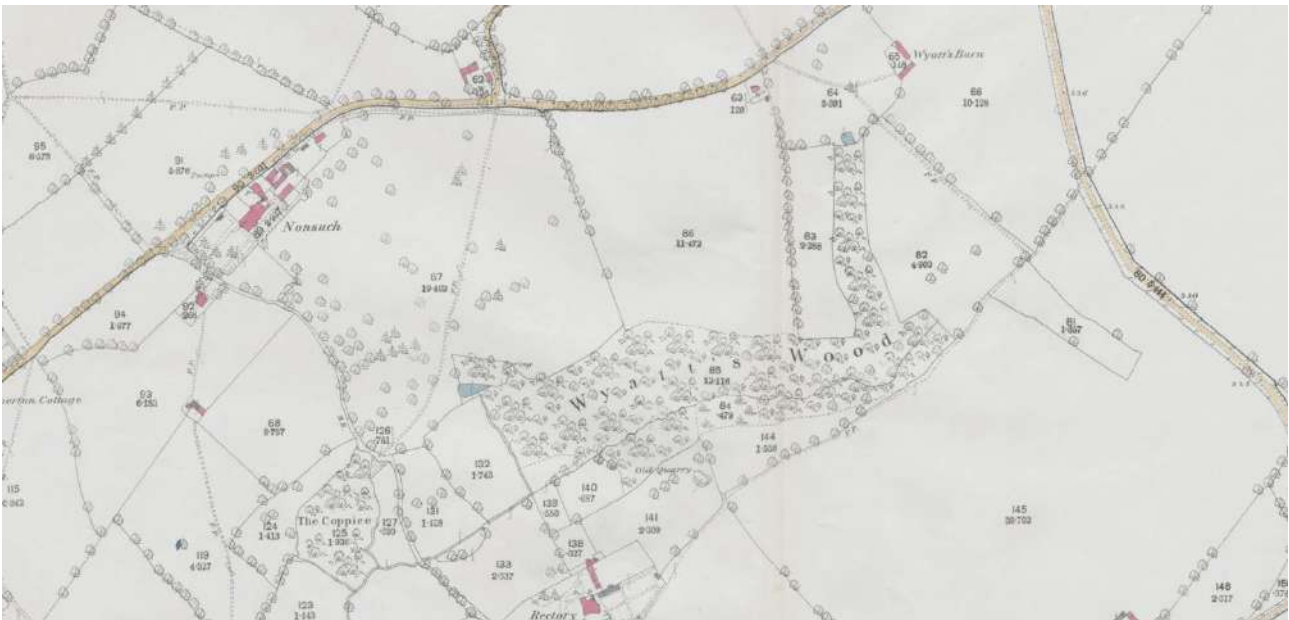
**7.7.1** The 1884 map shows Nonsuch House a different shape in plan, it's more rectangular, and longer to the NE. This shows the extension of the additional dormer in 'figure 12' to the rear and bay to the front. with the T- shape plan of the stable block gone, it has its current form, there was a later extension to the NE to join the two buildings, which is not seen on historic maps. There is also a small grey building in the West Lawn area. The Gate Cottage buildings (1.2.1, 1.2.2, 1.2.3) are all present on the map. The map also shows Barn A (1.2.6) & Barn C (1.2.8). There are 4 other block buildings within the farmyard area which are no longer present today. There are several lines to denote the separation of parts of the farmyard.

**7.7.2** There is a farm track along the back of the farmstead all the way along the north of the site. The garden wall and summerhouse do not appear to be present. There are trees along the edge of west Lawn, three of which are shaped as the Douglas fir trees which are present today. There is evidence of the remaining tree line avenue leading towards Westbrook Road. To the south The Rectory of Bromham is clearly shown

Figure 7.10 1st Ed OS

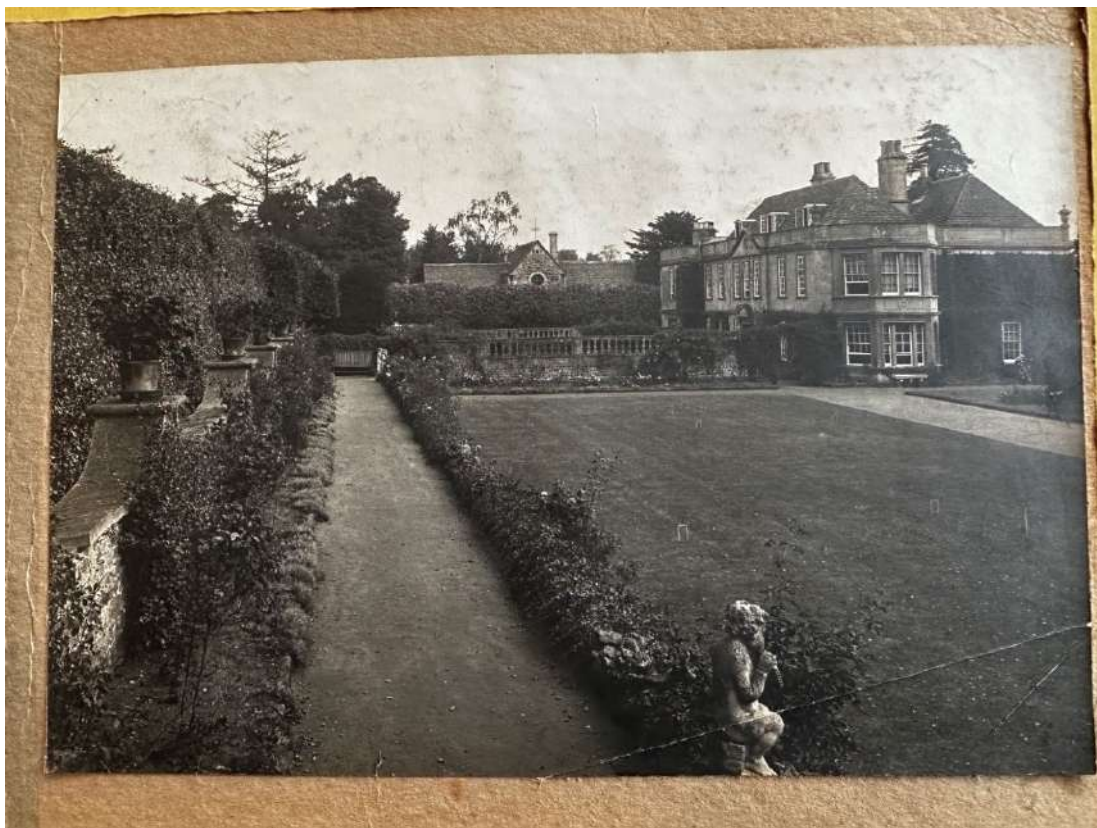
**7.8.2** The picture below was taken prior to the East Wing being built. The picture shows the Stable Block prior to being extended to the boundary wall. Nonsuch House is shown with 6x6 sash windows where as the current house has 9x9 formation. The bay window also has a different layout. The ground floor is shown as 3 windows where as the windows currently show two, the same as above, which shows there was a change of stone mullion arrangement. The window is also not shown to the master bedroom, although this could be covered by the climbing ivy vegetation. The vegetation is also not present today. In the typological context of R.W. Brunskill's *Vernacular Architecture*, Nonsuch house can be read in the following manner: the two piles, the parallel row of rooms and the parallel hipped roofs that site above them are crucially of differing widths. The southern rear pile (a consecutive row of rooms) is much wider than the northern front pile. This signifies that there is a high probability that the piles were built during different periods as a rational builder would construct roof trusses to the same dimensions of the piles if built at the same time. In terms of the setting, the Larch Garden lawn has a path going down the middle and along the front of the west elevation of the building. The forecourt and boundary walls are the same as present today. The edge of the lawn and the overall height of the edge to the left of the images, seems to indicate that it does not look like it has been raised at this point in time, although it is hard to distinguish from the angle of the photograph.

Figure 7.11: West Lawn & Nonsuch House

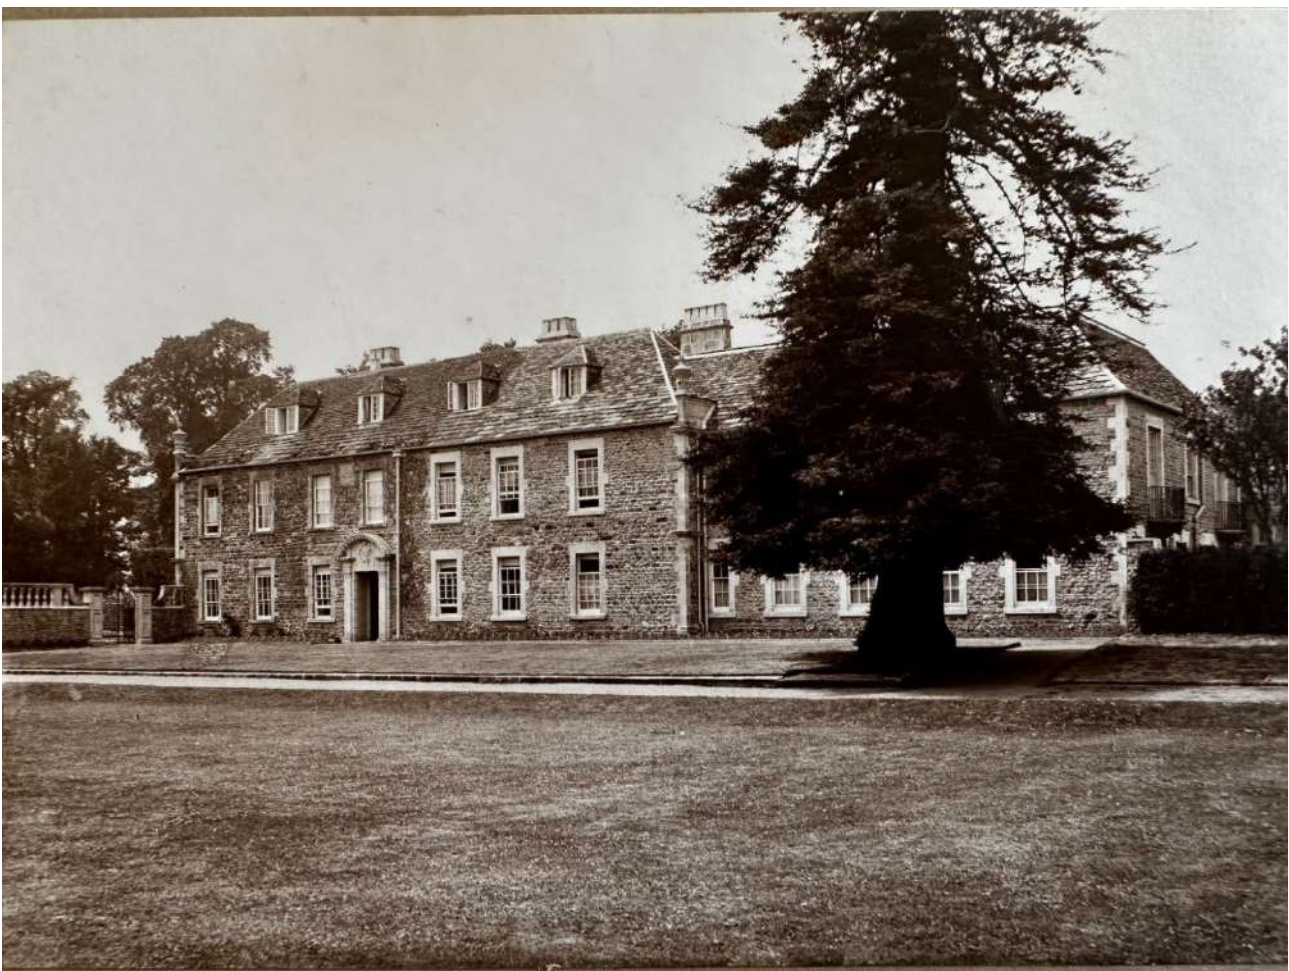
*Figure 7.13: Photograph circa 1920 from the Wiltshire Archives*

The East Wing is largely obscured by the larch tree in this image however it is possible to triangulate the different sources and conclude that the composition of the East Wing in terms of its elevational treatment follows the architectural style of the much older western section of the rear pile (bays 1 through to 6). The step in the rear façade signifies that this is the planform and elevation ‘starting point’ of the East Wing, however the submission of the seventh bay of the elevation into the latter style means that a moderate degree of articulation and thus significance has been lost. The rear façade reads more monolithically in a poor attempt of material cohesion.

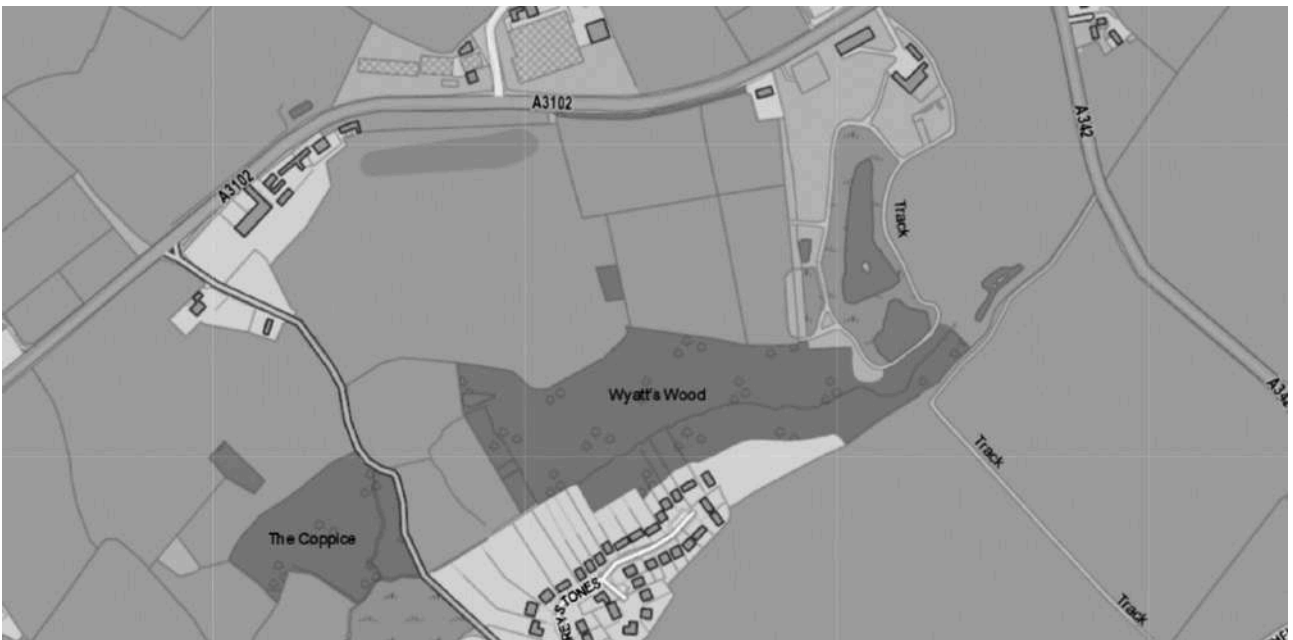
**7.11.1** The 2019 base map Q2 is how the site is seen today. Much archive and photographic evidence exists of the delight the McNeile Family took in enhancing the setting of the place through generations of collective gardening efforts. The few remaining former avenue trees are blocked out in a darker green running east to west.

**7.11.2** The map depicts the addition of a series of commercial greenhouse buildings north of Nonsuch House north of Westbrook Road known as Nonsuch Nurseries. Greystones Road was extended from Bromham village and a modern unsympathetic suburban housing estate built on the border of Wyatt’s Wood. Note that there is a lighter grey band beneath the land at Nonsuch House and the farmstead, which, using the rest of the map as a references, is an attempt at indicating domestic curtilage. This is not correct as it has inappropriately enclosed the working farmstead. This map has no legal or historical basis and the colour coding should be disregarded in terms of its assessment of curtilage. This based on the extensive research and morphological evidence presented within this compendium which offers a more accurate temporal and morphological analysis of curtilage.

Figure 7.14: base map of the site in the present (2024)
