**MASTER'S LODGE, MARLBOROUGH COLLEGE**  
**EXISTING STAIRS STRUCTURAL REPORT**

## EXISTING STAIRS STRUCTURAL REPORT

| SFK Document No: | | 25036/R02 | | |

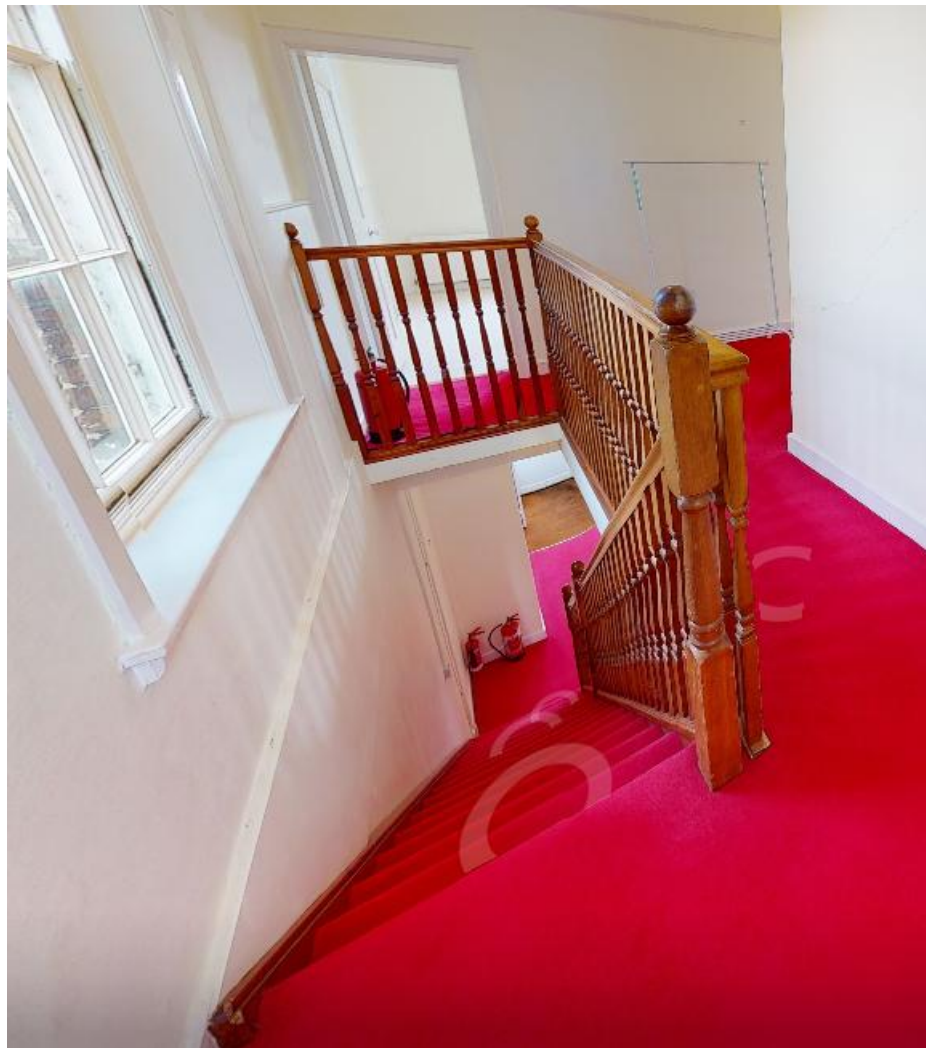
*Fig. 5.1. Staircase B viewed from first floor*

Stair B has single flight from ground to first floor in the east wing of the building, Fig. 5.1. It is a timber stair with a modern timber balustrade. The clear width of the stair is approximately 800-900mm. The height of the balustrade to the first floor is approximately 1100mm. Spindles are 40mmx40mm reducing to 20mmx20mm and have 60mm gaps. Balustrade geometry appears to comply with code requirements, but this should be checked and confirmed by the project Architect.

From site inspection the top newel post has movement at the base and requires further investigation for repair. The middle newel post is broken and requires repair. At the foot of the stair the newel post does not extend as far as the bottom of the stair and is likely to require extension.

- Project Architect to check stair geometry for code compliance.
- Structural repairs are required to the top and middle timber newel posts.
- Stair loading assessed as adequate for domestic loads based on previous use.
- Project Architect to consider extension of balustrade at foot of stairs.

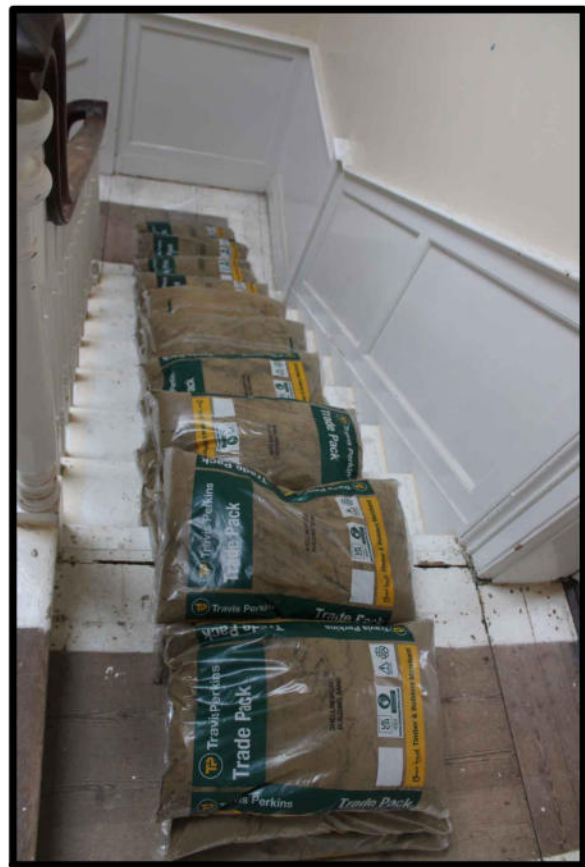
PHOTO 3 - LOAD STAGE 6 (FULLY LOADED)

APPROX SLOPE SPAN OF FLIGHT T10-T16 = 2200mm.  
GUIDE TO ALLOWABLE VERTICAL DEFLECTION =  $2200 \times 0.003 = 6.6\text{mm}$ .  
FROM LOAD TEST, DEFLECTION AT MIDSPAN UNDER FULL LOADING CONDITION ( $\sim 2.7\text{kN/m}^2$ ) = 2mm.  
THEREFORE CONCLUDE THAT STAIR HAS SUFFICIENT STRENGTH AND STIFFNESS TO MEET BS6399 VERTICAL LOAD REQUIREMENT OF NOMINAL IMPOSED LOAD OF  $3.0\text{kN/m}^2$ .  
IT IS OUR RECOMMENDATION THAT THE TEMPORARY STUD WALL UNDER THE FIRST 1/4 LANDING IS LEFT AS A PERMANENT STRUCTURE. BLOCKS FOR LANDING JOISTS TO BE REINSTALLED MORE SECURELY FOR THE PERMANENT STATE.
