## Photographic Survey

**Project 2620 – The Hollies, New Leaze Farm, Chippenham SN15 3RB**

Proposed – Rebuild southern end of the property with small extension and loft conversion.

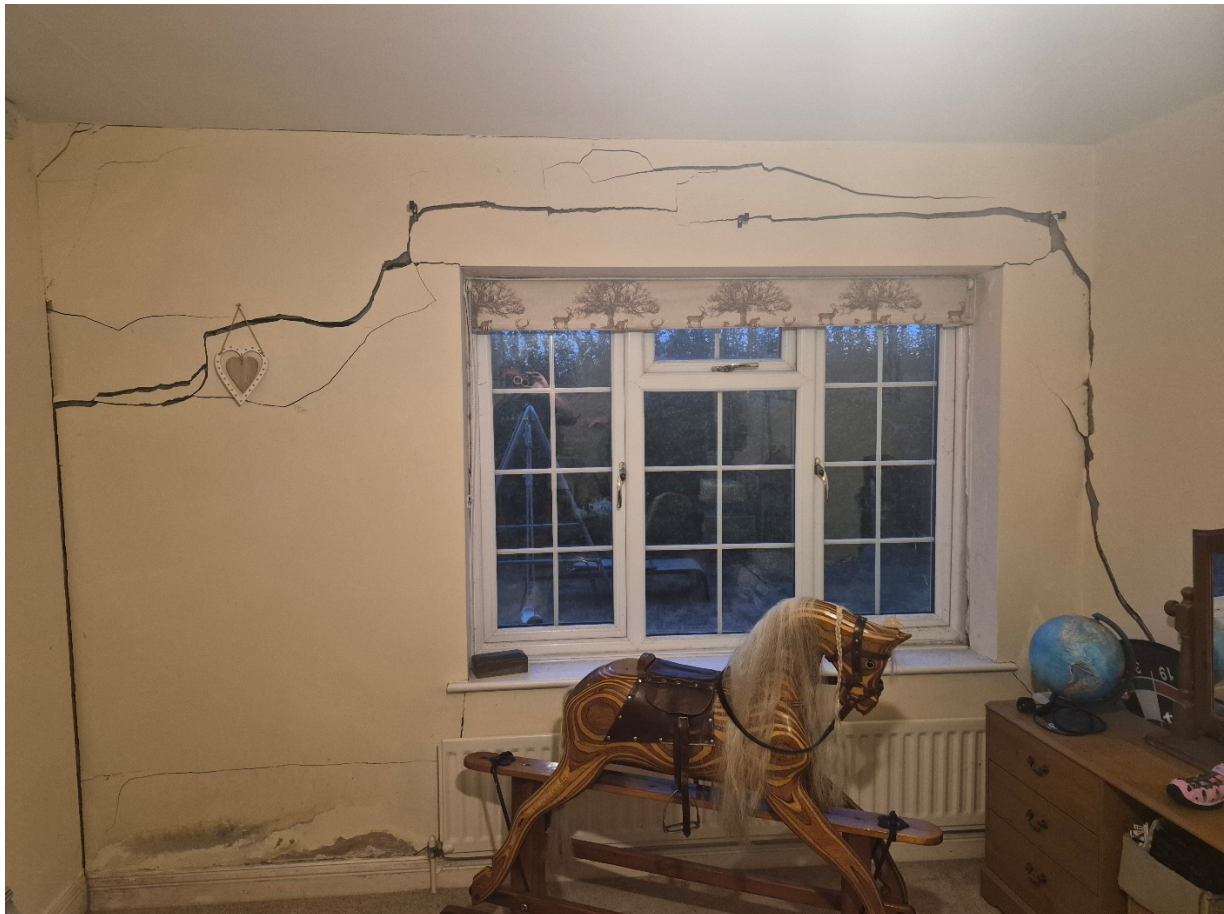
Initially, we visited the property in October 2024 to review some cracking on the end gable and return walls on the front and rear elevations. The concrete floor and walls to the southern end of the property have dropped, causing significant structural cracking. Photos of the cracking below from inside of the property at the southern end.

Since visiting in 2024 and assumed to be due to the hot dry weather, the ground-bearing slab and walls have failed further, resulting in the family having to move out of the property.

Our clients are looking to rebuild the end of the property to include a small extension so they can increase the depth of the foundations as required with the structural engineer.
