## Arboricultural Method Statement & Tree Protection Plan For construction works on land at Chicklade Services

Instructed by Blackford Projects Ltd

On behalf of InstaVolt Ltd  
6 Cedarwood  
Crockford Lane  
Chineham Business Park  
Basingstoke  
RG24 8WD

17<sup>th</sup> November 2025

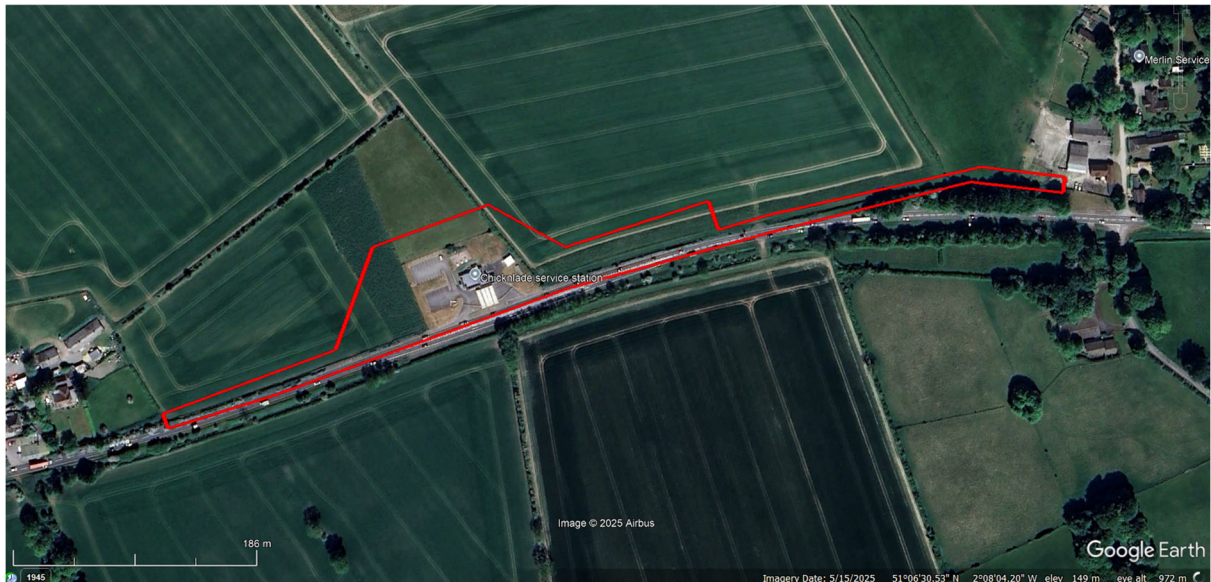
Figure 1: Site boundary.

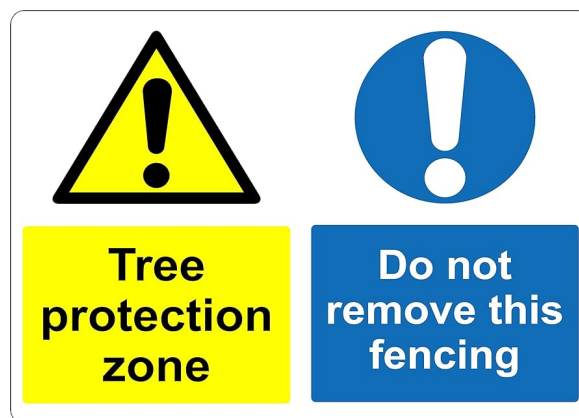
**Figure 3:** An example of signs that should be attached to the fencing.

All-weather notices should be attached to the fencing with words such as: 'Construction Exclusion Zone - No Access.' Throughout the construction period, attention should be paid to ensure that barriers remain rigid and complete.
