# JMW Arboriculture

## Arboricultural Impact Assessment & Arboricultural Method Statement

at  
**The Old Rectory**  
Mere  
BA12 6DS

on  
**13<sup>th</sup> August 2026**

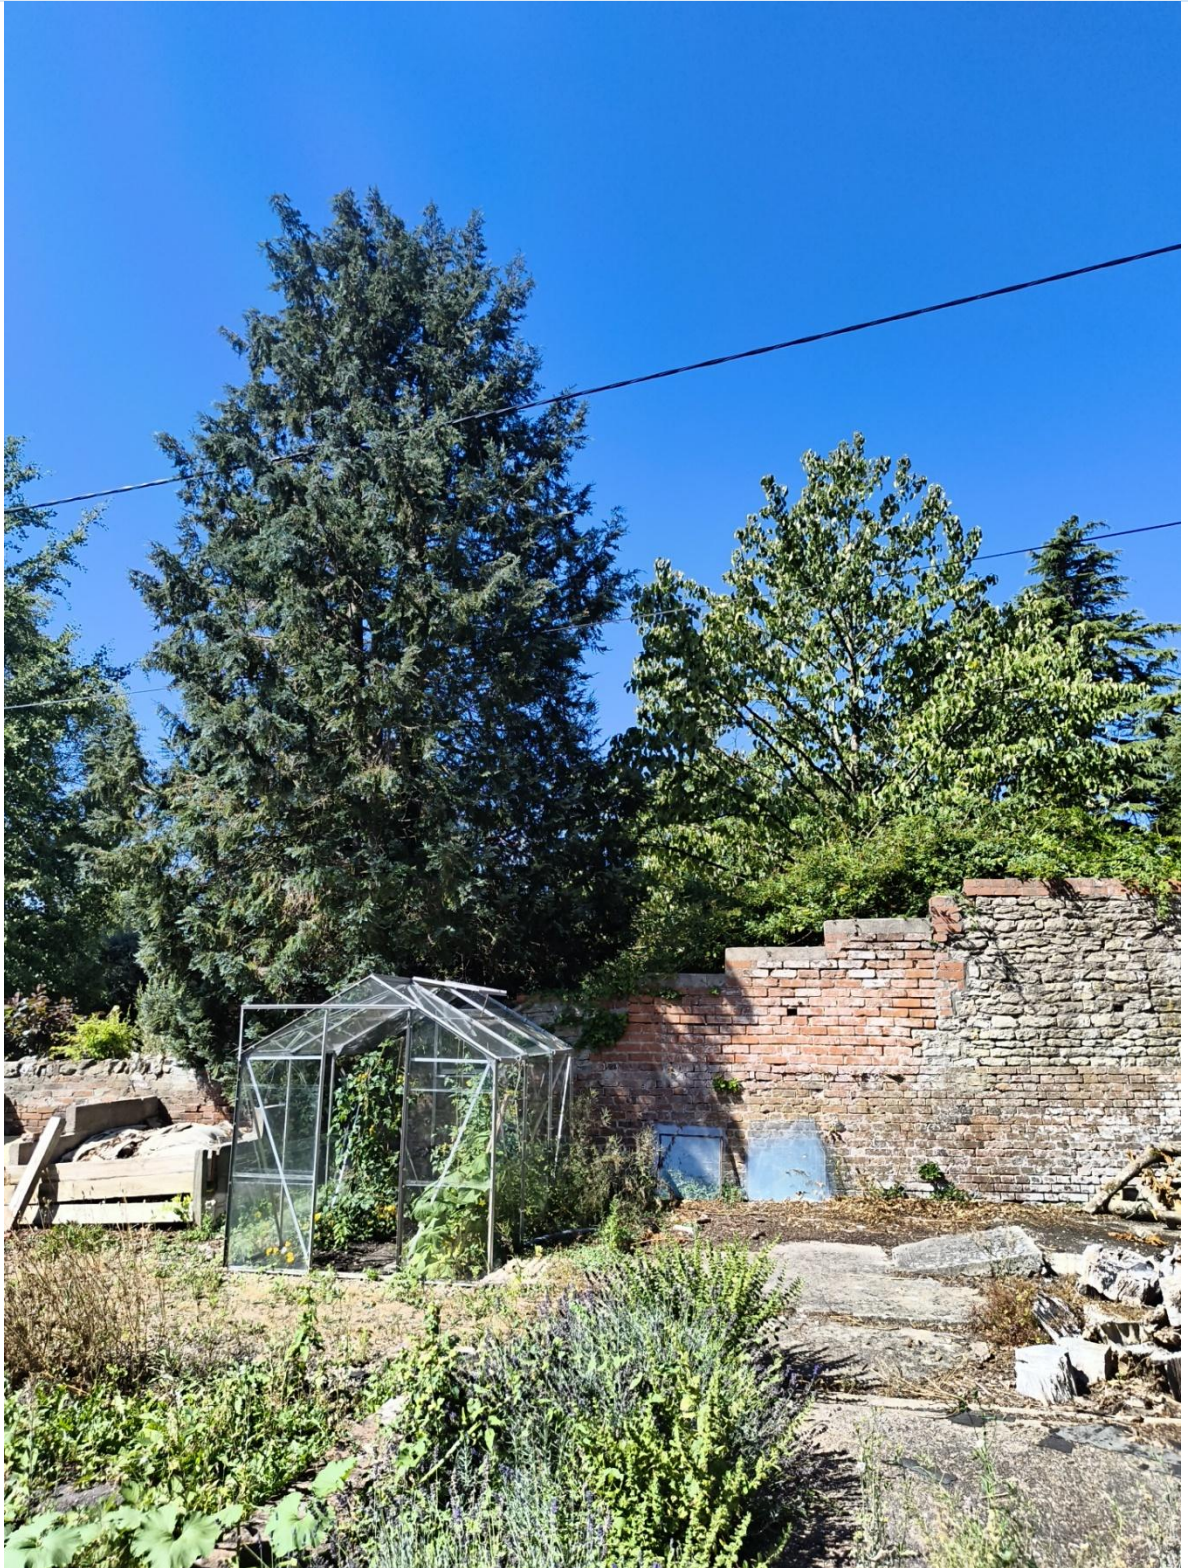
Photograph 1 – Siting of garage and Lawson's Cypress T7

**Proposed Garage:** Lawson's Cypress T7 and Beech T8 present a debris risk to the building's drainage system. Because T7 directly overhangs the proposed garage footprint, it will exert the greatest impact if retained. Regardless of whether T7 is retained or removed, routine gutter clearance will be required to ensure proper drainage.

regardless of the proposed development, as its stem is pressing against an adjacent wall and its canopy is encroaching on overhead utility lines. Although T7 is situated off-site and outside the Conservation Area, its removal creates an opportunity to plant a replacement species better suited to the local townscape, ultimately delivering a net gain in amenity over the medium and long term.

The proposed garage footprint intersects with the northeastern aspect of the crown of Lawson's Cypress T7. Removing this tree eliminates the need for initial facilitative pruning, as well as ongoing, cyclic maintenance pruning to preserve adequate clearance from the garage, which is the alternative.

If Lawson's Cypress T7 is retained, the foundation footprint of the proposed garage will encroach into its Root Protection Area (RPA) by approximately 15%. This level of encroachment exceeds the standard 10% threshold recommended under BS 5837:2012 for conventional continuous trench foundations. Standard excavation within this zone would risk severing significant lateral roots, potentially compromising both the health and structural stability of the tree.

- Lawson's Cypress T7

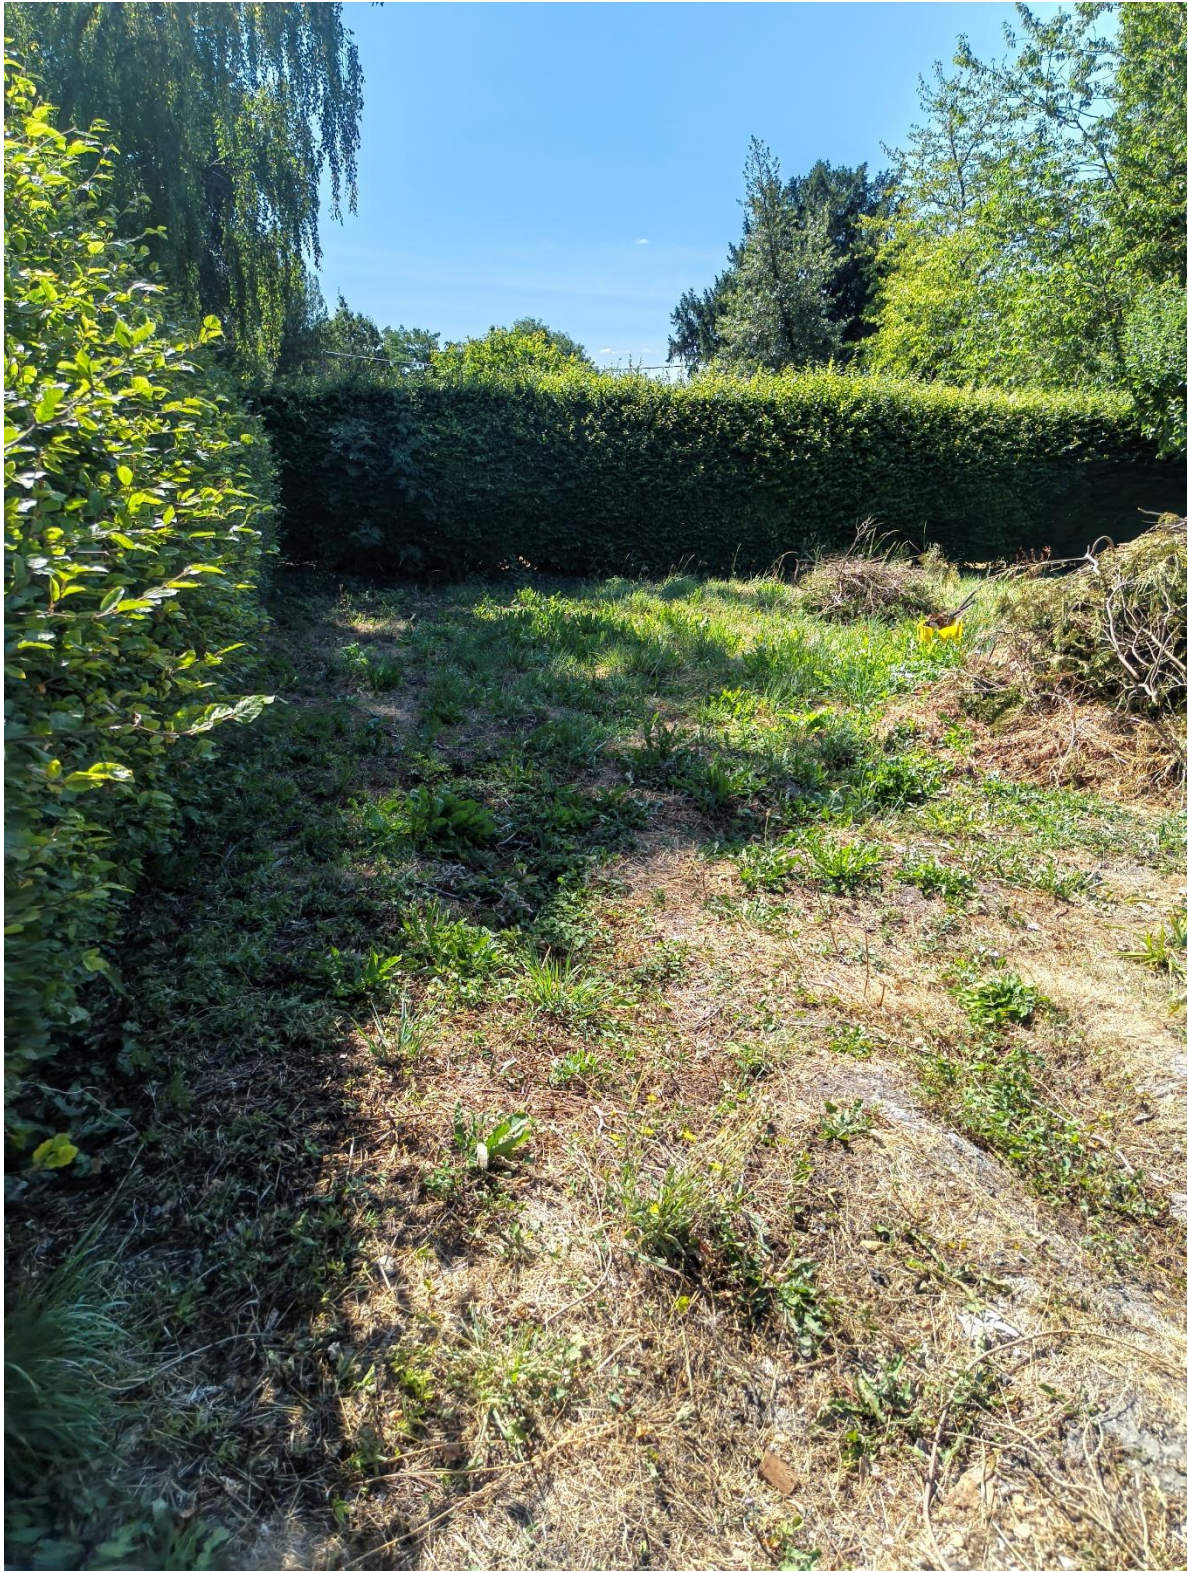
Photograph 2 – Siting of proposed swimming pool Beech H1, H2 and Silver Birch T2

The overall shade impact on the proposed pool is minimal. Silver Birch T2 casts minor morning shade across the northeastern aspect for a short duration, while Cherry T3 briefly affects the extreme southwestern corner in the early afternoon.

The Root Protection Areas (RPAs) of Birch T2, Apple T4, and Apple T6 face an increased risk of soil compaction and ground disturbance during the construction of the proposed swimming pool.

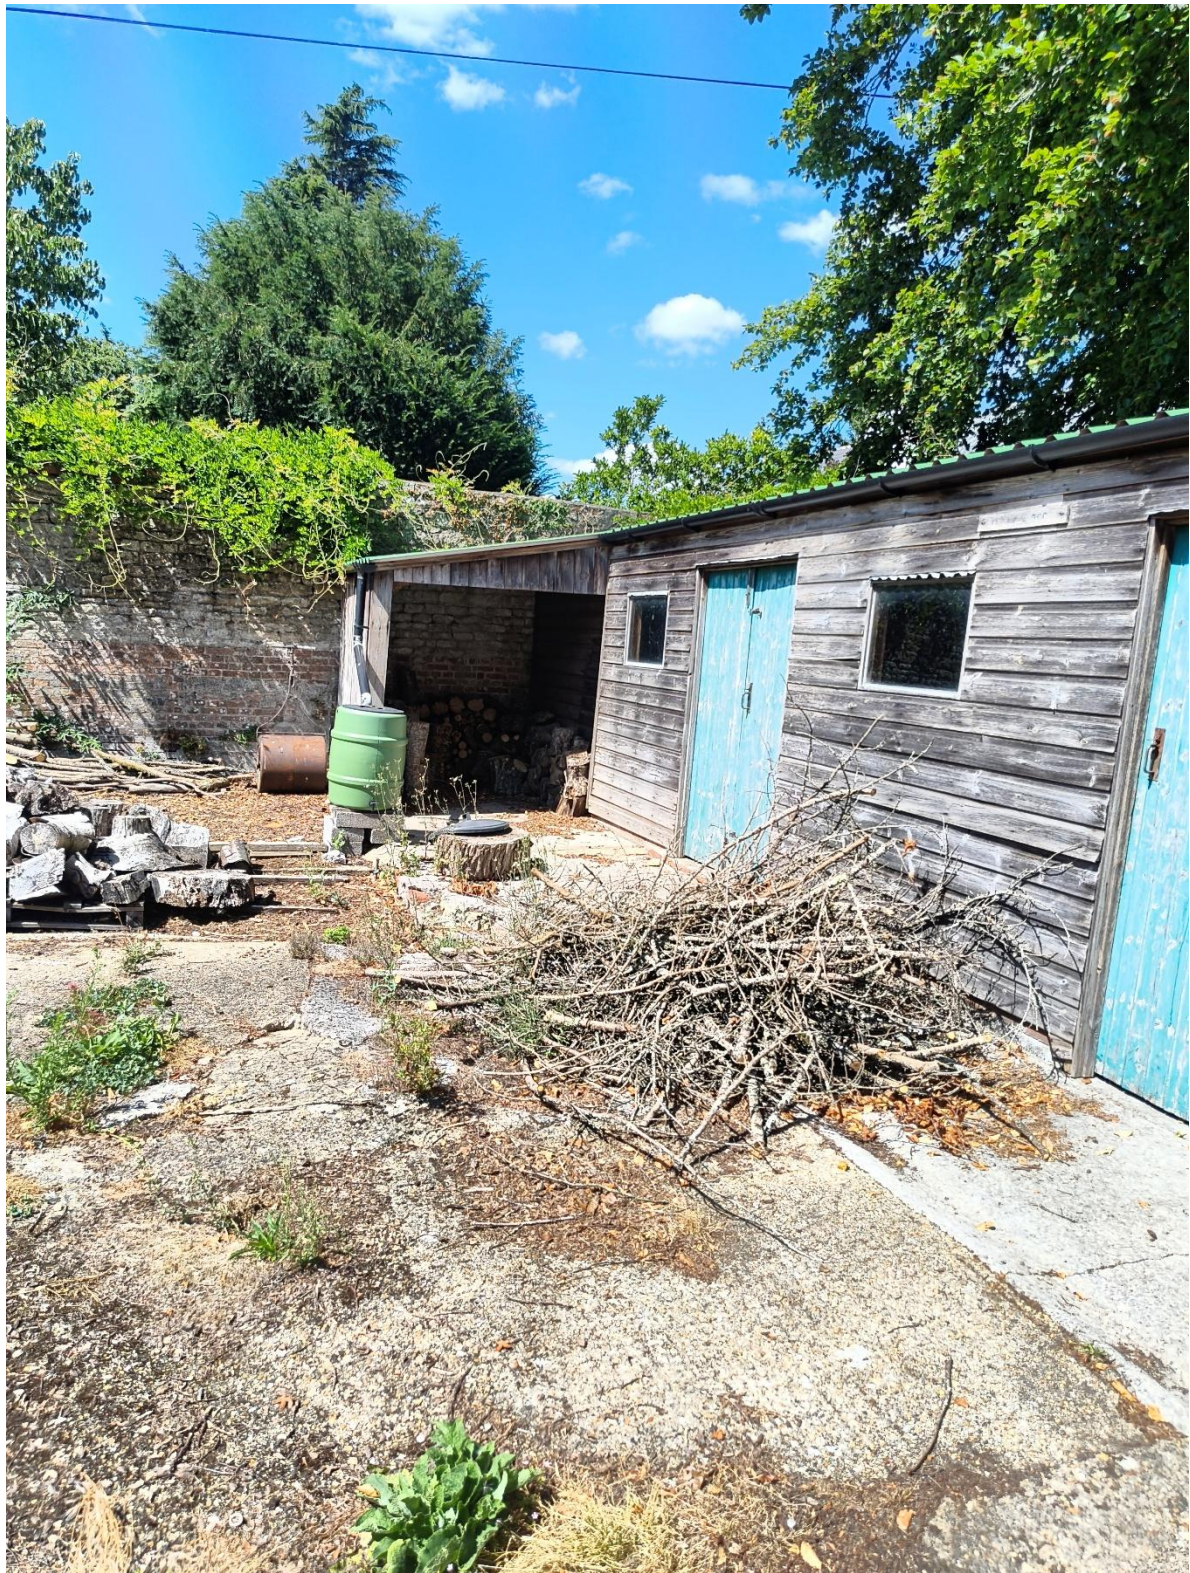
Photograph 3 – Hard surfacing over the RPA of Beech T8

Additionally, the existing outbuilding provides substantial physical shelter for Beech T8, leaving its stem and crown at no significant risk of damage.

Additionally, the RPAs of Cherry T3, Beech T8, Cut-leaf Beech T11, Hornbeam T12, and Mixed species G1 face a minor risk of disturbance from general day-to-day site operations. These risks

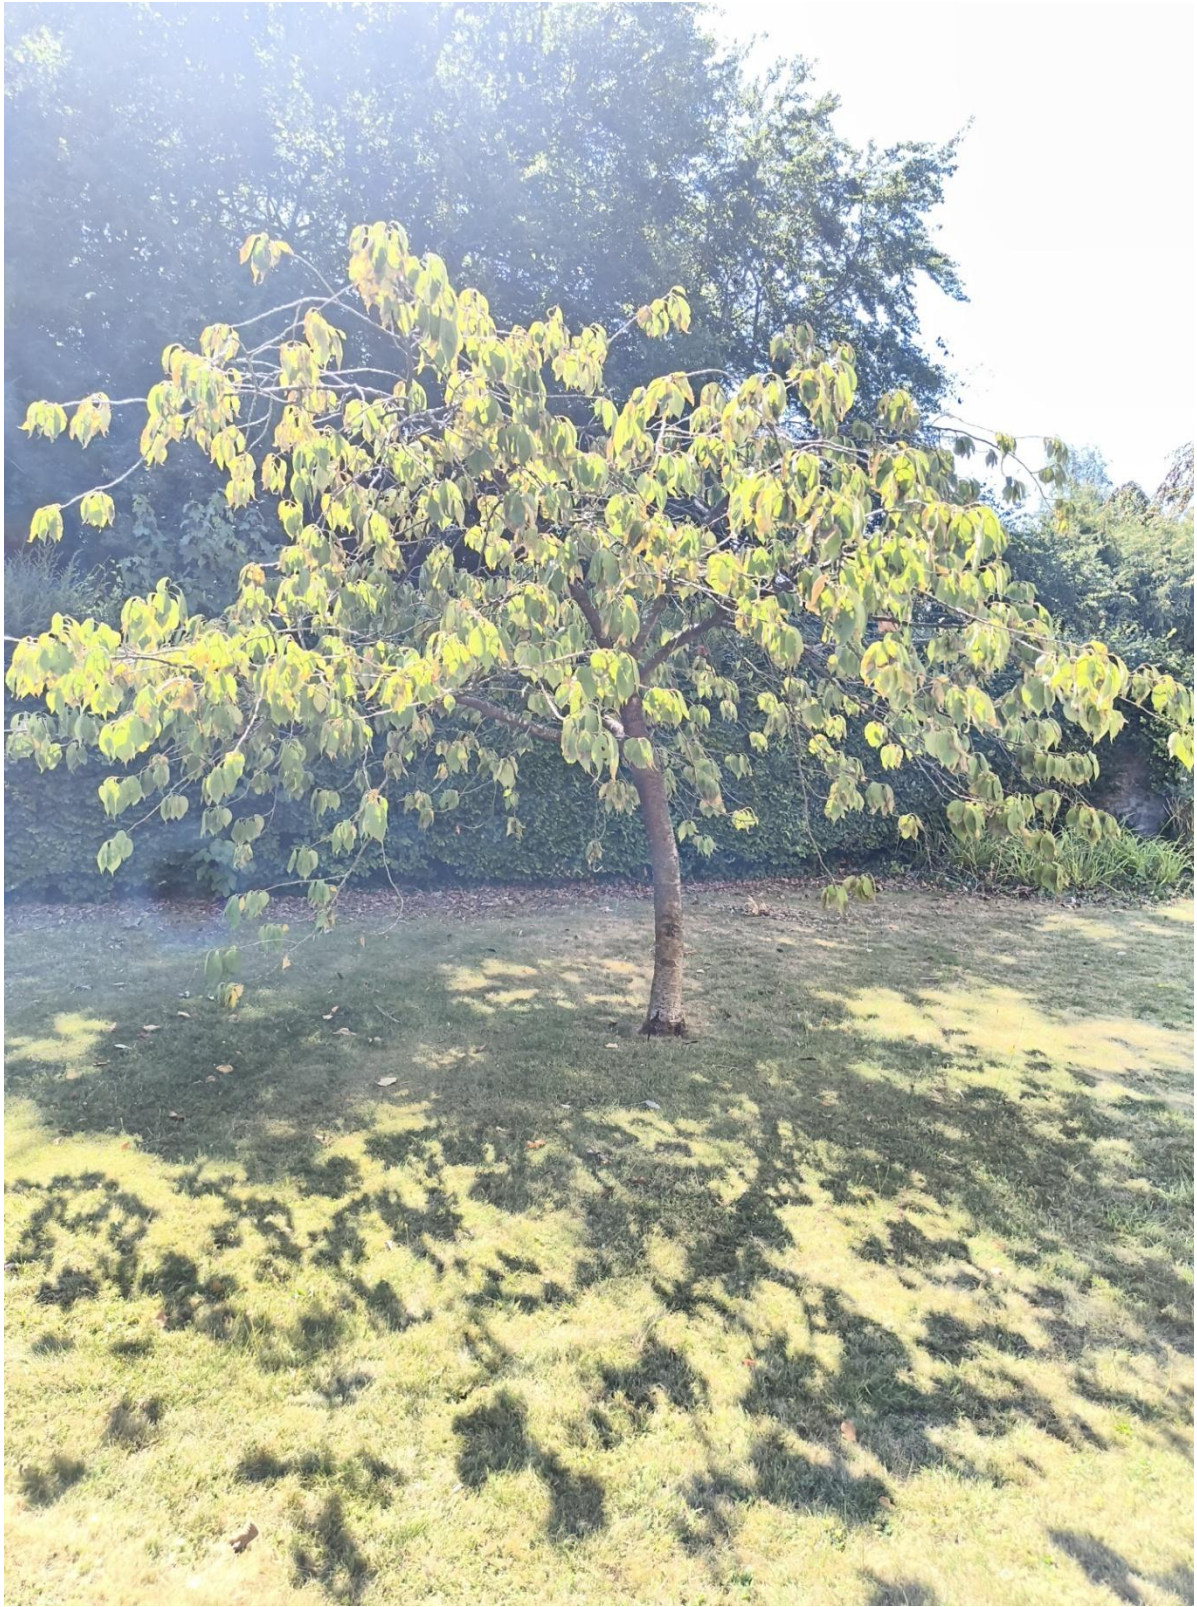
Photograph 4 – Cherry T13 next to siting of RHW proposal

Finally, Cherry T13 is vulnerable to accidental crown and stem damage during day-to-day site activity and the installation of the rainwater harvesting tank. All identified risks across these three construction zones can be straightforwardly mitigated through physical protection protocols specified within the Arboricultural Method Statement (AMS).

Finally, the RPA of Cherry T13 is vulnerable to heavy plant movement and excavation required for the eastern rainwater harvesting tank. All identified risks to root protection areas across these three site zones can be straightforwardly mitigated using protective measures detailed in the Arboricultural Method Statement (AMS).

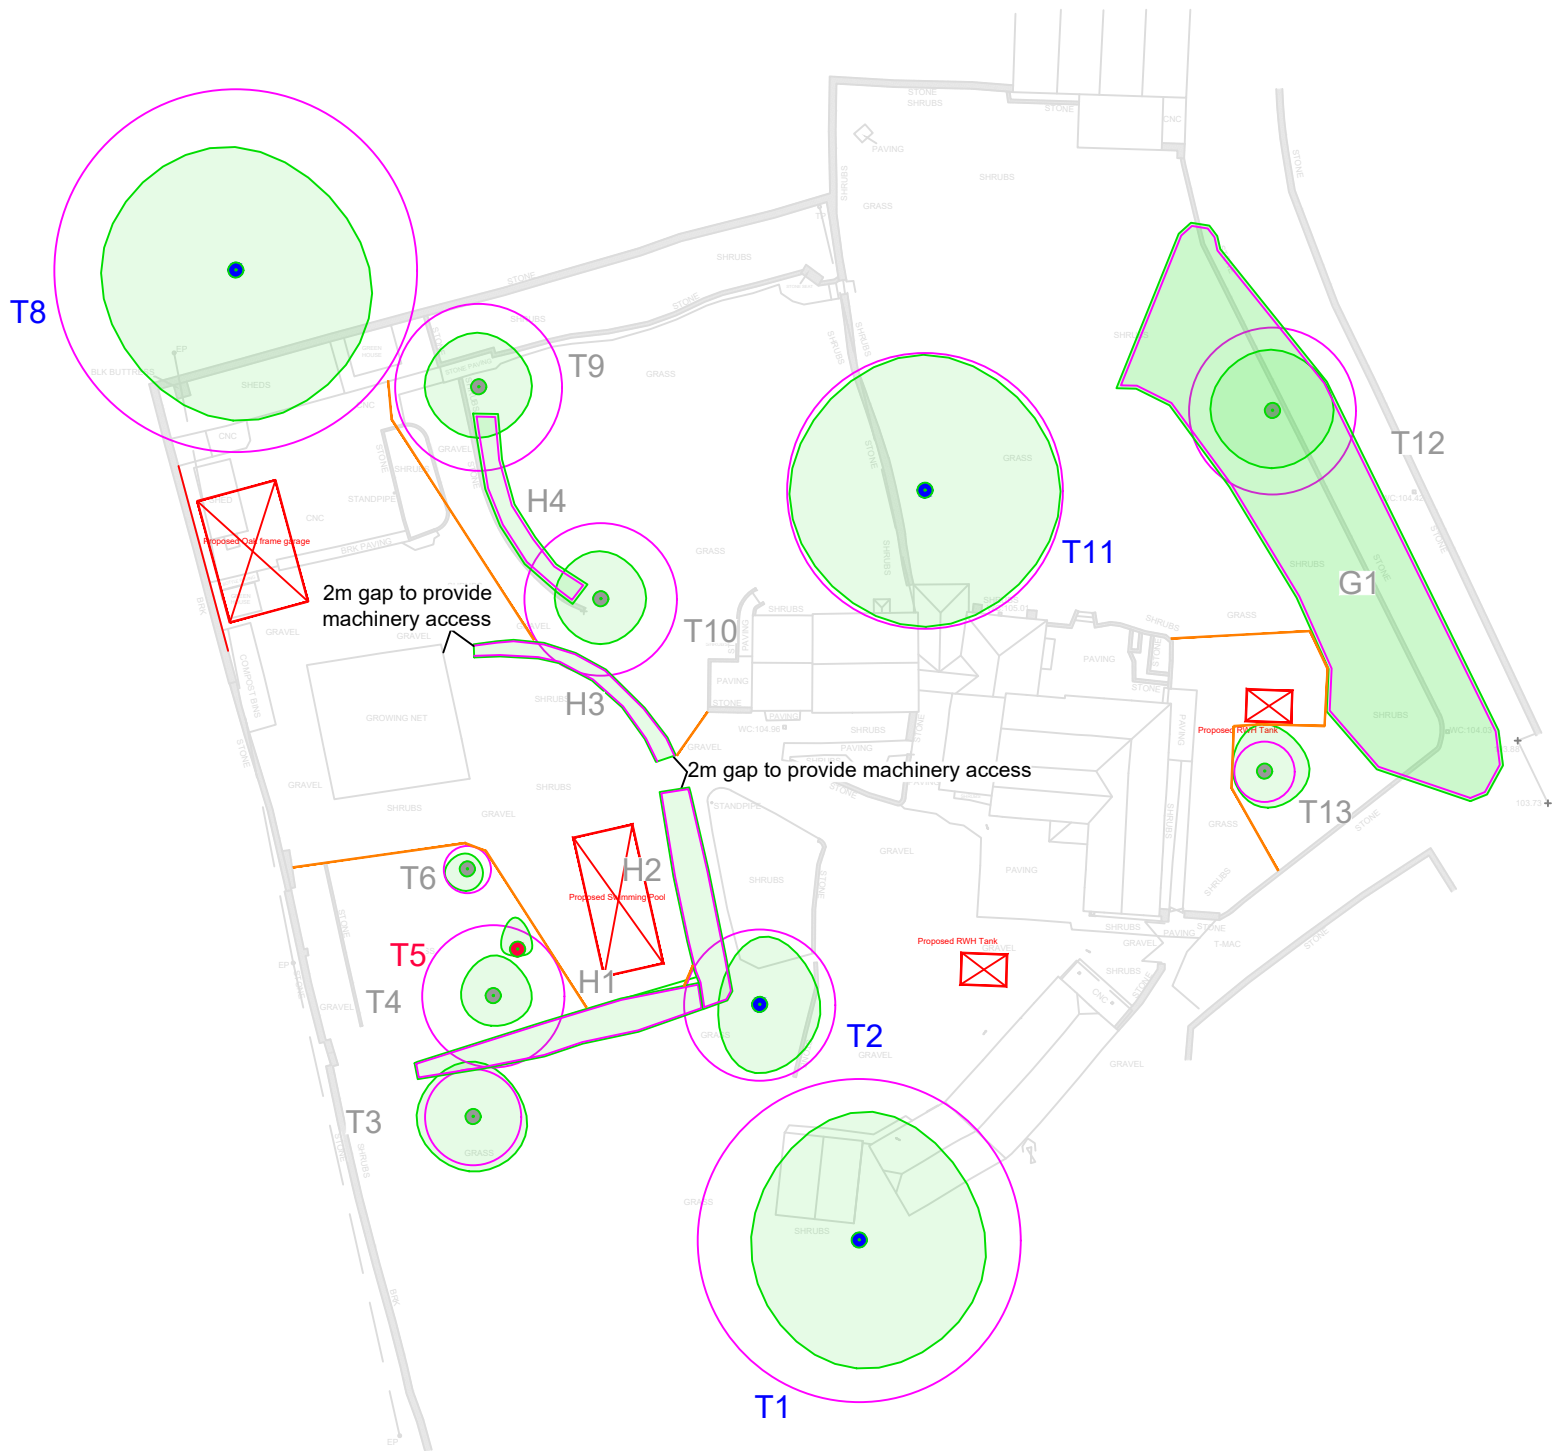
Drawing Number  
ORM/03

# Appendix F - Tree Protection Plan

- Prior to any construction works on site, the fences shown in the TPP will be installed to the BS5837 specification as described below. These Tree Protection barriers (TPB) will form the sacrosanct Construction Exclusion Zones (CEZ).

- The deployment of Tree Protection Barriers (TPBs) has been adjusted to align with the residential character and low-impact nature of the site. Existing structural features, such as low-rise walls, changes in elevation and hedges, provide sufficient natural protection against accidental damage, which is duly accounted for in the Tree Protection Plan (TPP).
