## **Furze Farm**

### **Bat Report**

**Furze Farm  
Ecology 9148  
Version 01**

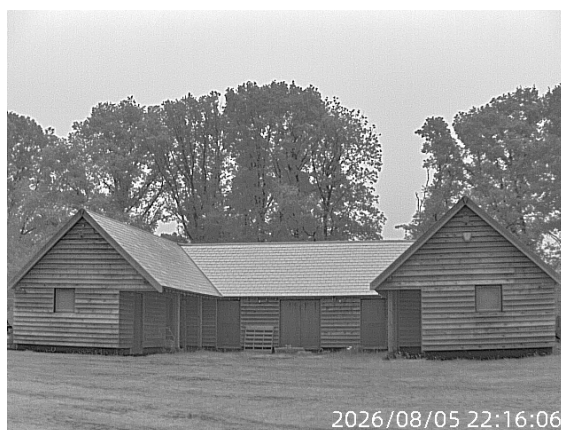
**Figure 1:** Southern elevation of the stable.

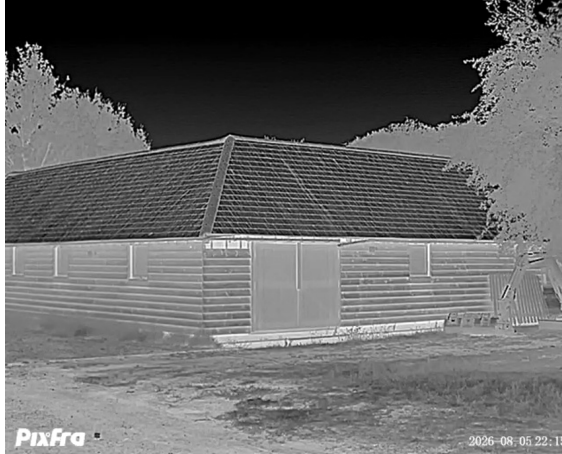
**Figure 2:** Northwestern elevation of the stable.

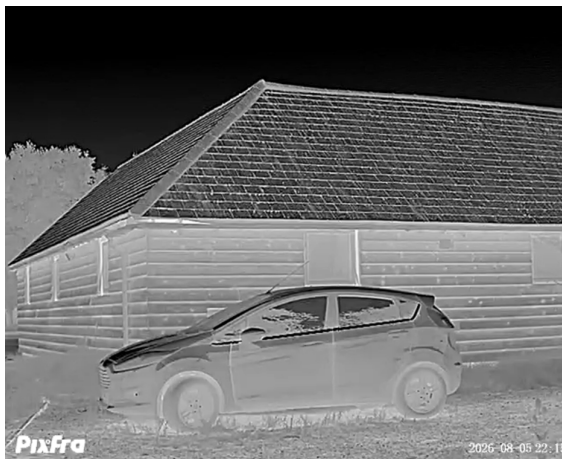
**Figure 3:** Northeastern elevation of the stable.

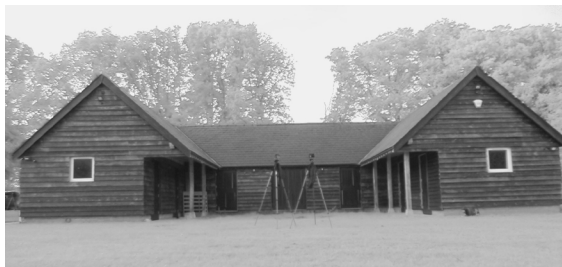
- 4.3 The stable building underwent a PRA assessment in February 2026 by Jonty Denton (Furze Farm, Phase one bat survey, 2026) and the building remains in the same condition. The building is a timber wooden clad C-Shape structure with an opening to the south. The roof is comprised of slate tiles on top of plywood. Windows were present on the southern aspect which were lined with UVPC (**Figure 1**). There are a few gaps present within the cladding which could create potential roosting features for crevice dwelling species.

**Figure 1:** External aspect of the stable

- 4.5 Lifted and missing tiles are present on the roof of the building, some of the tiles are curved, creating small crevice features. There are also gaps in the wooden cladding creating further features, creating a high potential to support roosting bats. Droppings indicative of long-eared bats were present in the roof void of the building confirming the presence of a bat roost.
- 4.6 Therefore, further emergence surveys were carried out to classify the roost.

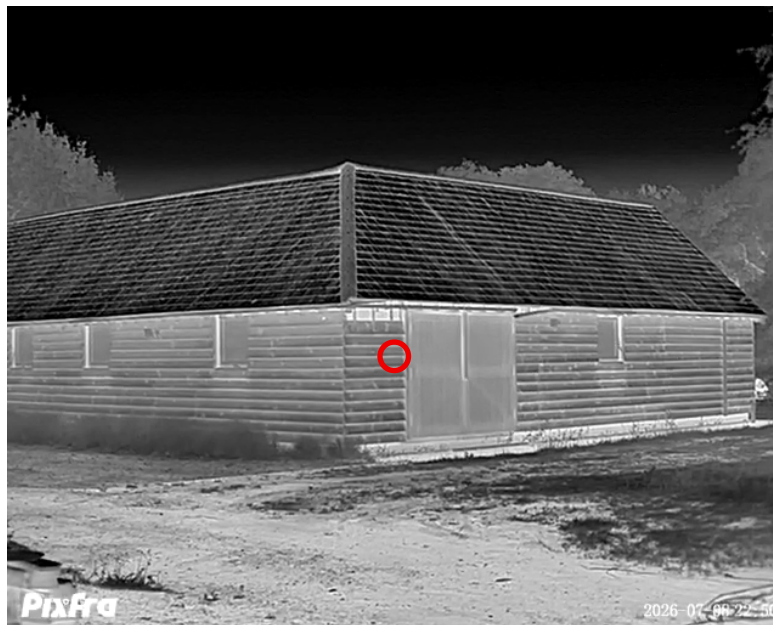
- 4.10 Three bats were recorded emerging from the building during this survey. The first was an unknown pipistrelle which emerged from a missing board at the eaves on the northwestern corner at 21:40 (**Figure 2**).

**Figure 2:** Pipistrelle emergence on the north west corner

- 5.1 The bat roosts within the building will be retained within the proposals with no impacts anticipated from the development. The proposed works are restricted to internal renovations and the installation of new doors and windows, which will not impact any of the roost locations. No internal works are proposed to the roof void, and the external cladding and slate roof will be retained. The contractors working on the conversion will be made aware of the presence of bats within the building and in the unlikely event that bats are encountered all works will stop and an ecologist will be consulted.

- 5.2 There is the potential for indirect impacts to the roosts when the development is complete from the addition of lighting on the building. Any proposed lighting will adhere to the following guidelines (ILP, 2023):

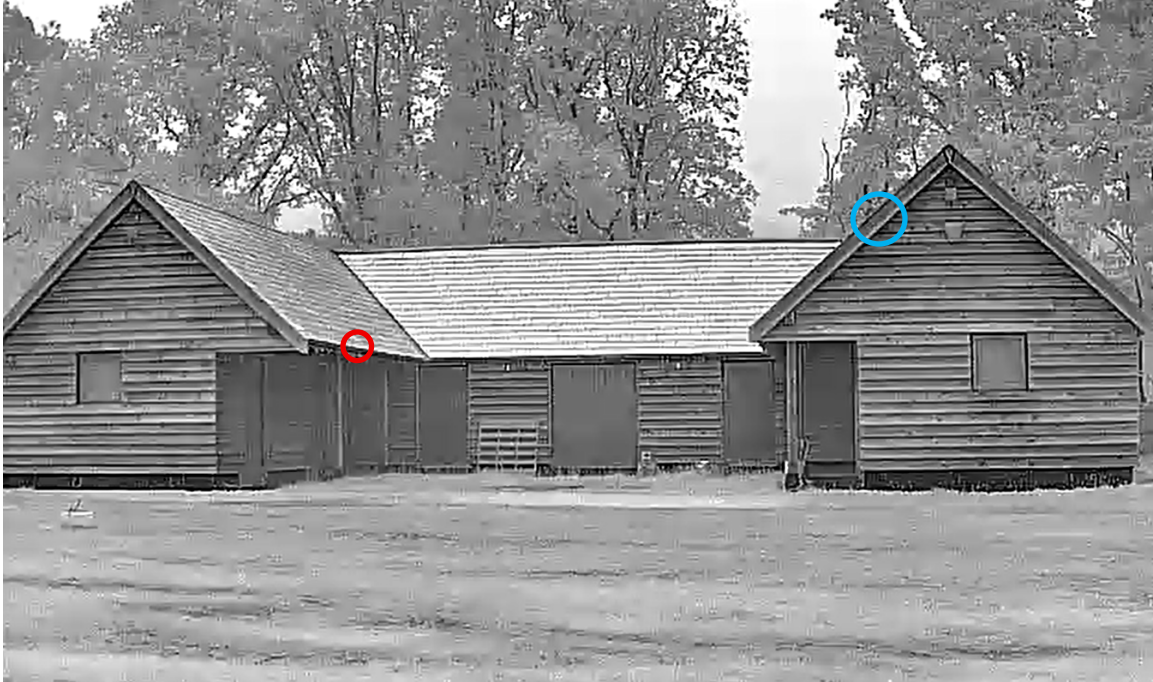
- 4.11 The second was a common pipistrelle at 22:13 which emerged from the eastern eave at the centre of the western gable and the third was a long-eared at 22:29 from the apex of the eastern southern gable (**Figure 3**).

**Figure 3:** Common pipistrelle emergence in red and long-eared emergence in blue

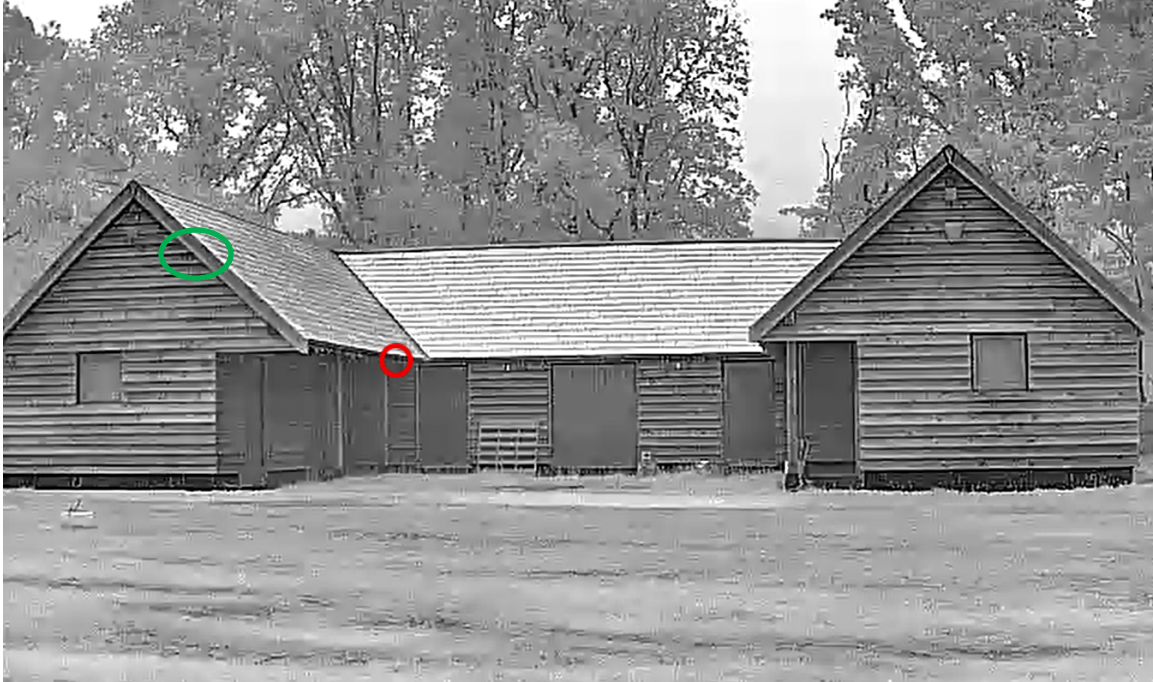
- 4.13 Two bats were recorded emerging from the building during the third emergence survey. The first was a soprano pipistrelle from the cladding on the western gable at 20:54. The second emergence was a common pipistrelle from the east facing eaves of the western gable at 21:19, the same location as the previous survey.

**Figure 4:** Common pipistrelle emergence in red and soprano pipistrelle emergence in green

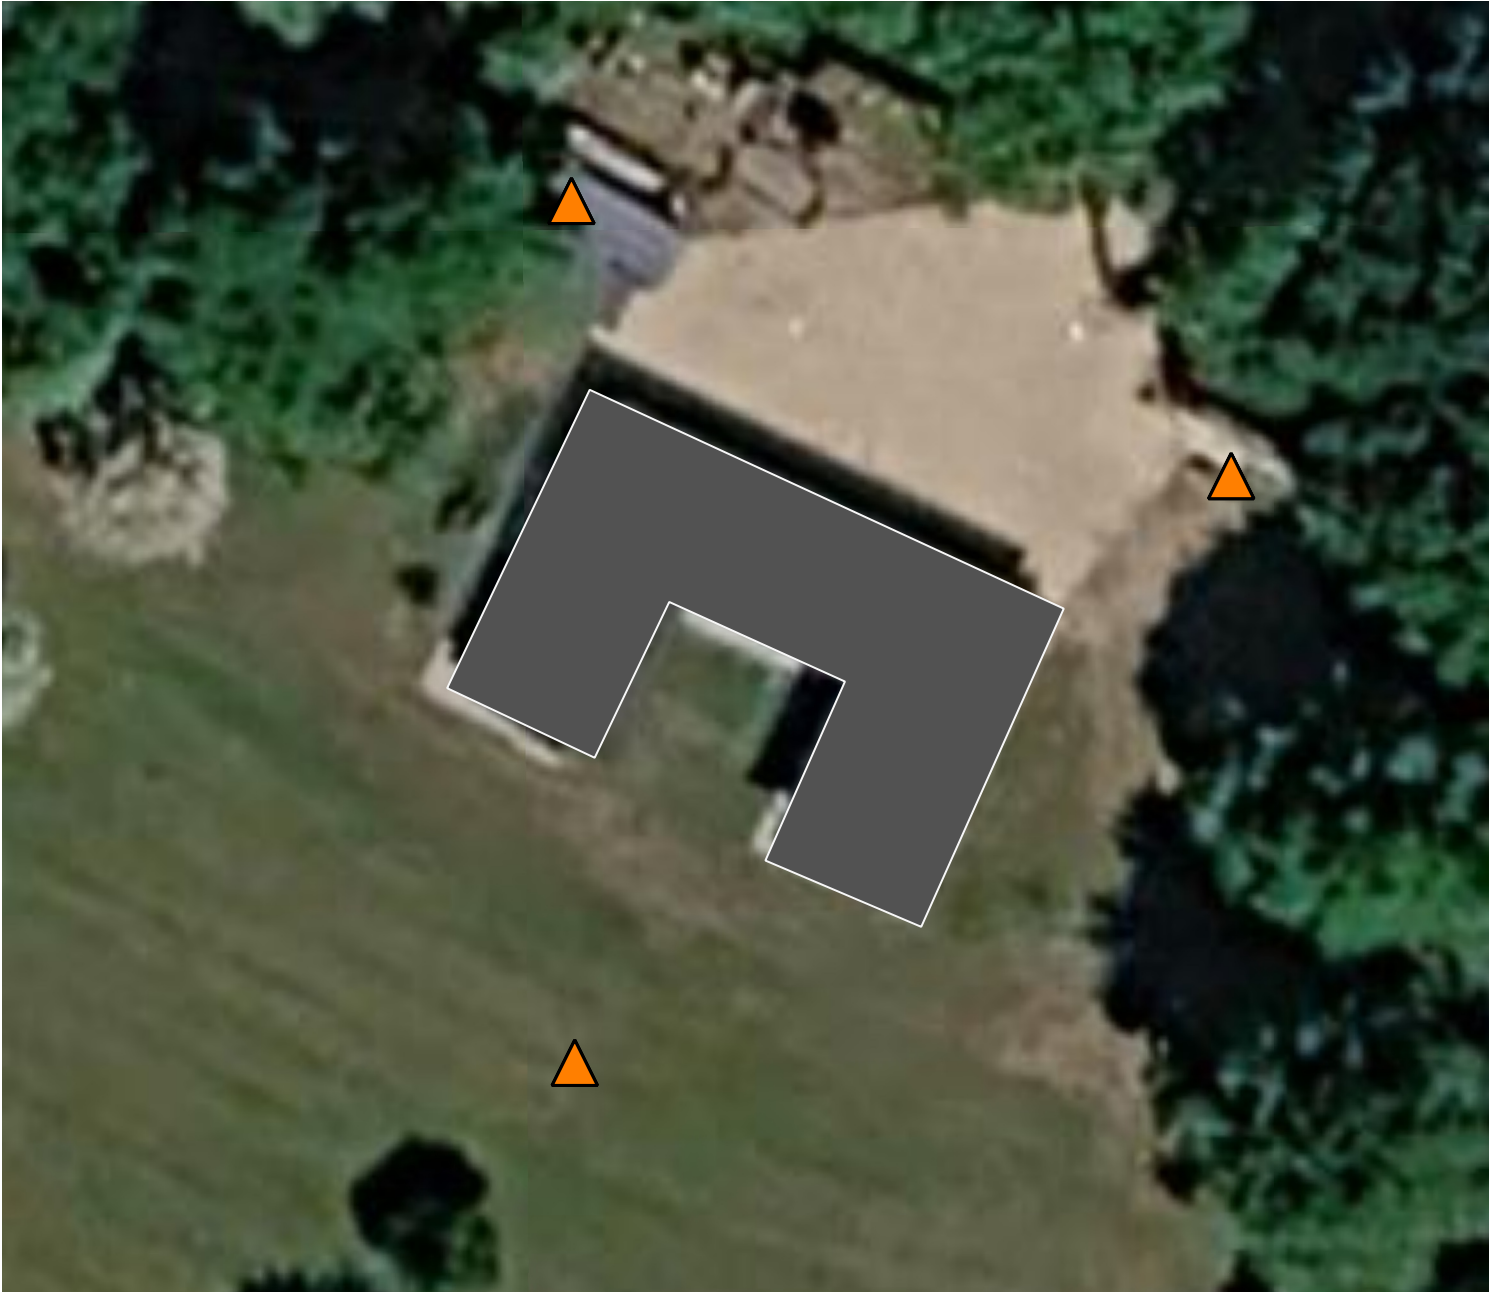
| DRAWING: | Emergence Survey one 10.06.26 | 1:300 | |

- 4.8 No bats were recorded emerging from the building during this survey.
- 4.9 Activity was low throughout the survey, with only six calls noted on the southern elevation. Activity was slightly higher on the northern elevation with multiple bats using the tree line for foraging. The majority of calls were from common pipistrelle followed by soprano pipistrelle. The first bats were two common pipistrelles which were foraging around the trees at the edge of the site from 21:35 until 21:41. Other species recorded included noctule at 22:25, a barbastelle (*Barbastella barbastellus*) was heard and not seen at 22:33 and a long-eared which was heard and not seen on the southern elevation at 22:35.

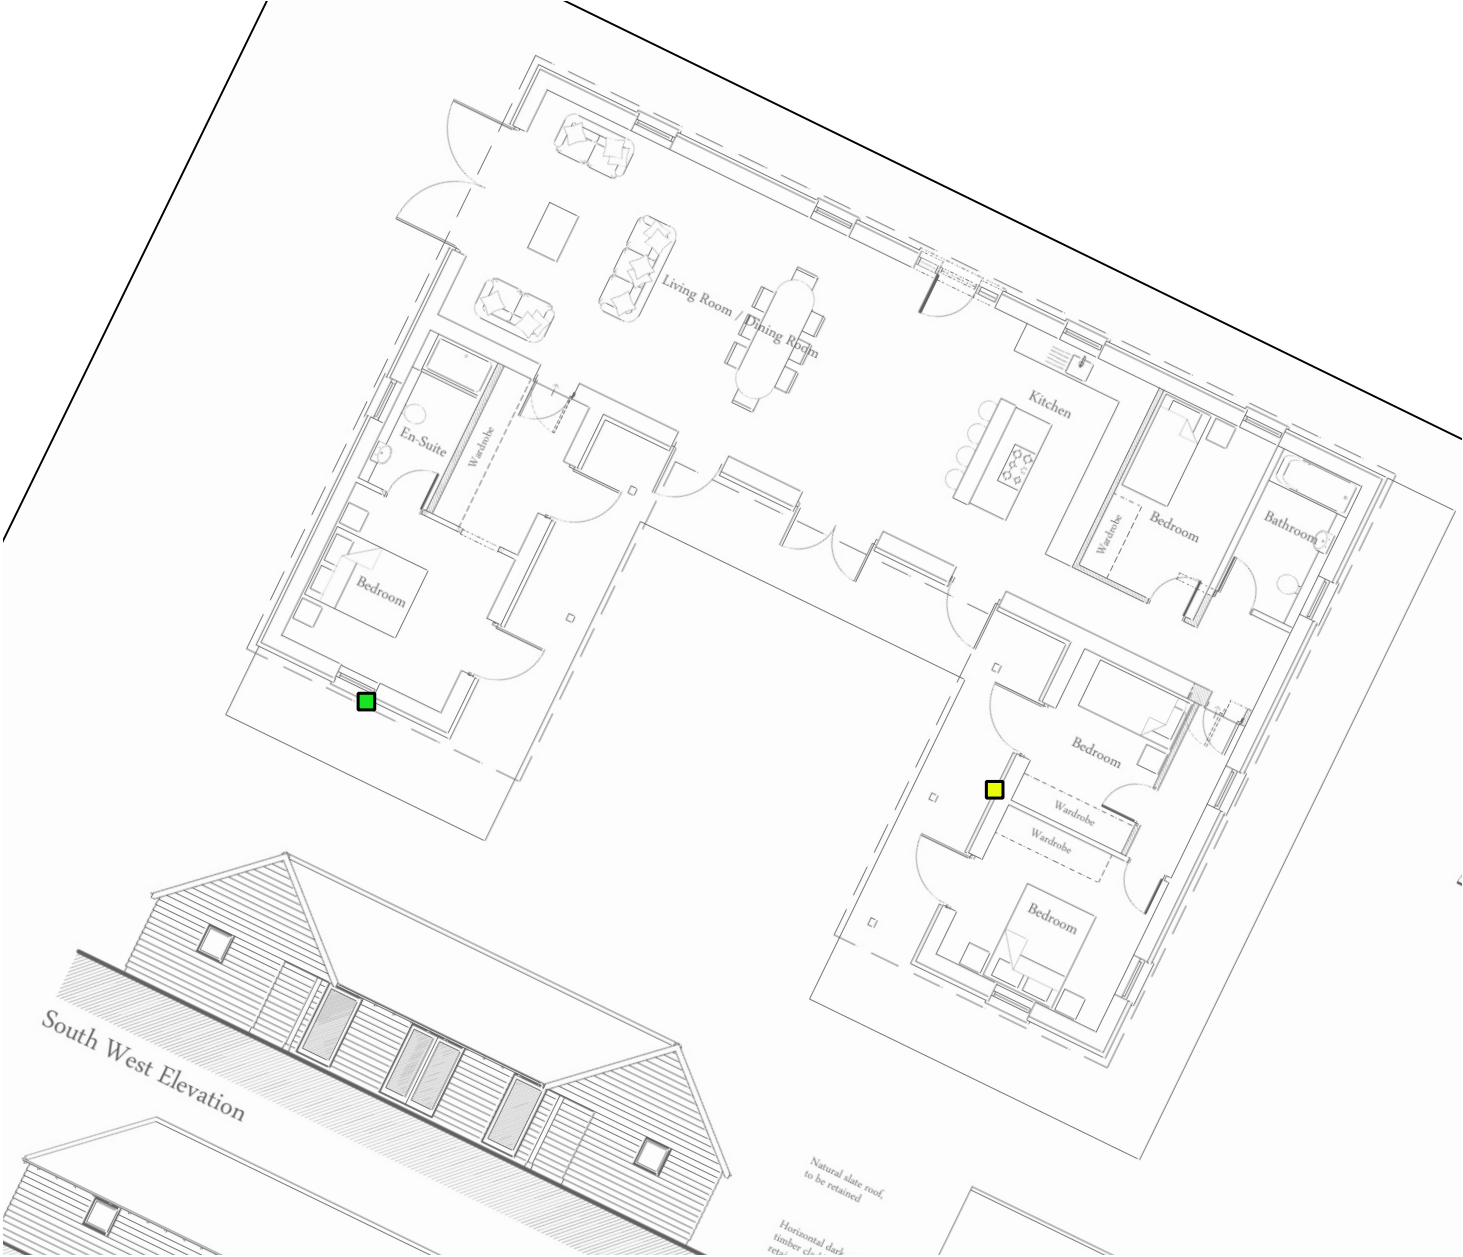
- 5.3 In accordance with the National Planning Policy Framework (NPPF, 2026) plans should minimise any adverse impacts on biodiversity and include features which support priority or threatened species such as swift, bats and hedgehogs.
- 5.4 To provide enhancements and to secure net gains which are specific to protected species on the site the following measures should also be included within the development design and are shown in **Appendix D**:
- A swallow nest box will be included within the development. This will be located on the south western elevation, under the porch.
  - A bat box will be included within the development, an integral box is not possible as part of this development, therefore a stand alone box will be placed on the southern cladding of the building. This has been located away from the existing roost locations.
