## Bat Scoping Survey and Nesting Bird Report:

Framfield, Church Lane, Trowbridge, Wilshire BA14 0EH

Client: Roy Pegrum

September 2026

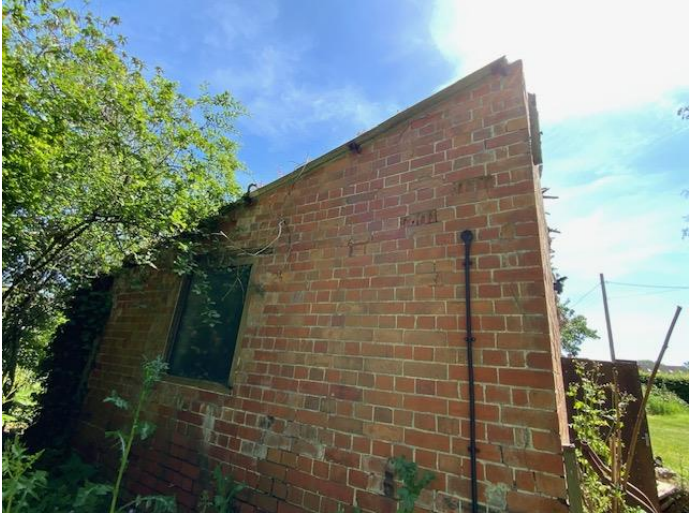
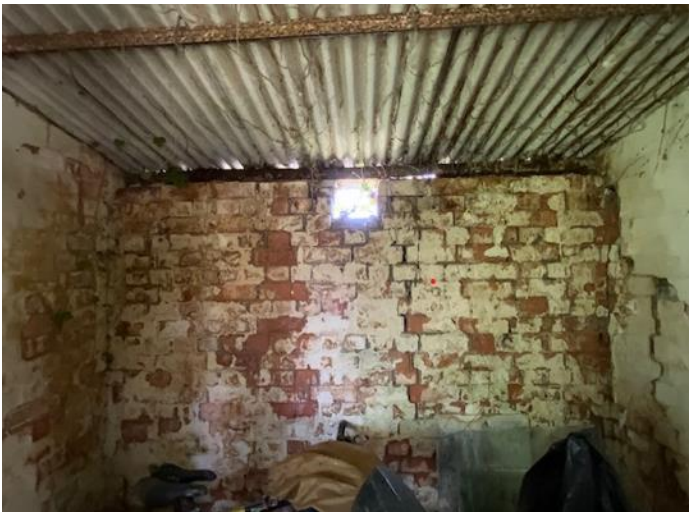
| Plates | Description |
|---|---|
| | <p>. This is a photograph of the rear of the building showing one of the windows present in the structure allowing light into the building. It also demonstrates the absence of fascia boards, soffits and barge boards.</p> <p>This photograph shows the unlined corrugated roof and absence of a ridge beam and joists. It also demonstrates light penetration through a missing ventilation brick and under the roof sheets.</p> |

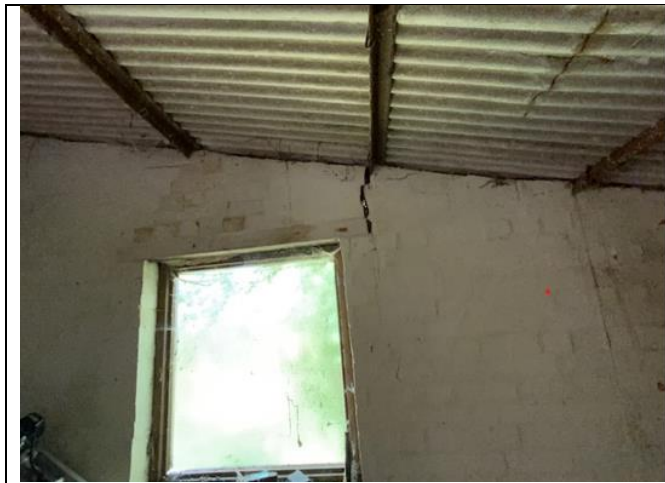
This photograph shows a window allowing light pollution into the building

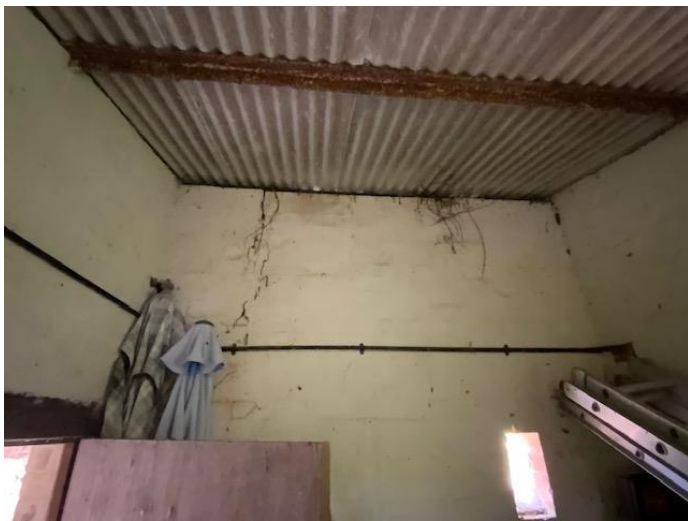
This picture demonstrates the lack of opportunity for roosting bats in relation to the roof structure.

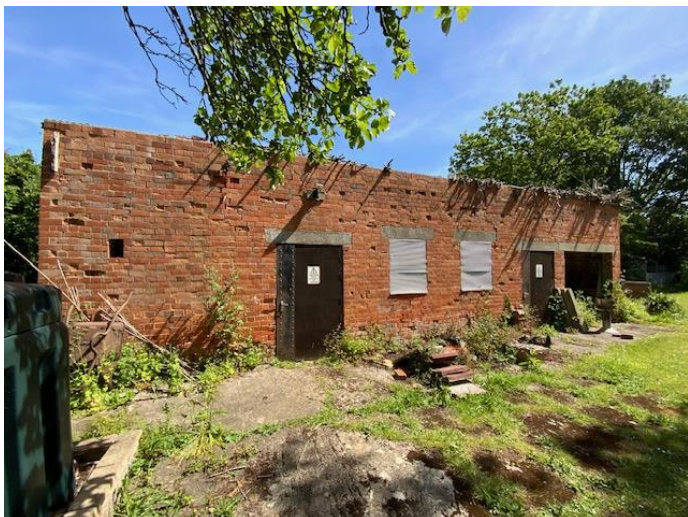
The is photograph of the front of the building and shows the damaged and missing bricks which were inspected during the survey. The missing bricks were found to be superficial voids and unsuitable for roosting bats and no physical evidence of bats was found in relation to them such as faeces, staining or feeding remains.

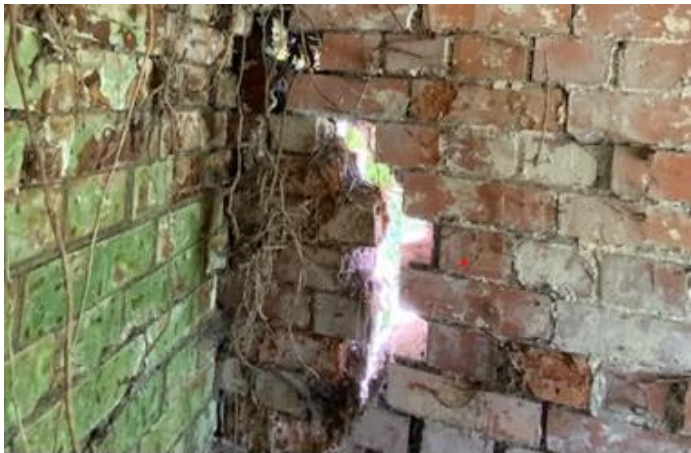
| | <p>The photograph shows one of the cracks present in the brickwork allowing light pollution into the building and without cavities.</p> |
