ISSUED FOR PLANNING

| PROJECT | Penleigh Farmhouse |
| DRWG TITLE | Wall Plinth Details |
| DRWG NO | A17 25 37 P3003 |

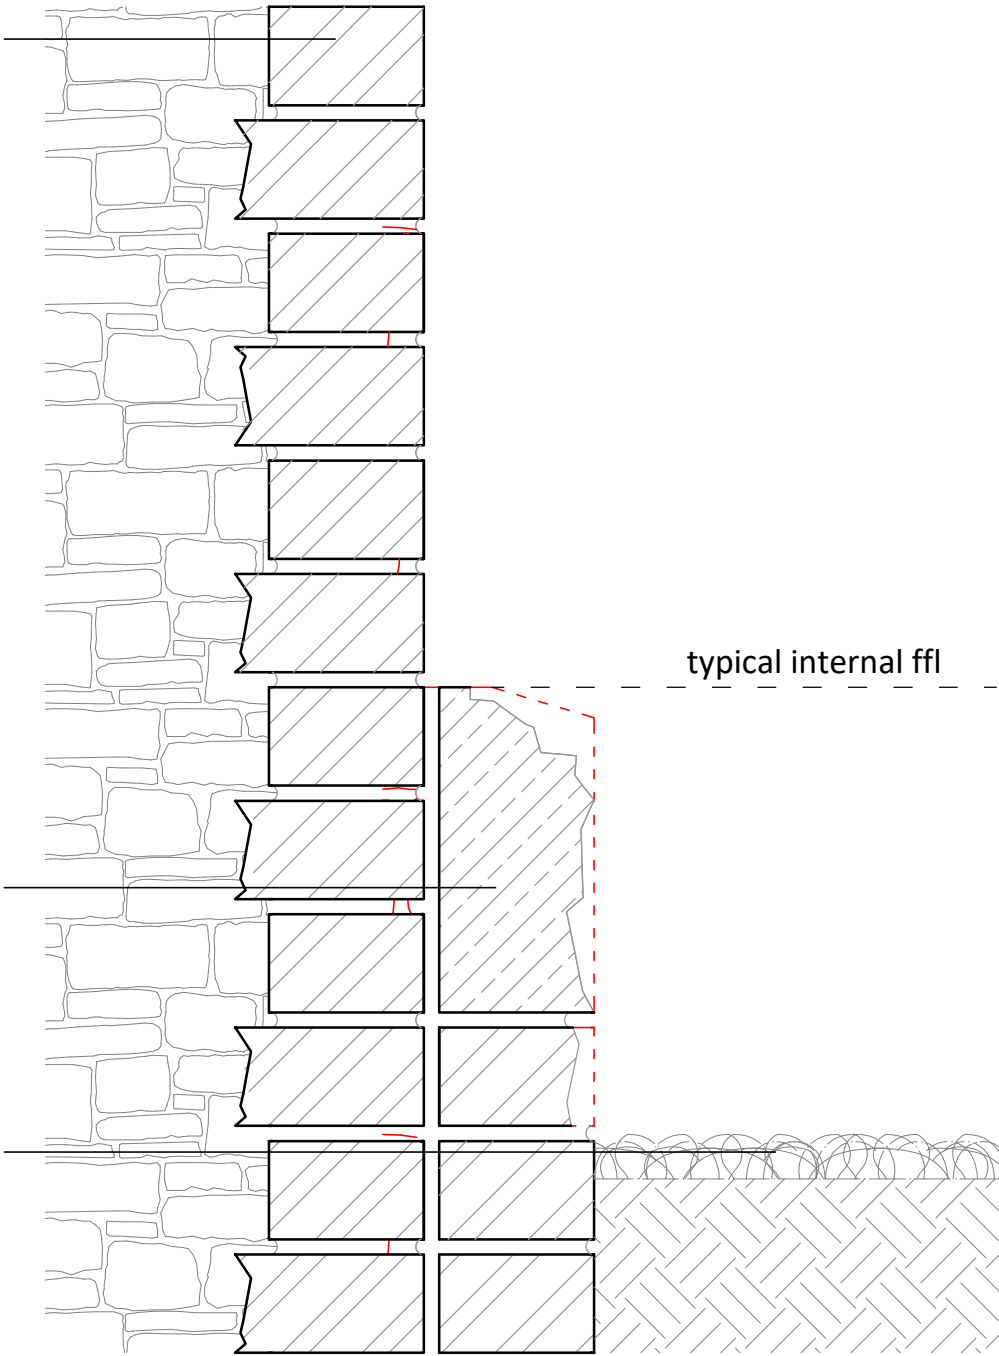
EXISTING WALL PLINTH DETAIL

existing solid masonry walls, red brick with rubble infill

failed / missing / damaged stone plinth course & facing brick below

low garden level

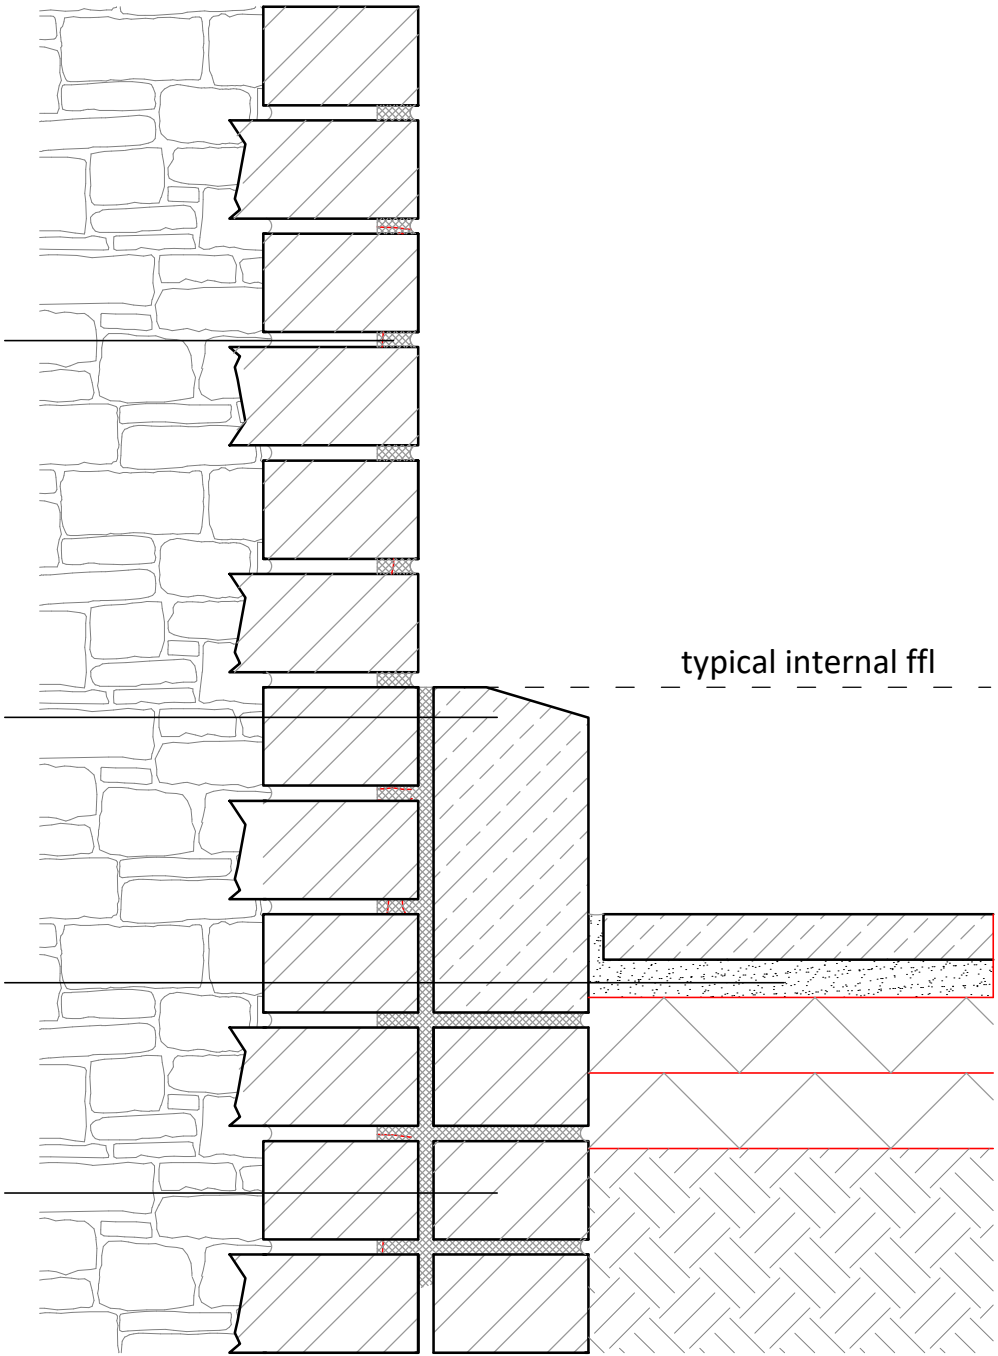
PROPOSED WALL PLINTH DETAIL

repointing with matching lime mortar

new bathstone ashlar plinth course with matching lime mortar bed and perp joints

new stone slabs, mortar bedded on compacted hardcore

new localised brck base reclaimed from elsewhere onsite with matching lime mortar bed and perp joints
