# **Heritage Assessment**

## **Tottenham House Estate – The Studio (Building 5): Amended Proposals**

**Our reference**  
GREH3020\_HTAL

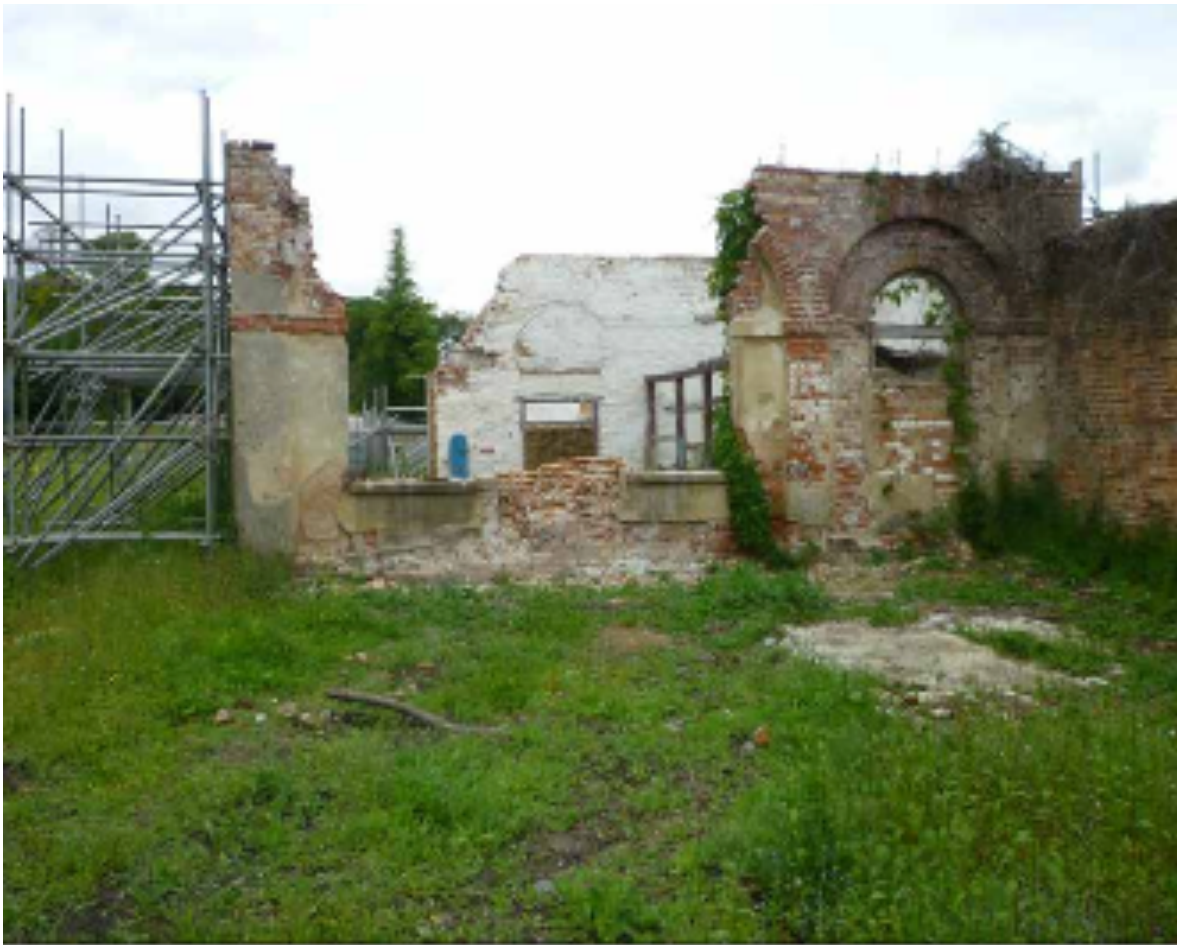
**Figure 1: South elevation of the south wing of Building 5**

- 1.12 The south wing was a brick and lime rendered structure, which once had recessed arches to three elevations, two blind in the west elevation, under a hipped slate roof. The blocking of windows in the west elevation evidenced alterations over time before the building fell into severe decline resulting more in collapse. Whilst its original purpose is not clear, the building when intact had the appearance of a politely designed pavilion with finely detailed masonry and a trussed timber roof with slates.

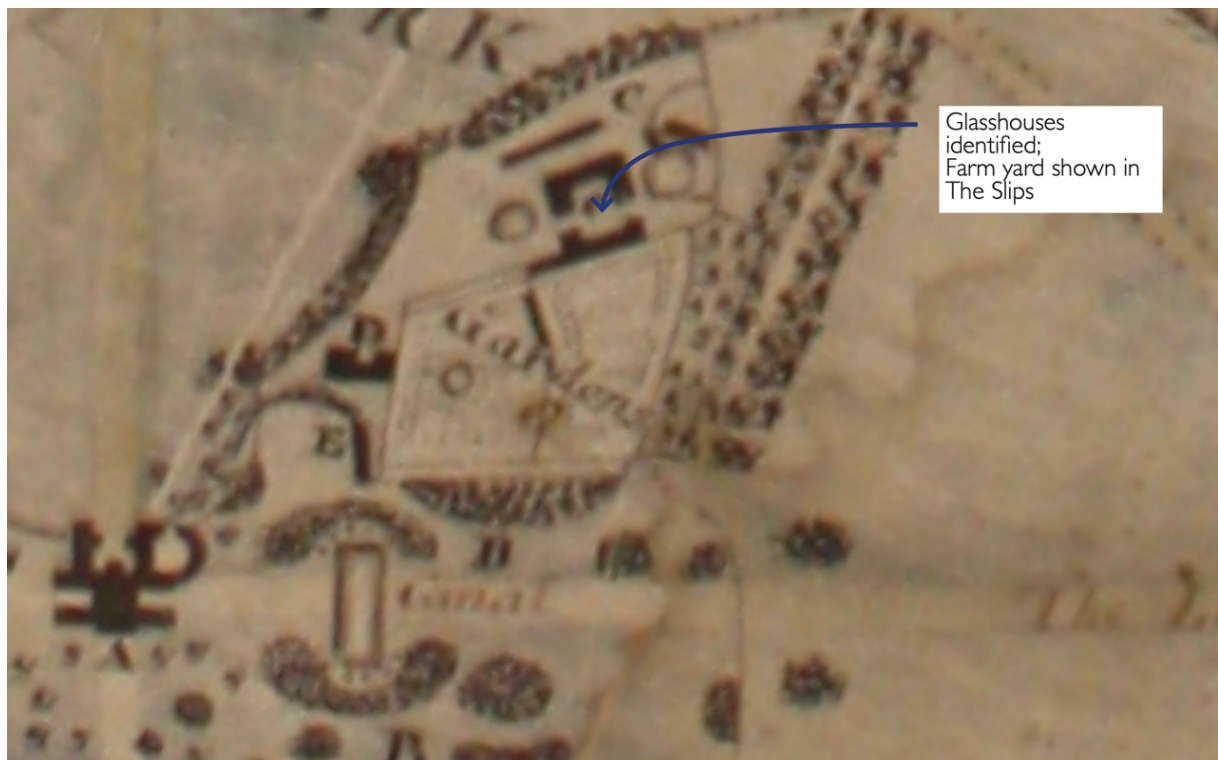
**Figure 2: 1786 Estate Plan (reproduced from Matthew Wigan Associates Walled Garden Analysis 2022)**

- 1.7 The 1786 Estate Plan (Figure 2) indicates a linear range of buildings on the outer side of the wall to the Walled Garden possibly partly associated with Home Farm and the farmyard before it was demolished around 1820 when the farmstead was relocated to Warren Farm. A Stewards Cottage was built in its place (now known as Pond Cottage - Building 7) and a new entrance was formed in the northwest section of the Walled Garden and further greenhouses and outbuildings were constructed.

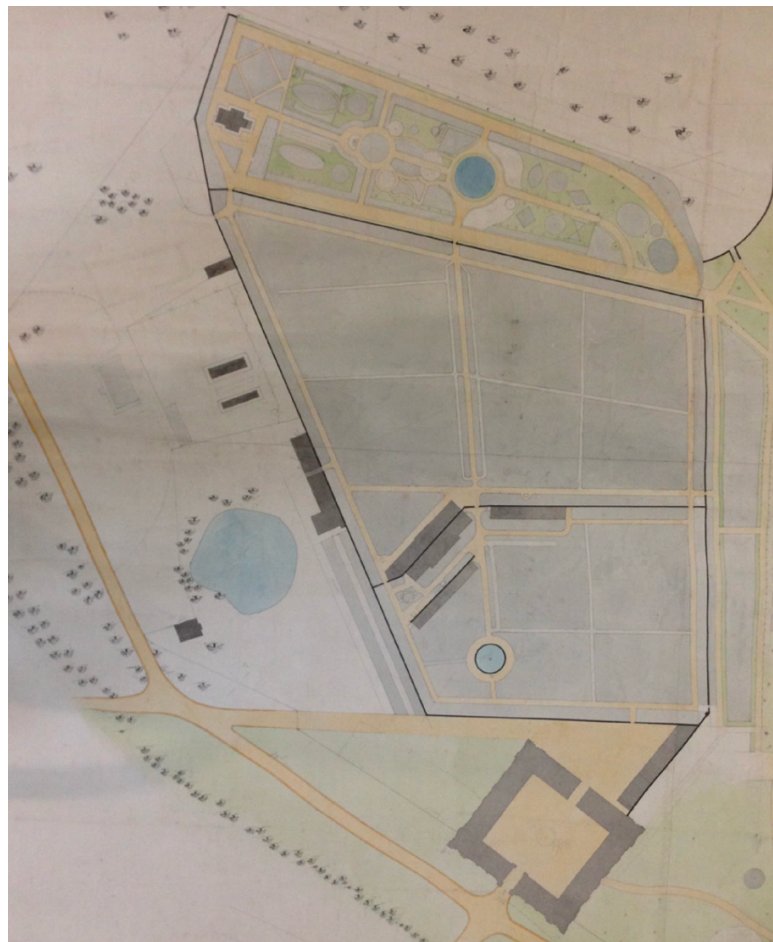
**Figure 3: Kitchen Garden 1830 Plan (Wiltshire Records Office) reproduced from Tottenham House & Estate Heritage Report Volume 1, 2017,**

- 1.8 The lower north range of Building 5, extant today and vernacular in character, may be a partial remnant of the farm buildings. By the early C19th (see Figure 3 1830 Estate Plan) the southern wing may have been enlarged or rebuilt, with larger footprint indicated, directly facing the fishpond in The Slips. By the 1960s OS maps suggest that the buildings were also extended further southwards, at some point, although these structures are not evident today.

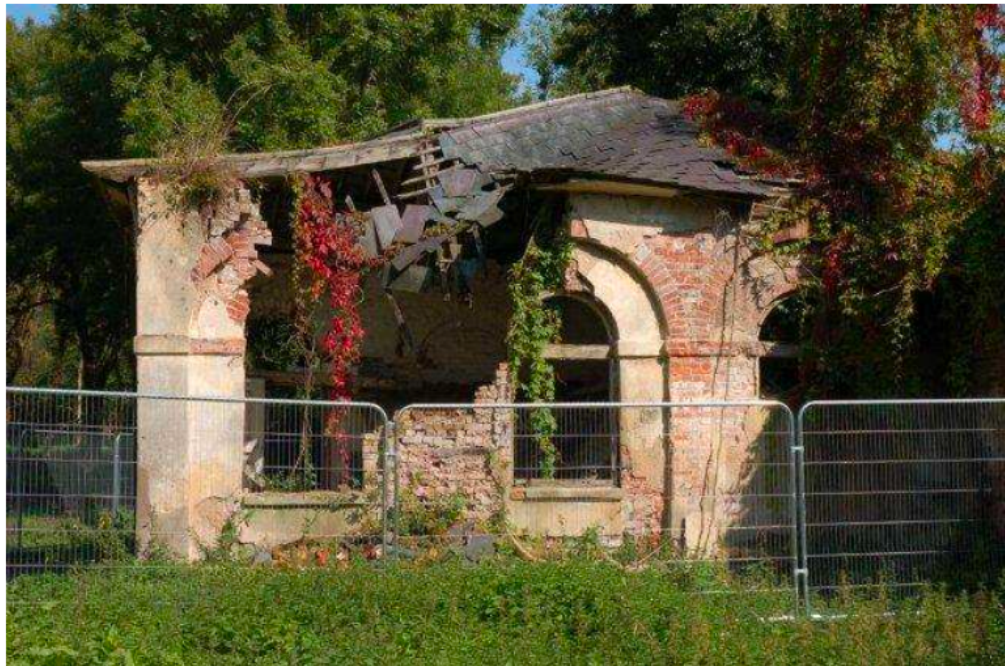
Figure 4: Estate Buildings Condition Survey and Schedule of Works 2015-2024 (prior to storm damage) - Adam Architecture

South elevation of south wing - 2015

West elevation showing south and north wings -2015

- 1.11 The building was already in decay and derelict prior to further significant storm damage in 2022 which then necessitated the urgent stabilisation works.

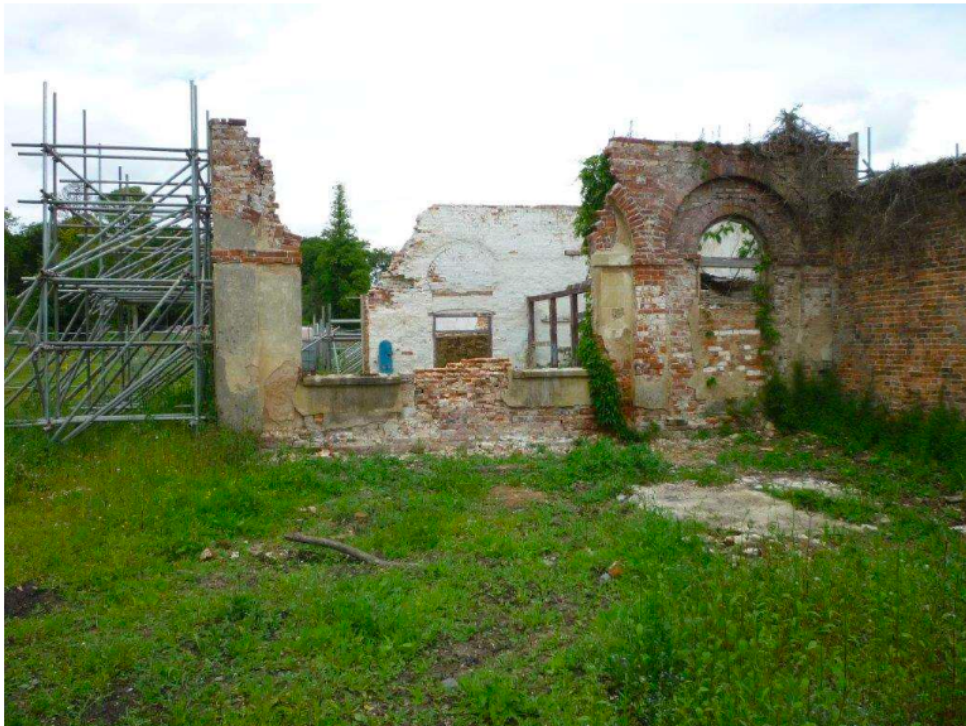
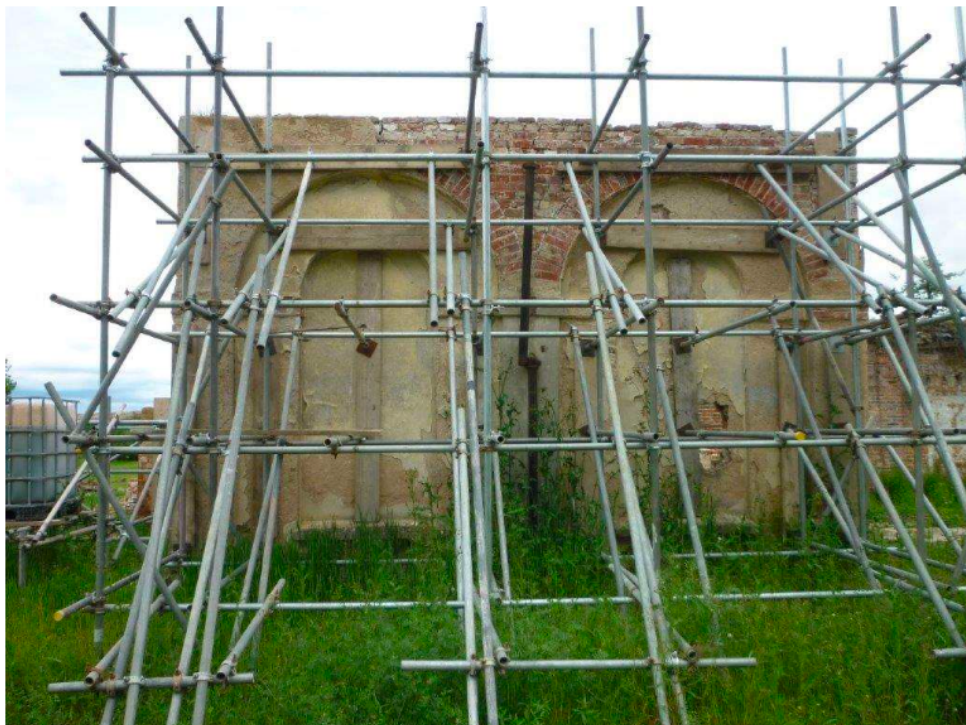
**Figure 5: Estate Buildings Condition Survey & Schedule of Works 2015-2024 (after storm damage) - Adam Architects**

South elevation of south wing – 2022

West elevation of south wing - 2022

- 1.10 The overall condition of the existing fabric is extremely poor with large areas of fabric missing and/or collapsed. Most of the masonry walls have either collapsed or are in very poor condition and the roof structure collapsed and been removed as part of previously agreed urgent stabilisation/ making safe works<sup>3</sup>.
