## **Ecological Impact Assessment**

Alvediston Manor,  
The Street,  
Alvediston,  
Salisbury,  
Wiltshire,  
SP5 5JZ

**August 2026**

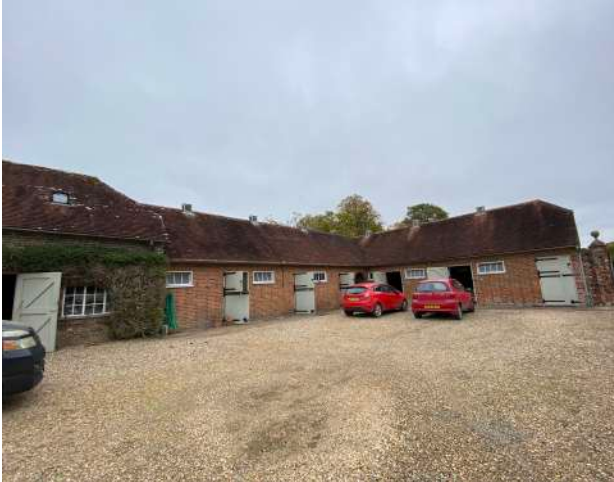
**Image 1:** Southern elevation of the building

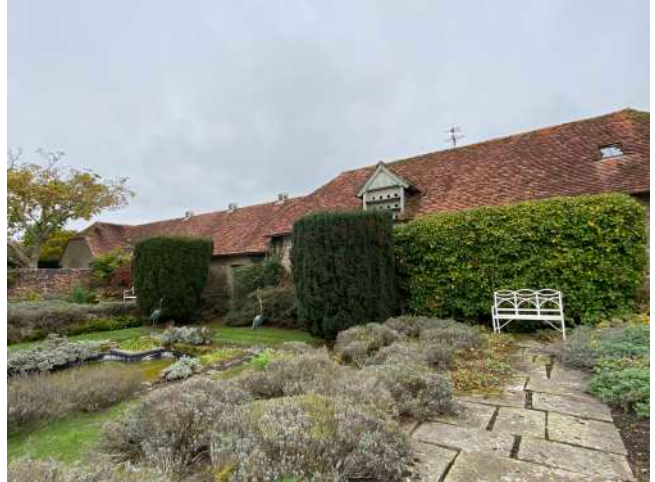
**Image 2:** Northern elevation

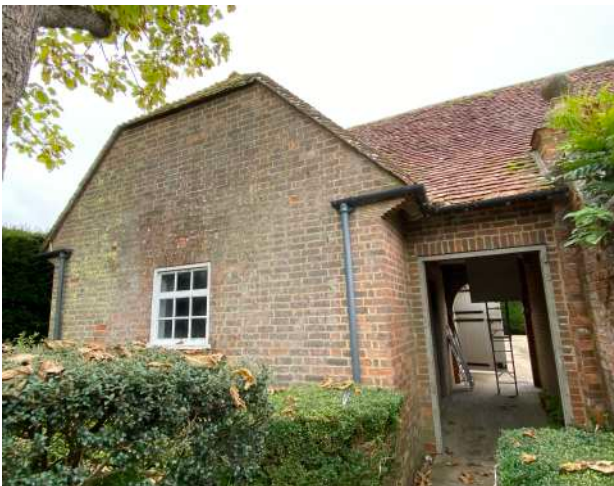
**Image 3:** Northern elevation of the area to be impacted by the proposals

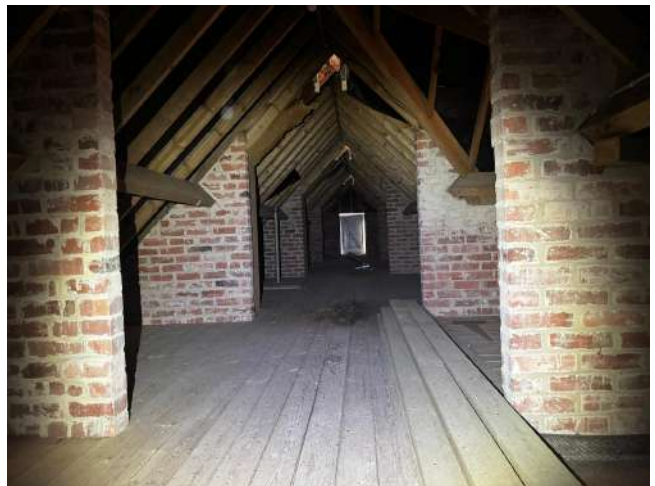
- 5.13. Above the eastern section of the stables was a large void, measuring 16m (L) x 6m (W) x 2.5m (H), of traditional cut roof construction, lined with bitumen felt, with vents at the ridge. The void was uncluttered, providing a large, clear flight space. The floor had been kept well swept; however, low numbers of bat droppings were still noted, scattered in places and stuck to the rafters and to the hay loft door. These were confirmed to be common pipistrelle *Pipistrellus pipistrellus*, brown long-eared *Plecotus auritus*, grey long-eared *Plecotus austriacus*, and serotine *Eptesicus serotinus* through DNA analysis. There was evidence of small amounts of staining at the rafters at each hip apex, indicative of regular use by roosting bats. Possible access points included the vents, over the wall plate and above hayloft door.

**Image 4:** Void A, looking towards hayloft door at southern end

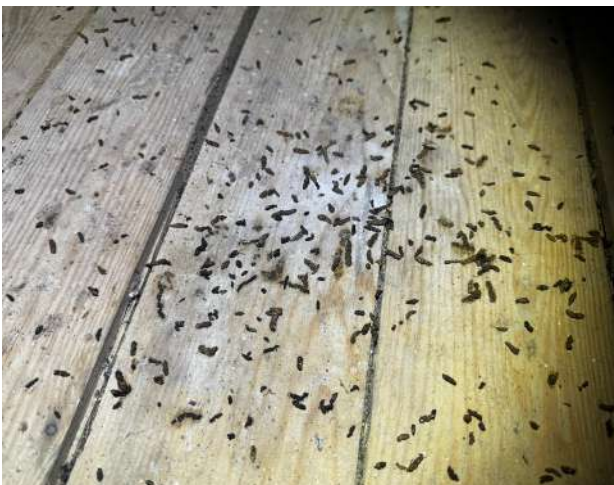
- 5.14. The update inspection in June 2026 found 100s of fresh droppings within this loft void, in piles, scattered throughout the central section and concentrated around the northern end wall. A new sample was taken of fresh droppings only, and DNA analysis found brown long-eared and common pipistrelle.

**Image 5:** Droppings in void A on update inspection June 2026

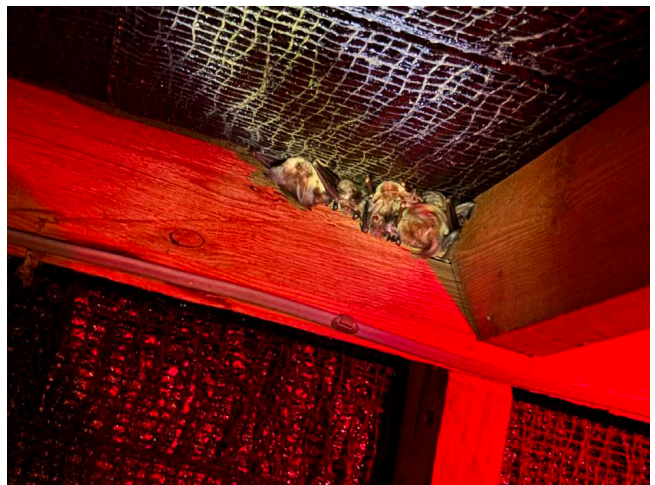
- 1.3. During the emergence surveys, twelve brown long-eared bats were seen within Void A before the final survey, juveniles and adults were seen, confirming the void as a maternity roost. Long-eared bats were observed using an eaves access point at the northeast corner of the building, flying around the hedgerow and vegetation in the area to the east and north of the building, and using the pond in the garden to the north of the building. Three common pipistrelle were also observed emerging from lifted tiles across the building on one of the surveys, with high levels of foraging activity in the gardens and using the pond. *Myotis* sp., serotine, noctule, soprano pipistrelle and lesser horseshoe calls were also recorded on site.

**Image 6:** 12 brown long-eared bats in Void A 4/8/26

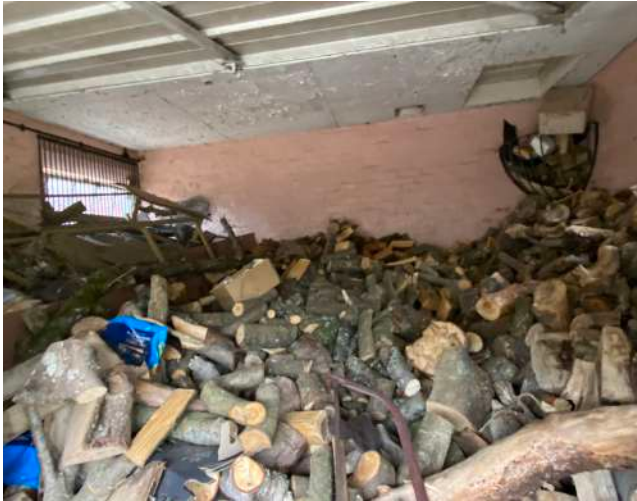
**Image 7:** Woodstore at southern end beneath Void A

- 5.25. *Survey 4 - 04/08/26:* An additional survey was completed for the eastern section of the building containing Void A, to provide further data due to the high levels of long-eared activity recorded on the third survey, to inform characterisation of the roost. 12 brown long-eared bats were observed in Void A before the survey, with both juveniles and adults present.
- 5.26. Multiple long-eared bats were observed emerging from and re-entering the access point identified at the eaves at the northeast corner of the building, with commuting and foraging activity around the ornamental hedgerow to the east of the building, back and forth to the pond in the garden to the northwest, both of which are important features for bats using the site. Long-eared bats were also noted flying into the open woodstore at the southern end of the building, used as a night roost.

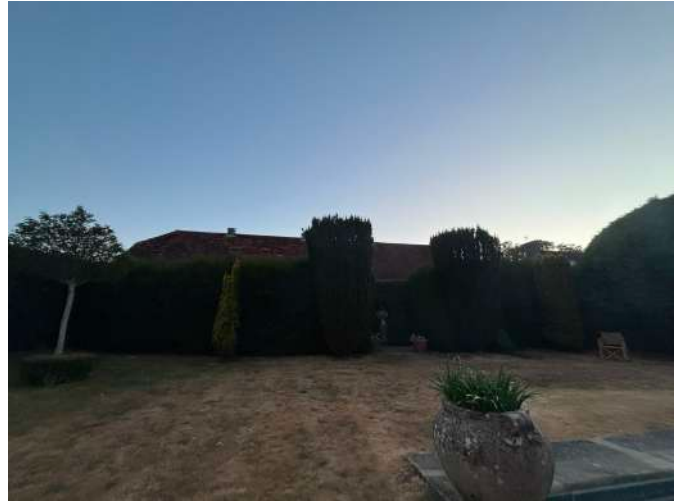
**Image 8:** Hedgerow to the east of B1, creating a dark corridor around the access point

- 6.7. Removal of the hedgerow around the access point, and increased light levels and disturbance from doorways and windows may cause bats to avoid the roost.
- 6.8. Potential impacts to bats at B1 therefore include damage (via modification) and/or destruction (via removal of access) of a roosting site, with potential for disturbance, injury or killing of bats in their roosts during works.
- 6.9. In the absence of mitigation, the works would therefore result in an offence under the *Conservation of Habitats and Species Regulations (2017)*.

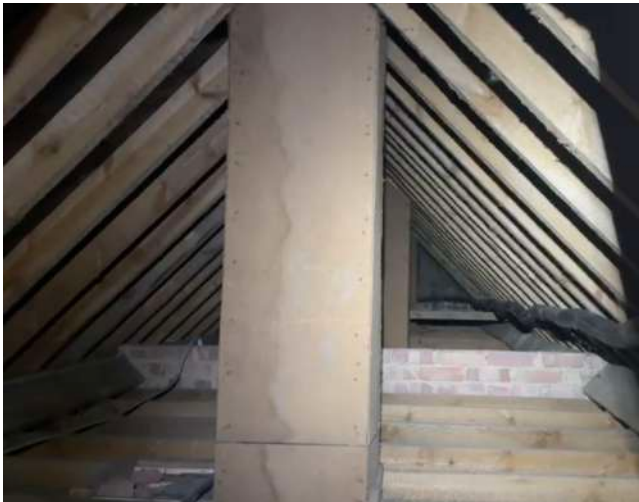
- 5.15. There was a sealed void above the storage spaces in the central section of the stable building, which was not possible to access. This section of the building had a slightly vaulted ceiling, above which was an enclosed void space. There were vent shafts running through from the ridge, and gaps in the hardboard ceiling in places, which could potentially allow access. A bird nest was noted in one of the vent spaces.
- 5.16. During the update inspection, a small panel was opened at the eastern end of this void to look through. The void was estimated to be 1.2m (H) x 2m (W), and from the access hatch, only a few singular bat droppings were visible in this section.

**Image 9:** Void B - only viewed through a small panel

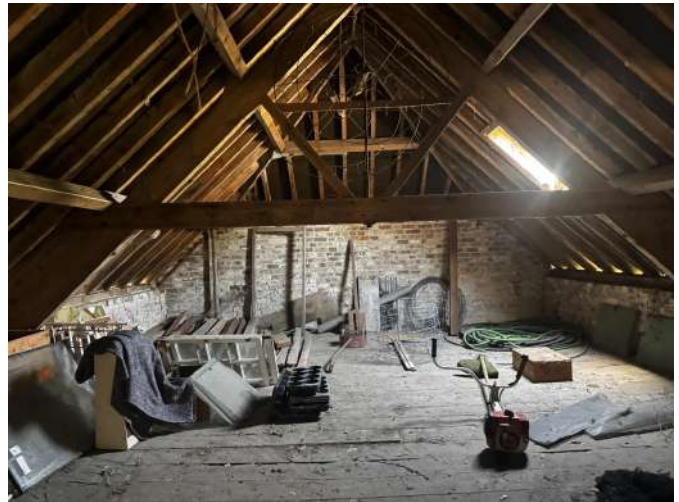
- 5.17. This was above the groundskeepers' workshop in the western section of the building. This void measured approximately 13m (L) x 5m (W) x 4.5m (H) and was of traditional cut roof construction with trusses also present beneath, providing a more cluttered but still extensive flight space. It was lined with bitumen felt in good condition, and two small windows let some light in. An old dovecot was also present, which was closed off with a door. There was a small pile of older long-eared droppings at the eastern end.
- 5.18. The update inspection found numerous fresher droppings both scattered throughout the void and concentrated at the northern end, which DNA analysis found to be common pipistrelle and brown long-eared.

**Image 10:** Void C - low numbers of old droppings

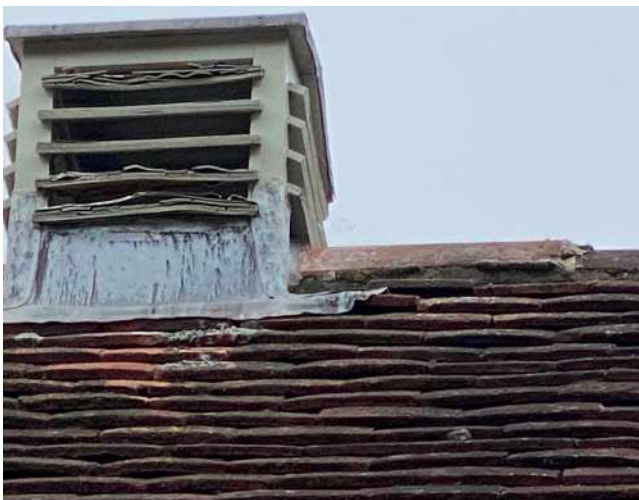
- 5.9. The building was brick-built with a traditional clay tile roof, with half-hips at the ends of the roof. There were numerous lifted tiles all over the roof, with occasional possible gaps at the ridge, and lifted lead around the vents. These features provide high crevice roosting potential and potential access into the loft voids in places.
- 5.10. At the northeast corner end, to be extended, the tiles were mossy, with some potential crevice access gaps at the corner and corners of the eaves.
- 5.11. An active swallow nest was observed within the covered corridor leading between the two sections of the building during the update inspection in June 2026.

**Image 11:** Example of lifted tiles, gaps around the lead flashing around the vents at the ridge.

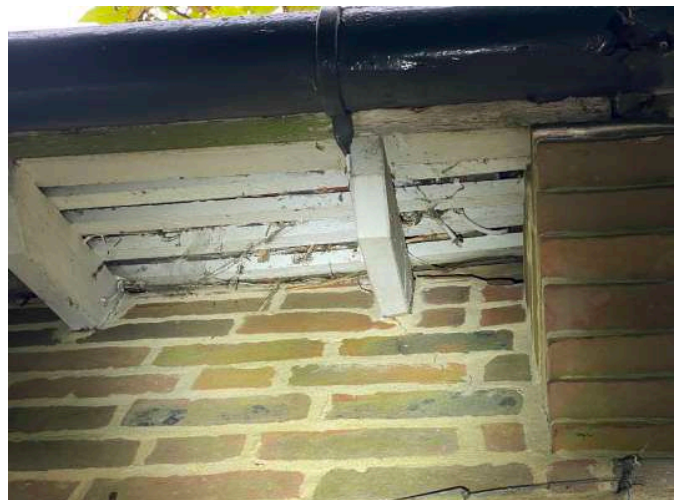
**Image 12:** Eaves access at the northeastern corner

- 5.22. *Survey 3 - 02/07/26*: A long-eared bat (likely brown long-eared due to internal droppings evidence) was recorded emerging from the eaves at the northeast corner of the building, from Void A. A peak count of four long-eared bats were observed flying in and out of this access point and foraging nearby, flying through the small gap between the building and the hedgerow, along this dark corridor and around the area to the south of the building. High levels of long-eared activity were observed around the building, and individuals were also seen entering the open woodstore at the southern end of the building and passing through the garden to the north and the courtyard to the southwest.

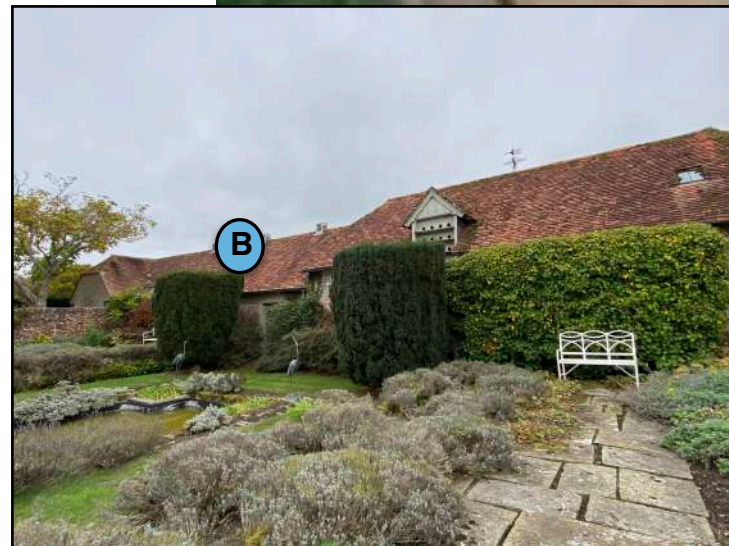
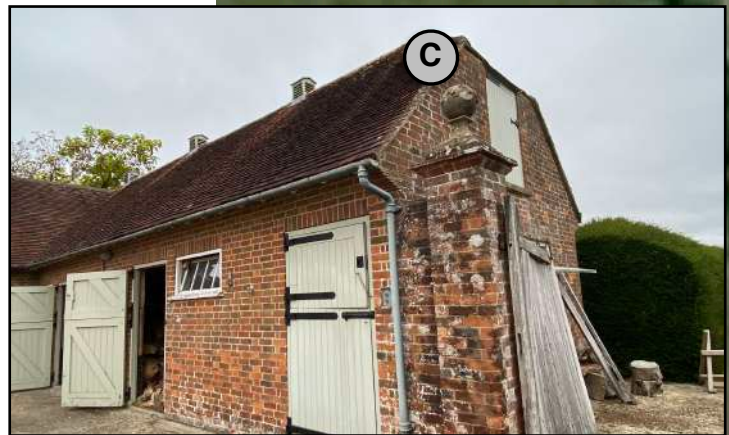
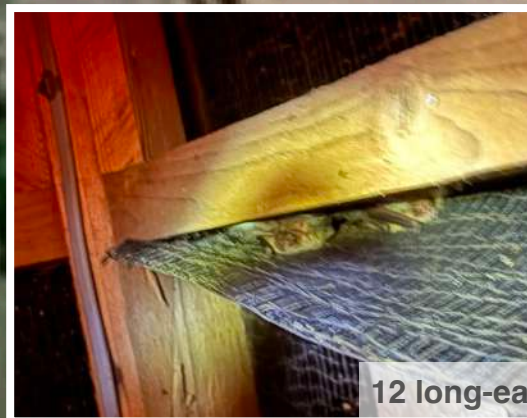
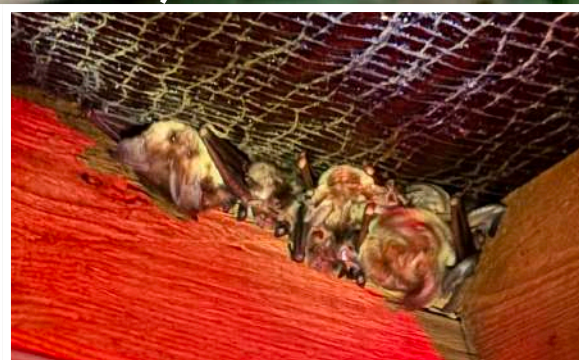
12 long-eared bats seen within Void A before survey 05/08/26

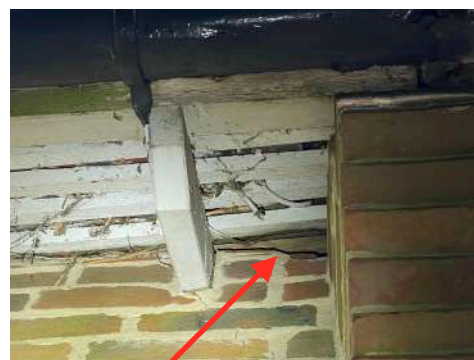
## Eaves access point

Existing eaves access point - to be retained or reinstated, with no new lighting and similar surrounding vegetation conditions to be maintained

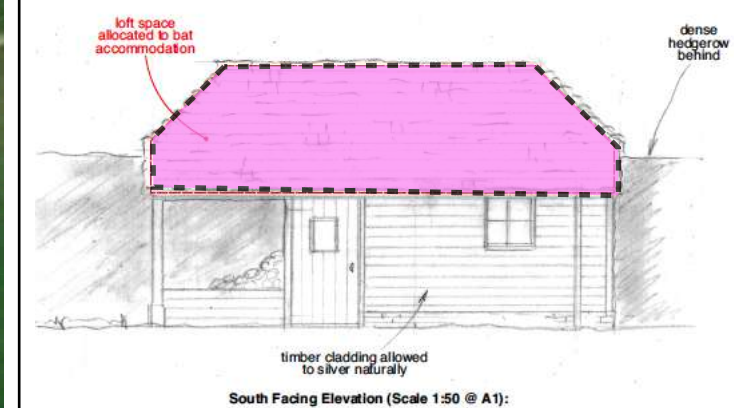
A new open-fronted woodstore and shed will also be built on site to provide night perching opportunities for bats, an additional void, wooden cladding crevice features, and a covered area to provide nest cups as compensation for the swallow nests to be lost.

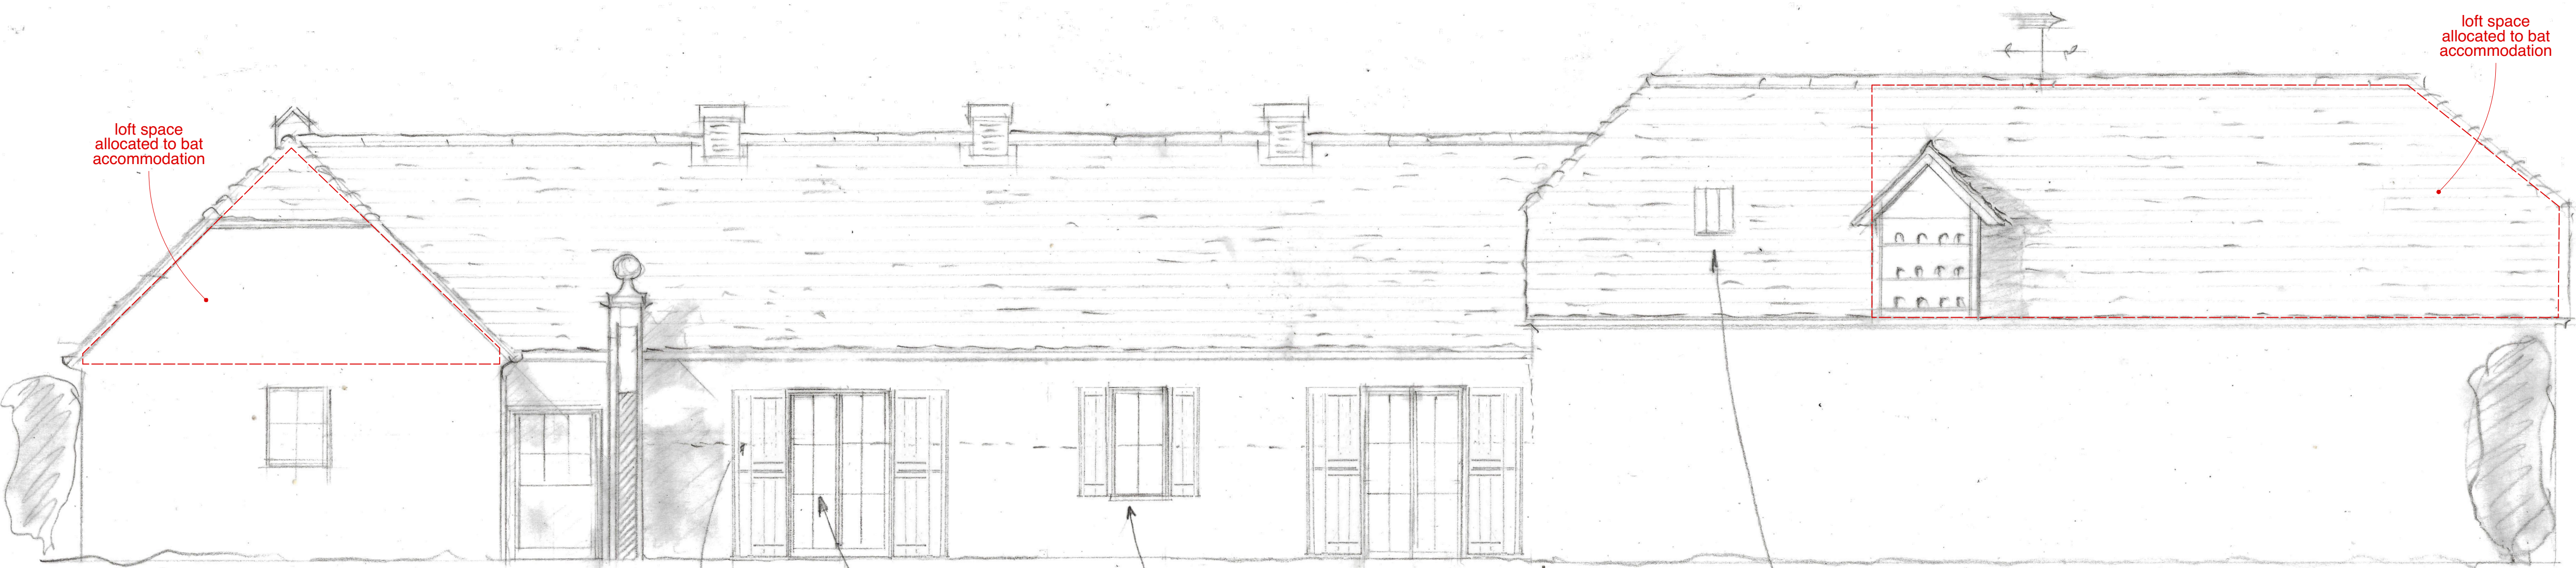
North Facing Elevation (Scale 1:50 @ A1):

traditionally detailed  
painted joinery (colour  
Farrow & Ball Pigeon  
Breast) into  
existing opening

existing rooflight  
moved to different  
location in roof

loft space  
allocated to bat  
accommodation

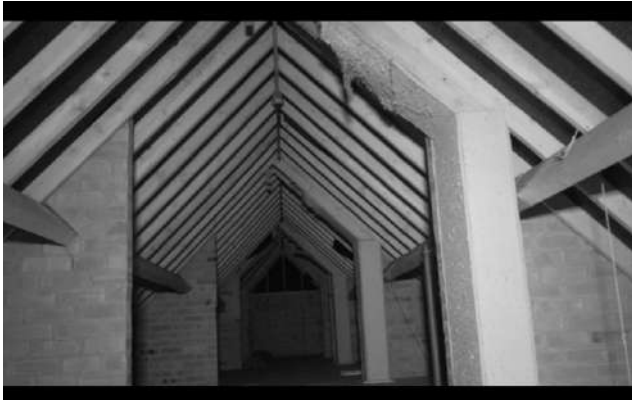
Survey 4 - 05/08/26 - Yellow cam inside void A

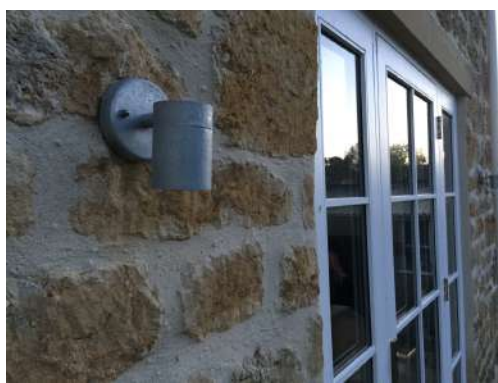
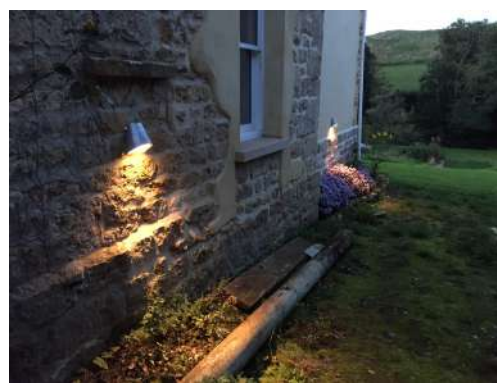
- Low pressure sodium lights or 'warm' LEDs
- Wavelength above 540nm
- Colour temperature below 2700K
- Shielded lights that prevent light spill above a 70 degree angle
- Passive infrared (PIR) motion sensors

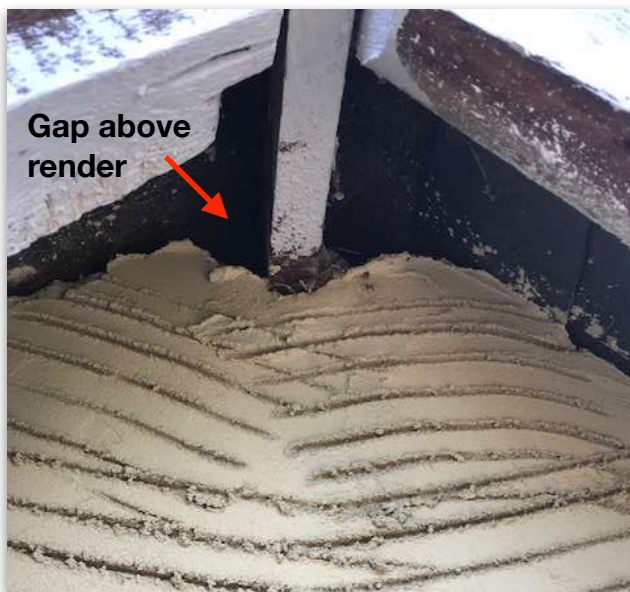
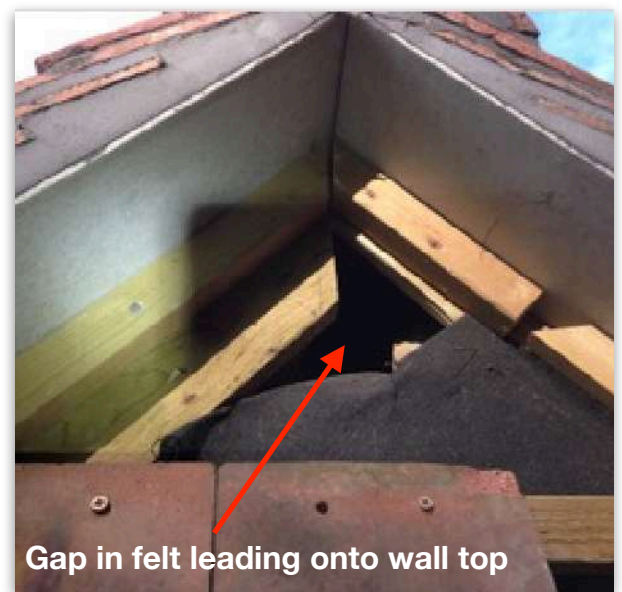
Note: This feature is used to ensure bats can access the loft void via the gable end

Depending on the construction of the building access needs to be created through both the external and internal layers of the wall.

External/Outer skin - This may be a small gap under hanging tiles, and wooden cladding or leaving a gap in the render adjacent to the ridge beam.

Internal skin - This is likely to require a cut in the felt for the bat to climb through and a gap at the wall top allowing the bat access into the loft void.

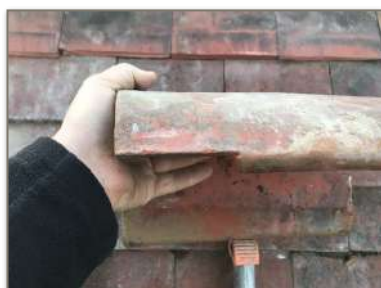
Note: Use three adjacent ridge tiles for one Ridge Tile Crevice Feature

1. Notch out the underside of a ridge tile measuring 20mm high by 50mm wide.

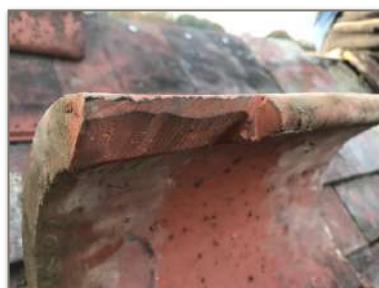
2. Or leave a gap in the mortar of the same size

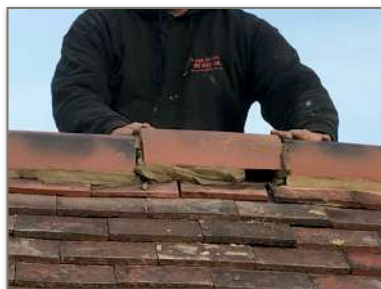
3. Leave the gap mortar free when bedding the tile onto the ridge.

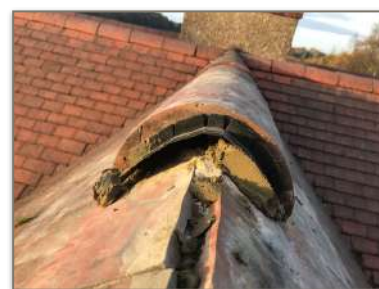
4. To ensure the three ridge tiles remain linked either; place a broken tile over the ridge and mortar only above the tile (left) or fill one side with mortar and leave the other side empty (do this on alternate sides to ensure the feature does not become draughty) (right).

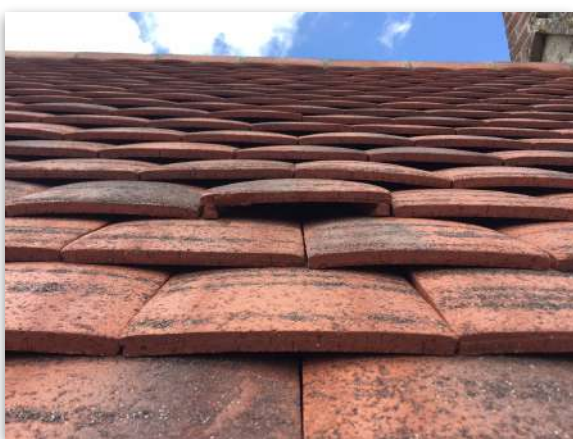
Lifted tiles provide a simple, discreet bat roosting opportunity which are great for replicating existing roost features on traditional tiled roofs. They can be cheaply and easily created using materials available on site to provide a bespoke mitigation solutions for bat licence projects.

Small pieces of tile, mortar, pieces of wooden batten or rolled lead tingle can be used to raise the tile and create a suitable access gap for bats.

Lifted tiles should provide a gap of approximately 15-25 mm beneath the tile to provide access to the batten space of the roof. The roof should be lined with bitumastic felt to create the perfect warm crevices suitable for roosting bats.

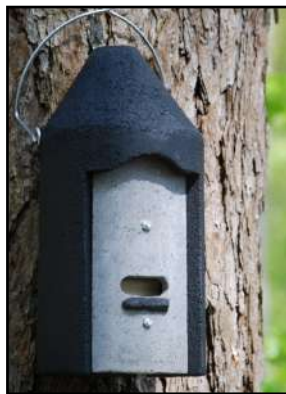
### Schwegler 2F Double Front Panel

- Manufactured from long-lasting woodcrete
- Lifetime - 20-25 years
- Suitable for pipistrelle and Myotis species
- A second inner wooden panel is fitted adjacent to the front panel imitating a cavity wall

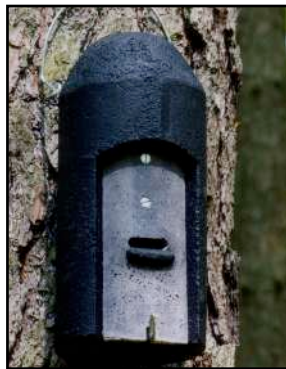
### Schwegler 1FD Double Front Panel

- Manufactured from long-lasting woodcrete
- Lifetime - 20-25 years
- Suitable for pipistrelle and Myotis species
- A second inner wooden panel is fitted adjacent to the front panel imitating a cavity wall
- Small entrance hole discourages birds from using the box

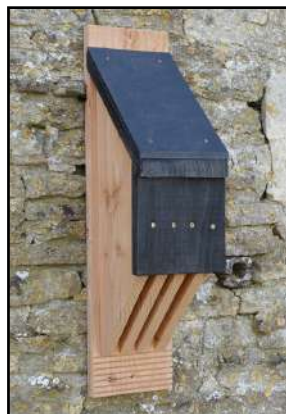
### Vincent Pro Bat Box

- Manufactured from timber and recycled plastic
- The front and the top of the box is black, which helps heat absorption
- Suitable for a range of species including pipistrelle species, Myotis species, and brown long-eared bats.
- No maintenance required

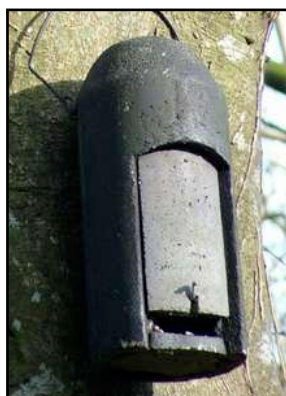
### Schwegler 2FN

- Manufactured from long-lasting woodcrete
- Lifetime - 20-25 years
- Suitable for pipistrelle species, Myotis species, serotine, brown long-eared, noctule and Leisler's bats
- Dual entrance
- Birds and dormice have also been found using this box
- A newer model is now available, Schwegler 3FN, designed with smaller entrance holes which discourage birds and dormice

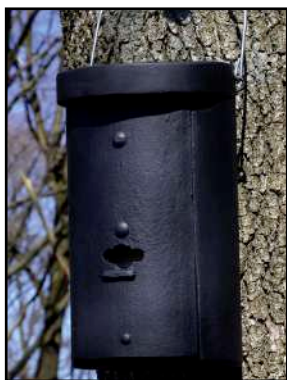
## Schwegler 1FS Large Colony Box

- Manufactured from long-lasting woodcrete
- Lifetime - 20-25 years
- Suitable for a range of bats including pipistrelle species, Myotis species, Noctule, and brown long-eared bats
- Three grooved inner wooden panels are connected to the front panel, which are ideal for bats to cling to.
- Accommodates large summer colonies

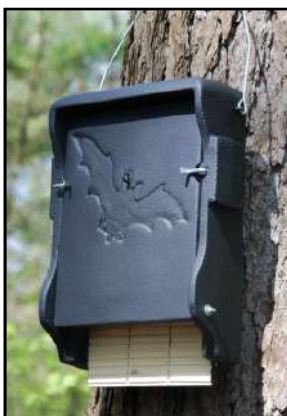
## Schwegler 1FF Colony Box

- Manufactured from long-lasting woodcrete
- Lifetime - 20-25 years
- Suitable for a range of crevice dwelling bats including pipistrelle species, barbastelle, noctule, and brown long-eared bats
- Rough wooden surface for bats to cling onto and climb

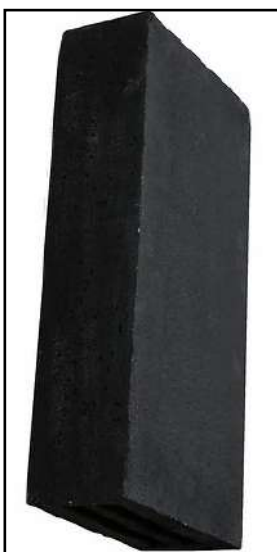
## Greenwoods Ecohabitats Small Hollow Bat Box

- Manufactured from long-lasting ecostyrocete
- Lifetime - 20-25 years
- Suitable for a range of bats preferring a cavity space, including pipistrelle species, myotis species, noctule, and brown long-eared bats
- Suitable for hibernating bats

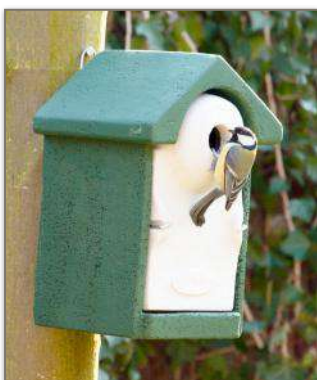
### Vivar Pro Seville 32mm WoodStone Nest Box

- Manufactured from woodstone - increases longevity and provides a consistent internal temperature
- The nest box compensates for the lack of natural cavities that are found in trees
- Suitable for blue tits, tree sparrows, house sparrows, great tits, crested tits, nuthatches, coal tits and pied flycatchers
- Should be installed between 1.5m and 3m high

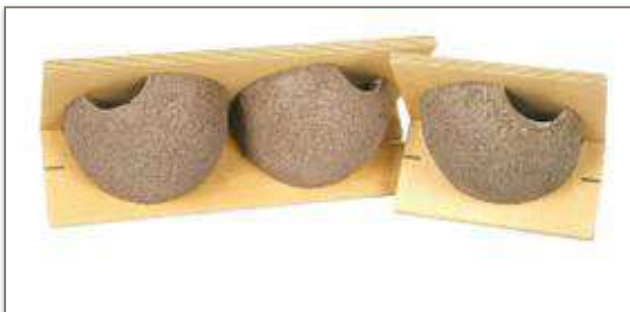
### House Martin Nest Cups

- Suitable nest building mud is difficult for house martins and swallows to find
- Alterations to house construction and roof design have resulted in a decrease of suitable nesting sites
- Install swallow nest bowls within an outbuilding or garage that has flight access - 6cm below the ceiling
- Install house martin nest cups under the eaves of a house - minimum of 2m high

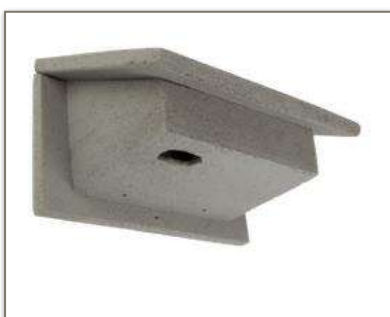
### Swift Nest Box

- Swift numbers are declining partly due to a loss of nesting sites
- The entrance hole discourages other birds such as starlings and sparrows
- Install a minimum of 5m high with unobstructed airspace in front of the nest
- Integrated models of swift nest boxes are also available
