## **Heritage Assessment**

*Barn at Church Farm, Lower Seagry, Chippenham, SN15 5EP*

On behalf of Mrs H M Waddington

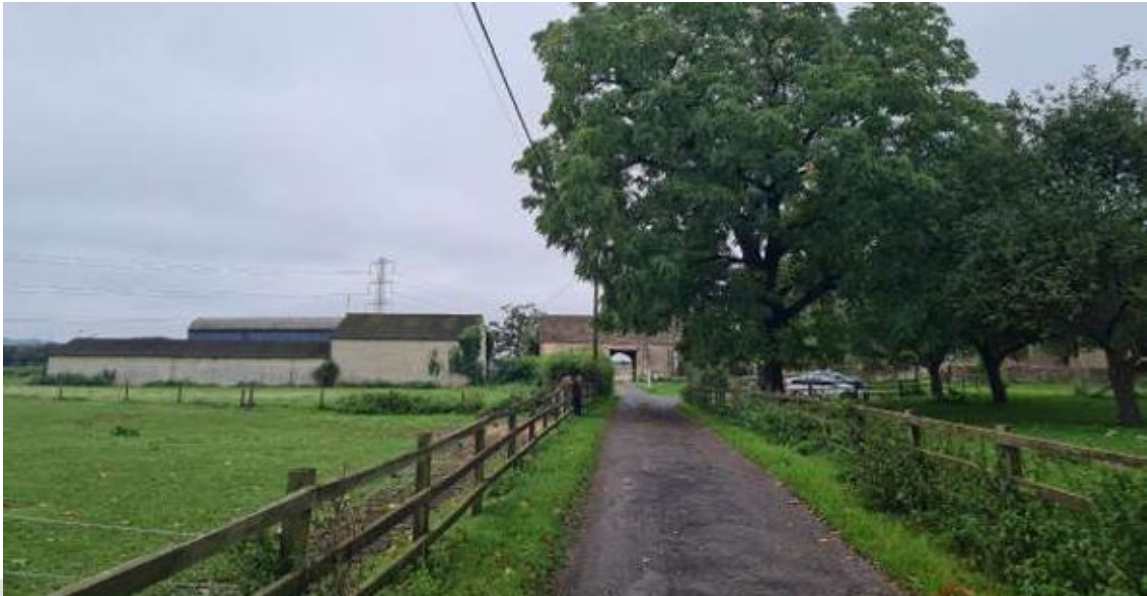
Figure 4

- 2.38 **Figure 4** shows the access approaching Church Farm Farmstead. Note host buildings to the left, Tithe Barn straight on and St Mary's Church to the right concealed behind trees.

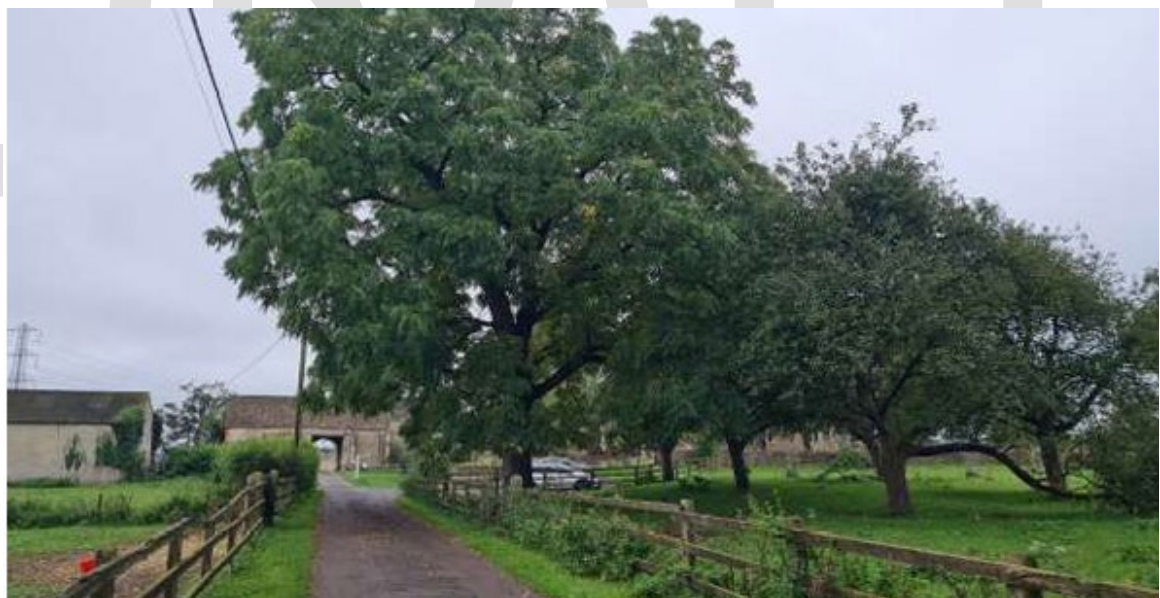
Figure 5

- 2.39 **Figure 5** shows the access approaching Church Farm. Note host building to the left, Tithe Barn straight on and St Mary's Church to the right concealed behind trees.

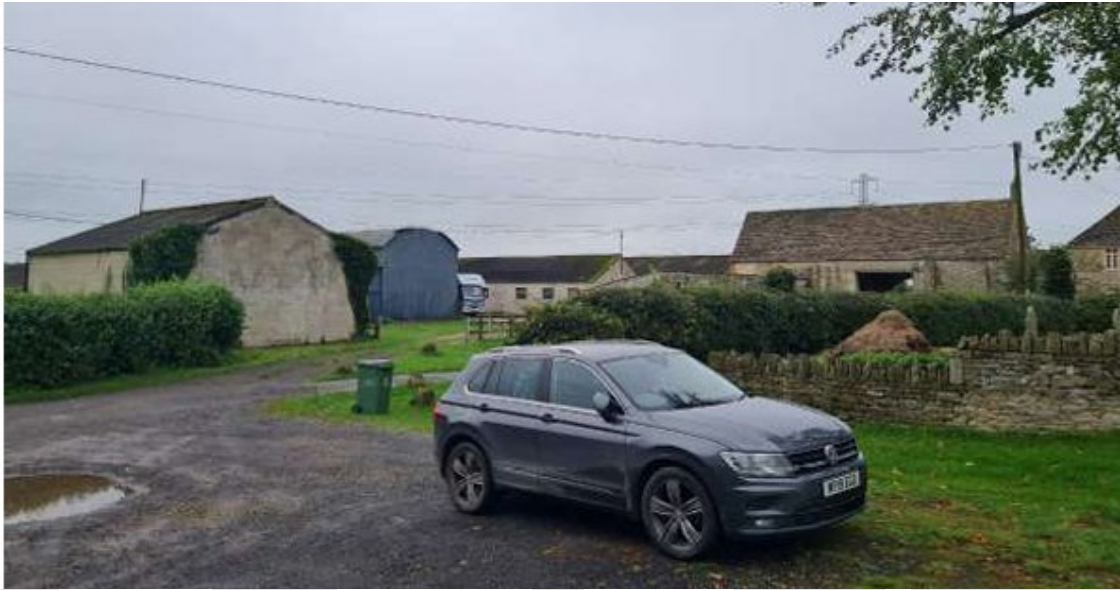
Figure 6

- 2.40 **Figure 6** shows view from Church car park. Note how the host building to the left forms part of the larger grouping of post war agricultural; buildings. The Tithe Barn is to the right.

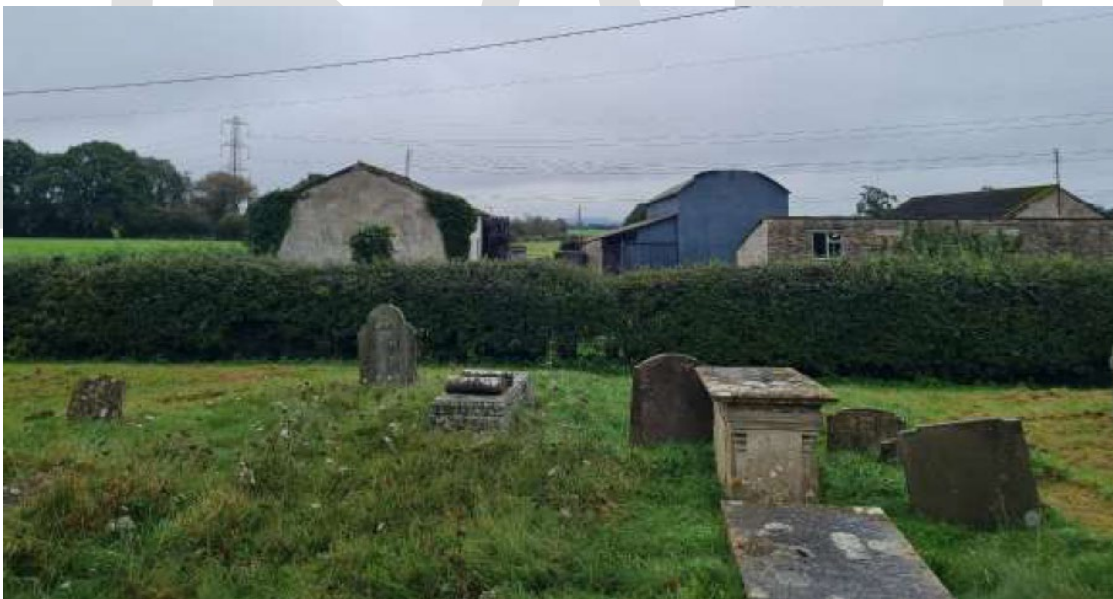
Figure 7

- 2.41 **Figure 7** shows a view of the host building (to the left) from the churchyard. Note other agricultural outbuildings to the right and the low rise north wing of the Tithe Barn.

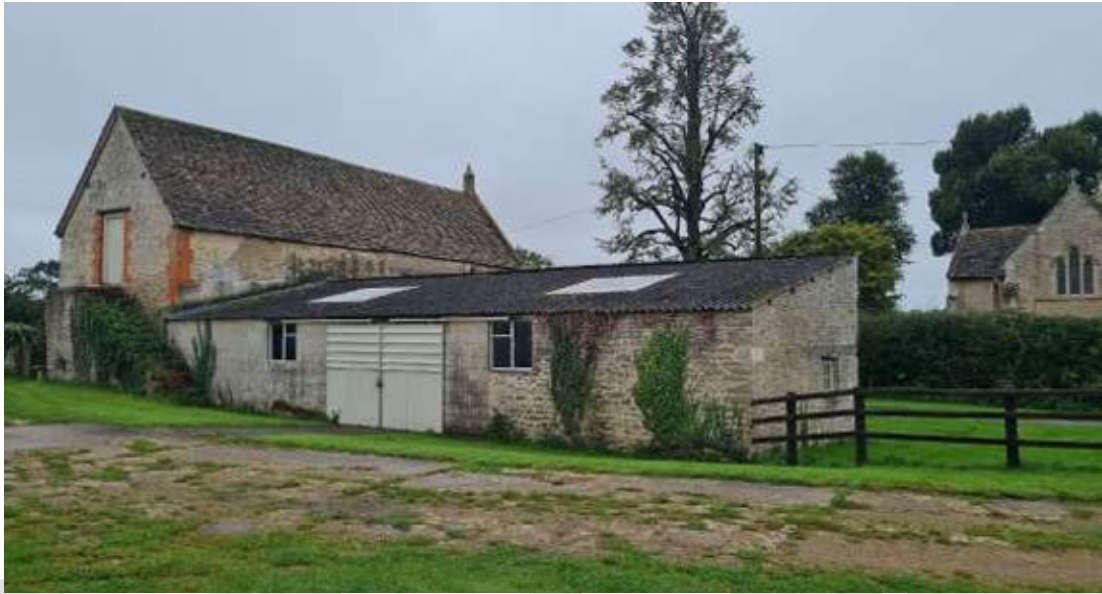
Figure 8

- 2.42 **Figure 8** shows the view of the Tithe Barn and Church from host building. Note the low-rise north wing of the Tithe Barn in the foreground and how 2/3 of this are of recent construction, of similar date to that of the host building. Note too that this modern section abuts The Tithe Barn.

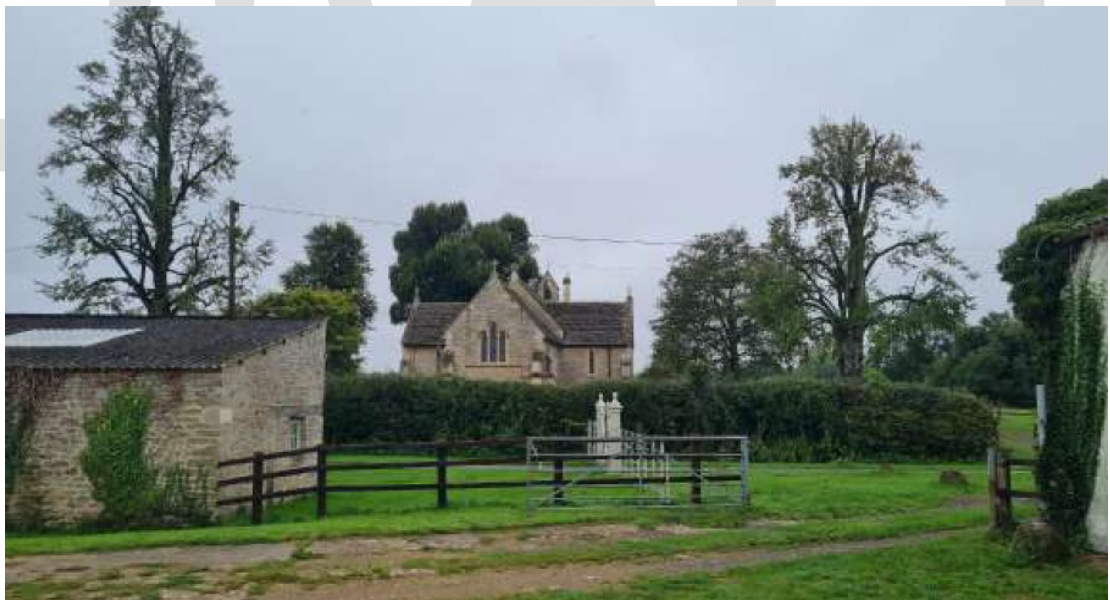
Figure 9

- 2.43 **Figure 9** shows view of Church from the host building. Note how the actual churchyard is concealed from view by mature hedgerow. Note to the fact that there is an established vehicular route through, leading to other outbuildings and land.

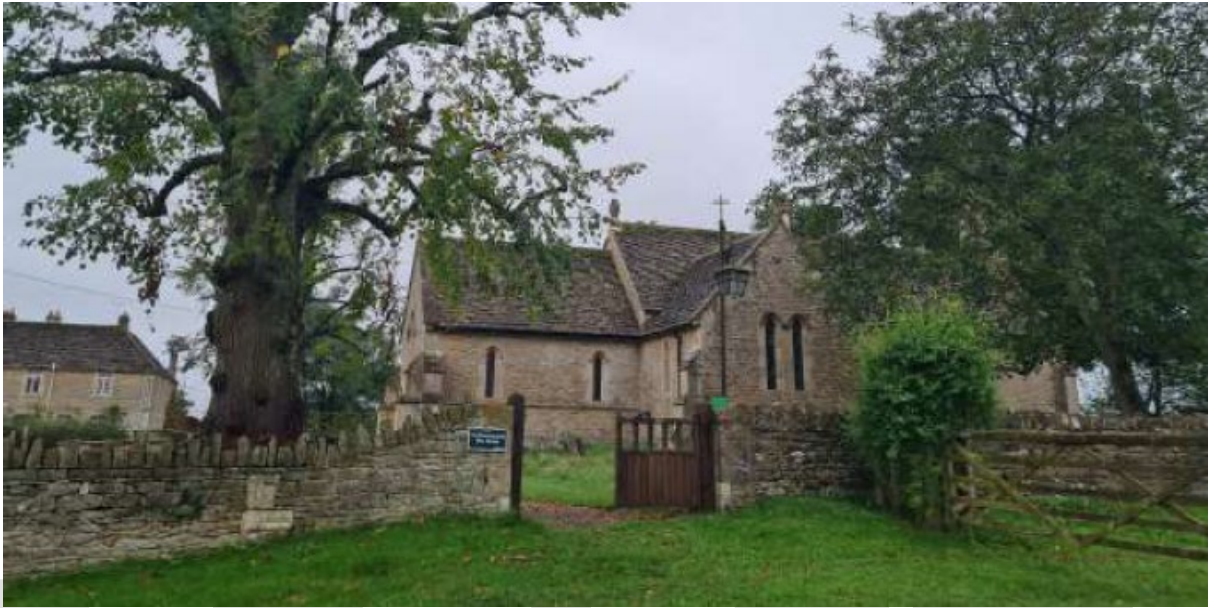
- 2.44 **Figure 10** shows the view of north/east Facades of St Mary's Church.

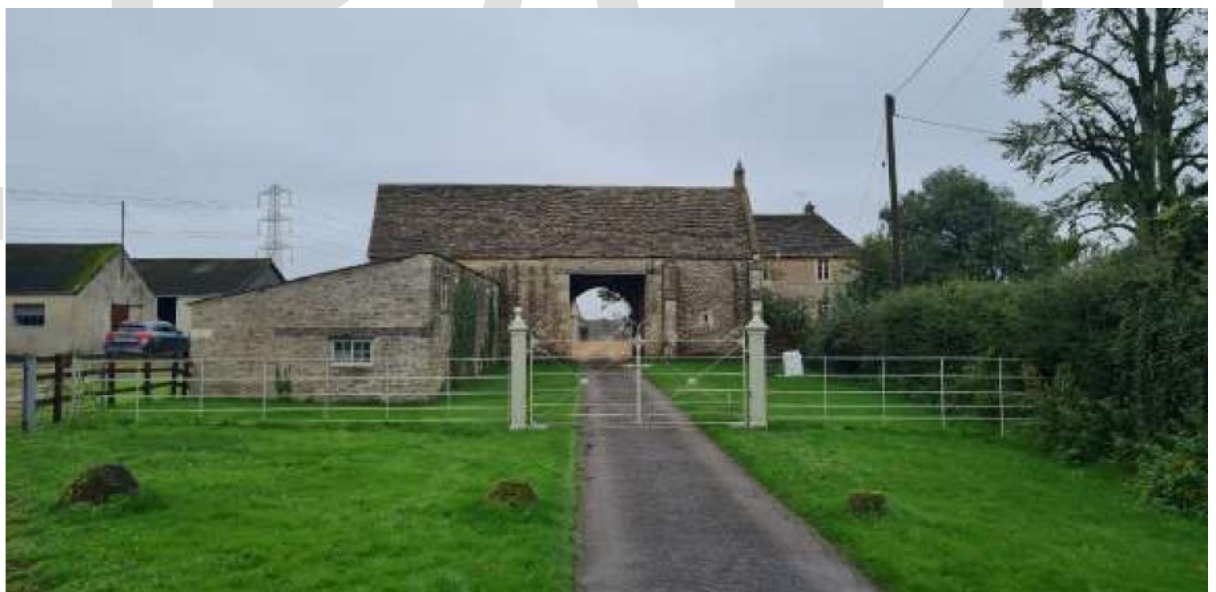
2.45 **Figure 11** shows view of the north Facade of Tithe Barn.

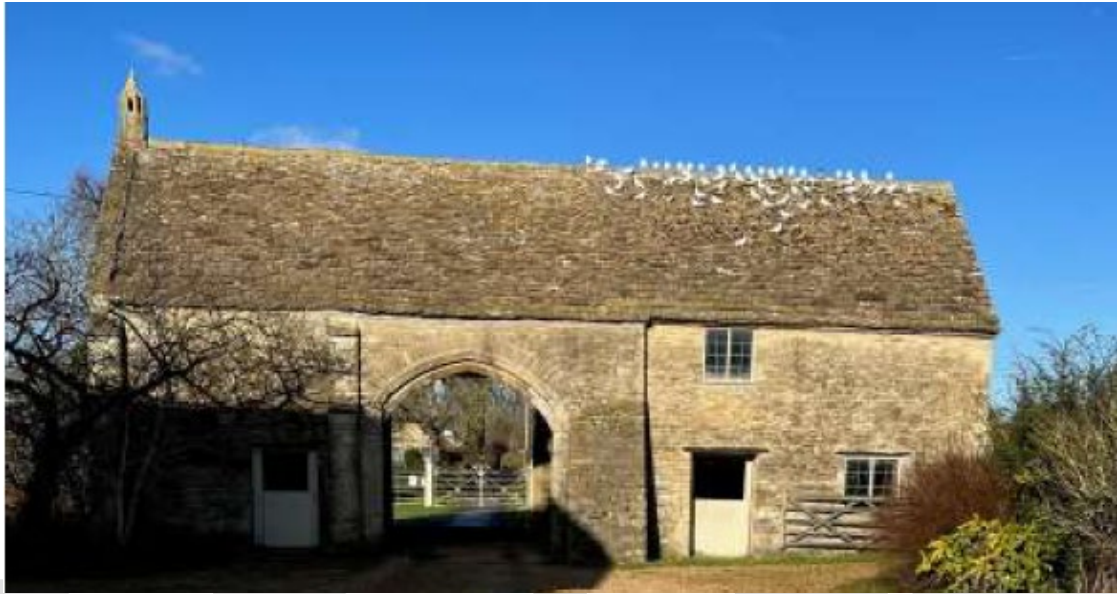
2.46 **Figure 12** shows the view of south Facade of Tithe Barn. Note later extension to the right of the arched entrance.

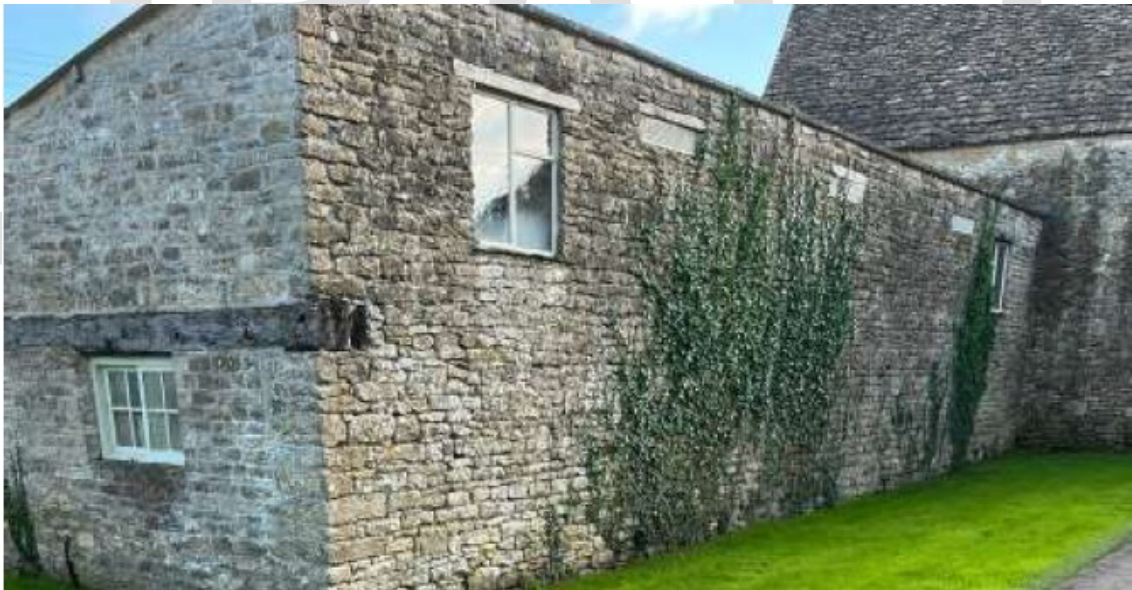
2.47 **Figure 13** shows the view of west facade of north extension to Tithe Barn.

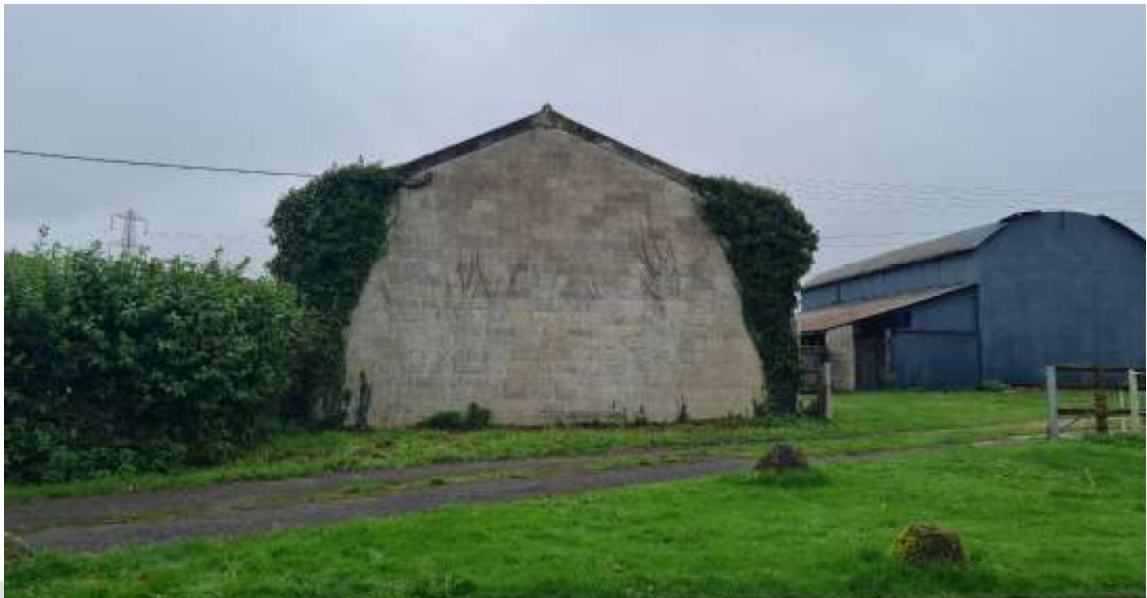
2.48 **Figure 14** shows the Host building, west Facade.

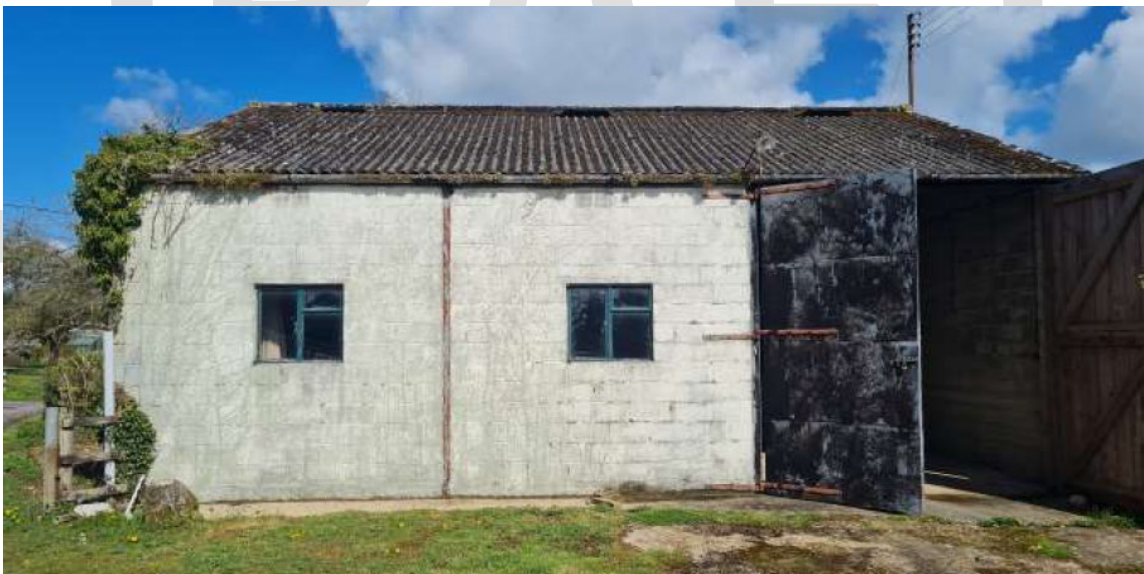
2.50 **Figure 15** shows the Host building, south façade.
