# Design and Access Statement

FORMstudio, architects working on behalf of the current owners of Northfield House in East Tytherton SN15 4LT, have prepared this Householder Application for Planning Consent with Listed Building Consent for minor works to the Grade II listed building and an outbuilding within its curtilage. The proposal seeks to balance improvements to the amenity of the existing property with a clear sensitivity to the historic fabric of the listed building and the conservation area to which it belongs. The proposal has also accounted for potential risks to ecology and habitat within the Zone of Influence of two local SSSI. To support this proposal with independently established evidence, FORMstudio, have commissioned a Heritage Impact Assessment and an Ecology report, included as appendices to this application, both supporting a low to no-risk assessment of the proposed works. Preapplication advice was given on 3 July 2026, recommending these reports be submitted in conjunction with a householder application with listed consent application.

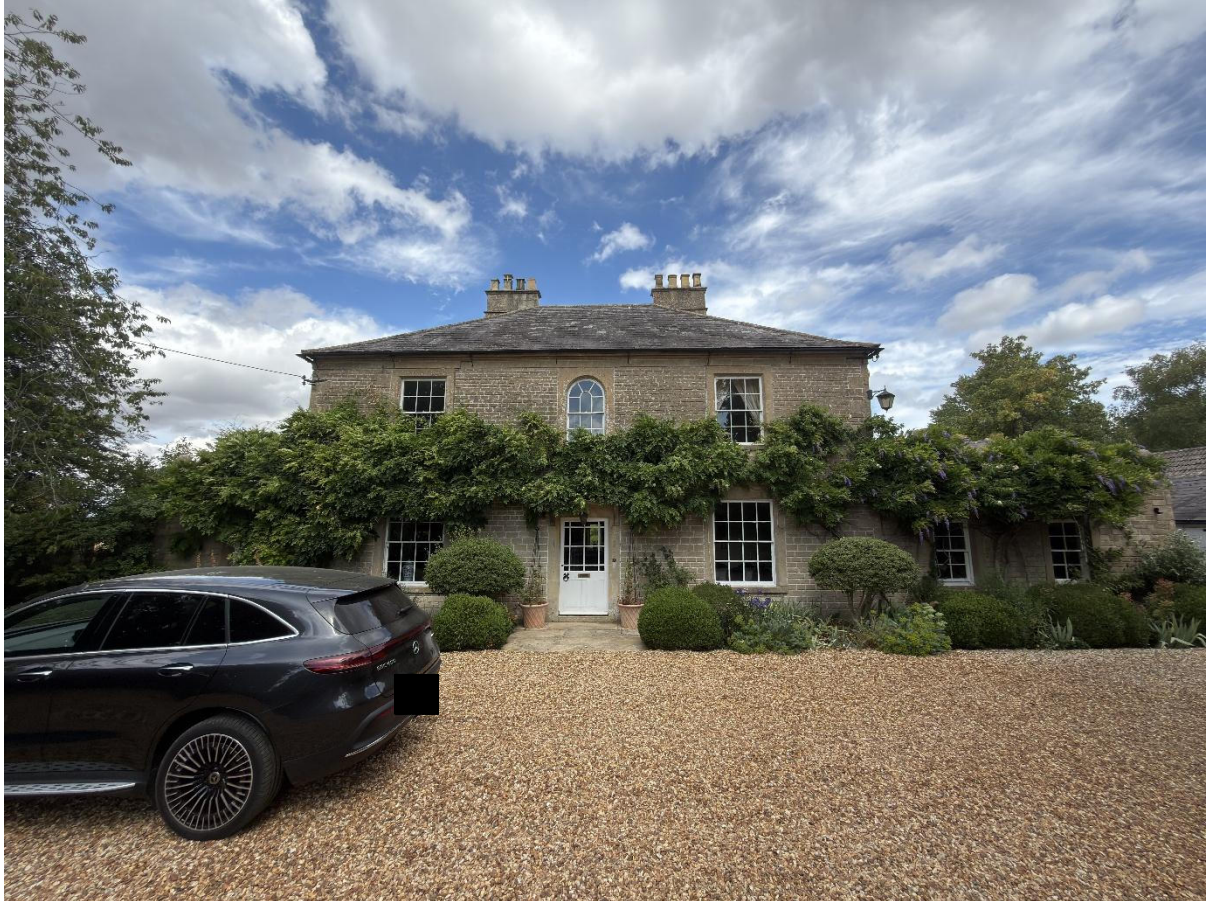
*Figure 1. Front South facing elevation of Northfield House*

Northfield House (fig.1), alternatively referred to as Field House, is a Grade II listed building in East Tytherton, Wiltshire, built c.1840, set back from the South facing frontage of a nominally 1.5 acre plot, protected from public view by hedgerow and mature trees that line the front of the property facing Maud Heath's Causeway which runs between East Tytherton and Kellaways. The building is comprised of an historic structure faced in squared rubble stone with ashlar dressings, a slate hipped roof, and axial stacks on the side roof slopes. Alterations to the 1840 fabric, having taken place between 1899 and 1920, have been demolished and replaced by a later single storey addition held behind a flanking garden wall was granted planning approval in May 1980.

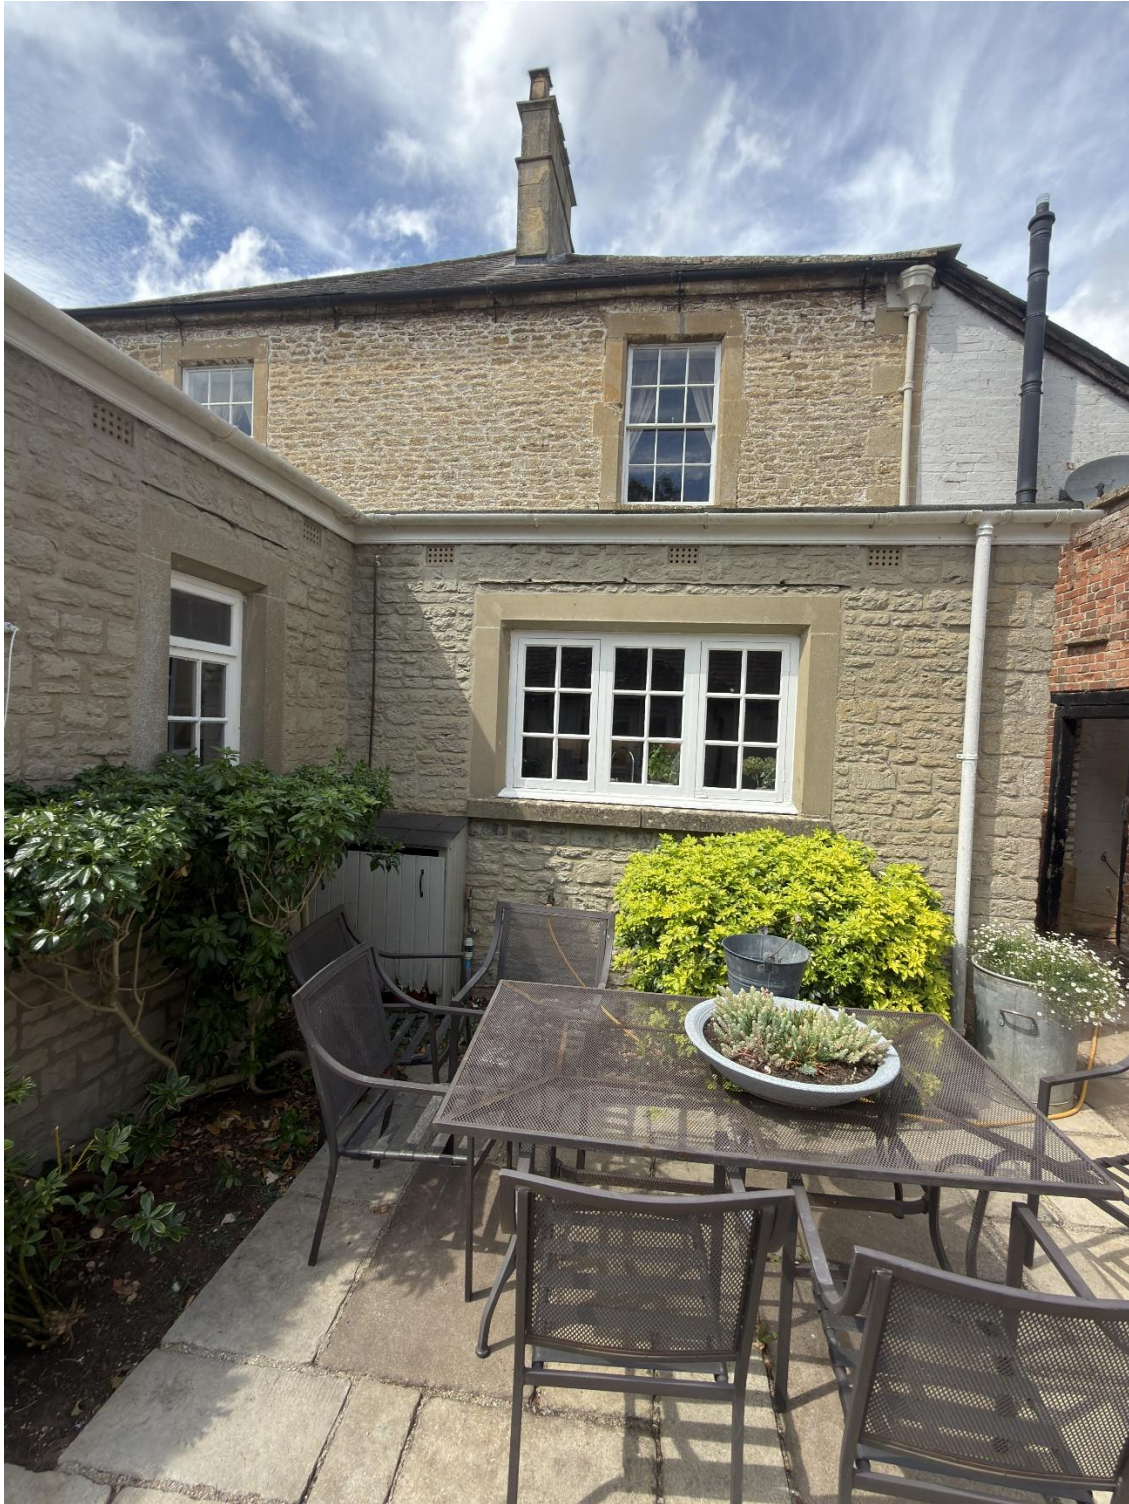
Figure 2. Existing condition of window sill to be lowered in proposal (area A)

The proposal for area A (fig. 2) of the kitchen facing the Paved courtyard (GA plan and plan excerpt 985-002 and 985 – 102; and elevation 3 on 985 – 004 and 985 – 104) seeks to drop the existing sill height of the kitchen window and install a set of double doors to match the painted timber appearance of the current arrangements. The existing window is part of a flat roofed 1980s extension to the property, the construction of which represents a noticeably incongruent departure from that of original building fabric. The proposal also seeks to add one rooflight to the flat roof extension, and to replace the existing domed rooflight with a flat low-profile rooflight.

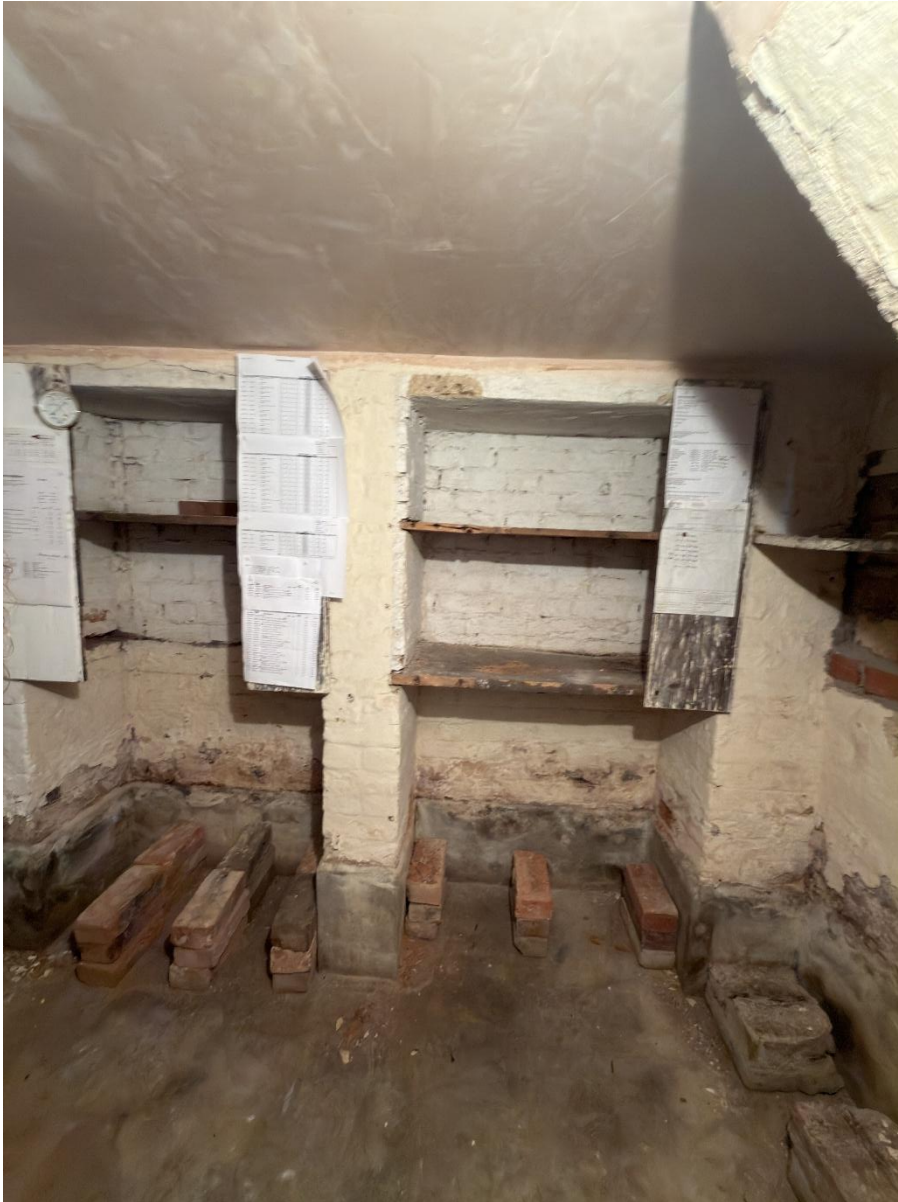
*Figure 3. Existing kitchen cellar to be waterproofed and covered at kitchen floor level*

The proposal for area B (fig.3 and 4), where the current cellar/store arrangement exist (GA plan and plan excerpt 985-002 and 985 – 102) seeks to demolish an existing internal light-weight partition surrounding a cellar and dry-store that bear no reasonable resemblance to the set-out of windows and other existing features of the original building. As it has been established in the Historic Impact Assessment accompanying this application, the existing configuration of these spaces are a ‘wholly modern insertion’, and that the proposal has a positive effect by better revealing the historic plan-form. The original cellar will be made accessible by floor hatch, and the current water ingress measures maintained and enhanced as needed to prevent rising damp.

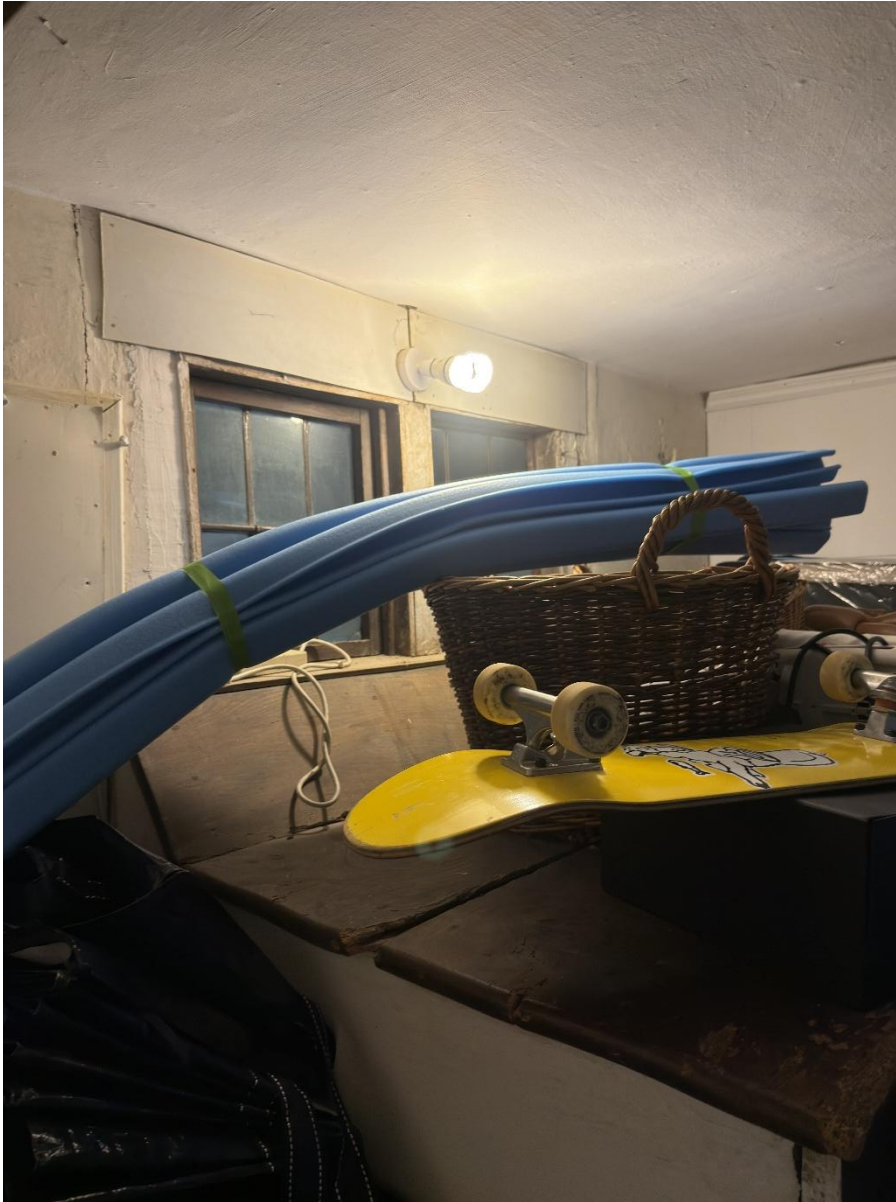
*Figure 4. Store above cellar to be replaced by kitchen refurbishment*

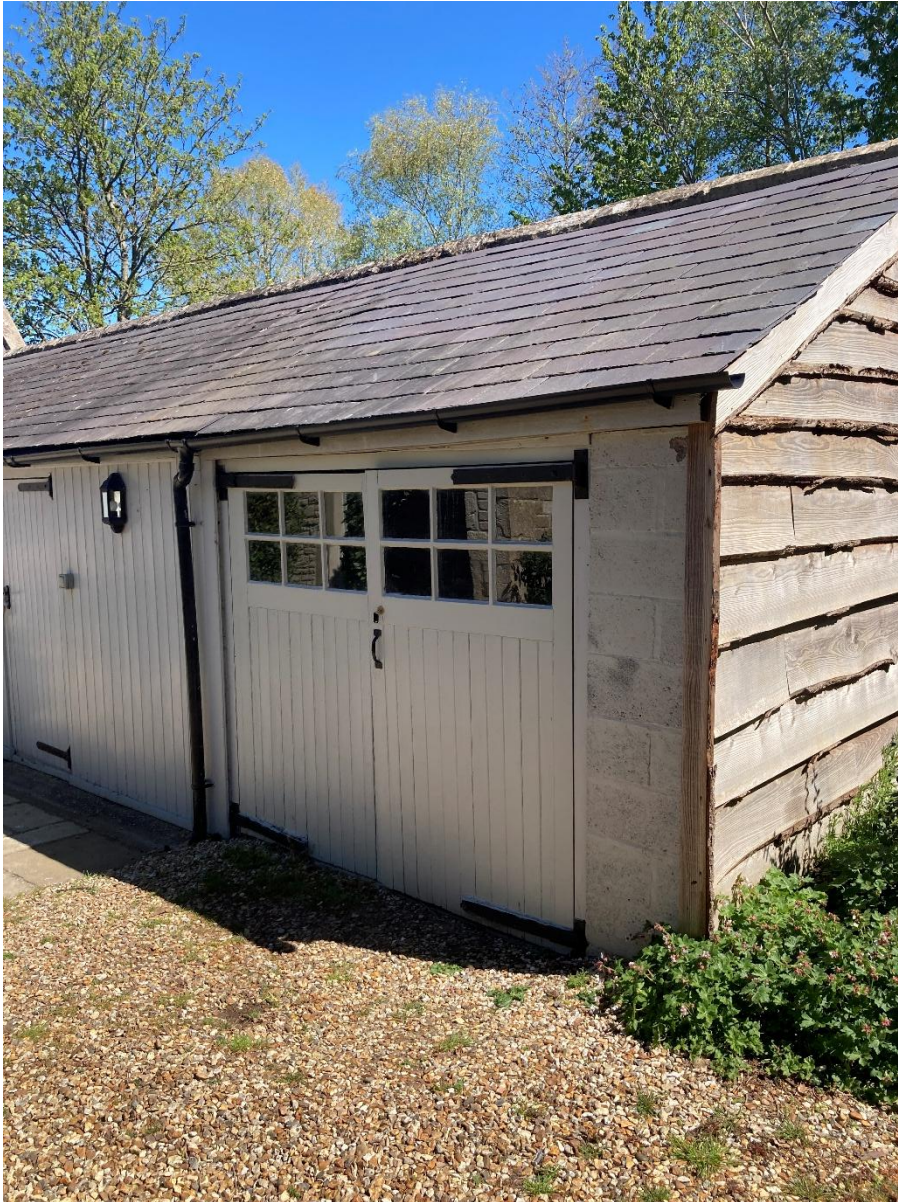
Figure 5. Blockwork garage extension (area C).

The proposal for area C (fig.5), the modern blockwork garage extension to the loose boxes /guest annex / studio (GA plan and plan excerpt 985-002 and 985 – 102; and elevations 2 and 8 on 985 – 005 and 985 – 105) seeks to develop the existing blockwork addition to the single-storey outbuilding by replacing the existing garage window (pictured), with a set of French doors to match the painted timber appearance of the current arrangement and adjacent elevation. The interior of this space would be properly insulated, plastered and finished to make it suitable for occasional use as an office. The proposal also seeks to install 2no. conservation rooflights to the roof slope facing away from the house, in a manner similar to the existing configuration of rooflights over the original Coach House extension.

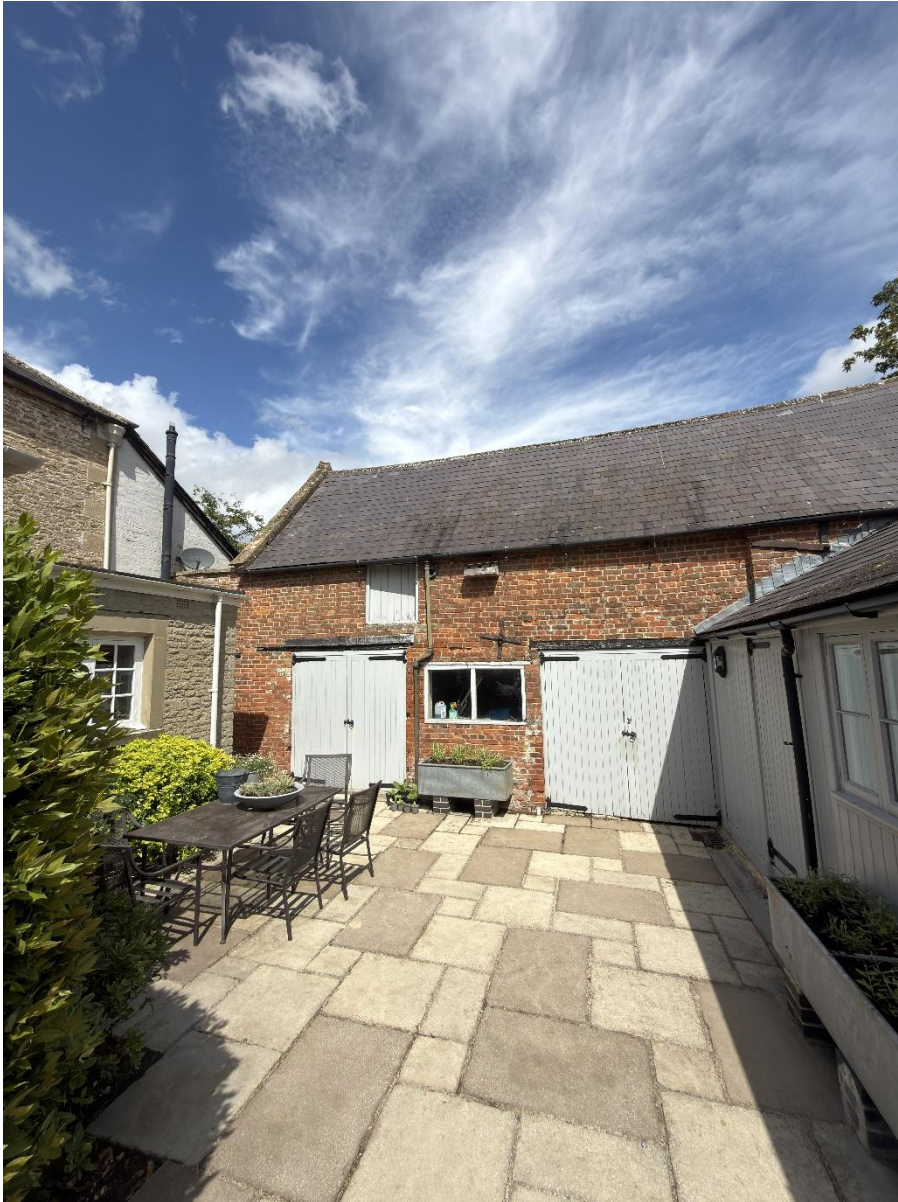
Figure 6. Coach house and loose boxes

The official list entry makes reference only to the 'formal two-storey, three-window front with flush quoins, plinth, raised bands and moulded eaves cornice,' without mention being made to the additional fenestration at the front elevation of the 1980 extension, or the associated out-buildings on the East side of the house (fig. 6).

The house is accompanied by a coach house and loose boxes, now renovated as a studio/guest annex, lining a small courtyard at the East side of the house. At the North end, a two-level pitched slate roof coach house made of stone rubble and brick quoins on three sides. The front elevation is characterised by red brick façade. The coach house is unsuitable for habitation in its current state, although it does contain garden storage, small power, plumbing, and two oil tanks.

A single storey pitched slate roof perpendicular extension to the coach house, the loose boxes, form the East edge of the courtyard, and are clad in painted timber over brick. The brick structure, visible from the east facing elevation, appears similar in colour and mix to the brick comprising the front elevation and flanking wall of the Coach House. The internals of this structure have been modernised and fit with modern plumbing, electrics, and 2no. rooflights on the east facing slope of the pitched roof. A modern concrete block structure has been appended to the end of this extension as a garage/shed, and remains unfinished internally.

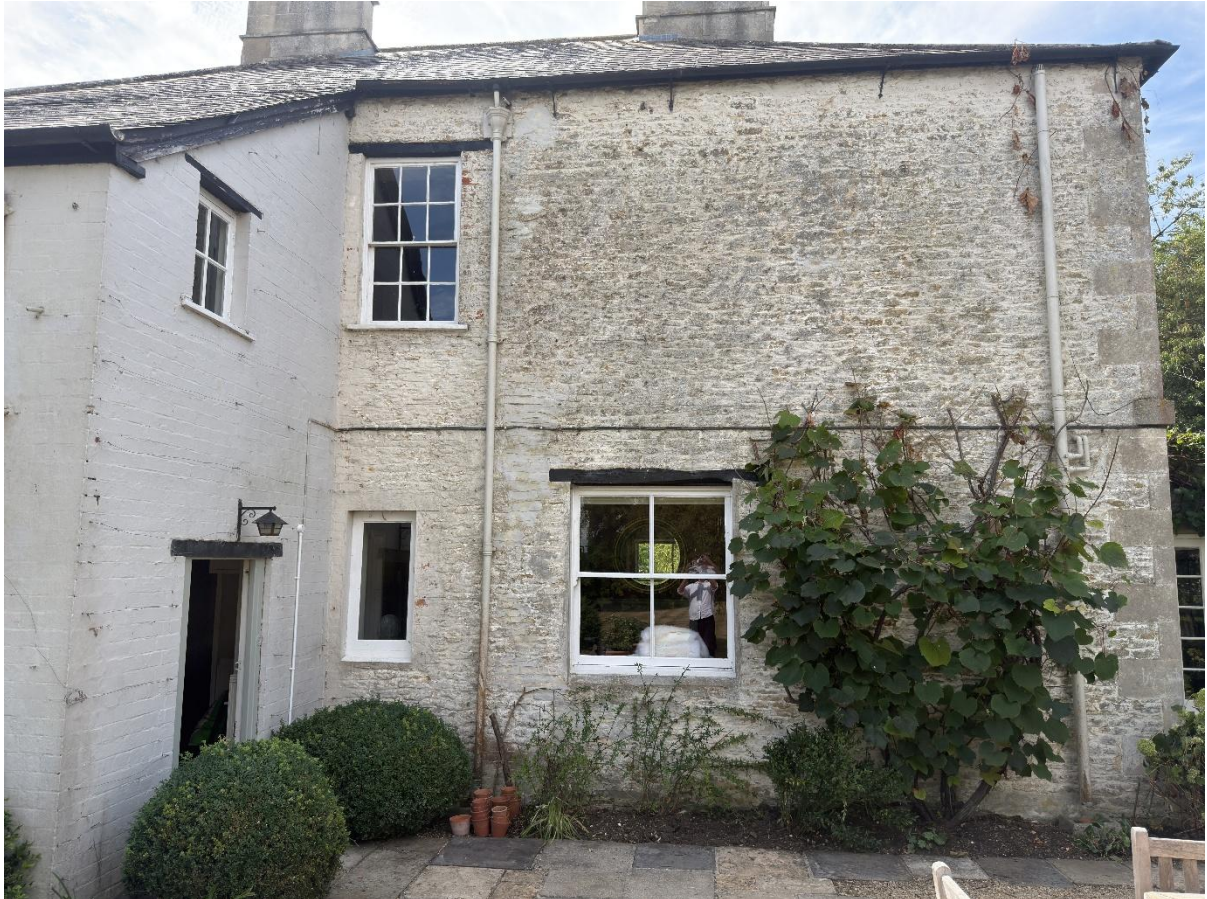
*Figure 7. Elevation with poor cementitious render to be locally removed and replaced with lime render.*

In an onsite discussion with Sam Driscoll of Heritage Planning Services Ltd., the question of how to address an unsightly ignorant repair made to the historic stone rubble masonry at the rear elevation of the property was raised. It was suggested that the inappropriate and poorly executed cementitious render (Elevation 6 985-005 and 985-105, fig. 7), should be replaced with a conservation grade lime mortar as a breathable and sympathetic repair.
