The Rosiers, Wood Street  
Bat Activity Surveys & Assessment  
*For Mrs & Mr Greenhaulgh*

16<sup>th</sup> September 2026

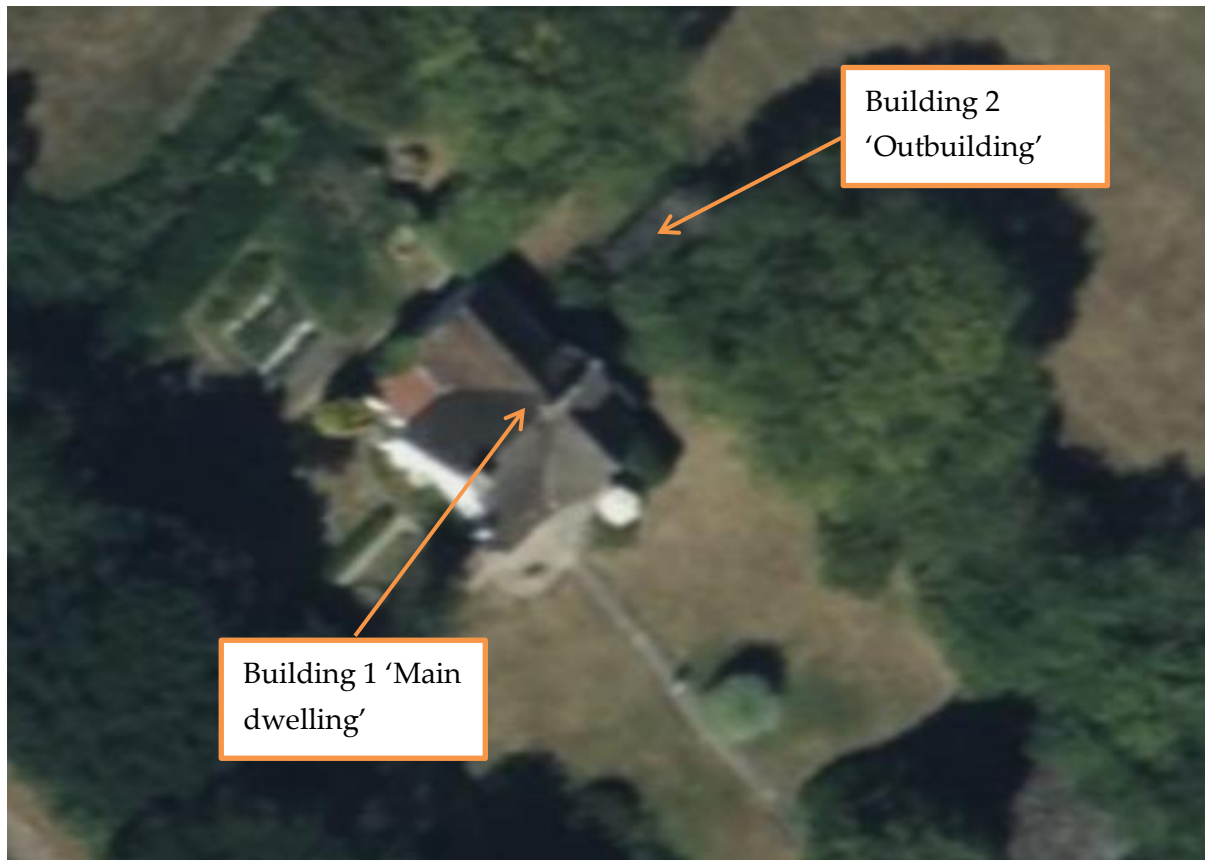
*Figure 1: showing the buildings within the site*

There are two buildings on the site as shown on **Figure 1**.

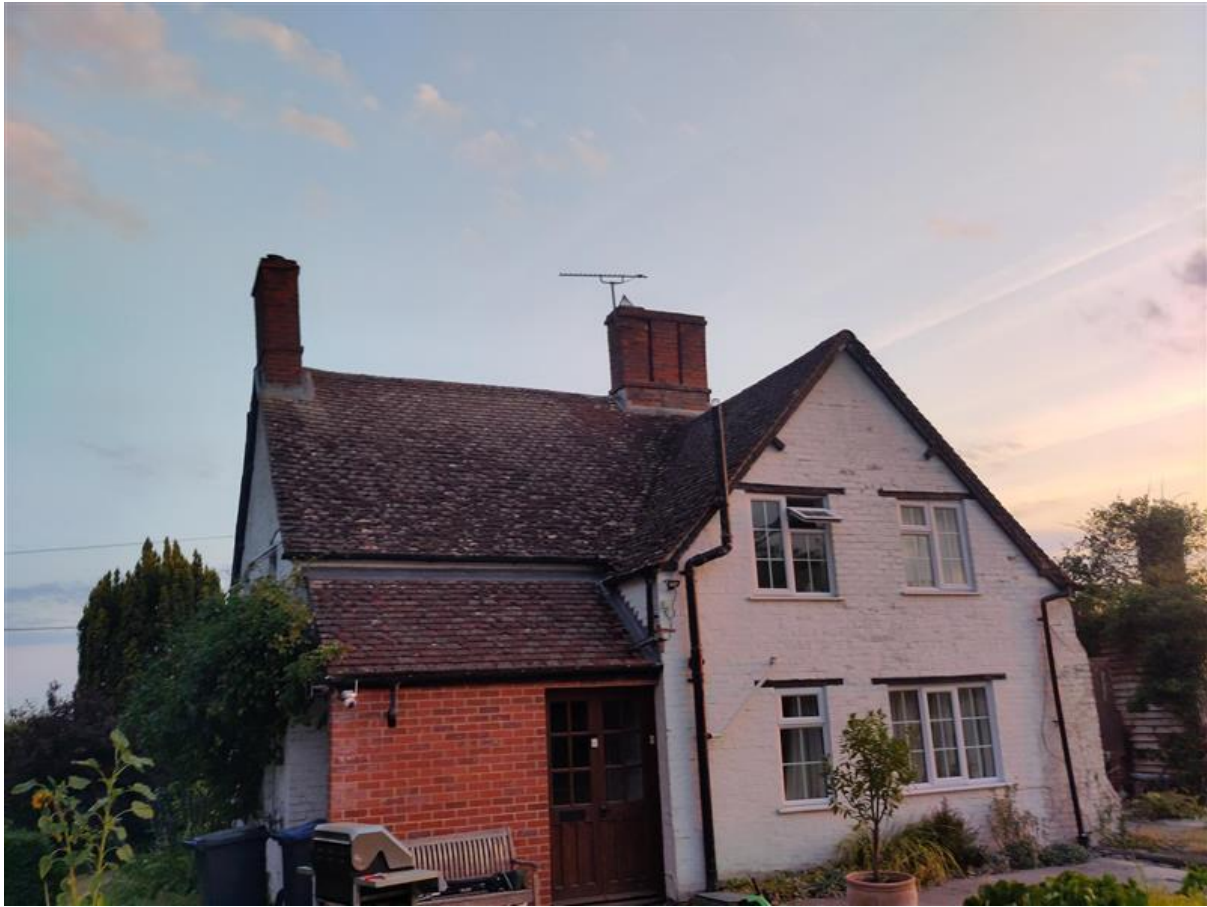
Building 1 (a two-storey dwelling and combined outbuilding) is constructed from red brick with some of the external walls rendered. No evidence of bat activity was found on the external walls of the building, and no gaps or crevices were found in the wall structure that would provide suitable roosting spaces for bats.

The windows and doors of the building were found to be in good condition with no gaps where bats could gain access to the internal spaces for roosting. No evidence of bat activity, such as droppings or feeding remains, was found around the doors or windows.

*Photograph 1: showing a view of Building 1*

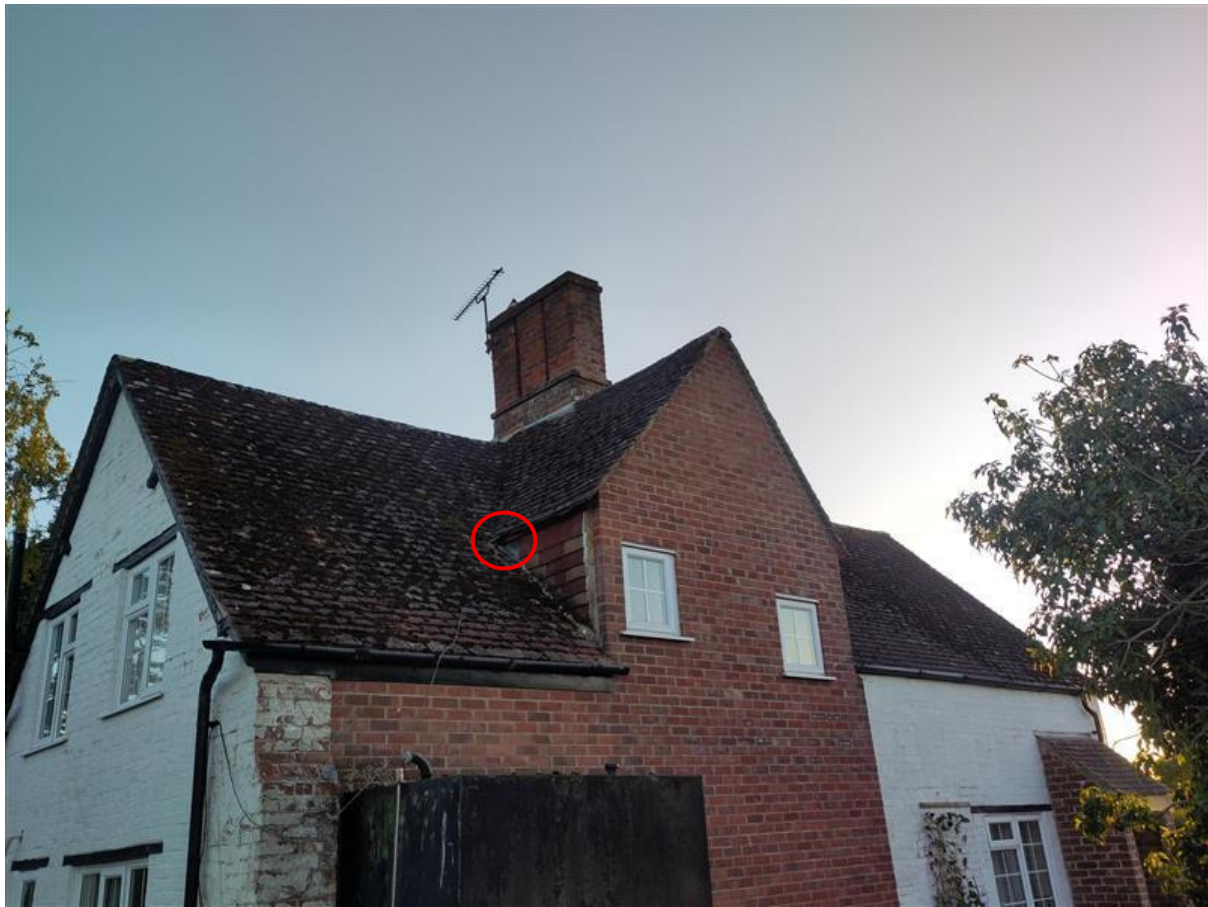
The roof of the building is covered externally with tiles that have notable areas of moss growing, indicating that the external surface of the roof is damp. The majority of the roof was found to be in a good condition with the roof tiles fitted securely and no gaps, loose or lifted tiles were found across the majority of the roof. However, a potential access/egress point for bats into the loft was identified to the eastern side of the building.

*Photograph 2: showing a potential bat access/egress location (marked as red circle)*

The roof of the building is covered externally with tiles that have notable areas of moss growing, indicating the external surface of the roof is damp. The majority of the roof was found to be in a good condition with the roof tiles fitted securely and no gaps, loose or lifted tiles were found across the majority of the roof; however, a potential access/egress point for bats into the loft was identified to the eastern side of the building

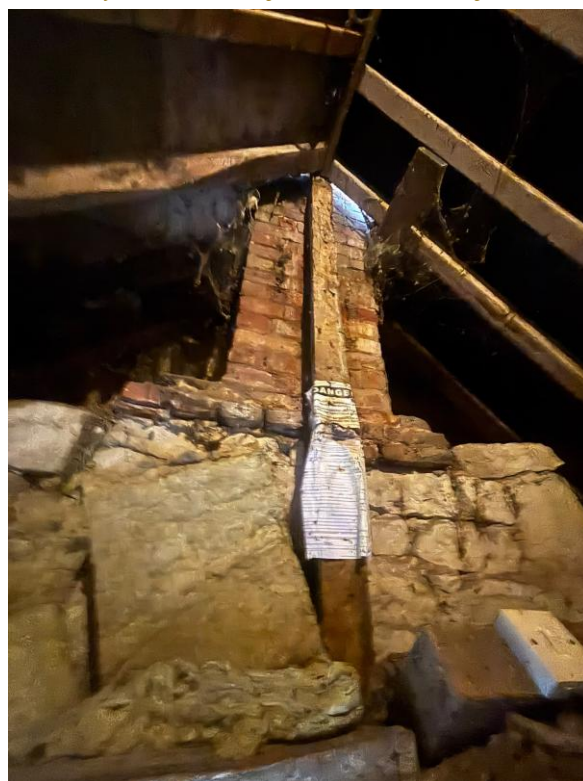
Internally, the loft space is separated by a large chimney stack. The loft is a traditional cut timber construction with deteriorating bitumen felt. Several areas are damp particularly around the stack and the lead work to the roof which would allow access for bats. There are no droppings or feeding remains which indicate bat usage.

*Photograph 4: showing a view of the chimney stack internally*

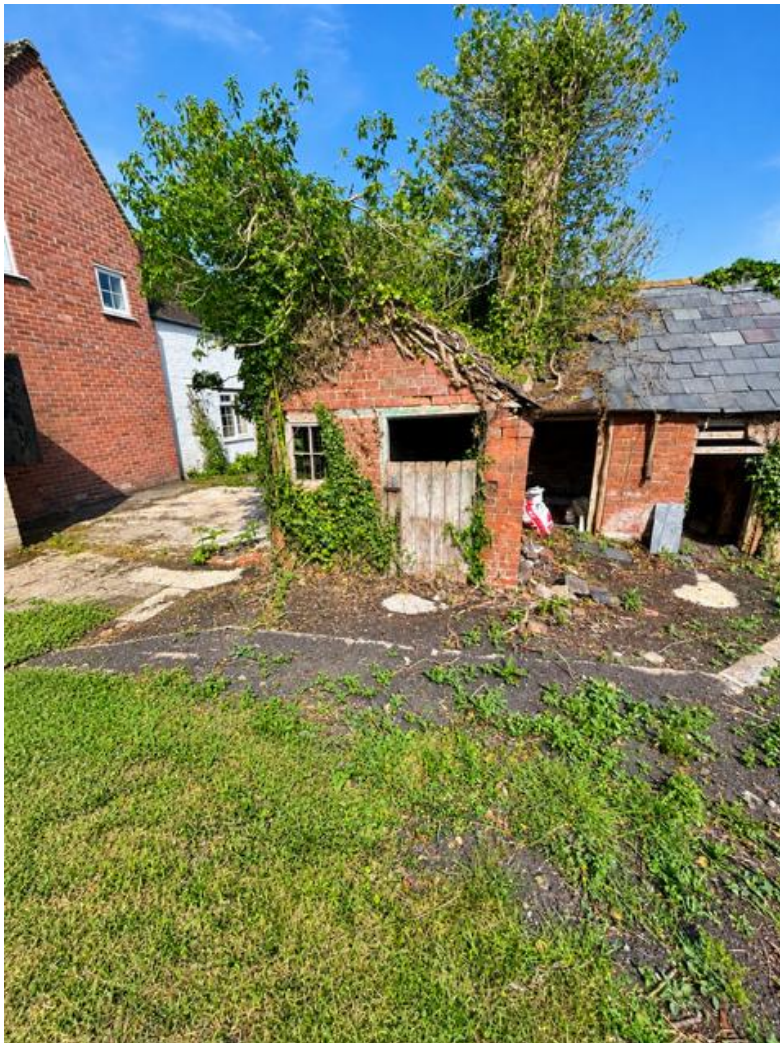
Building 2 is a small red brick outbuilding located to the rear of the main dwelling and was found to be in a poor condition and partially collapsed. The roof is constructed from a timber frame with slate tiles on the external surface and several holes were found that allow wind and rain to enter. This makes the internal space of the building cold and damp and some water damage was noted internally.

*Photograph 5: showing a view of Building 2*

No evidence of bats was found during the survey and the building is considered to have poor thermal properties; it is therefore unsuitable to support roosting bats. The building provides Negligible Roost Potential for bats and no further surveys are recommended here. This building is not considered further in this report.

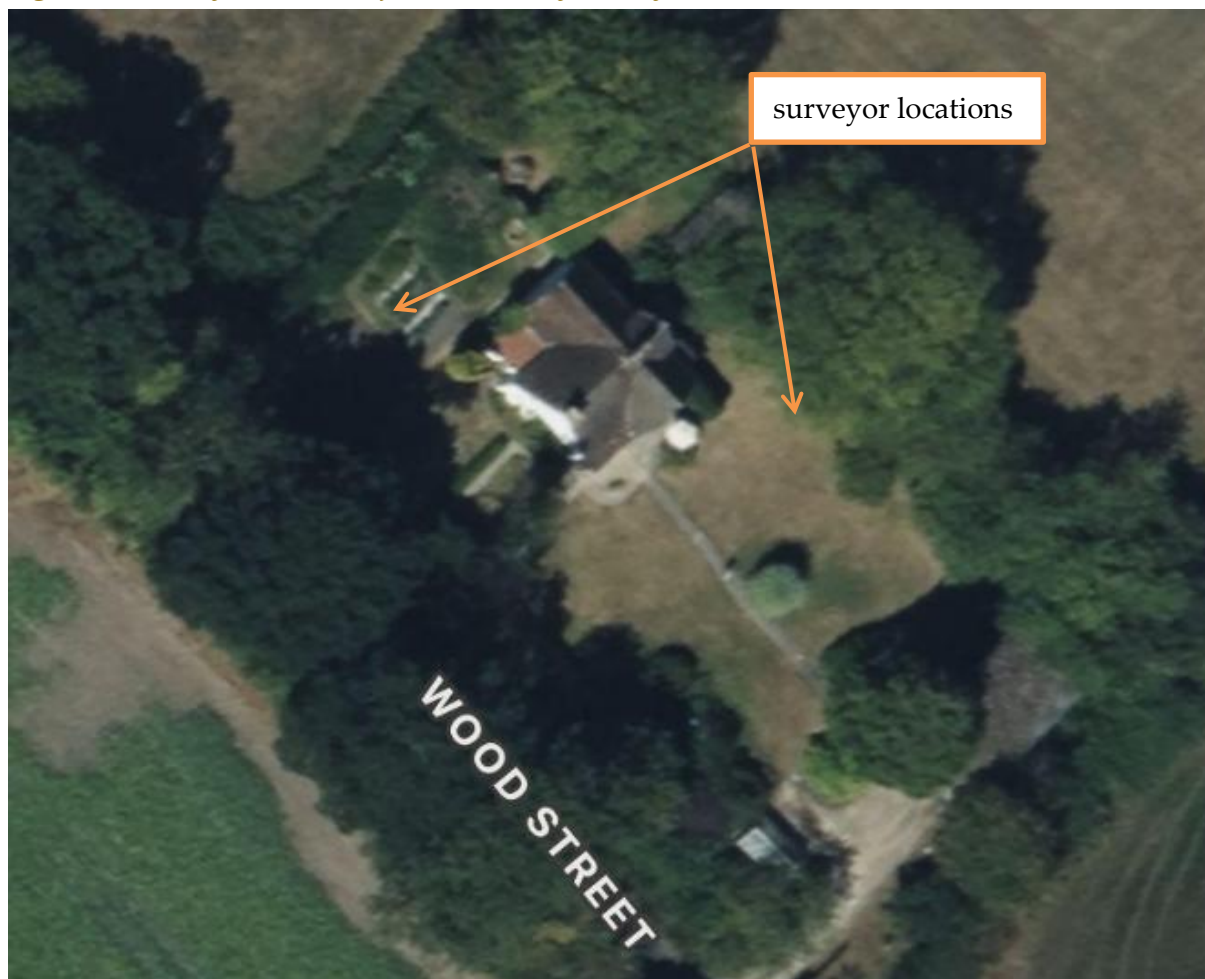
*Figure 2: surveyor locations for the activity surveys*

Both surveyors were located in a static position to cover all aspects of the building during the survey, as shown on **Figure 2**.

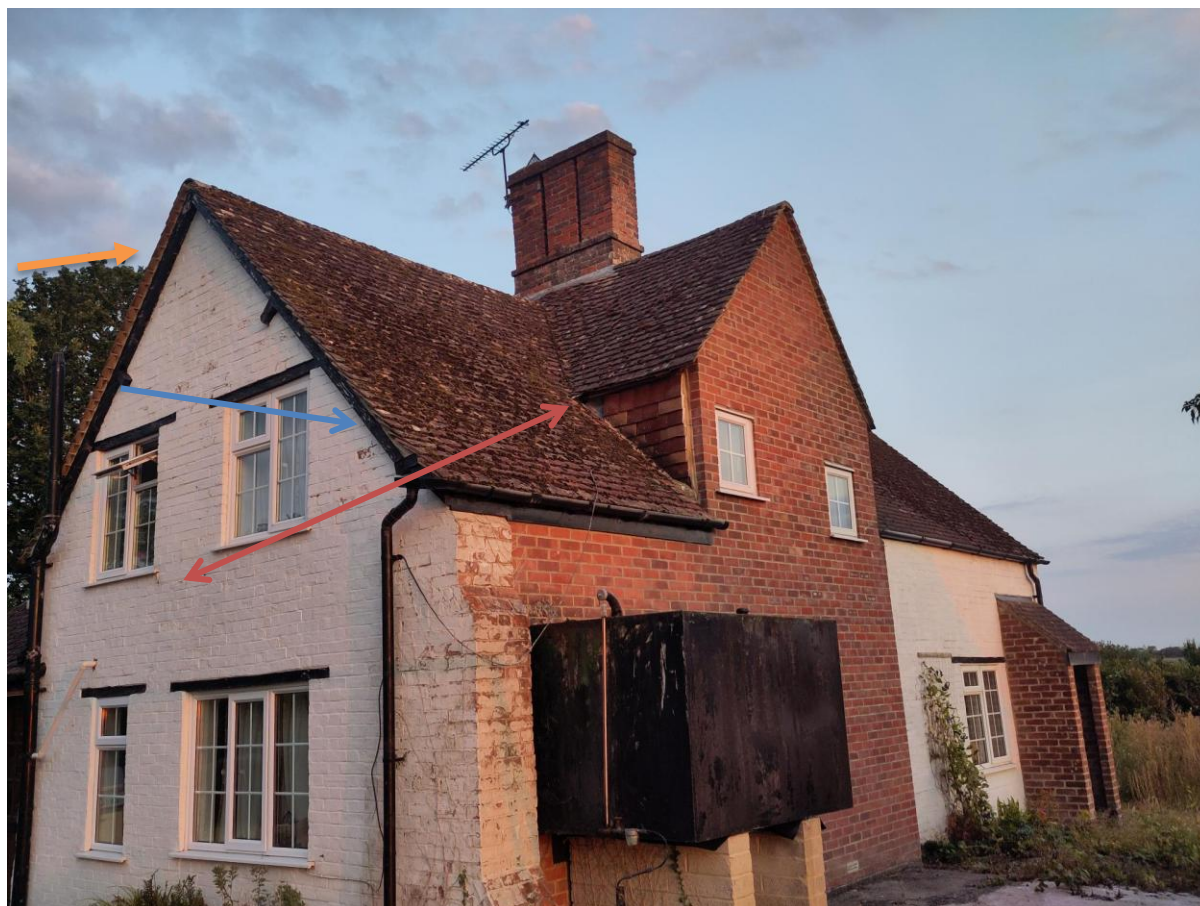
Bat activity was recorded throughout the three surveys, with bats emerging and returning to roost in the building. Thirteen common pipistrelle bats emerged from the building during the first survey. Three common pipistrelle bats were also observed re-entering the roost space, with one seen landing on the tiles below the roost space before crawling inside

Figure 3: showing bat egress/ingress locations on the building (main dwelling)

- ↔ Common pipistrelle bats emerged from and entered the building
- ← Common pipistrelle bat entered the building

- It is recommended that mitigation features should be employed that will allow bat species access to suitable roosting habitat;
- It is recommended that the works on the buildings are restricted to a suitable time when bats will be least disturbed by the works;

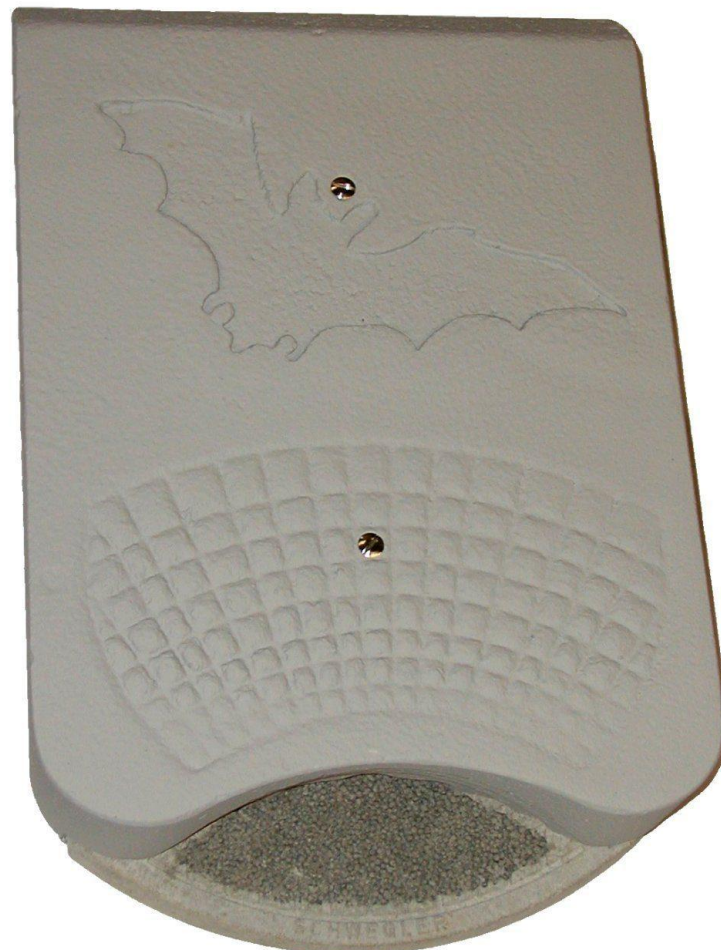
*Figure 4: showing a 1WQ Schwegler Summer & Winter Bat Roost*

This highly sophisticated bat roost is designed for the safe hibernation of bats in winter as well as for roosting, forming of colonies and raising of young during summer. The layered structure of the bat roost materials means that the 1WQ has excellent insulating properties whilst guaranteeing air convection and permeability. As with all Schwegler products, this extremely durable box will last for many decades, maintenance free.

The boxes will be placed in suitable locations and positioned so that they will not be impacted by the proposed works and will be located as high on the building as possible.
