# Bremeridge Farm, Dilton Marsh

## Ecological Impact Assessment

September 2026

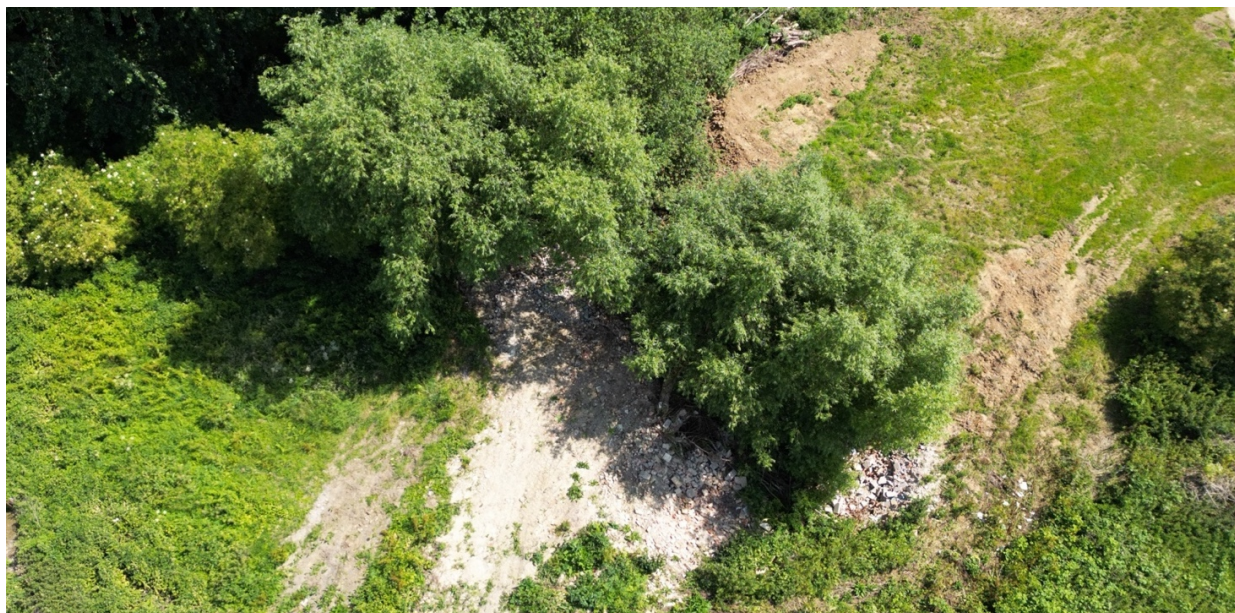
**Figure 1 : Areas of disturbance to pond showing light coloured rubble at the north edge and darker coloured rubble to south**

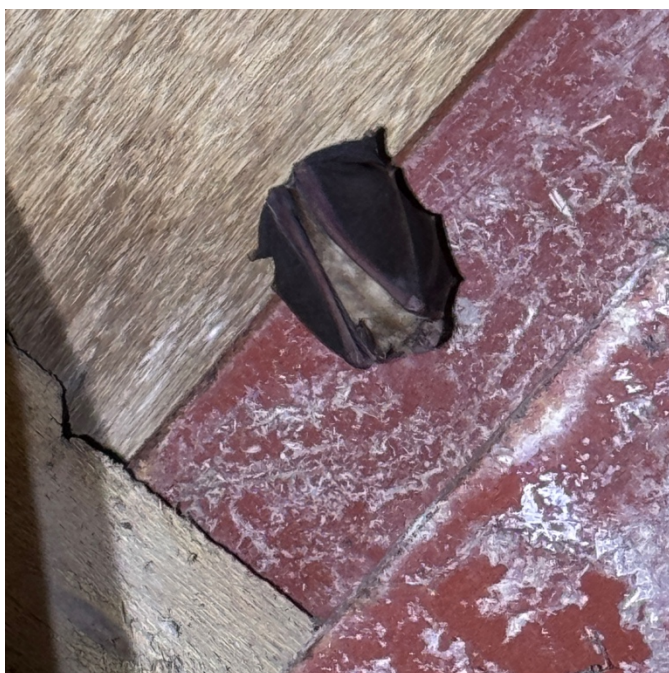
44. A single greater horseshoe bat was identified roosting within Section 2, under the mezzanine floor, between joists (Figure 3).

Figure 3: Greater horseshoe bat roosting between joists of mezzanine floor

| Roost Ref | Species and Number | Roost type and Location | Conservation Significance <sup>11</sup> | Potential Effect | Level of Effect (in absence of mitigation) |
|---|---|---|---|---|---|
| <b><u>Roost 6</u></b> | Greater horseshoe<br><i>Rhinolophus ferrumequinum</i> (1) | <b><u>Day Roost</u></b><br><b>Location</b> – Section 2, under mezzanine floor - between joists<br><b>Access</b> – unconfirmed <sup>7</sup> | Low / Moderate | Roost destruction; disturbance; and killing/injury | Major adverse at local level |

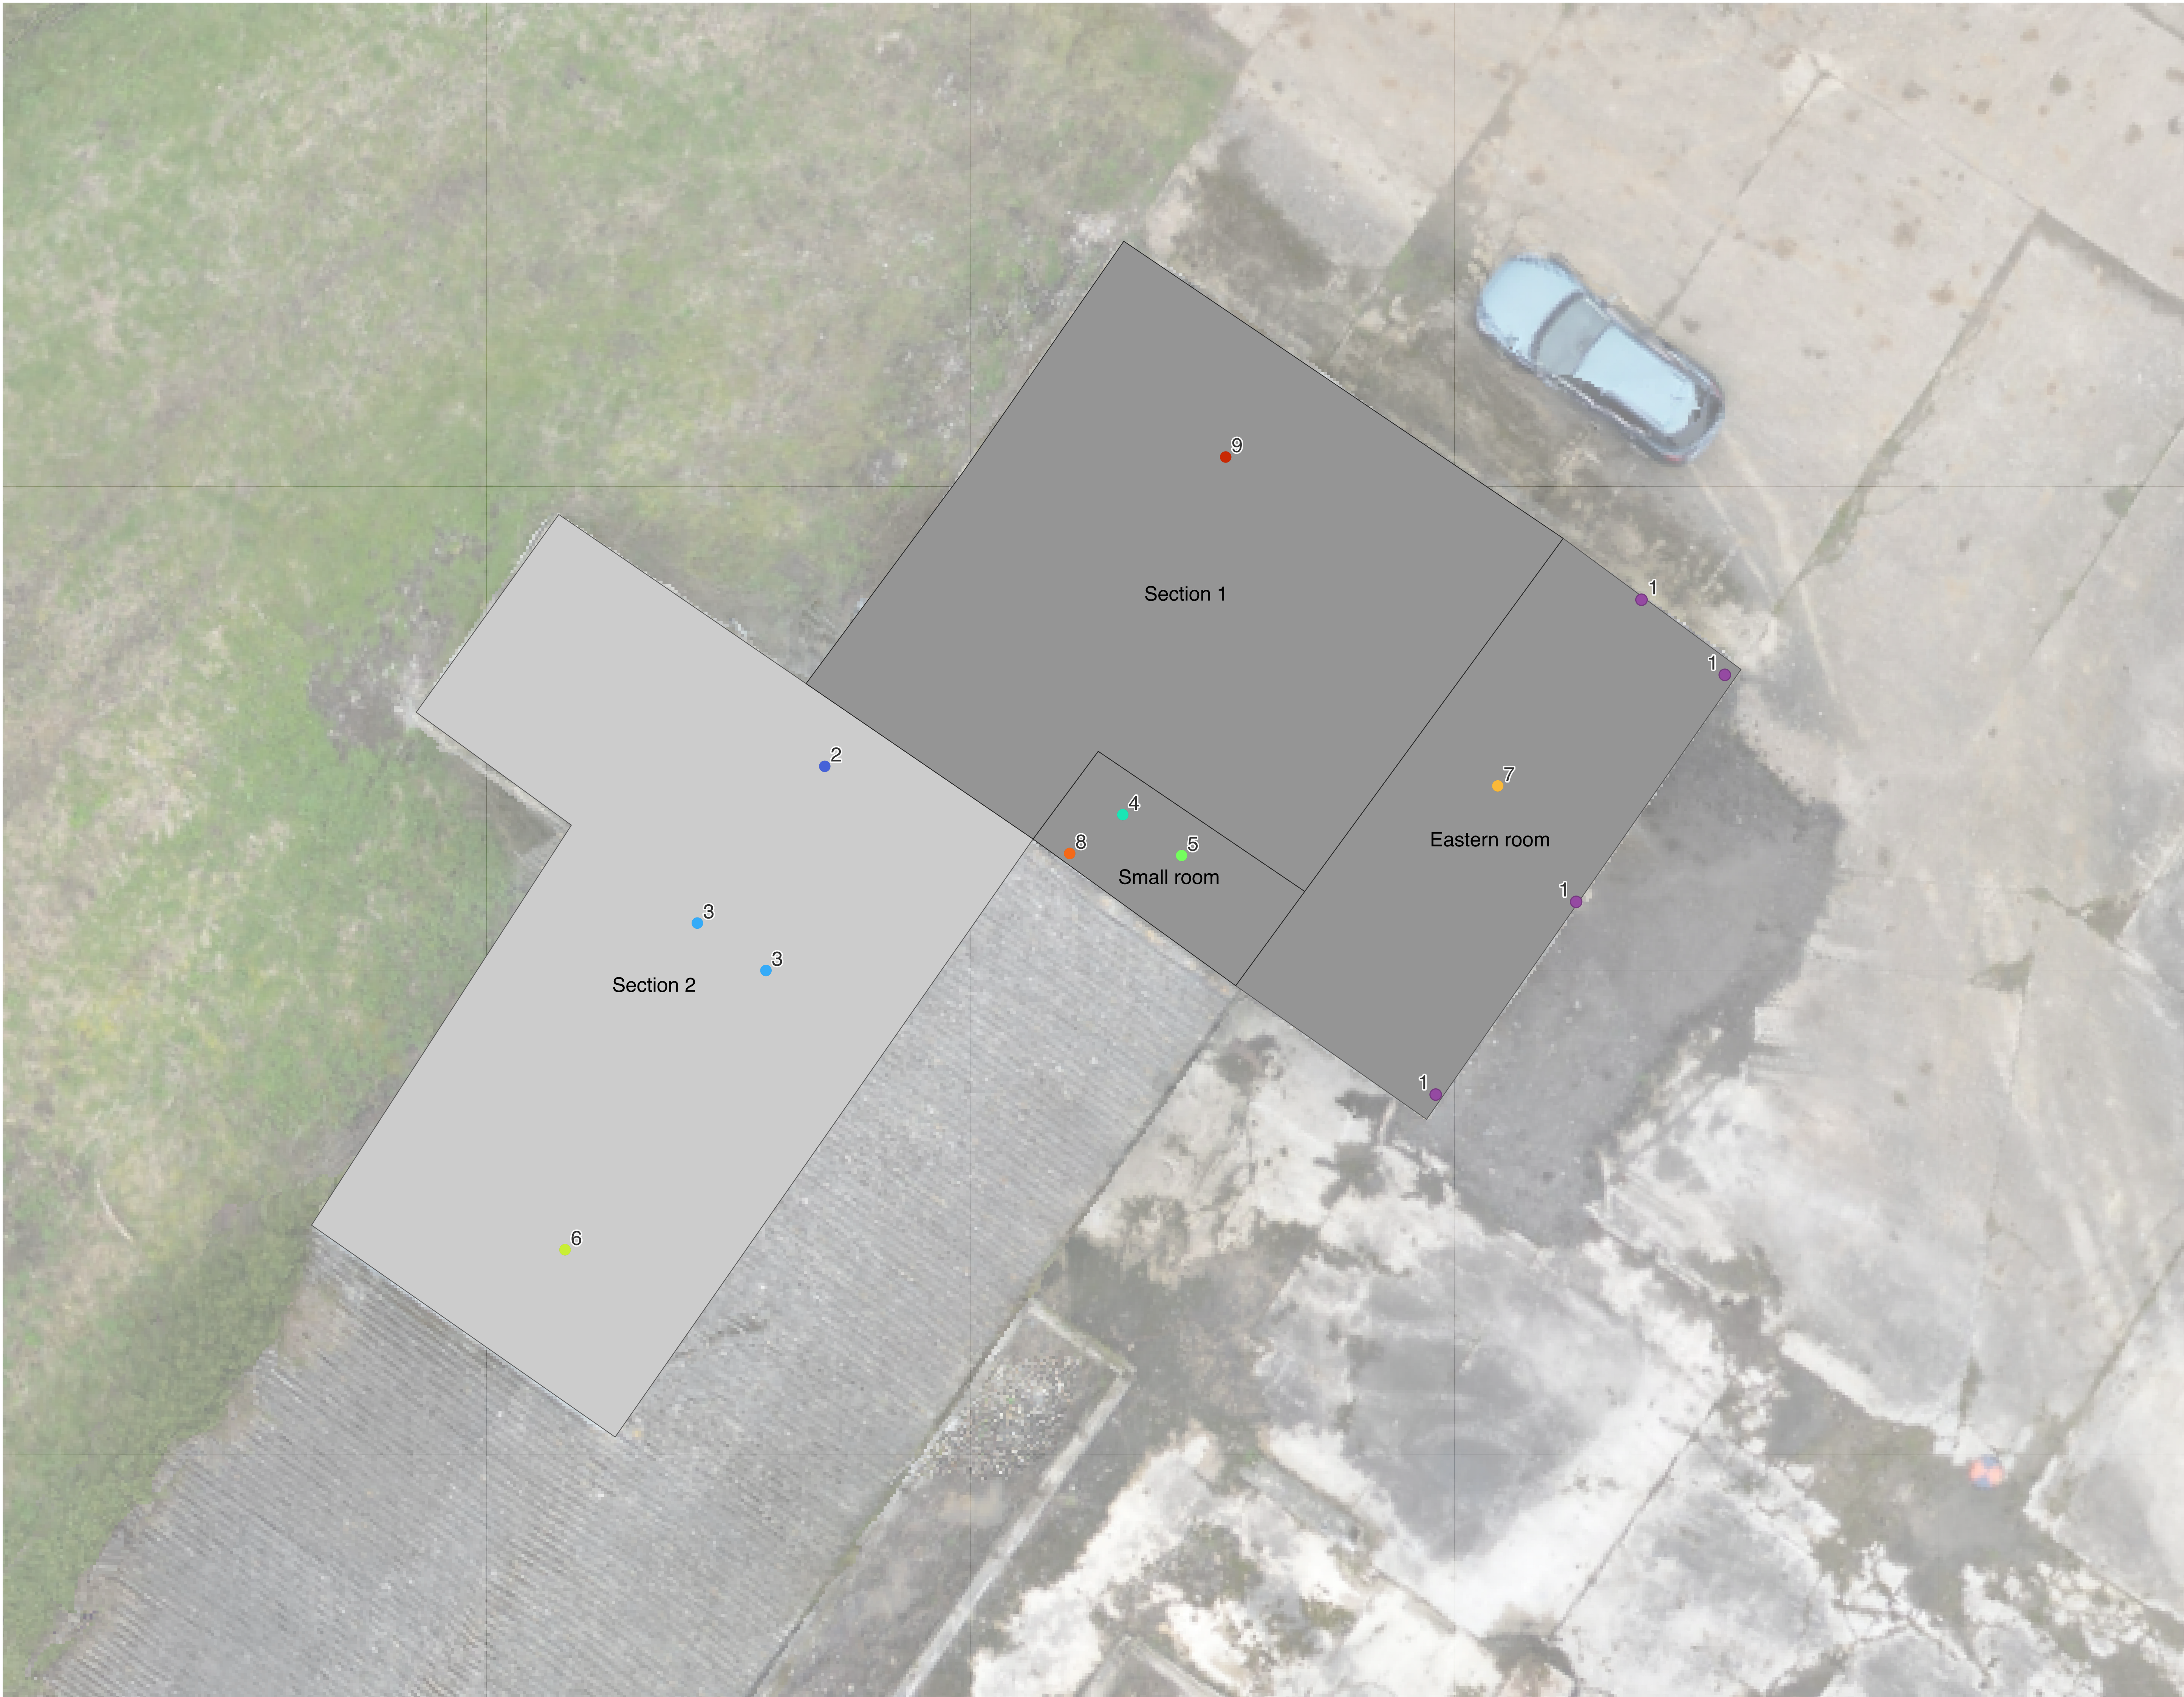
# Appendix A: Results Plan

47. Below is a summary of all bat roosts identified (See 'Appendix A: Results Plan' for roost locations)
