## Flood Report

December 2013  
January and February 2014

Warminster Town Council has received information regarding recent flooding events which have occurred within the Parish. The photographs submitted relate to the period 22nd December through to 18th February 2014.

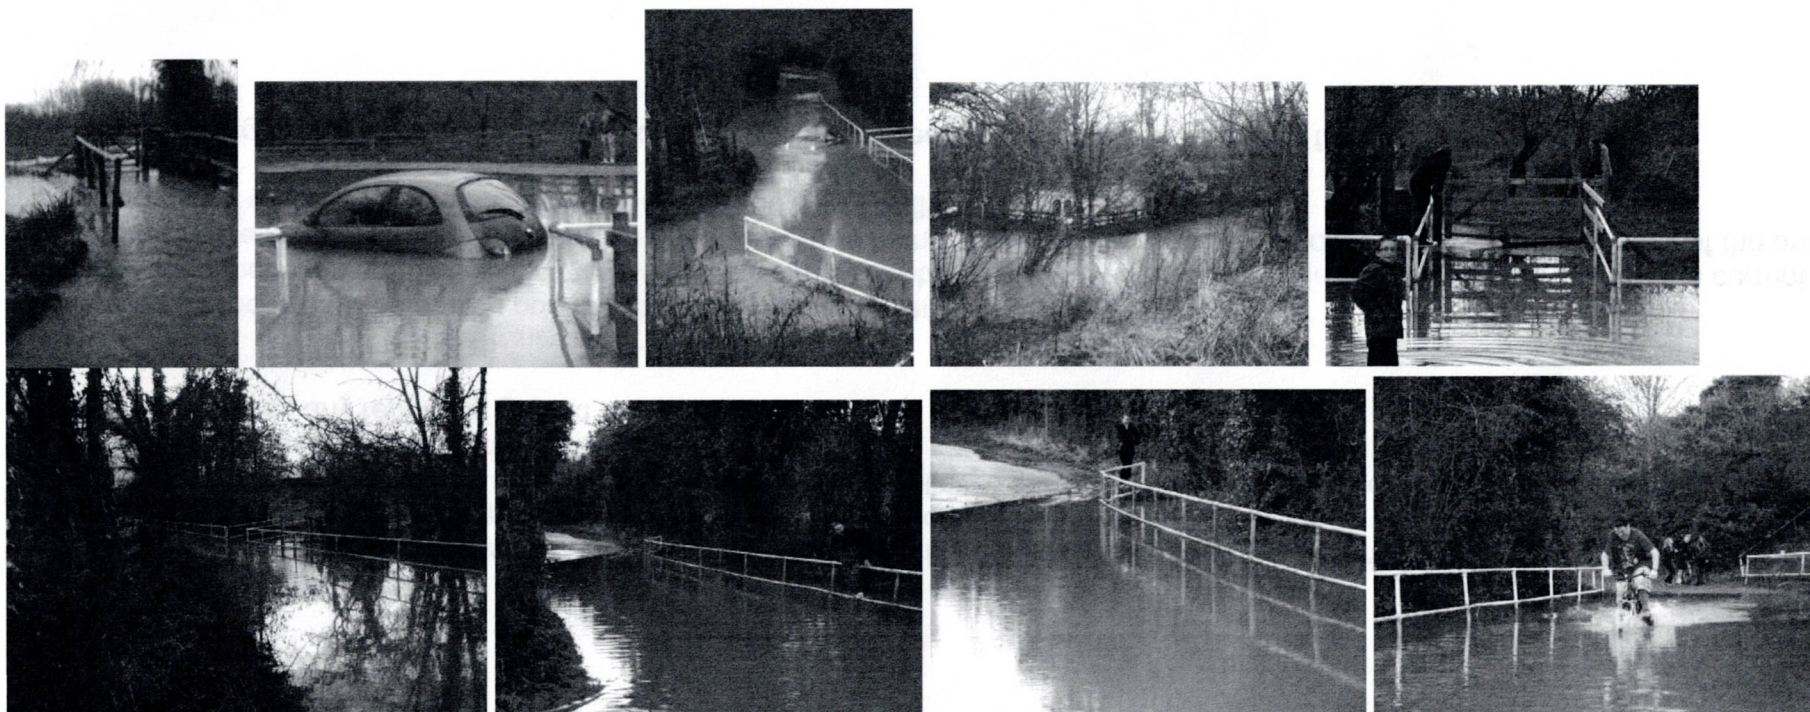
Smallbrook Road Warminster

Pictures taken January 4th & 5th 2014.

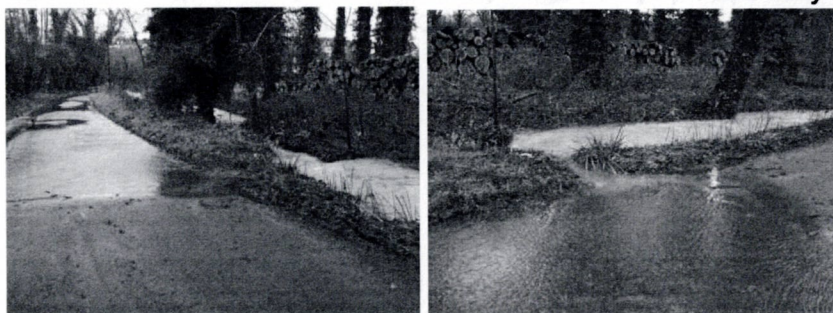
Smallbrook Road Warminster

These pictures were taken on 5th January 2014. Water flows from the River Were onto the road and down hill. This is not in Smallbrook Meadows reserve. The Culvert blockage was reported on line by the Flood Warden and the item closed down advising that it was not a matter for Highways to deal with. The break needs to be repaired.

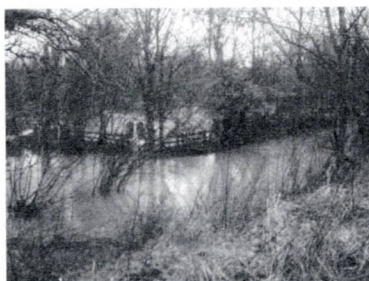
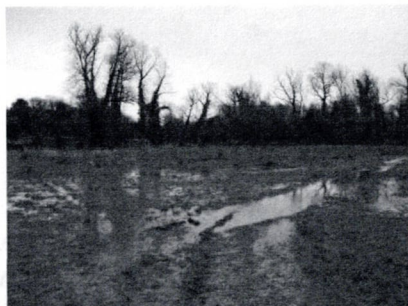
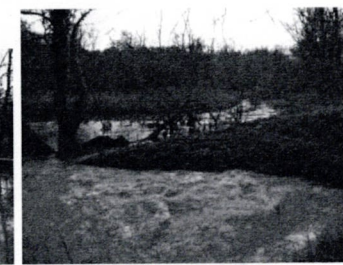
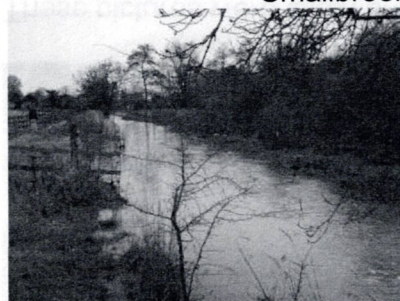
Smallbrook Meadows

Part of the new paths created during 2013 are above water level during January as the Were is overflowing onto the old Water Meadow. This is how the meadows were engineered and absorbs part of the flow.

Much of the flooding in the reserve is from the overflowing River Were.

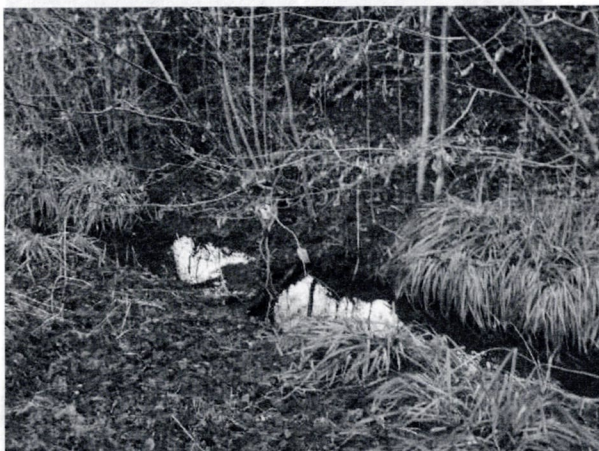
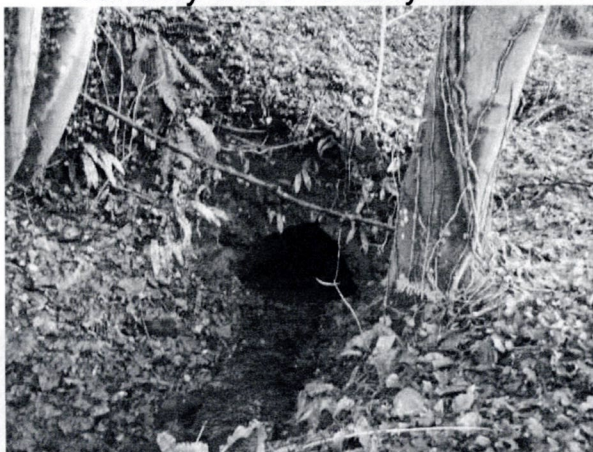
This is the ditch below Willow Crescent. It has had an appreciable flow all 2011 despite the dry year, since the culvert under Smallbrook Road was cleared. The water comes mostly from draining the Smallbrook Meadows but when it rains the run off from Smallbrook Road and in high water the surplus drains out of the Were and runs down the road into the ditch. Wilts CC own the land on both sides of the ditch. It had been hoped a year ago to use this as an example of what land owners could achieve by cleaning out their ditches. The shot of the culvert under the path down from Willow Crescent shows that now there is no grid. Not only could flood debris enter the culvert and block it, there is nothing to stop a child crawling in. The other end is slightly lower. There is a strong possibility that this is a summer roost for Daubenton's bats. I am asked to point out that the culvert emerges into an old course of the river Wylde and this swampy area eventually takes the water to the Wylde. Digging this out would improve the flow greatly. Thus this area could be an example of good land use by Wilts CC which would improve the drainage by removing impediments to the flow. Action taken a year ago has allowed unrestricted access by children to the culvert. I have not seen anyone tempted, but the possibility exists.

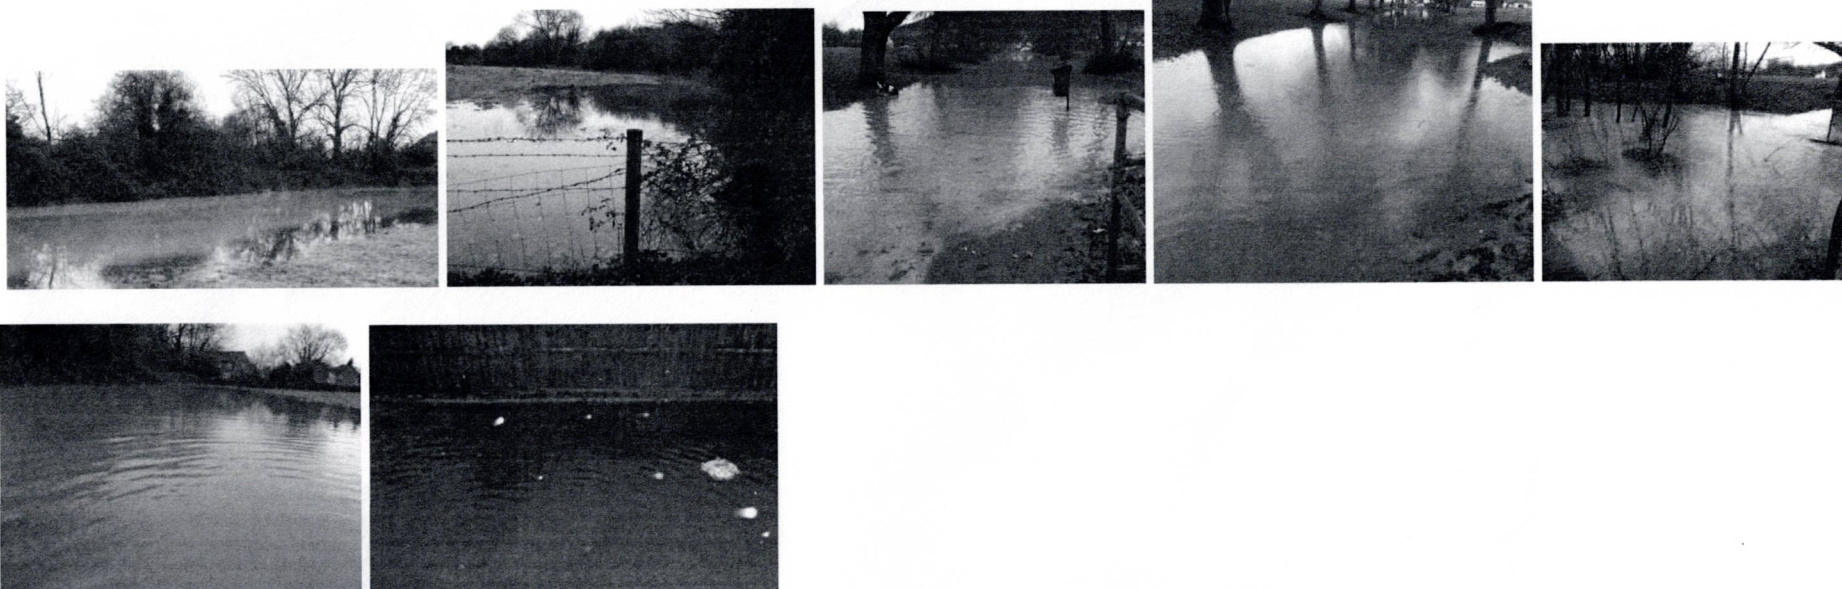
Dorothy Walk view from East and West. Connects to Portway Estate, Manor Gardens and Rectory Close.

Christmas 2013 and into January 2014.

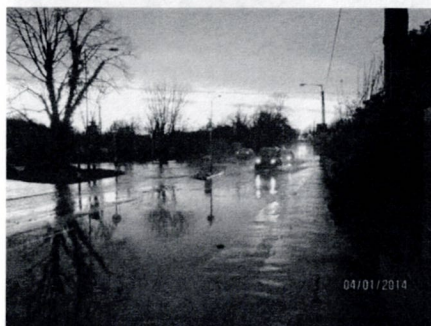
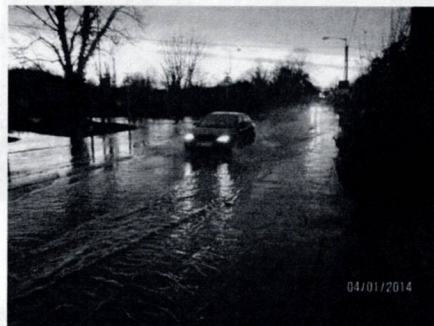
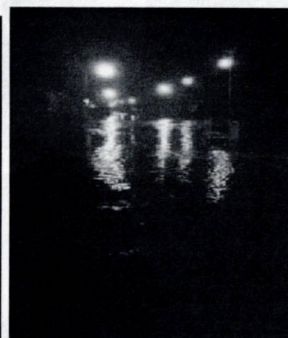
Boreham Crossroads

The owners of the land advise that this field is outside the flood plain and if a proposed planning application is granted, work to improve drainage around the site will be undertaken which will assist in periods of heavy rainfall. The project engineers using a flooding model, have advised that the site itself does not flood, but water run off from Boreham Road currently discharges into the sites perimeter watercourse and this caused localised flow back onto the junction. Planned clearing of the ditches, widening of the access culvert and improvement to highway drainage would prevent this happening in the future following completion of the development.

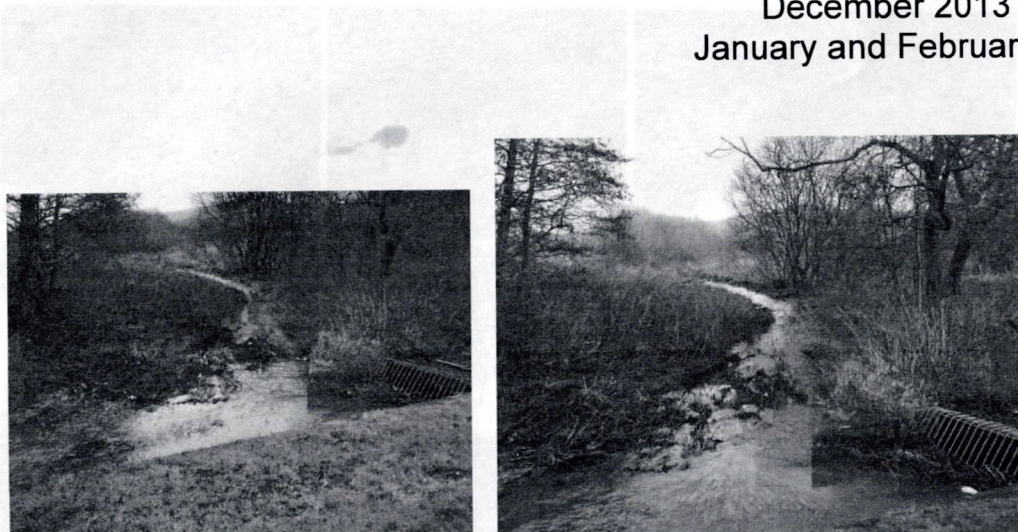
### Groveland Estate

The water flows in a distinct stream over the marshy area. None is stored and goes to the culvert in the embankment ST865453 and straight through to join Were North.

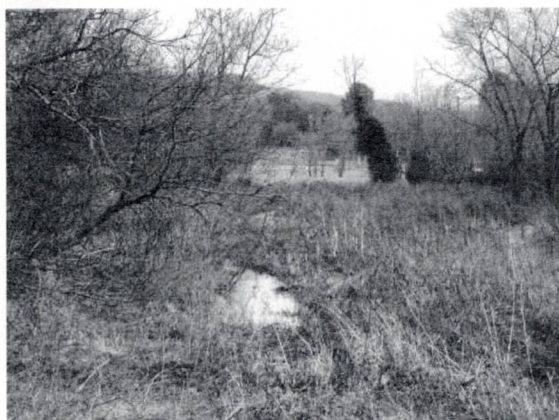
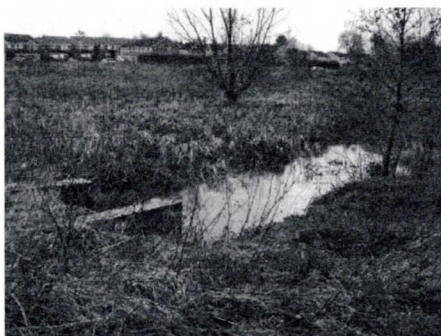
Grovelands Estate balancing pond

The water flows straight through the culvert with no storage and past the Warminster School sports ground and joins what flows under Cold Harbour Lane, then round behind the Minster, joined by what is called Were North and is culverted from George St Place until it emerges in the park.

Water flows in a distinct stream right across the area and into the culvert on the left. Created a wonderful wilderness for water voles. Pictures taken January 2014. In the foreground is the diversion weir with debris and silt most of the water if flowing across what is intended to be a holding pond but none is trapped. This is diverting water from flowing down by the Brambles and Pippins sections of the estate but adding to what goes by Cold Harbour Lane.
