PRELIMINARY ECOLOGICAL APPRAISAL  
AND BAT SURVEY REPORT

THE BARN, SWEETWELL FARM, SEDGEHILL,  
WILTSHIRE

stark ecology<sup>ltd</sup>

SEPTEMBER 2026

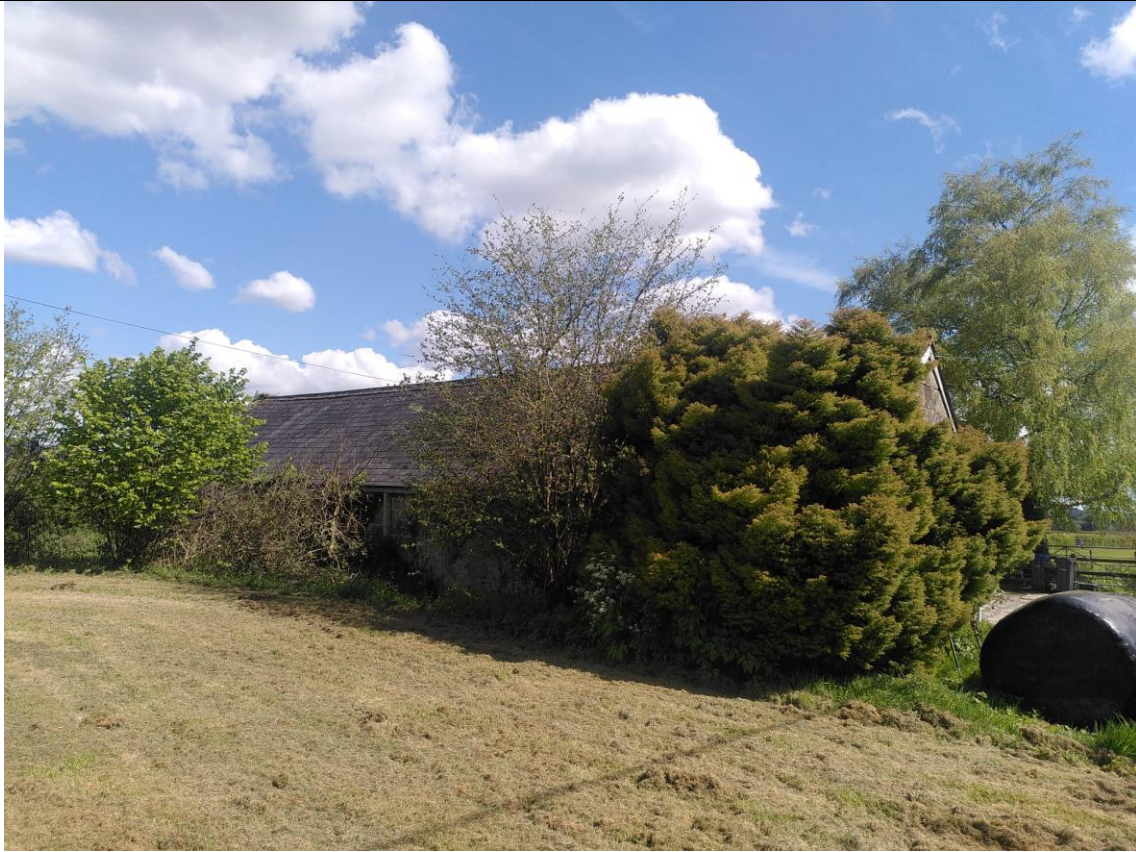
**Fig 2.** The barn at Sweetwell Farm was flanked by amenity garden to the west. Photo taken 20<sup>th</sup> April 2026 facing northeast.

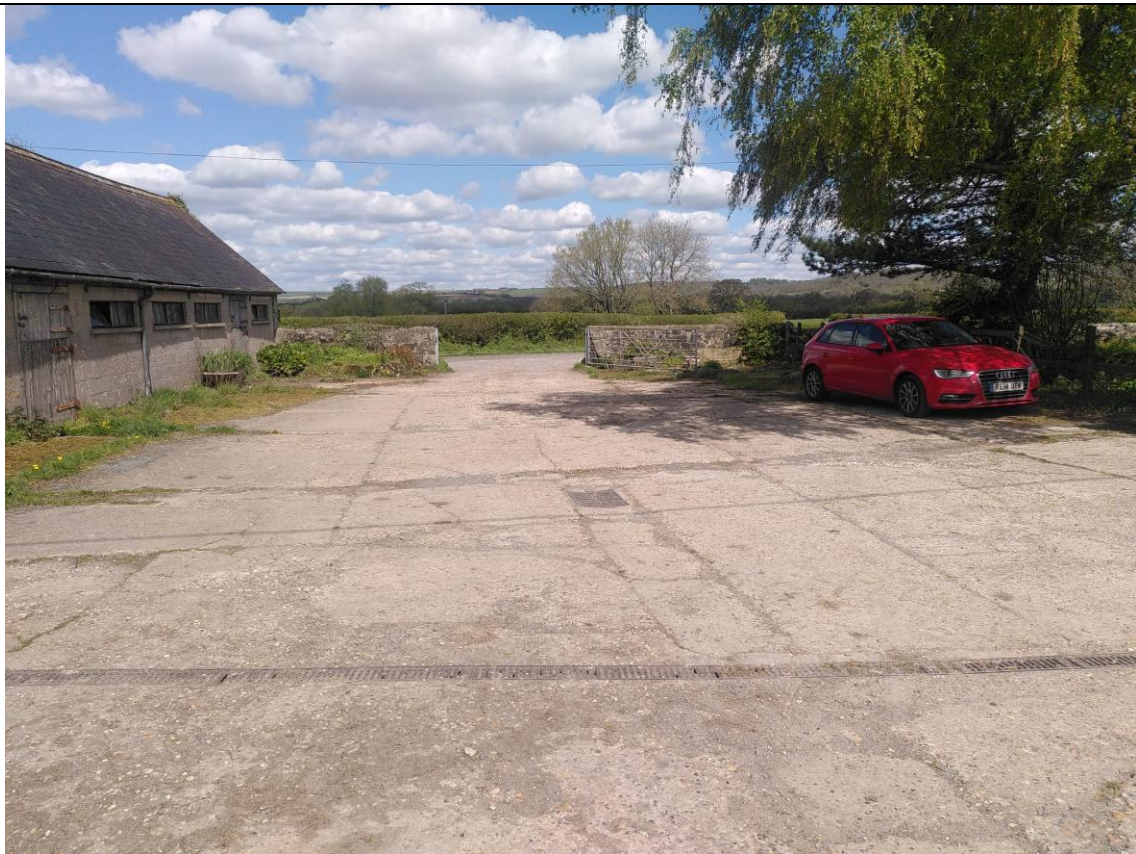
**Fig 3.** To the east of the barn was hardstanding. Photo taken 20<sup>th</sup> April 2026 facing north.

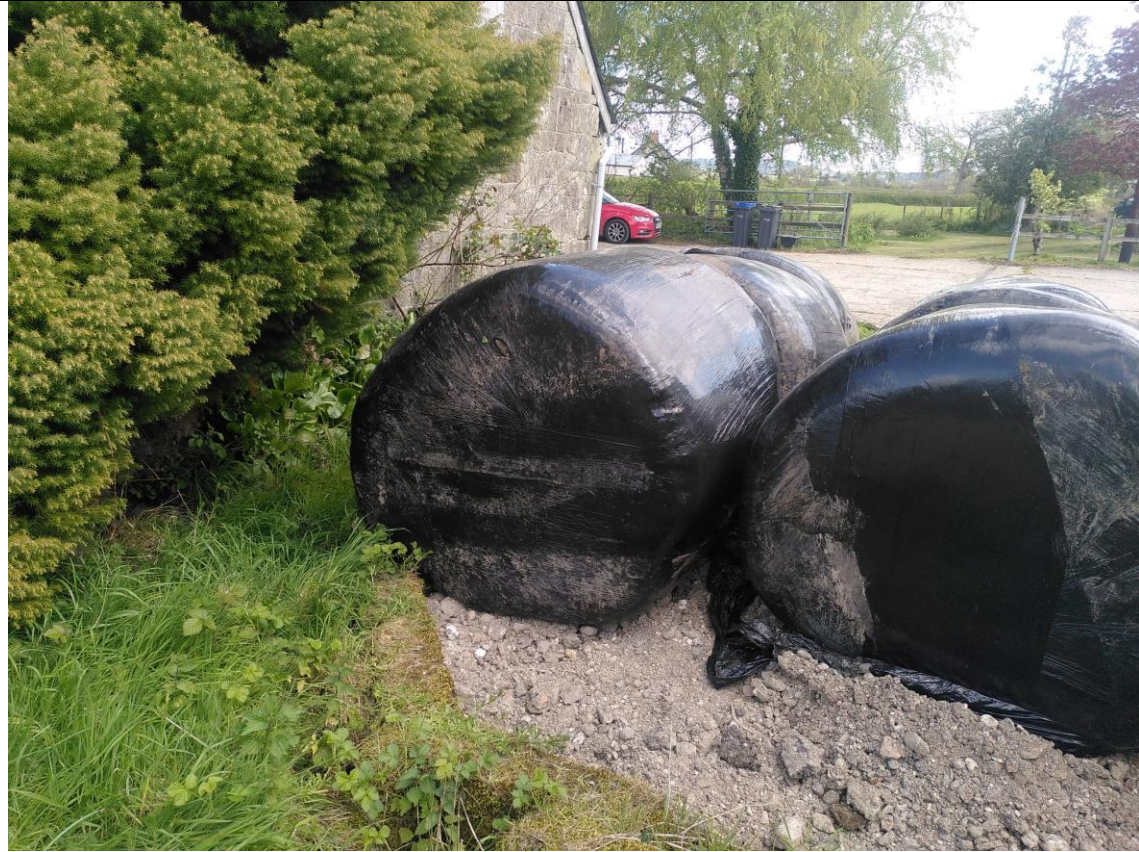
A small area of banded loose hardcore was to the south of the barn, upon which was stored 12 bales of silage. The redline boundary bisects this permeable area.

**Fig 4.** A small area of banded loose hardcore was to the south of the barn. Photo taken 20<sup>th</sup> April 2026 facing east.

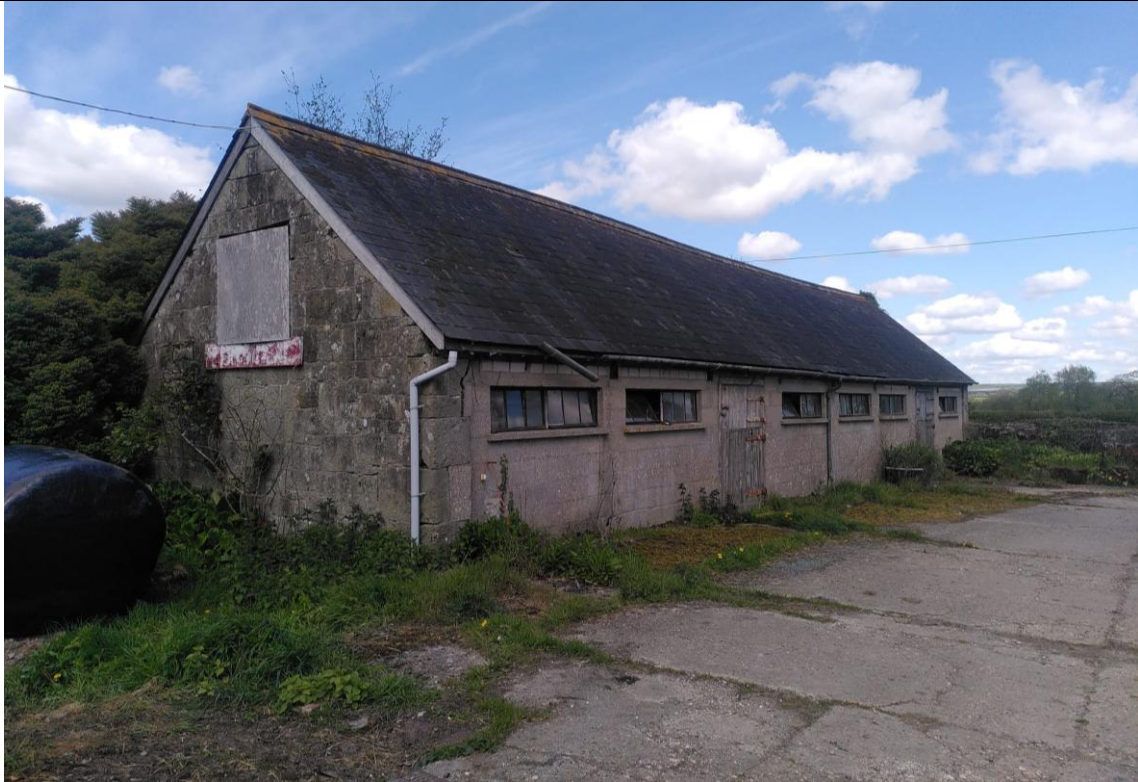
The barn at Sweetwell Farm is a single storey barn originally built of stone block-work with the more recent addition of cement block to fill in the eastern wall which also had the only doors and windows. The roof of the barn is covered with slates over bitumen felt and the ridge runs north-south.

**Fig 5.** The barn at Sweetwell Farm. Photo taken 20<sup>th</sup> April 2026 facing northwest.

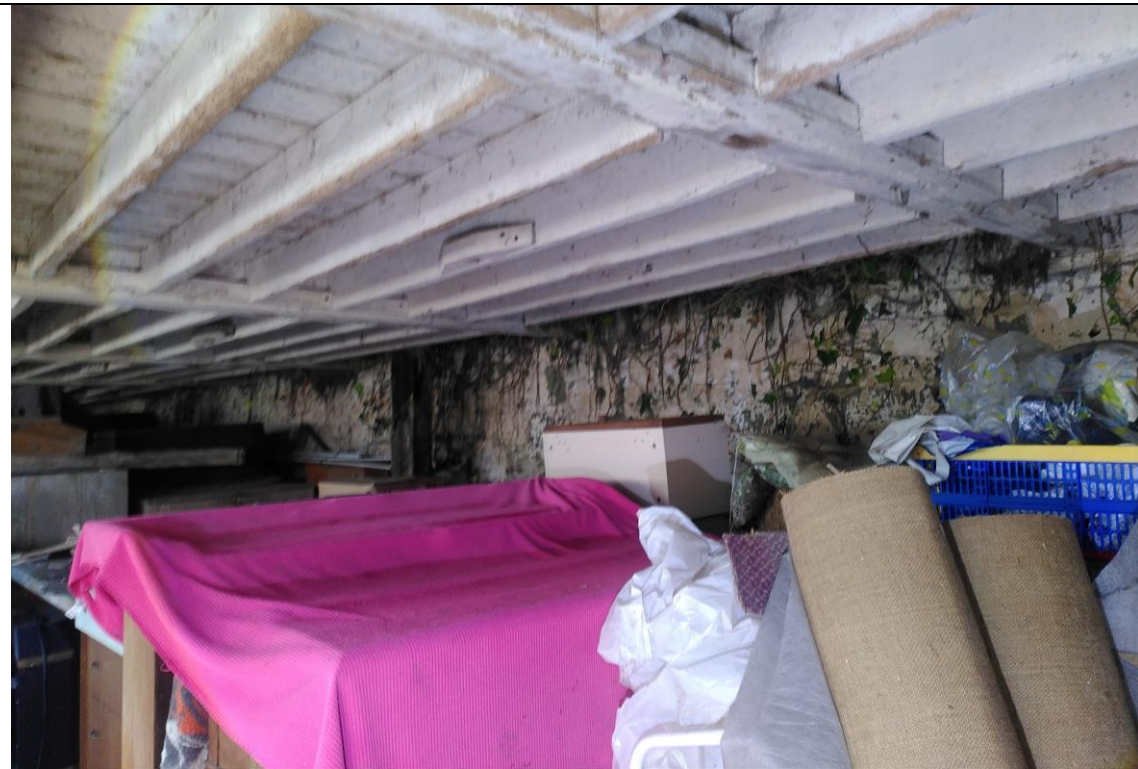
**Fig 6.** The interior of the barn consisted of a low-ceilinged room occupying the whole of the ground floor. Photo taken 20<sup>th</sup> April 2026.

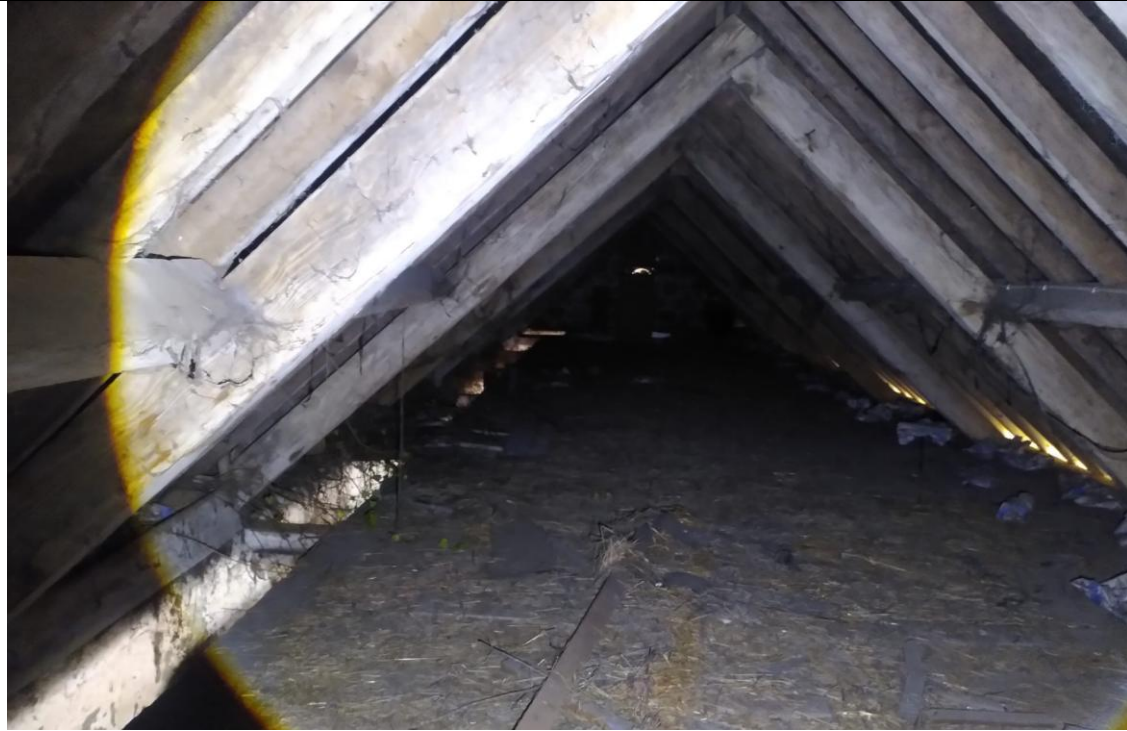
**Fig 7.** The interior of the barn had an empty roof void which was a single, continuous space. Photo taken 20<sup>th</sup> April 2026.

The roof void was approximately 2 m high to the ridge and formed one continuous space of several metres, except for an internal wall at the southern end approximately 30 cm from the external wall. It was not possible to look behind this wall, but many gaps were present to link the spaces. The loft was empty with residual straw carpeting the floor and ivy encroaching from the west. The roof was in good condition, the bitumen felt had no holes but did not overlap at the ridge. All beams and joints were checked and no bats were present. The block work of the gable ends had many holes and crevices, but no bats were found.

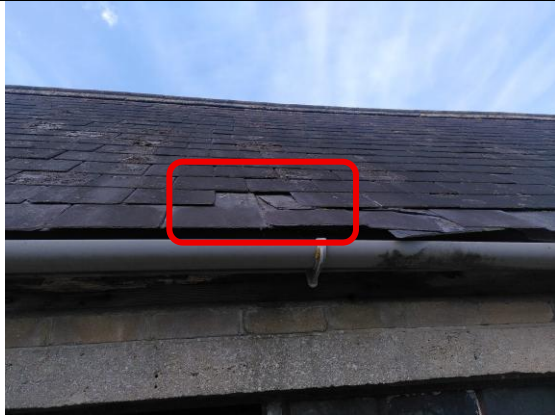
The roof of the barn was in good overall condition. The western roof was intact with no missing or damaged slates, while the eastern roof had two missing slates, one towards the centre and the fifth in from the north end. The entire length of the ridge was accessible on both sides under the tiles.

**Fig 8.** Eastern elevation: missing slate at the centre. Photo taken 20<sup>th</sup> April 2026.

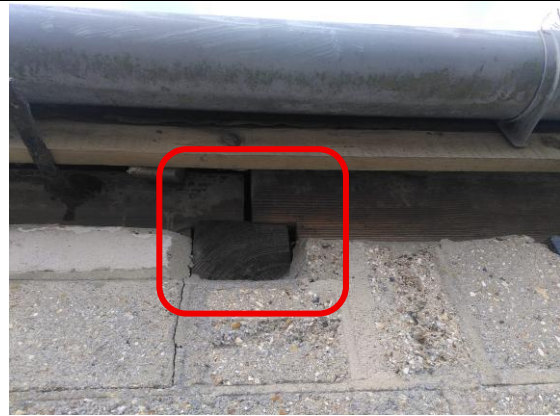
The eastern elevation had many access points into the barn and crevice features. Three windows were permanently open and the stable doors, though routinely kept closed, had holes. A gap in the joists was noted to the left of the northern most door frame and cracks were found in the block work at the northeastern corner. Further cracks were located at the southeastern corner, but these were judged too open for shelter and would function as access points only.

**Fig 9.** Eastern elevation: gap at joist. Photo taken 20<sup>th</sup> April 2026.

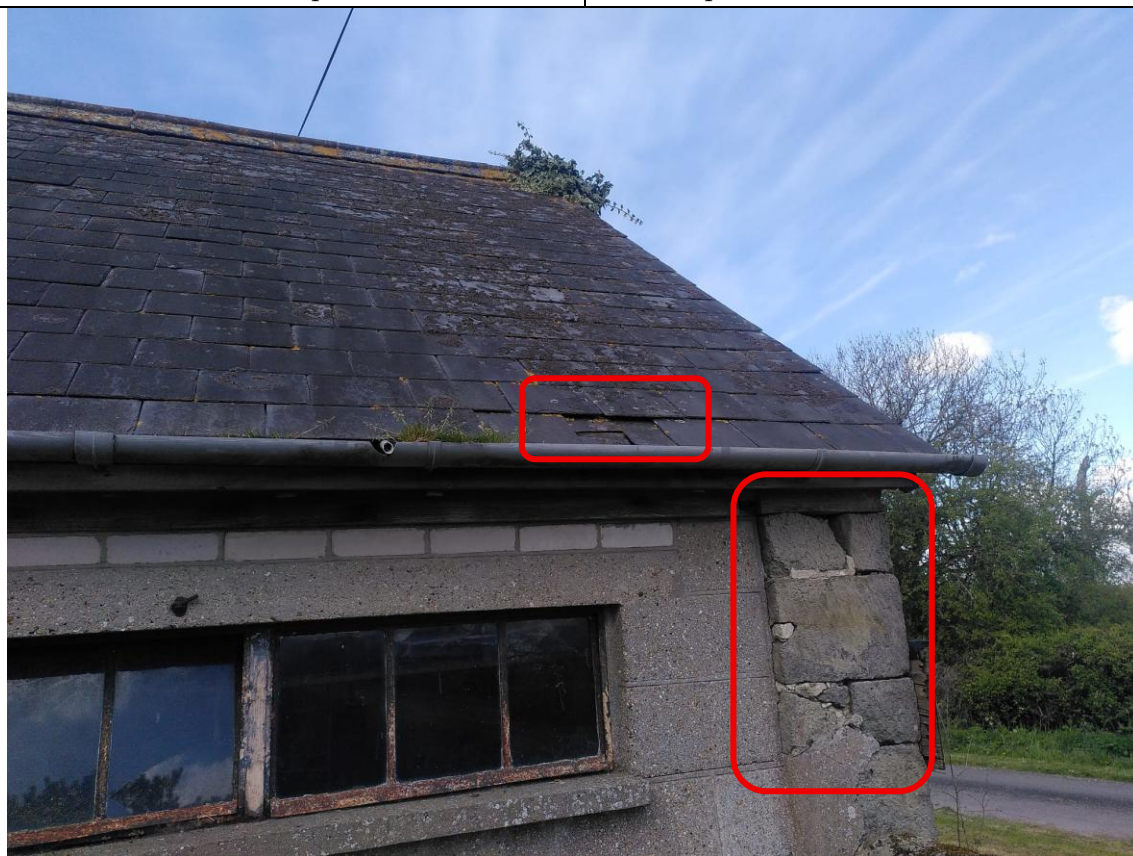
**Fig 10.** Eastern elevation: missing slate at the northern end of the eastern roof and the cracks on the northeastern corner. Photo taken 20<sup>th</sup> April 2026.

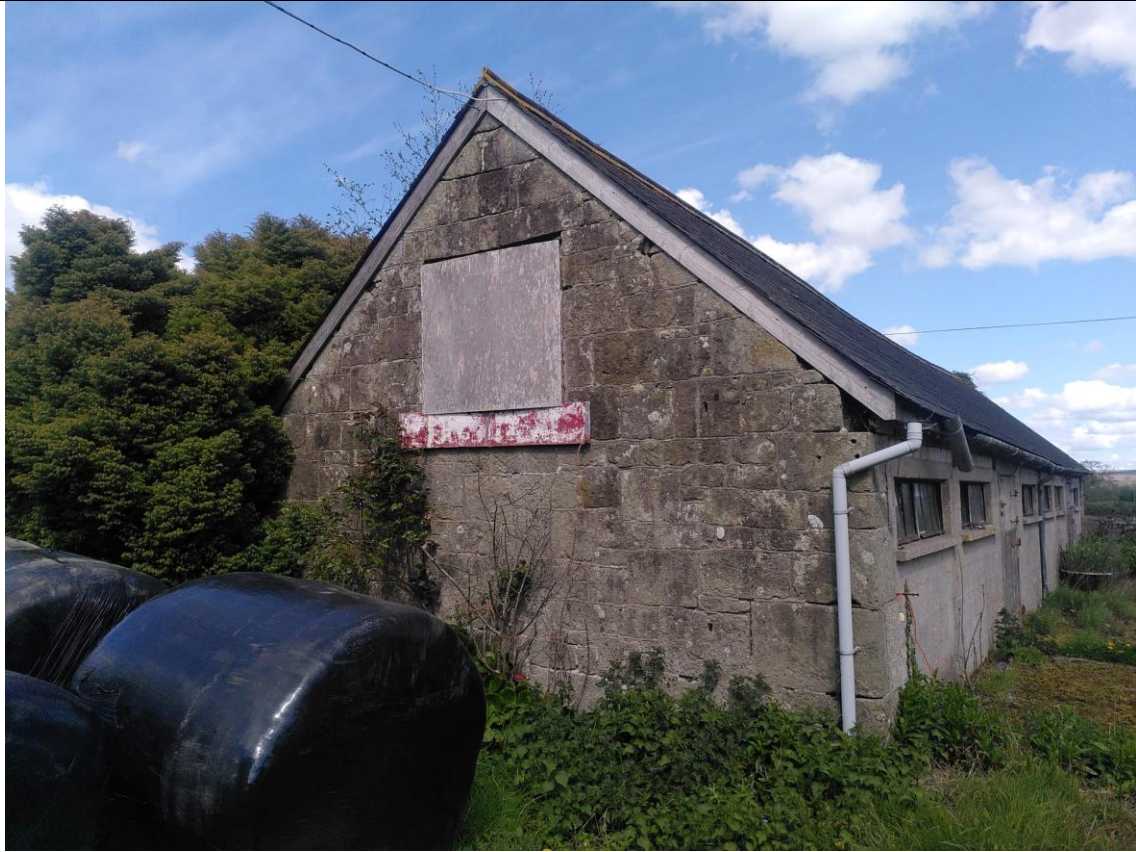
The southern elevation was a gable end with a boarded window in the centre. The barge boards on the left had gaps where the board was slightly lifted as well as gaps from holes in the block work. Mortar was missing from the top blocks of the wall, but it was not clear from the ground how deep the resulting crevices were. Further holes were identified on the right side of the gable end with a substantial cleft behind the downpipe and several smaller holes in the blockwork. There were additional larger holes which gave access to the barn's interior.

**Fig 11.** The southern elevation was a gable end and had a boarded window in the centre. Photo taken 20<sup>th</sup> April 2026.

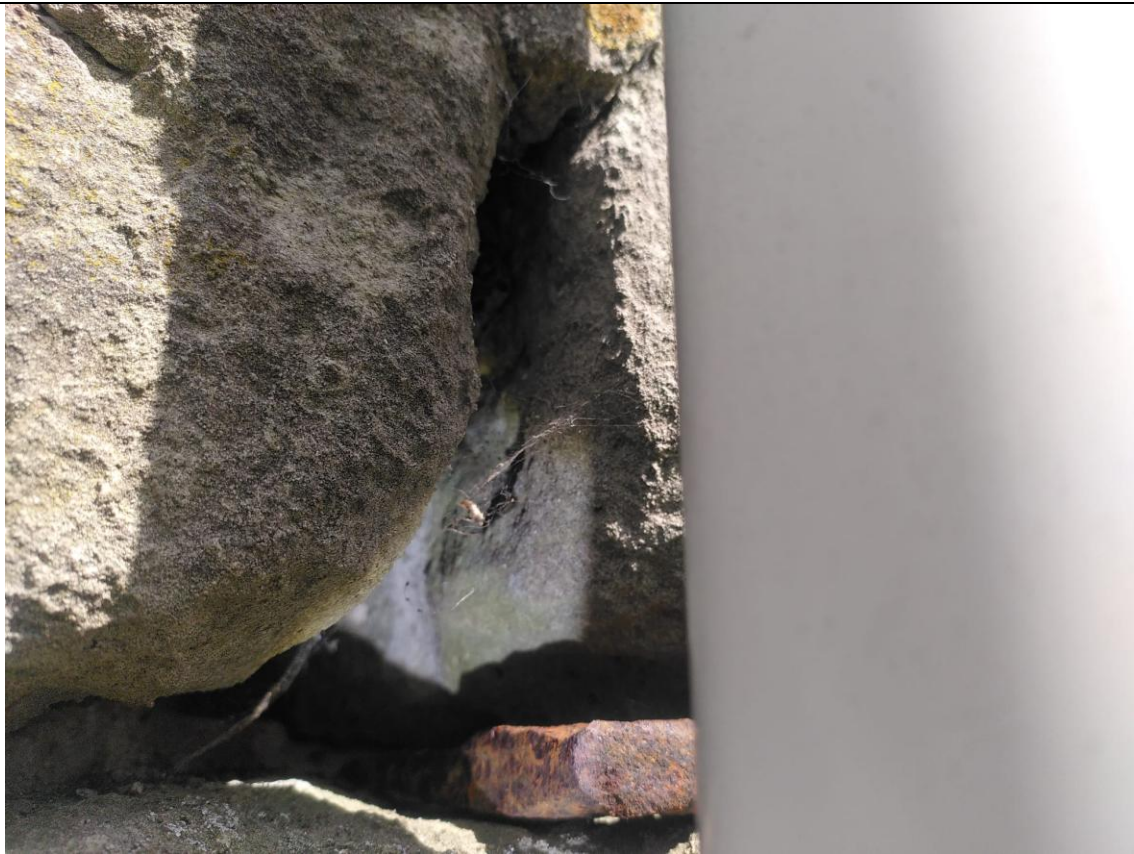
**Fig 12.** Southern elevation: a substantial cleft behind the downpipe. Photo taken 20<sup>th</sup> April 2026.

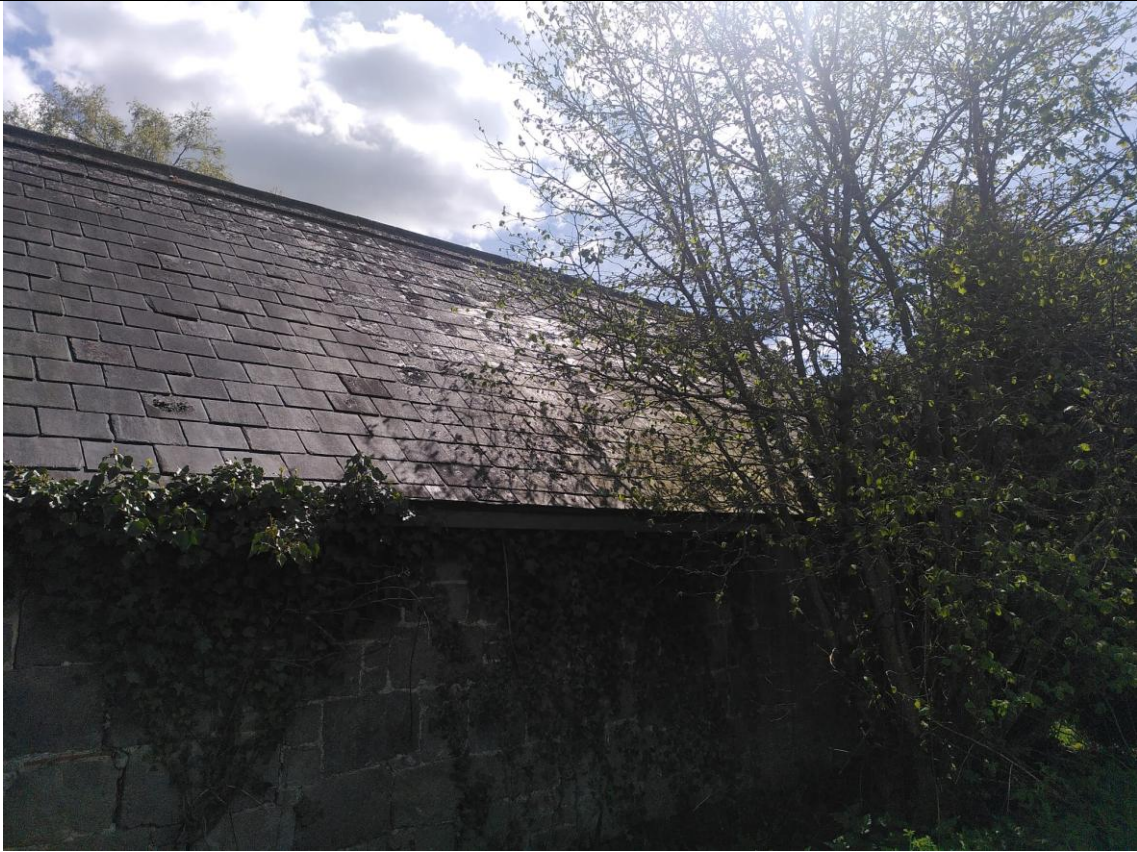
The western elevation was flanked by shrubs and medium sized trees with ivy encroaching on the walls up to the eaves in places. The roof slates all appeared intact. To the northern end several large cracks were present in the wall, providing potential roost features as well as access to the interior. In addition, it was noted that the eaves were open, giving access to the roof void.

**Fig 13.** The western elevation: ivy encroaching on the walls up to the eaves in places. Photo taken 20<sup>th</sup> April 2026.

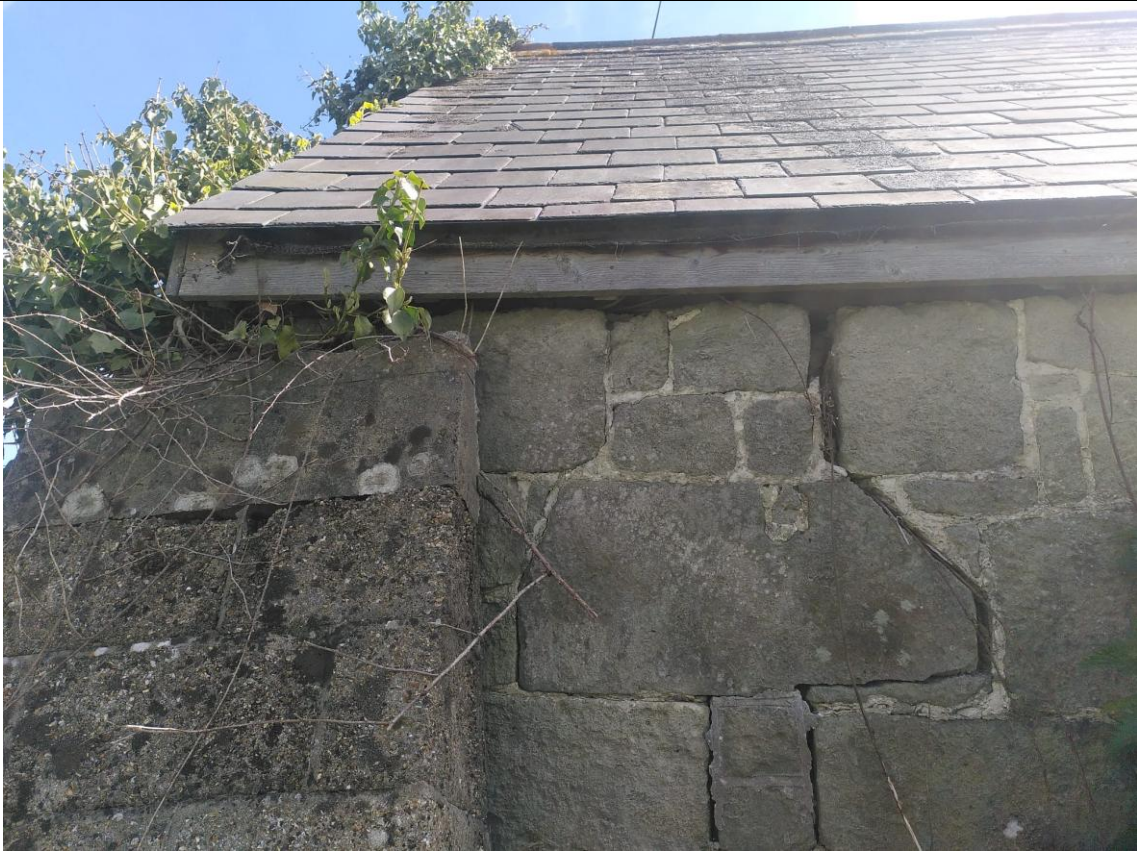
**Fig 14.** Western elevation: on the northern end several large cracks were present in the wall, providing potential roost features as well as access to the interior. Photo taken 20<sup>th</sup> April 2026.

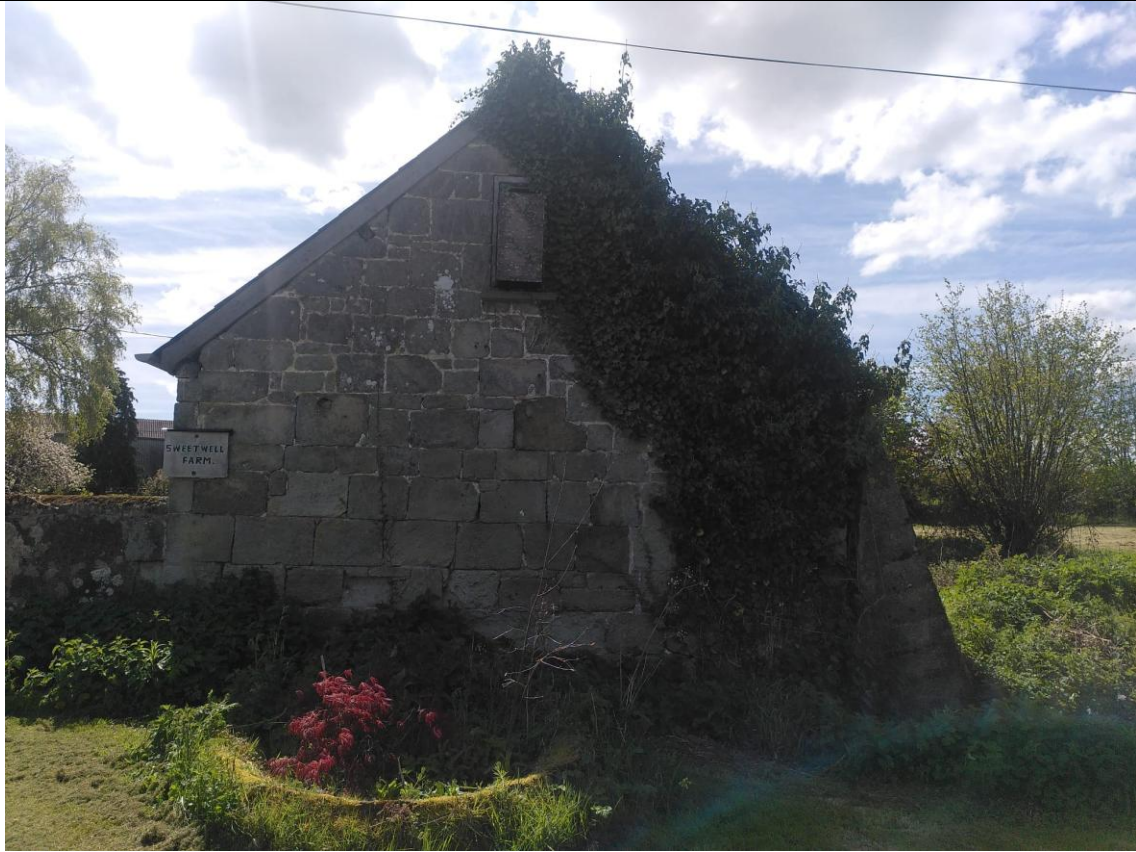
The northern gable end was covered in substantial ivy growth obscuring the western half of the elevation up to the apex. Along the left side bargeboard gaps were present forming crevices for roosting as well as access to the interior. In addition, mid-way along the edge, two crevices were identified in the joists. The centre of the gable end had a box fixed over the window which was fully open at the base and loosely attached all around.

**Fig 15.** Northern elevation with ivy and box. Photo taken 20<sup>th</sup> April 2026.

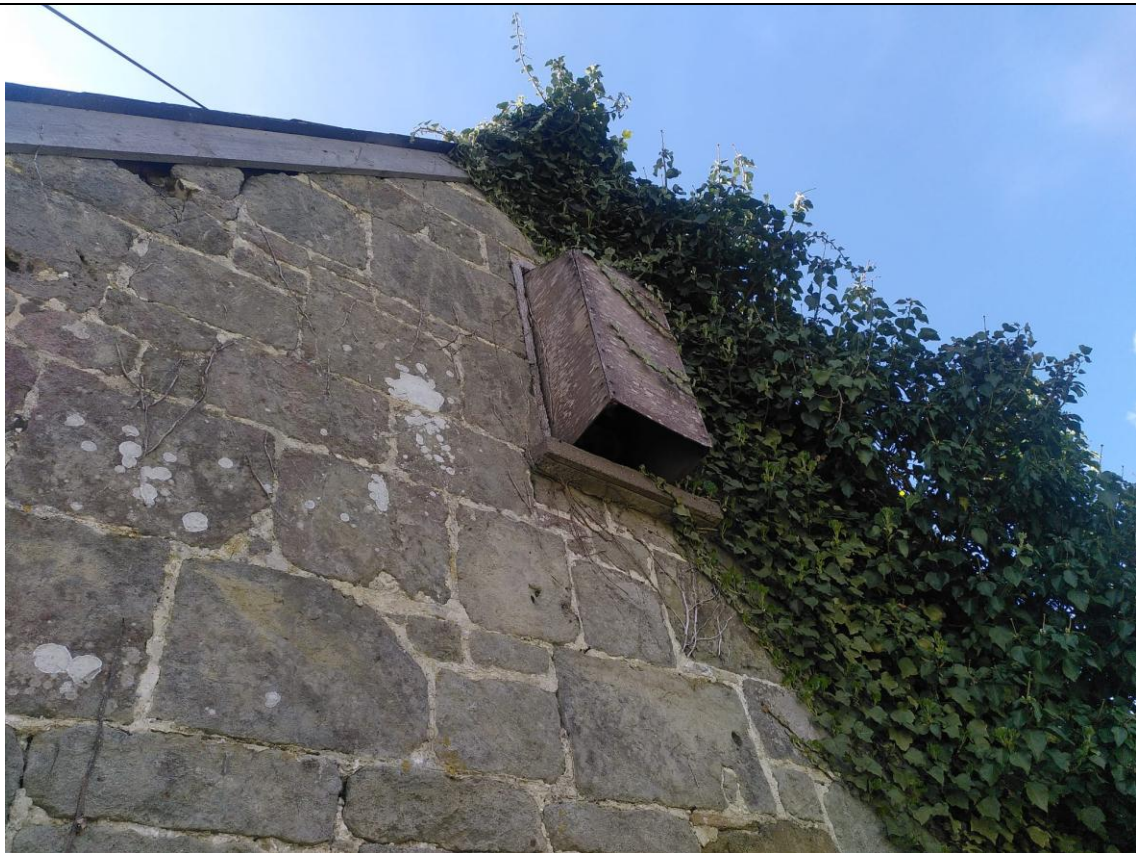
**Fig 16.** Northern elevation: the centre of the gable end had a box fixed over the window which was fully open at the base and loosely attached all around. Photo taken 20<sup>th</sup> April 2026.

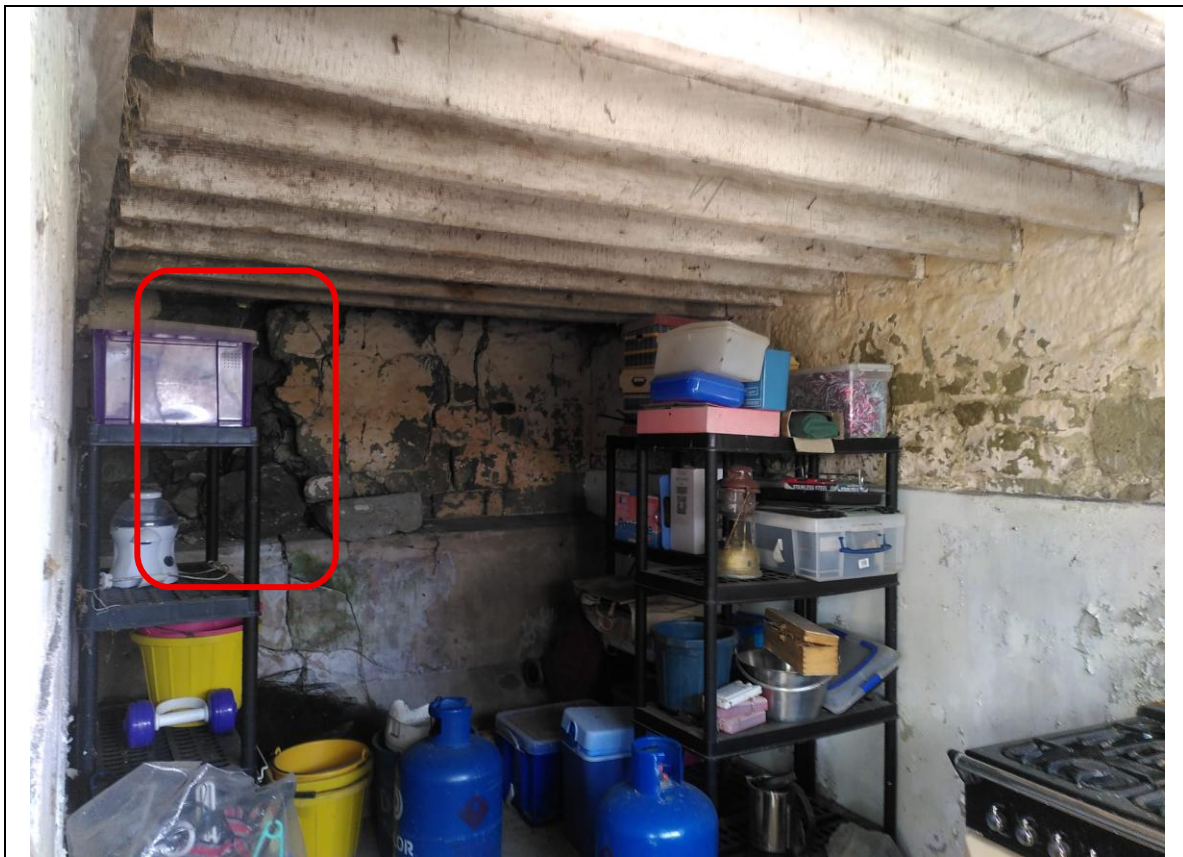
The ground floor was well lit from the multiple windows on the eastern elevation. The block work had deteriorated over time and caused many crevices in the back (western) wall, especially toward the north end. Ivy had grown through the eaves and into the room from the western elevation. Access between the room and roof void was clear in many locations via space in the ceiling. Minor crevices were present between the beams. No evidence of bats such as droppings, staining or scratches was found in the ground floor, however the amount of stored furniture meant not all surfaces could be checked and some evidence may have been obscured.

**Fig 17.** The block work has deteriorated over time and caused many crevices in the back (western) wall, especially toward the north end. Photo taken 20<sup>th</sup> April 2026.

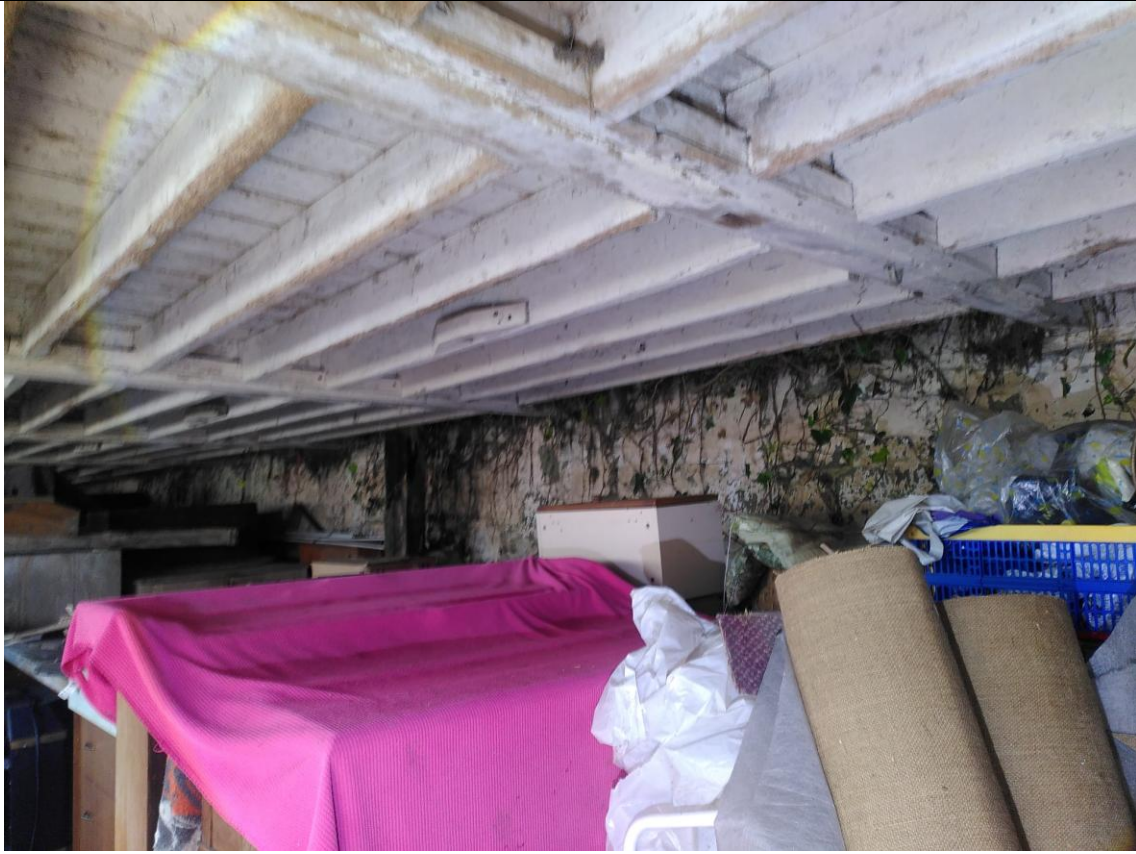
**Fig 18.** Ivy had grown through the eaves and into the room from the western elevation. Photo taken 20<sup>th</sup> April 2026.

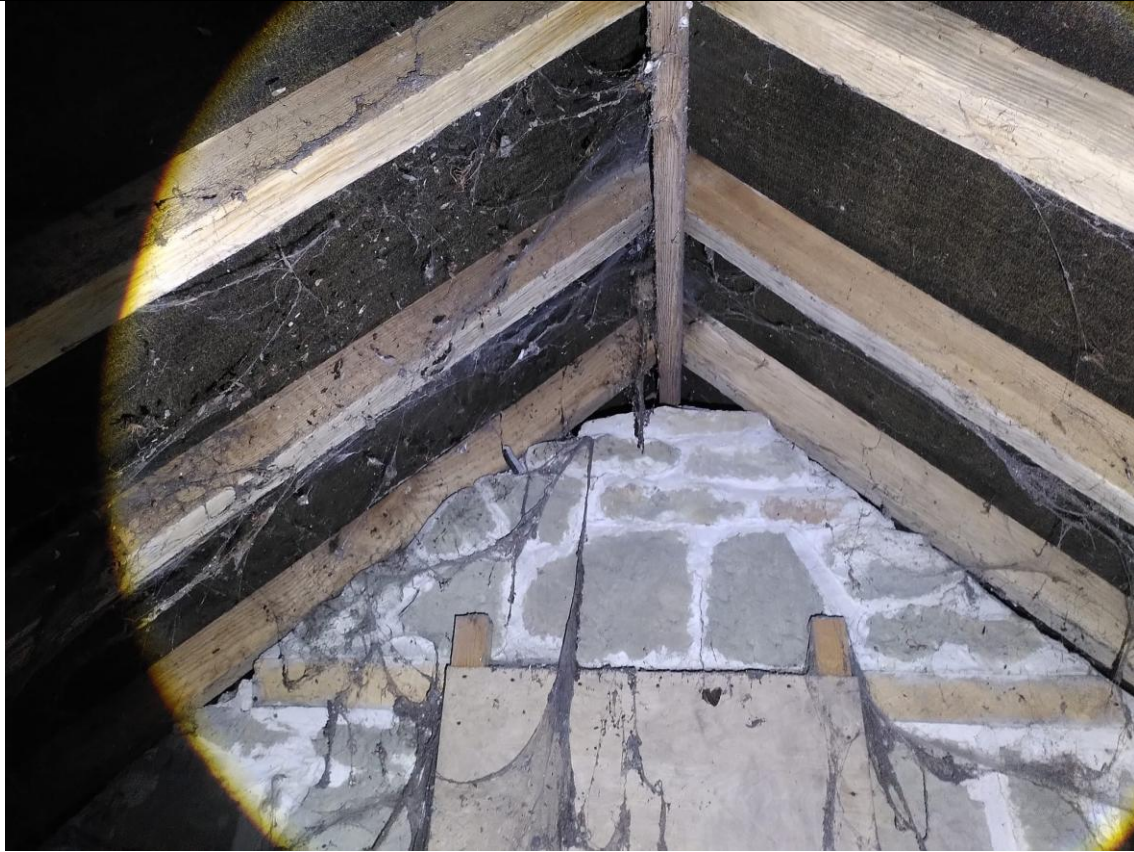
**Fig 19.** An internal wall at the southern end approximately 30 cm from the external wall. Photo taken 20<sup>th</sup> April 2026.

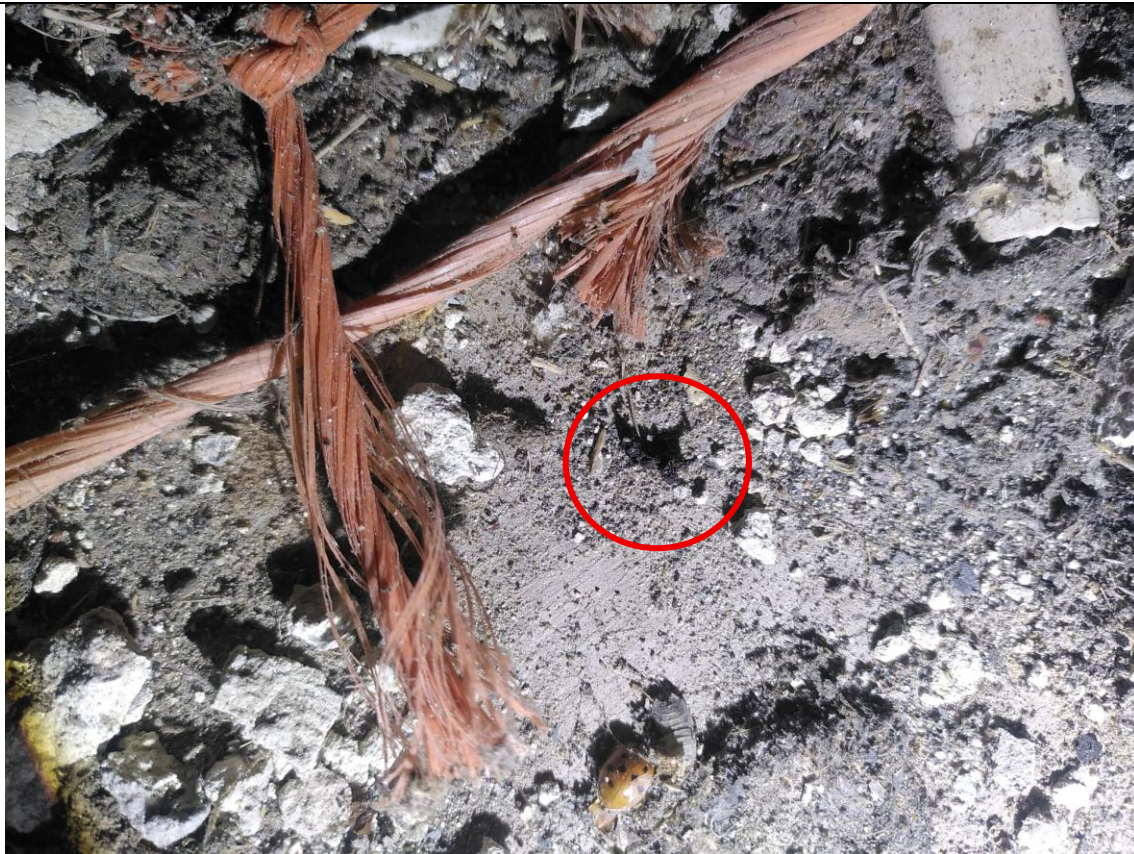
Bat droppings were found in small quantities (< 30 approximately) throughout the roof void, predominantly at the two ends, both on the floor and stuck to the plyboard on the wall. The droppings were mostly very old. The droppings varied in size and samples were collected for DNA analysis which showed soprano pipistrelle and brown long eared bats. Single wings of two butterflies were found at separate locations in the roof void, which may indicate bats feeding, however the very small number of wings reduced the certainty of this.

**Fig 20.** Example of bat dropping found on the floor of the barn roof void.

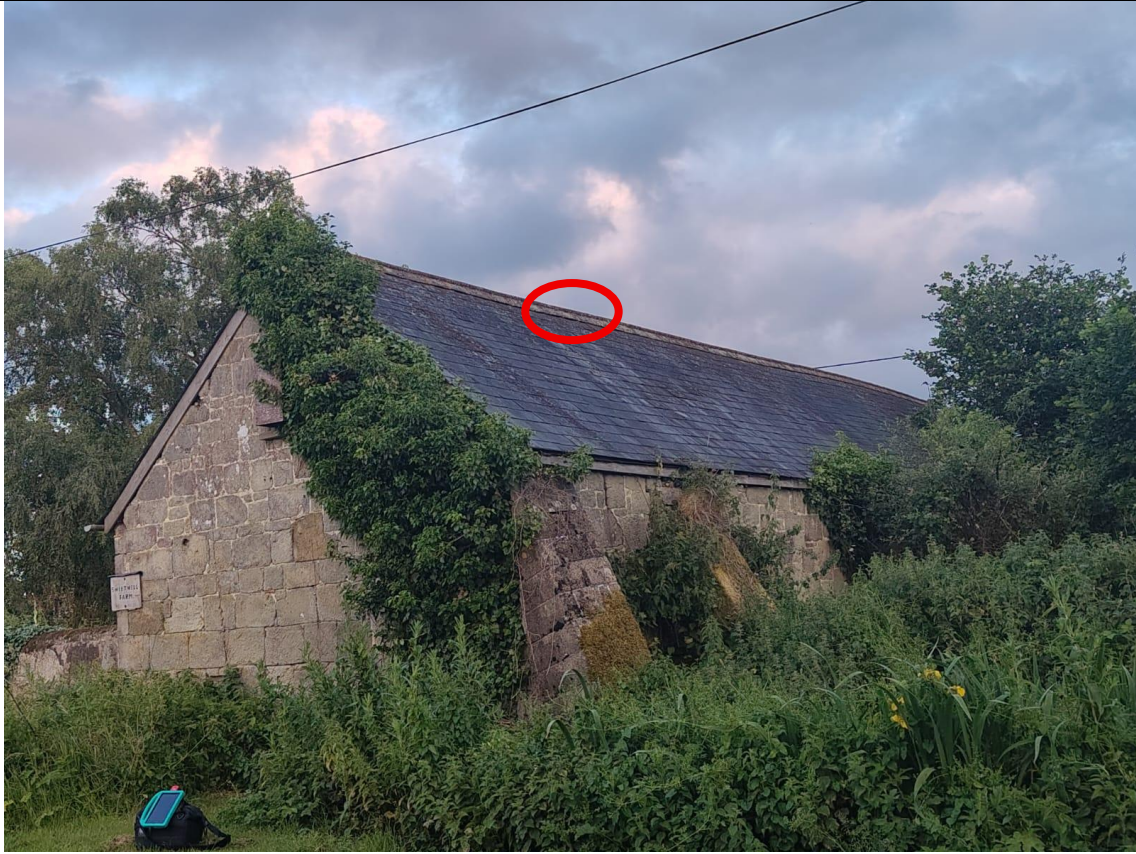
At 2150 surveyor one recorded one bat emergence from a third of the way down the ridge from the northern apex. The bat flew off site to the south. No call was recorded for the emergence, but common pipistrelle calls were recorded before and after.

**Fig 21.** At 2150 surveyor one recorded one bat emergence from a third of the way down the ridge from the northern apex.

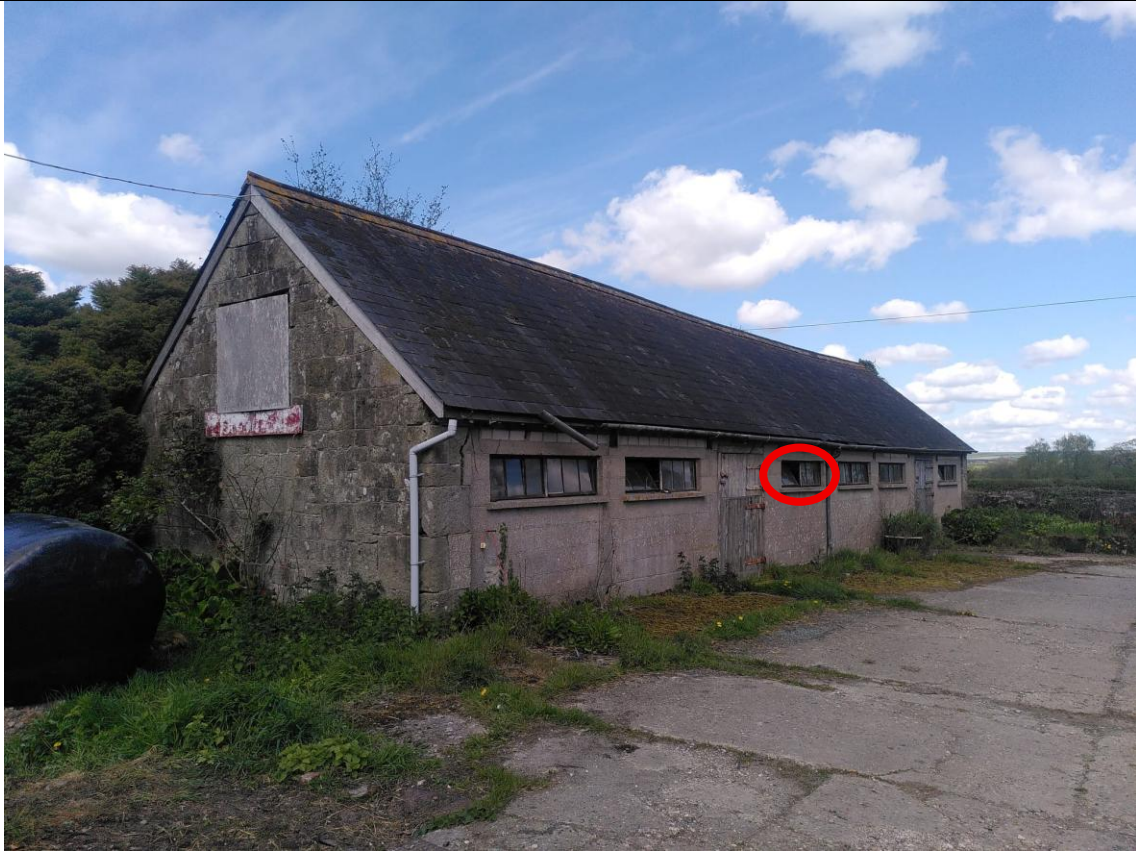
At 2217 surveyor two recorded one common pipistrelle emergence from the centre window of the eastern elevation. The bat flew off site to the east.

**Fig 22.** At 2217 surveyor two recorded one common pipistrelle emergence from the centre window of the eastern elevation.

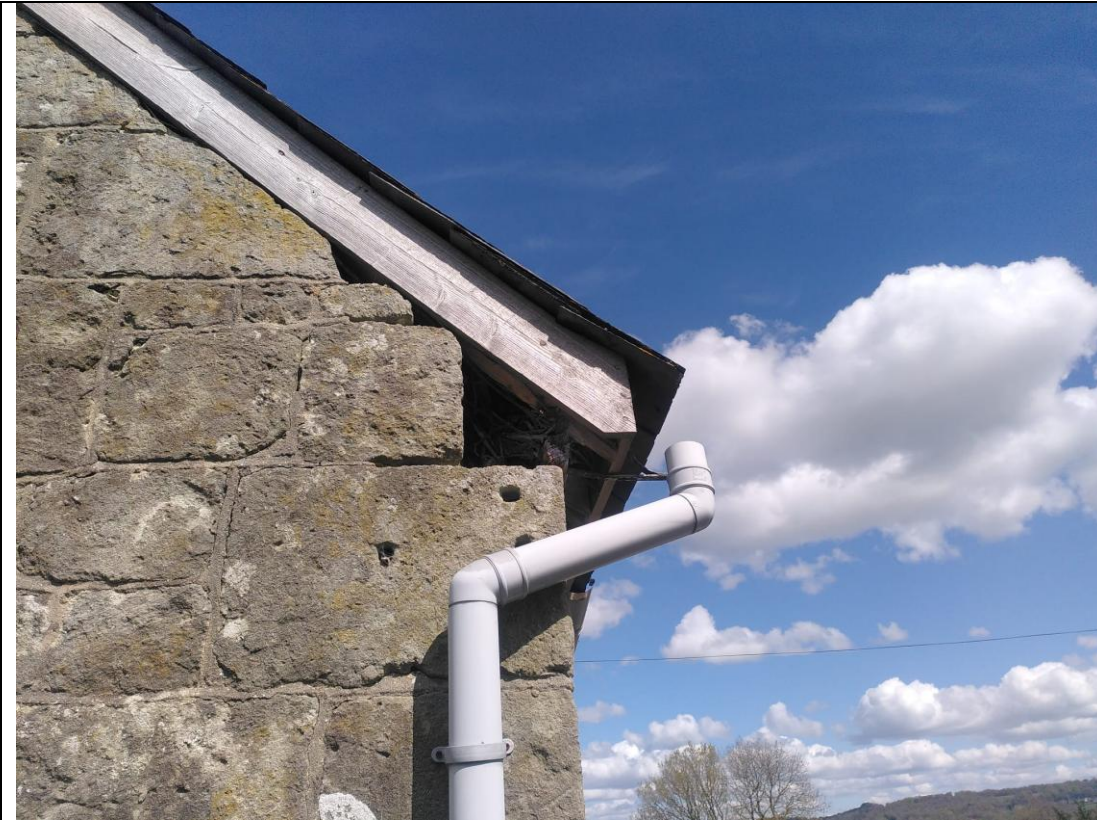
Many sticks were evident in the largest of the holes at the base of the gable end in the righthand corner, indicating historical activity by nesting birds.

**Fig 23.** Southern elevation: many sticks were evident in the largest of the holes at the base of the gable end in the righthand corner. Photo taken 20<sup>th</sup> April 2026.

The amenity shrubs and trees in the garden of the property are suitable for nesting birds between March and August (inclusive) and the barn has been confirmed to have been used by nesting bird species. Vegetation will be removed under the proposed plans for this site and given the protection afforded to all breeding birds, their nests, eggs and young, where areas of habitat are to be removed it is strongly recommended that any removal of, or disturbance to, vegetation or structures that offer potential nesting habitat for breeding birds, should be undertaken between October and February, inclusive, outside of the main bird breeding season. Demolition of the barn will need to be carried out when nests are not active.
