PRELIMINARY ECOLOGICAL APPRAISAL  
AND BAT SURVEY REPORT

THE BARN, SWEETWELL FARM, SEDGEHILL,  
WILTSHIRE

stark ecology<sup>ltd</sup>

SEPTEMBER 2026

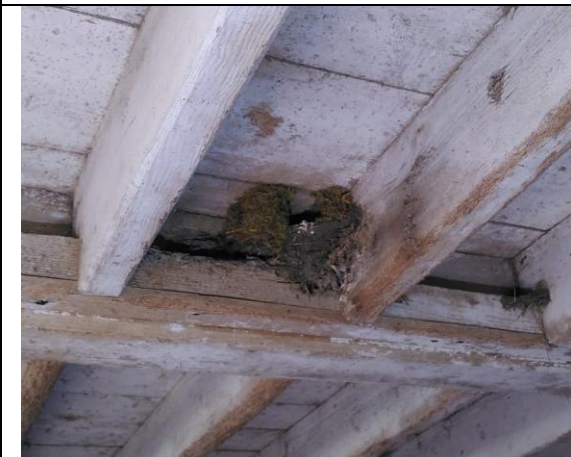
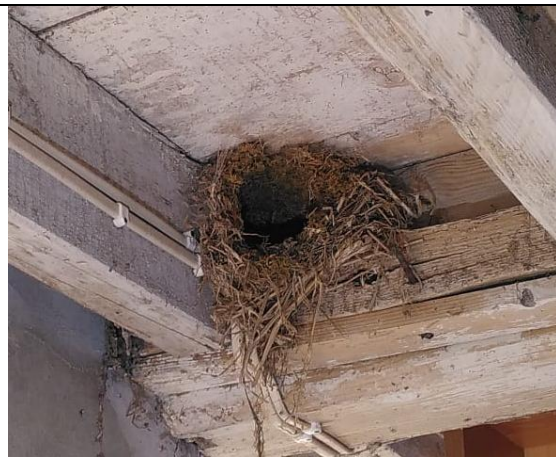
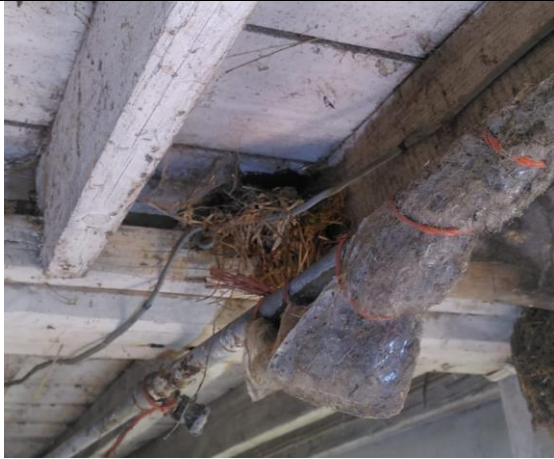
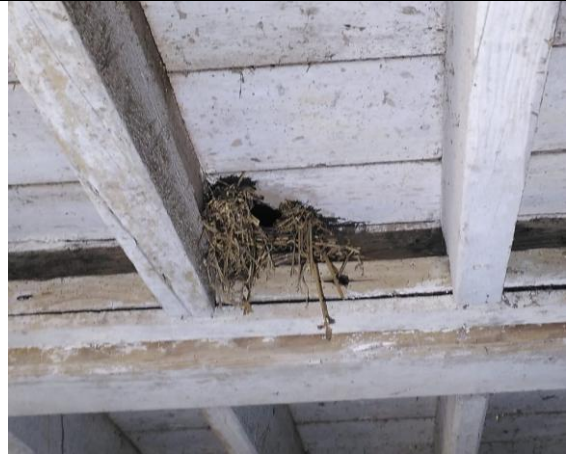
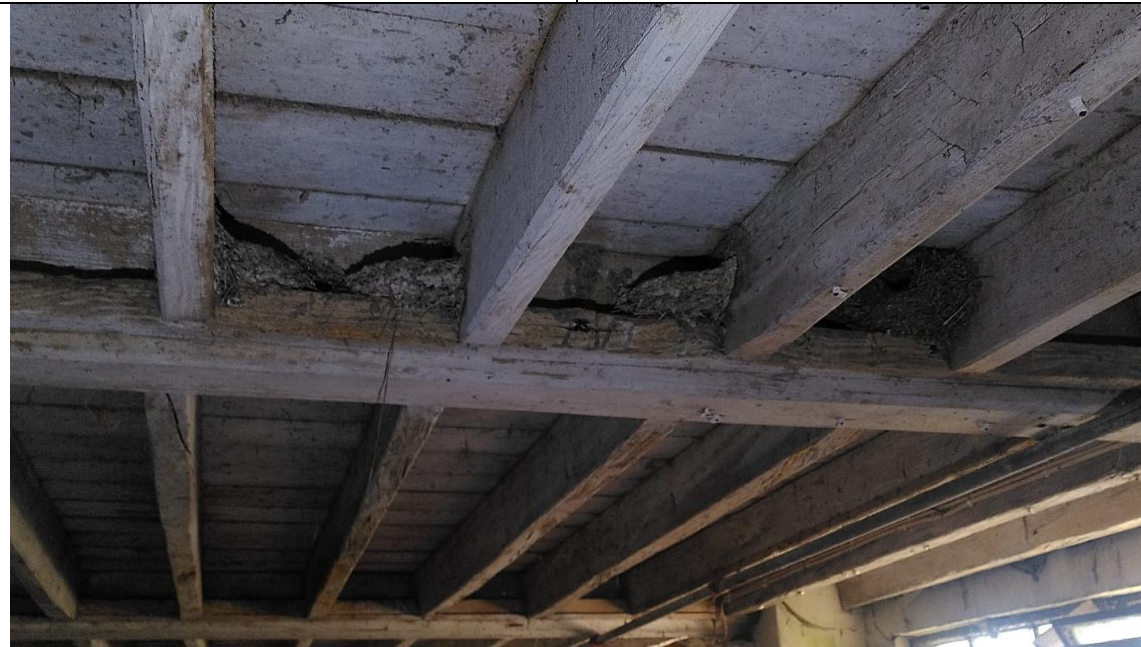
Internally eleven bird nests were counted fixed to the rafters, a combination of robin *Erithacus rubecula*, wren *Troglodytes troglodytes* and swallow *Hirundo rustica*.

**Fig 24.** Bird nest fixed to the rafters. Photo taken 20<sup>th</sup> April 2026.

**Fig 25.** Bird nest fixed to the rafters. Photo taken 20<sup>th</sup> April 2026.

**Fig 26.** Bird nest fixed to the rafters. Photo taken 20th April 2026.

**Fig 27.** Bird nest fixed to the rafters. Photo taken 20th April 2026.

**Fig 28.** Bird nest fixed to the rafters. Photo taken 20th April 2026.

The amenity shrubs and trees in the garden of the property are suitable for nesting birds between March and August (inclusive) and the barn has been confirmed to have been used by nesting bird species. Vegetation will be removed under the proposed plans for this site and given the protection afforded to all breeding birds, their nests, eggs and young, where areas of habitat are to be removed it is strongly recommended that any removal of, or disturbance to, vegetation or structures that offer potential nesting habitat for breeding birds, should be undertaken between October and February, inclusive, outside of the main bird breeding season. Demolition of the barn will need to be carried out when nests are not active.

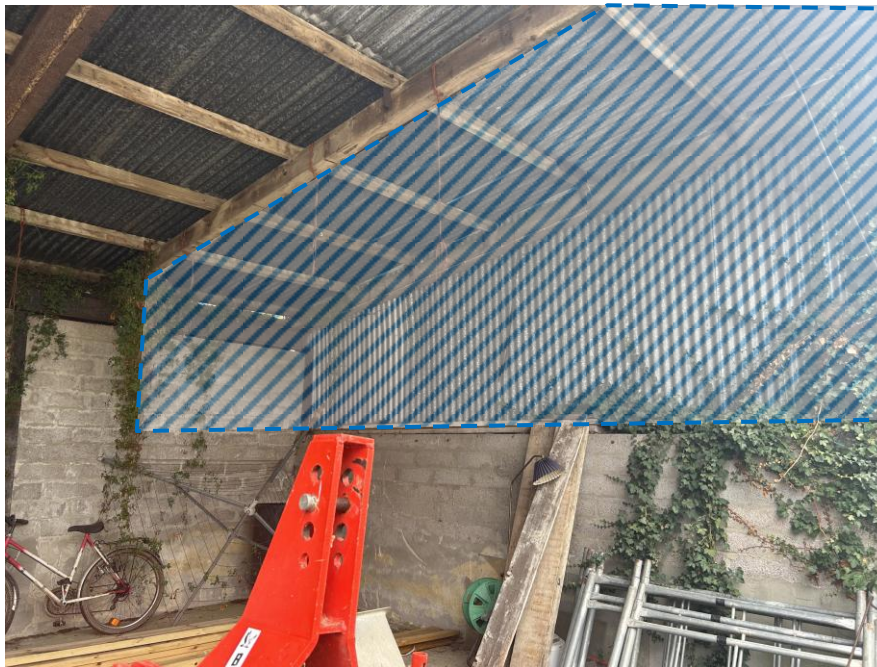
Void space for brown long-eared bats

**Fig 30:** This area of the barn to the south of the new dwelling will be enclosed to provide a void space for brown long-eared bats.

The void space will be created inside the barn using plywood sheets which will be insulated with insulating board. Access to the void space will be provided in the east face of the void space, using [1FE Schwegler Bat Access Panel | NHBS Practical Conservation Equipment](#).
