# Colerne Industrial Estate (The Project)

Kemble Business Park LLP

**Flood Risk Assessment & Drainage Strategy**

July 2026

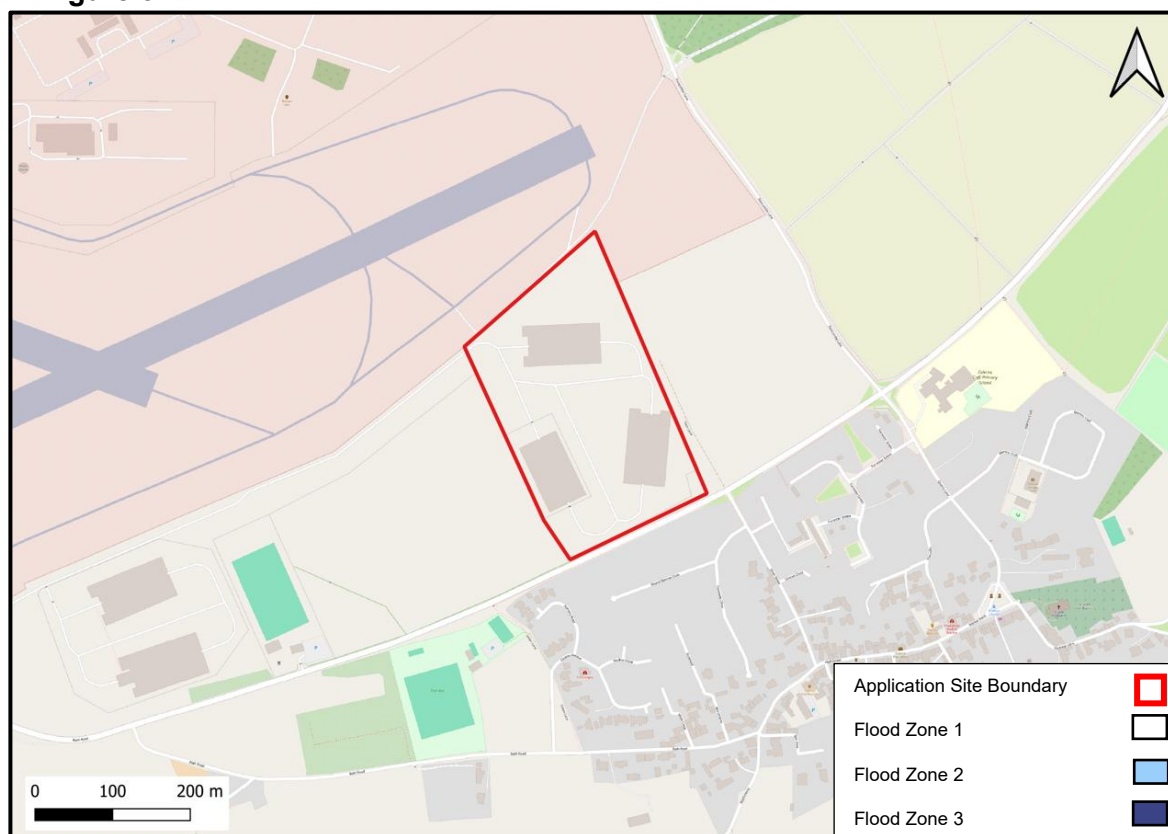
**Figure 3.2** Environment Agency Flood Map for Planning

- 3.12 Flooding from watercourses occurs when flows exceed the capacity of the channel, or where a restrictive structure is encountered, which leads to water overtopping the banks into the floodplain.
- 3.13 EA mapping indicates that the entire site is located within Flood Zone 1 (Low Risk). This indicates that the site has a <0.1% chance of fluvial flooding occurring across the site. Refer to **Figure 3.2** below.
