# Detailed Unexploded Ordnance (UXO) Risk Assessment

| Project Name | Colerne Industrial Estate |
| Site Address | Colerne Industrial Estate, Colerne, Wiltshire SN14 8HT |
| Report Reference | DA23079-00 |

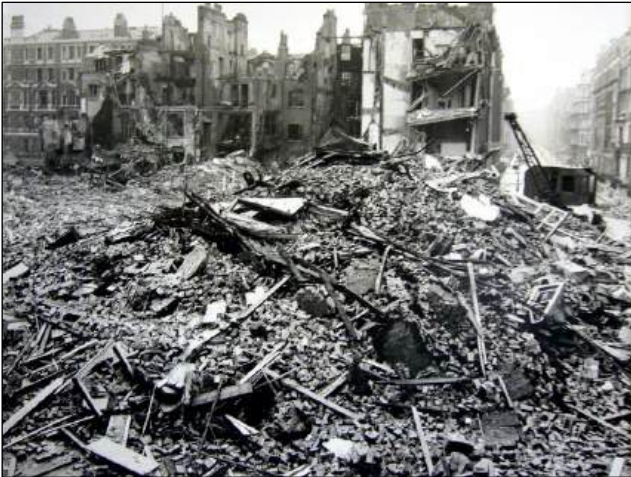
**Top:** J-curve Effect - Due to angle of entry, unexploded bombs would often end their trajectory at a lateral offset from point of entry, often ending up beneath adjacent extant structures/sites.

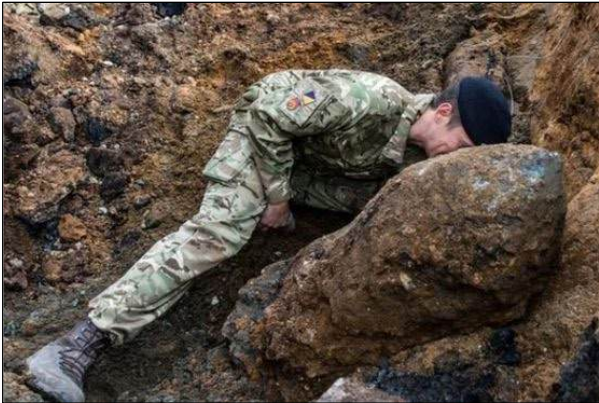
The photograph **above** shows a 250kg unexploded bomb found in Bermondsey in 2015, pointing upwards, demonstrating 'J-curve'.

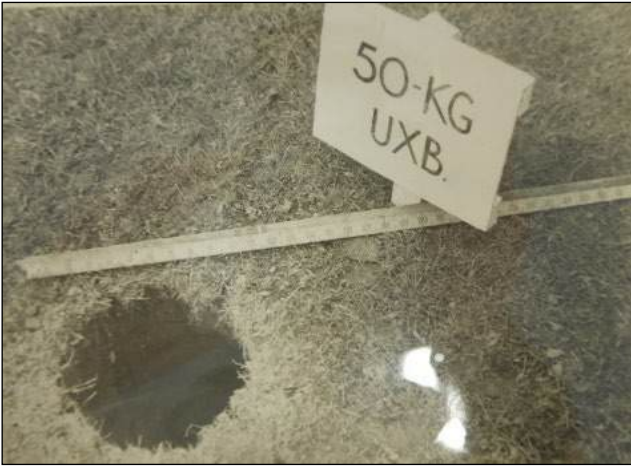
One of the most common scenarios for UXO going unnoticed was when a UXB fell into a 'bomb site' (such as the area shown **Top Left**), the entry hole of the bomb obscured by any debris and rubble present. Note that the entry hole of a 50kg UXB could be as little as 20cm in diameter (**Left**).

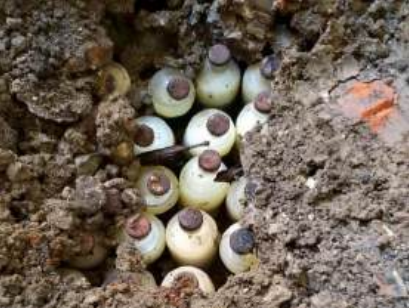
At around 9.30am, the digger rubbed against the lid of something which was approximately 600mm below ground - and would have blown up instantly if broken.

AW Bombs are yellow phosphorous hand grenades in half pint clear glass bottles weighing 1.5lbs each, which ignite instantly once their liquid contents react with the outside air.
