PRELIMINARY ROOST APPRAISAL

RUSTIC BARN, ALL CANNINGS, WILTSHIRE

stark ecology<sup>ltd</sup>

JULY 2026

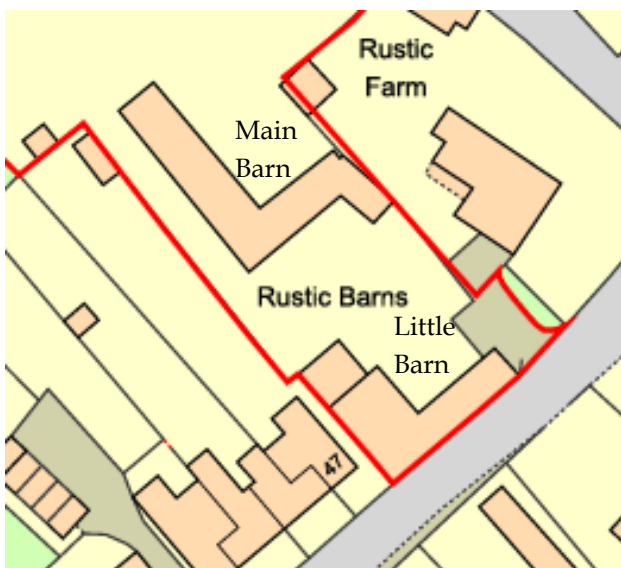
The property known as Rustic Barns comprises two separate buildings, the Main Barn, which is the primary dwelling, and the Little Barn, which provides ancillary accommodation. Solar panels are proposed for installation on the roofs of both buildings.

**Fig 2:** The property comprises the Main Barn and the Little Barn.

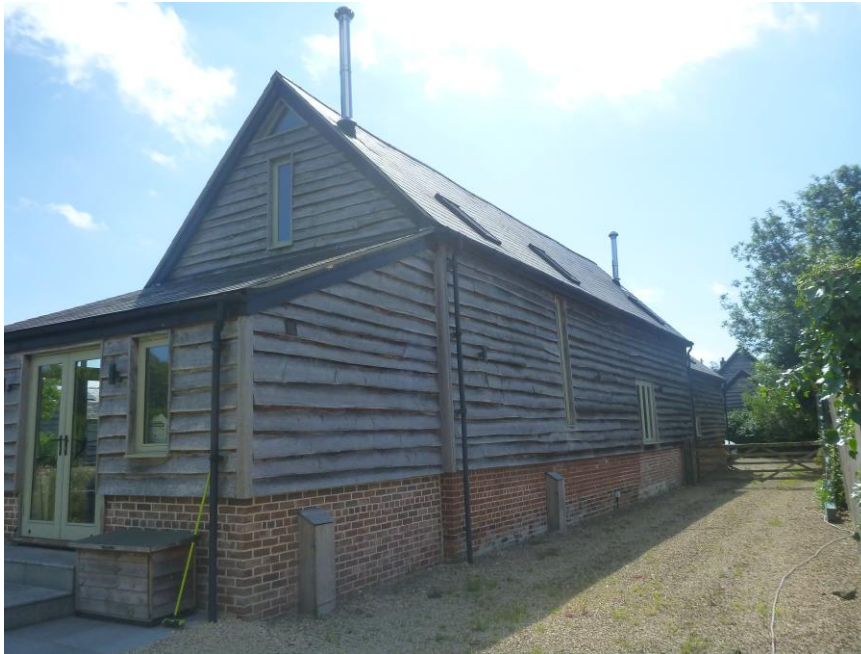
The Main Barn is a two-storey property which has brick walls at the base with wan-y edged board above.

**Fig 3:** The Main Barn.

This photo taken facing south on 19<sup>th</sup> June 2026.

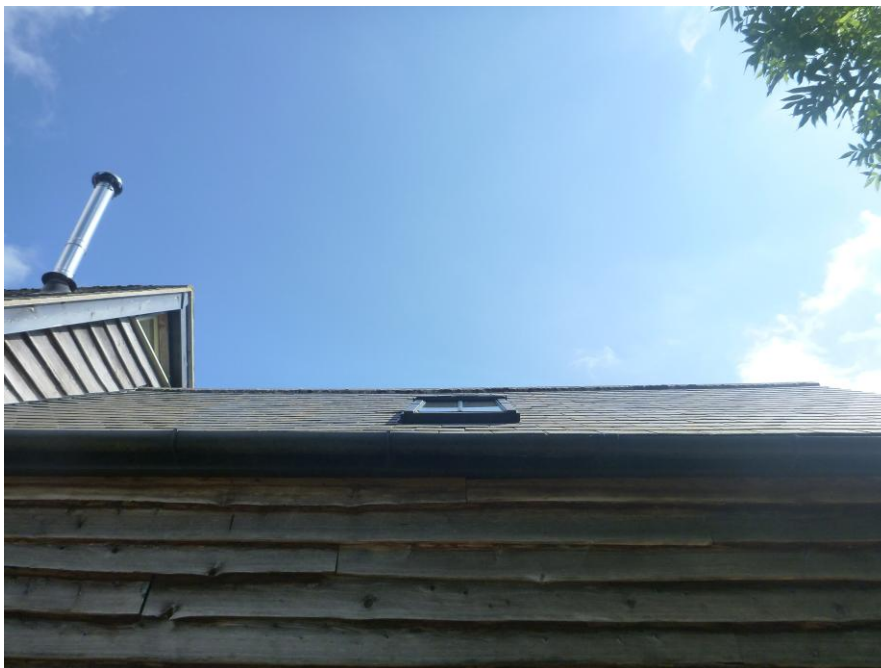
The roof of the barn is slate and the property is fully converted to the ridge with roof lights incorporated along both aspects. The slates are tight fitting and none were noted to be lifted, slipped or damaged. The ridge tiles are also in good condition and the mortar along the length of the ridge, and at the roof verges, is well sealed.

**Fig 4:** The roof slates and ridges are well sealed.

This photo taken facing east on 19<sup>th</sup> June 2026.

The roofs of the Main Barn and Little Barn are both considered to have Negligible potential to support roosting bats.

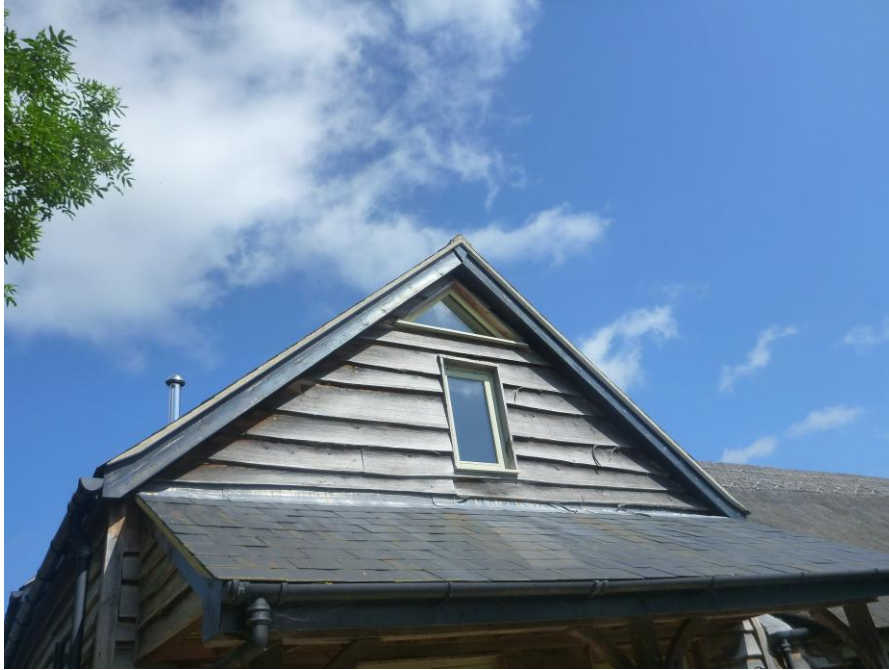
**Fig 5:** The mortar at the roof verges is in a good state of repair.

This photo taken 19<sup>th</sup> June 2026.

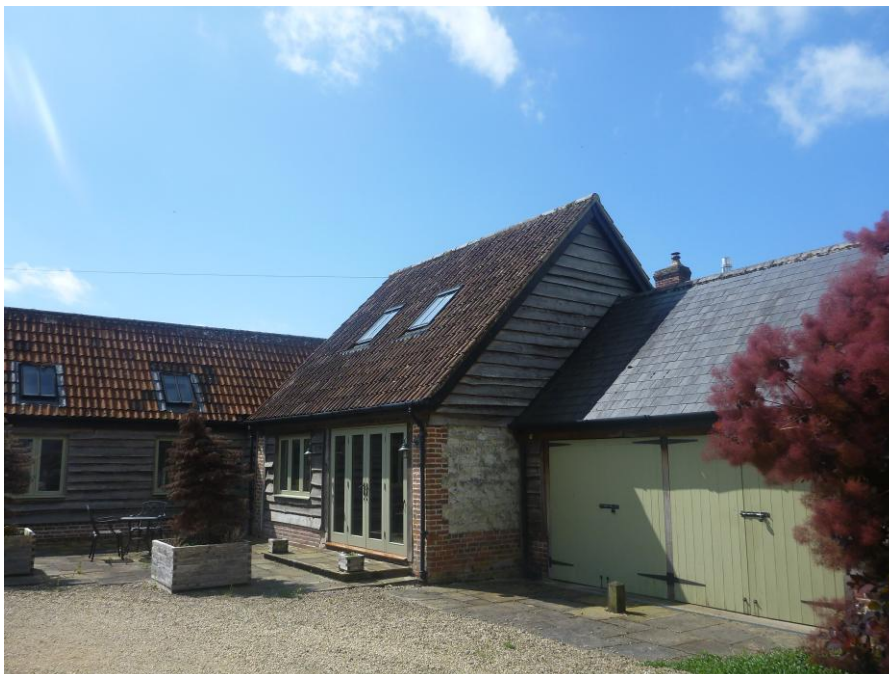
To the south of the Main Barn the Little barn is a single storey building which has brick and stone walls with some waney edged timber. In most areas the roof is clay pantiles with slate on the roof of the garage.

**Fig 6:** The Little Barn.

This photo taken facing south on 19<sup>th</sup> June 2026.

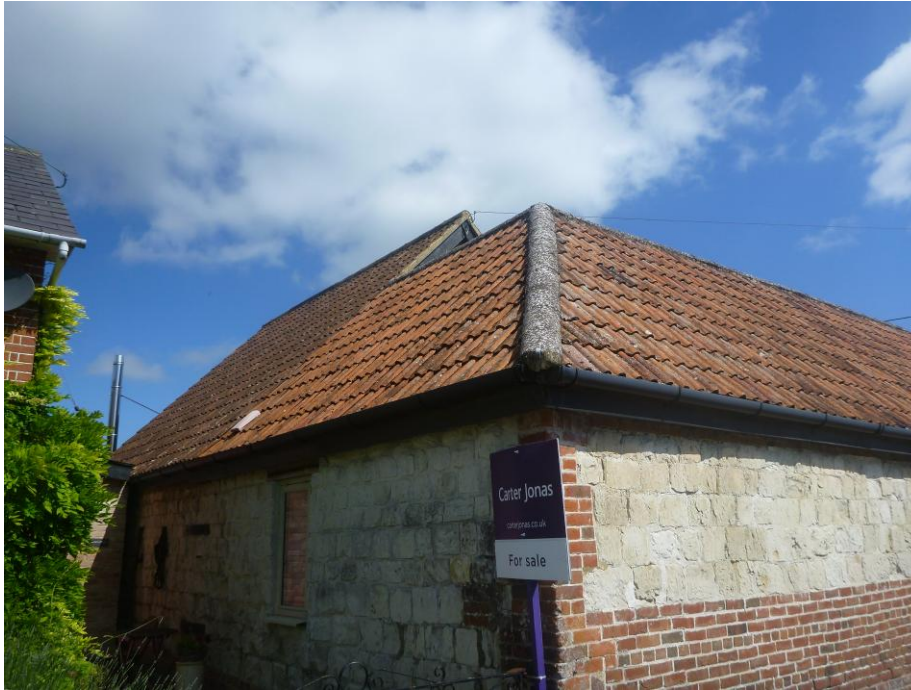
The Little Barn also has no internal void spaces with roof lights installed on the north and east aspects. There are no roof lights on the south or west faces of the roof.

**Fig 7:** There are no roof lights installed in the south or west faces of the roof of the Little Barn.

This photo taken facing northeast on 19th June 2026.

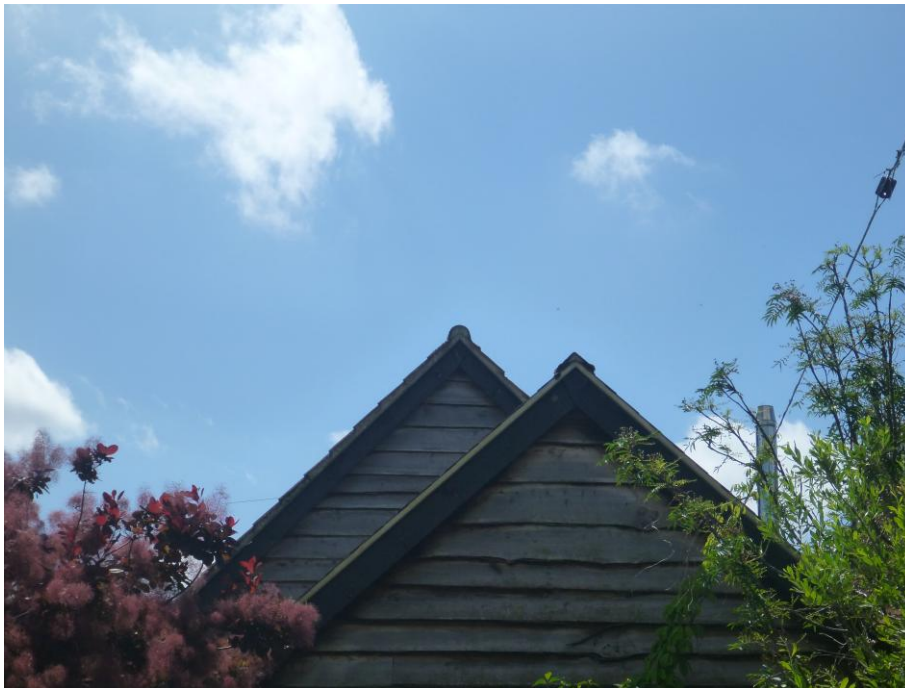
The roof of the Little Barn is also well sealed with no lifted, slipped or damaged tiles and mortar at the ridge, hips and roof verges in good condition.

**Fig 8:** The mortar at the roof verges is in good condition.

This photo taken facing south on 19<sup>th</sup> June 2026.
