# ALDERBURY HOUSE, SALISBURY

## Proposal for changes to the walled garden

### Heritage Impact Assessment and Statement of Significance

Ptolemy Dean Architects

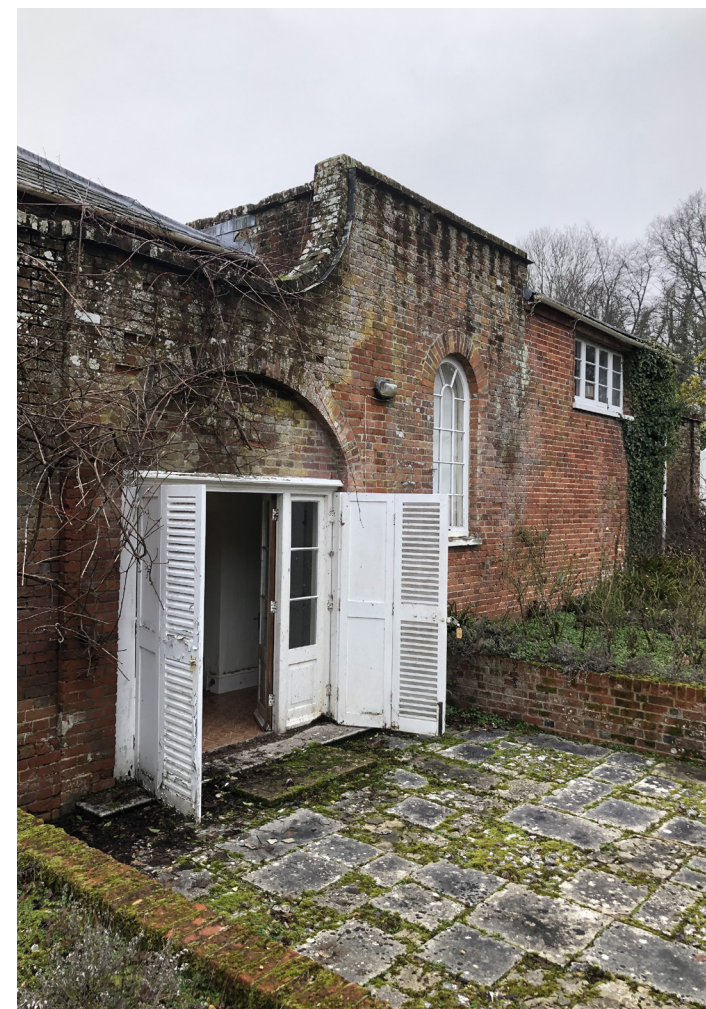
Figure 01. South service range east elevation, with a muddle of different levels and steps in combination with the assorted 1960's fenestration

Alderbury House is a substantial building by S. P. Cockerell constructed in the 1790's. It consists of a principal range, faced with stonework salvaged from the demolished campanile of Salisbury Cathedral, and two red brick service ranges. Archival research undertaken as part of the project identified a surviving cost book which confirms that the house, service range, coach house and walled garden are all part of single composition by S. P. Cockerell. Consent was granted in March 2022 (PL/2022/00073) to repair and remodel those ranges so that they created an improved relationship with the very beautiful walled garden that lies to the east. An elevation that had been badly remodelled in the 1960's (Figure 01) has now been reordered to express architecturally its compact service ranges once more (Figure 02).

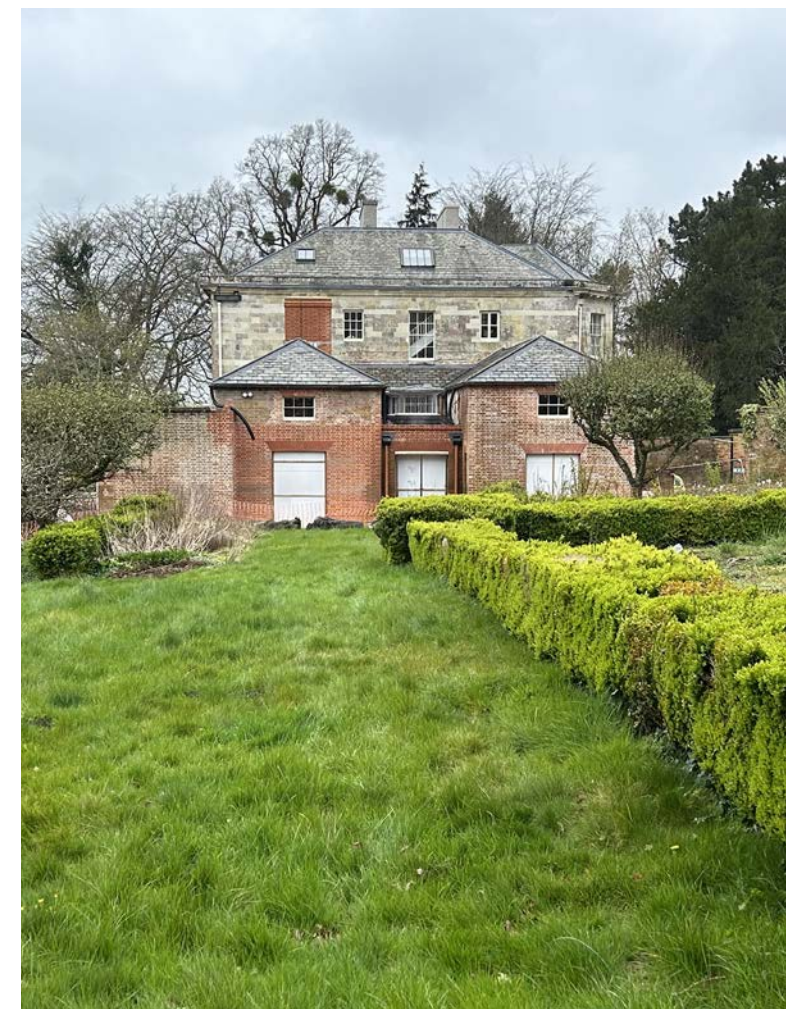
Figure 02. South service range east elevation, now re-ordered to express its compact ranges

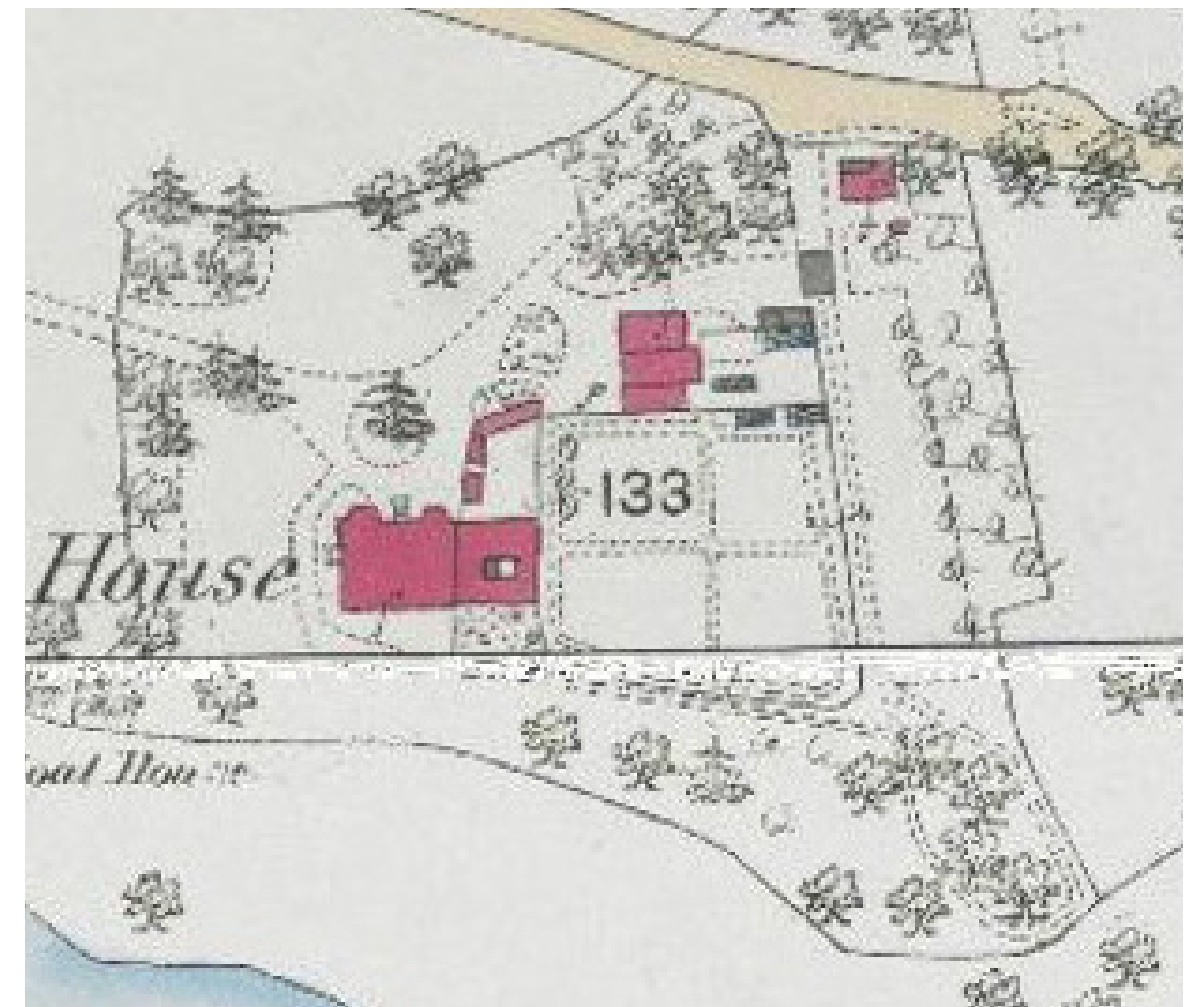
Figure 04. 1885 OS 1st Edition Map (Know Your Place Wiltshire)

A separate building south east of the walled garden had already disappeared by the date of the first edition OS map of 1885 (Figure 04). This first detailed and accurate plan shows the walled garden with a characteristic cruciform arrangement of paths and glasshouses in its NE corner. Apparent also is the addition of further service and glasshouse buildings built up against the north and east sides of the second walled garden area to the east of the Coach House. This second walled area would have provided a discrete location for additional support and service accommodation.

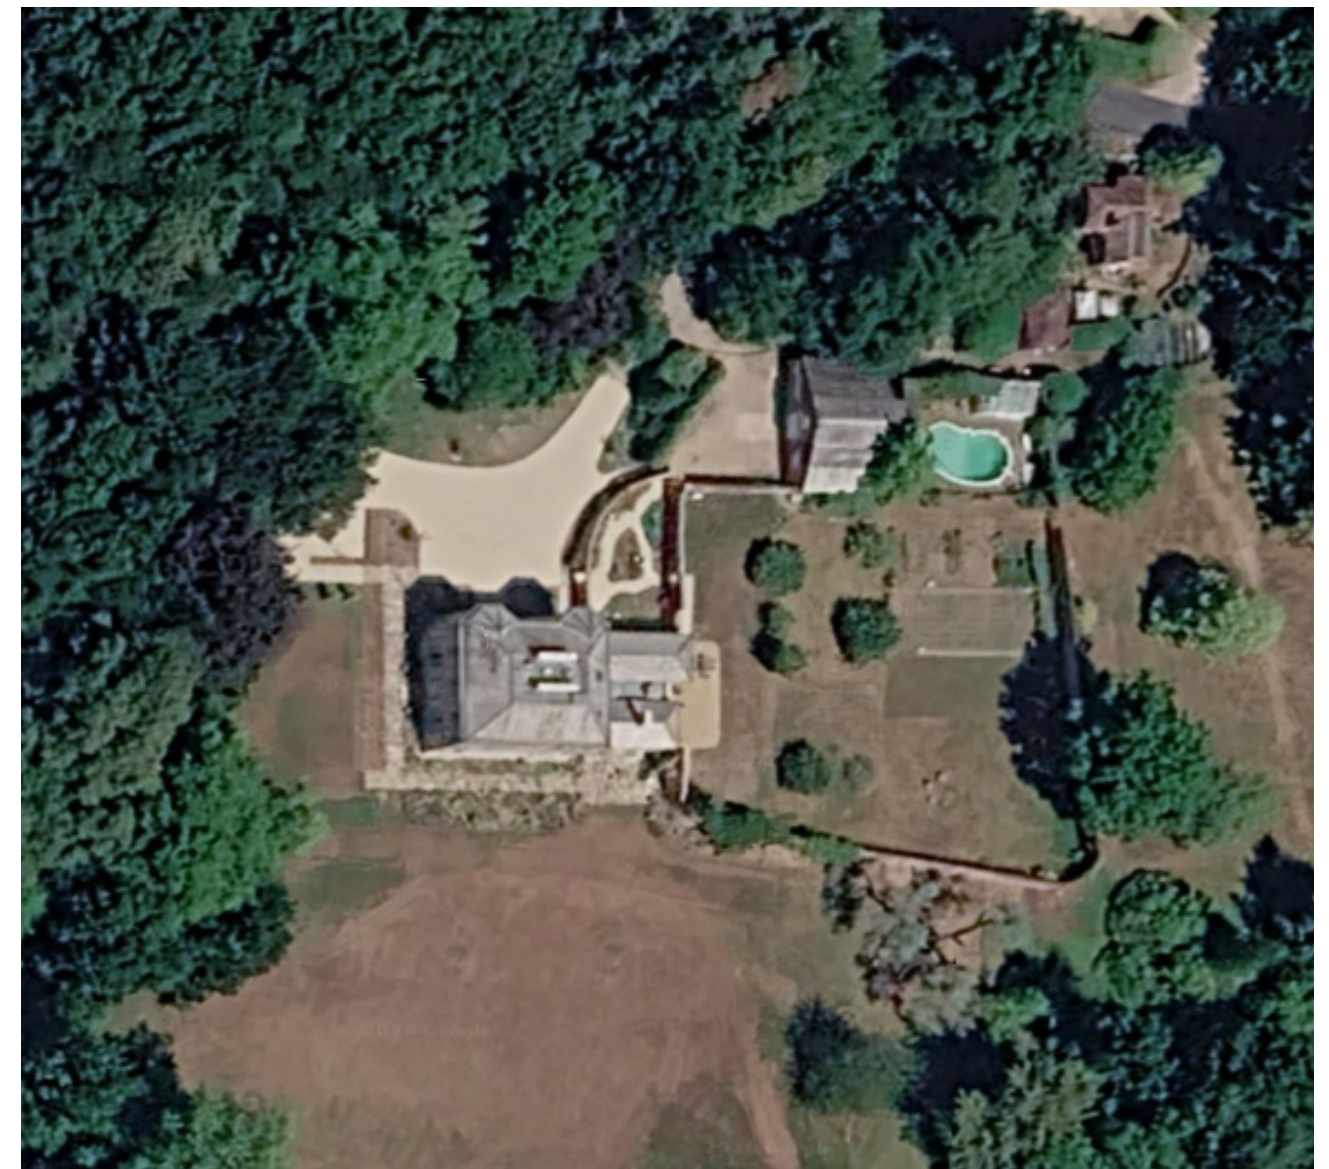
Figure 08. Aerial view of Alderbury House, 2026 (Google). This view shows the recently created landscaping already achieved by Charlie Hawkes to the west of the walled garden.

The current OS map (Figure 07) shows the walled garden toned in grey, extending up to the east of the Coach house, with the free-standing out range and Garden lodge to the north east. It can be compared with the Google earth view, where the kidney-shaped swimming pool occupies the area of walled garden to the east of the Coach House (Figure 08).

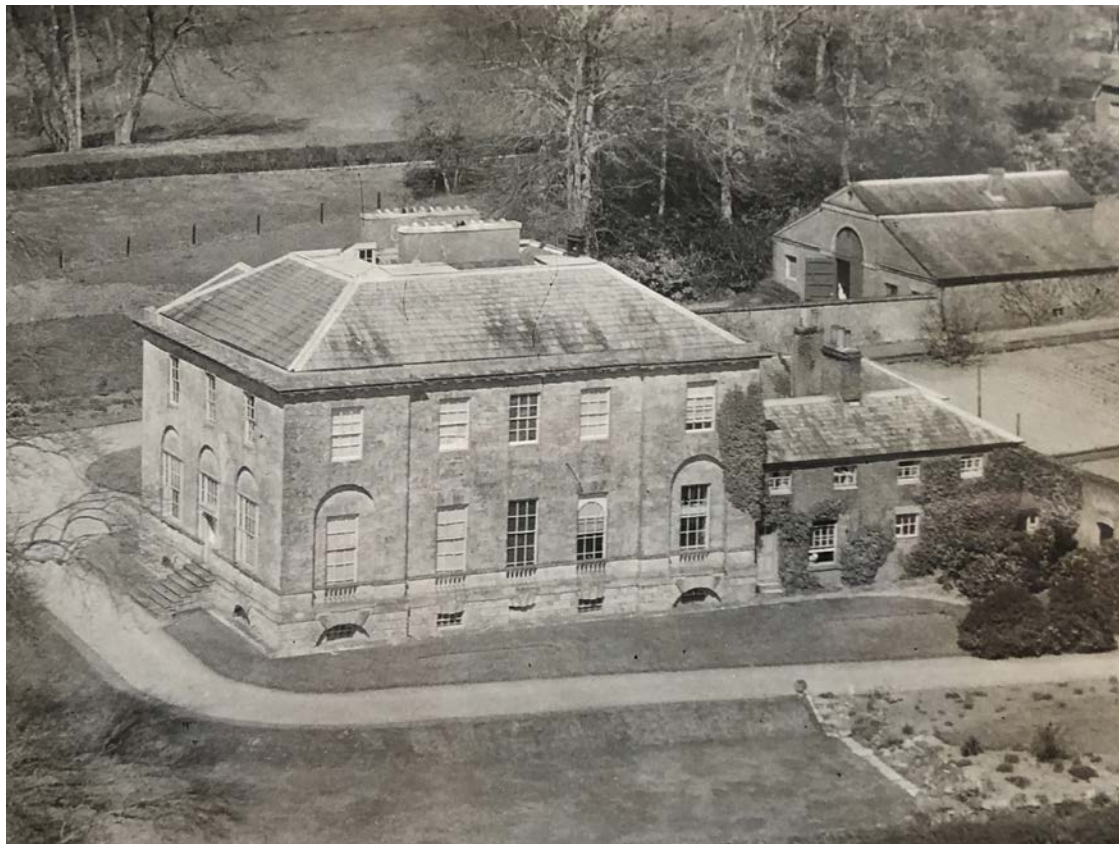
Figure 09. Early C20th aerial view of Alderbury House showing the southern elevation of the service range and walled garden beyond (Lady Wrenbury's private collection)

Unsurprisingly, there are very few images of the walled garden from earlier years, as this was a working part of the estate. An aerial view, perhaps of mid-C20th date, shows the western part of the walled garden prior to the 1960's and 1980's alterations (Figure 09). The existing SW entrance of the walled garden is shown, but none of the buildings to the east of the Coach house. These lost service ranges can be made out on a further aerial view, taken from a moving aeroplane further to the south east (Figure 10). Unfortunately, there are focus challenges to this image, but the former glass houses are shown in the north east corner, along with the division wall between the main body of the walled garden and the smaller area to the east of the coach house. The garden itself appears to be traditionally cultivated for domestic produce with its cruciform plan of pathways in tact.

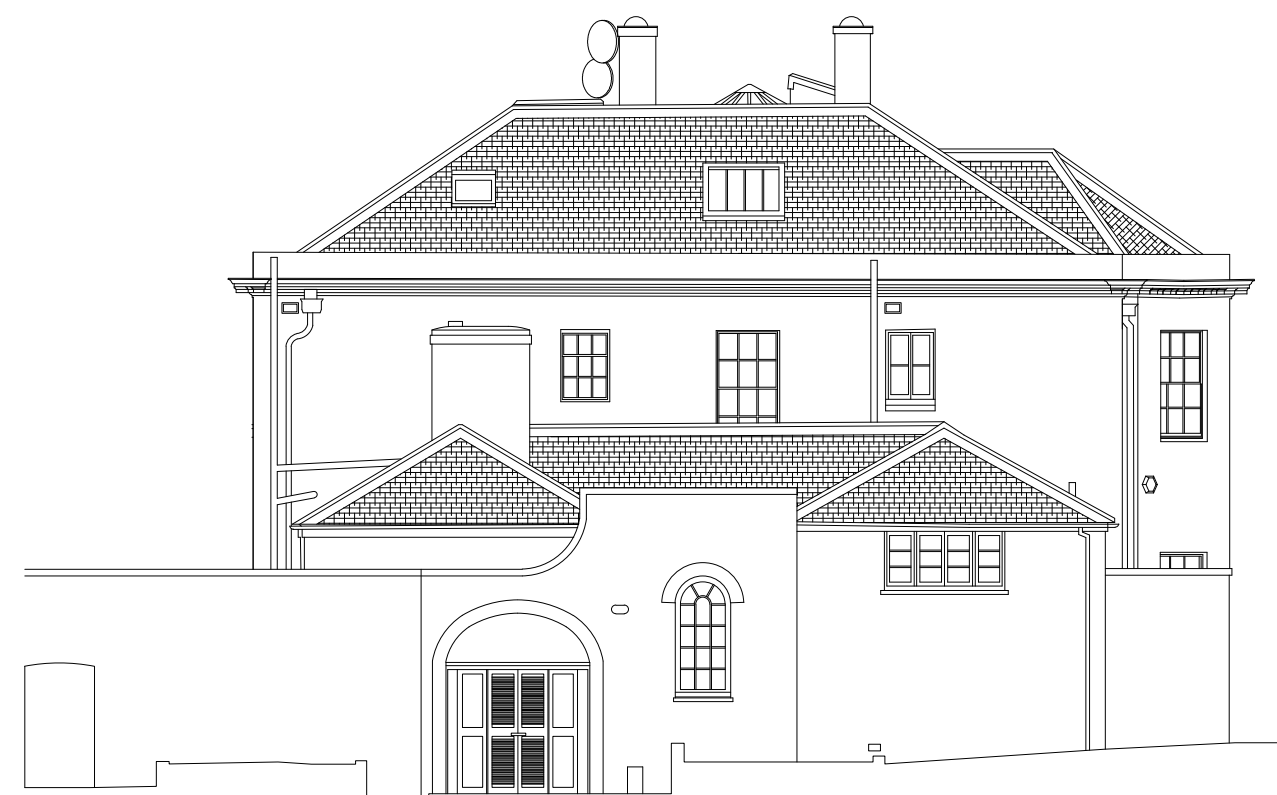
Figure 13. East elevation, as existing in 2021

It was proposed that the elevation to the east, that looks into the walled garden, should be remodelled into a garden frontage retaining and improving the connections between the house and garden on this side. The existing rather unbalanced elevation created in 1963 (Figure 13), was remodelled to form a new garden front with french doors opening out into the walled garden from a new kitchen and dining area formed in this area (Figure 14).

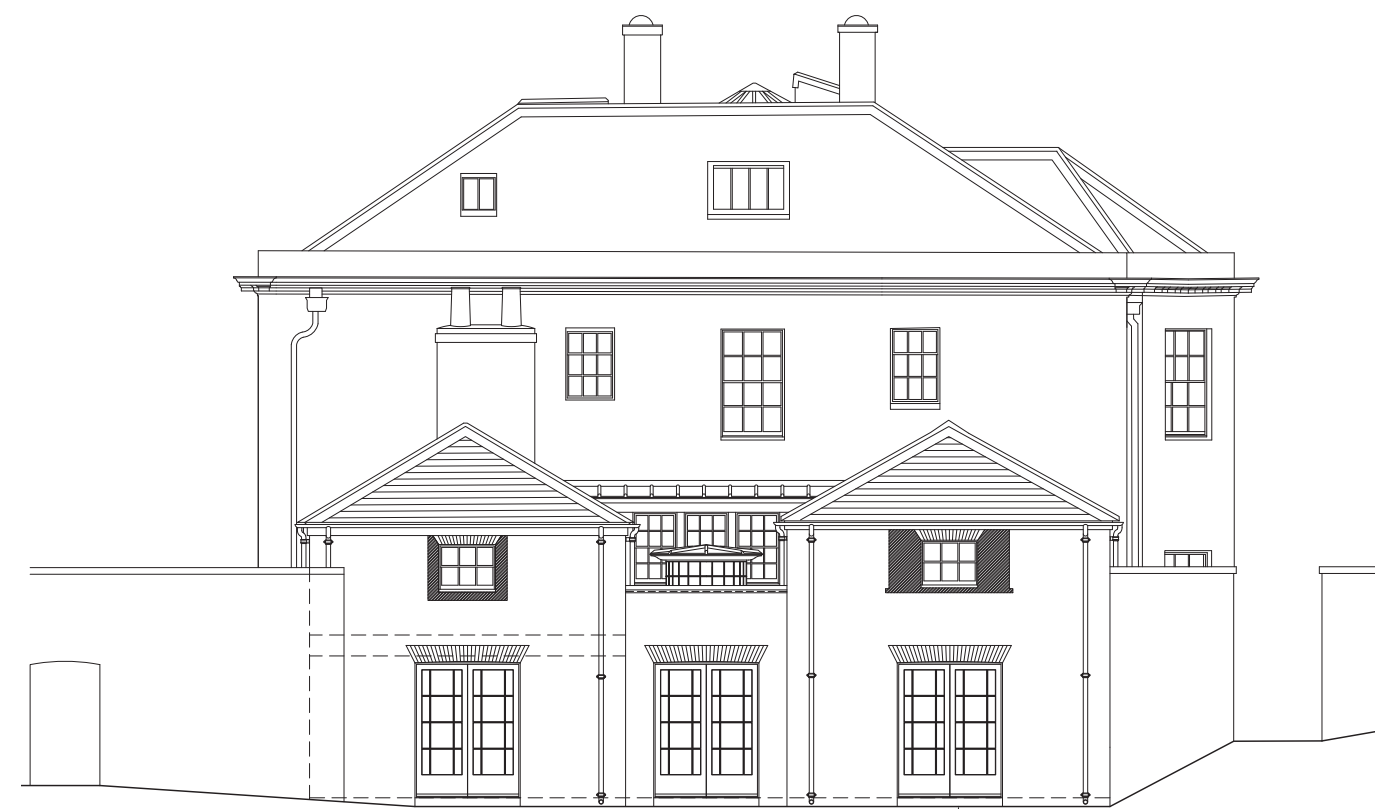
Figure 14. East elevation consented proposal, completed 2024

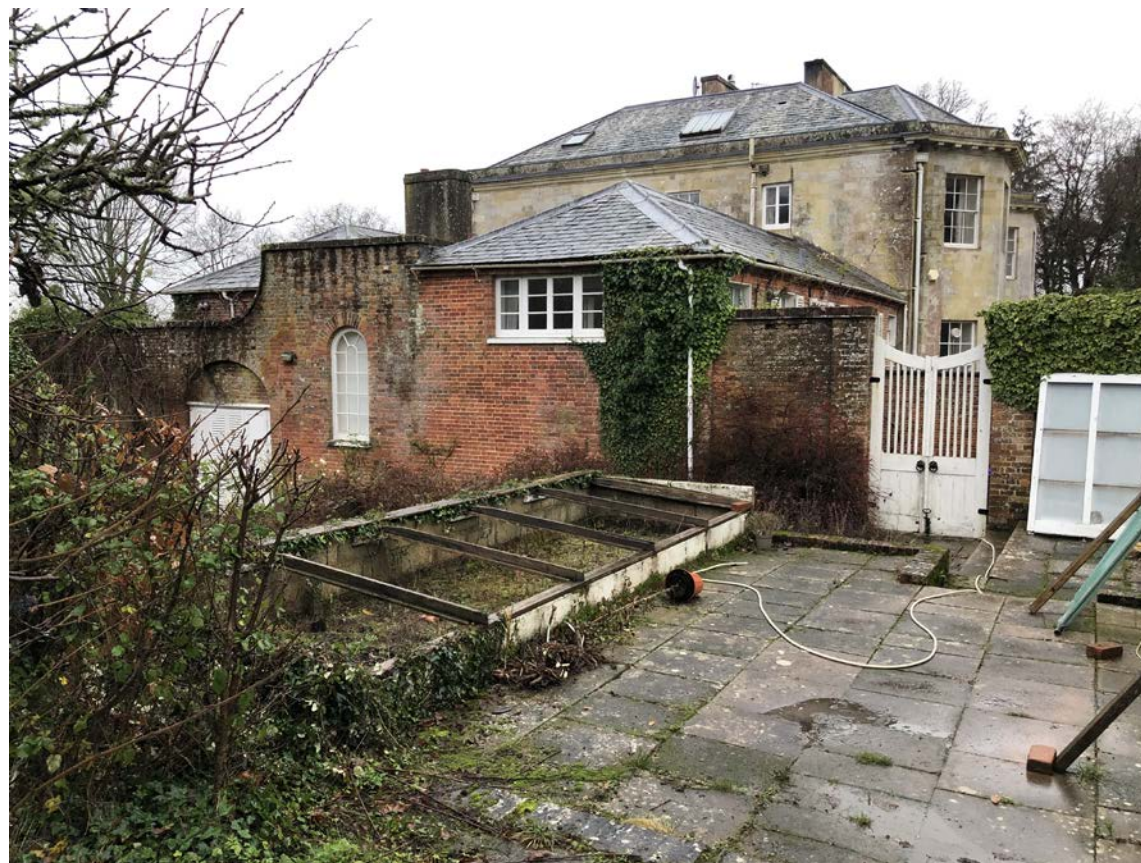
Figure 16. The C20th gateway opening to the right prior to the commencement of the works.

In June 2024, a further application was made to try to improve levels and entrances to the north west corner of the walled garden where it abutted the former service range (now kitchen). The proposal, which, was consented, replaced a 1960's double door entrance to the walled garden that was badly decayed with one to match the more historic proportions and pattern that had survived elsewhere. The existing entrance and associated landscape had become very rundown and visually intrusive (Figure 16). The 'traditional' Cockerell era brick opening appeared to survive best on the south west corner of the walled garden (Figure 17). The work has now been carried out in association with a scheme to repair the brick walls of the walled enclosure north of the service range and to re-landscape it (Figure 18 & Figure 19).

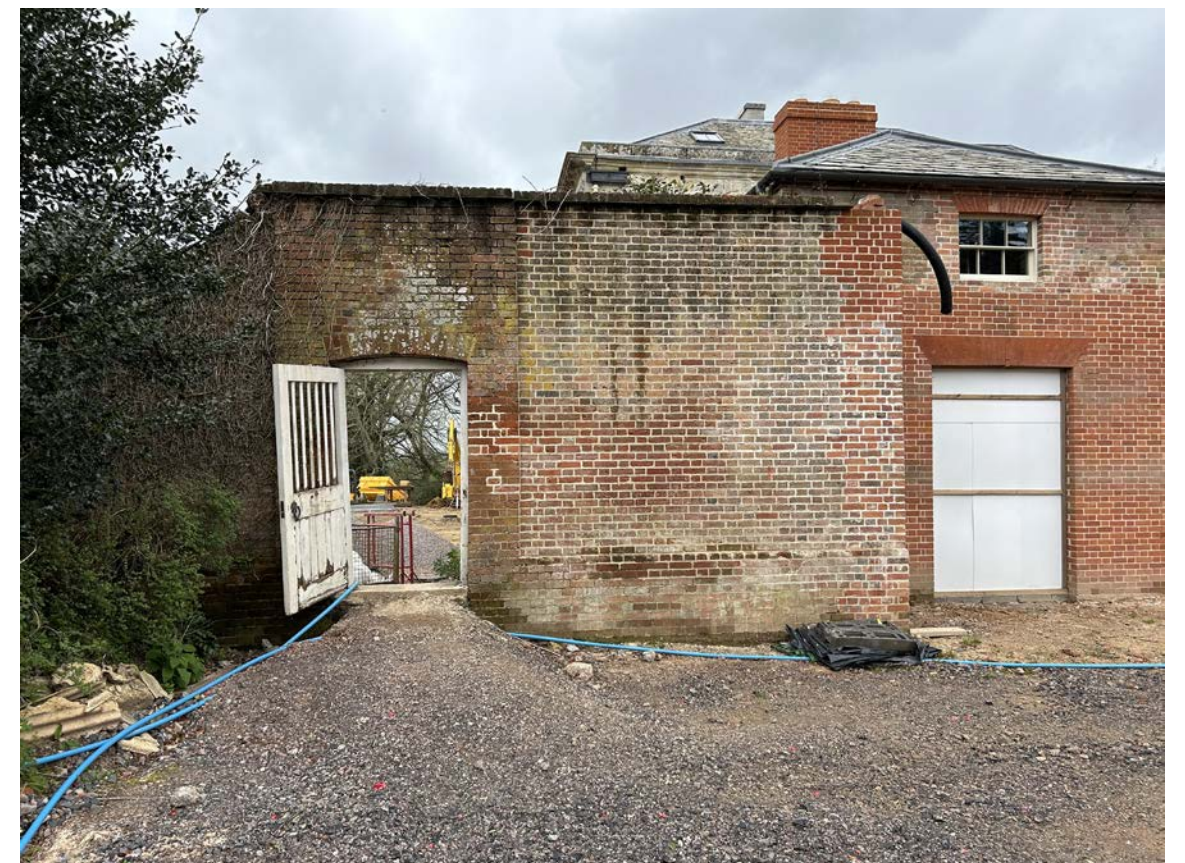
Figure 17. Cockerell period door opening to the SW, which is set in a thicker brickwork panel

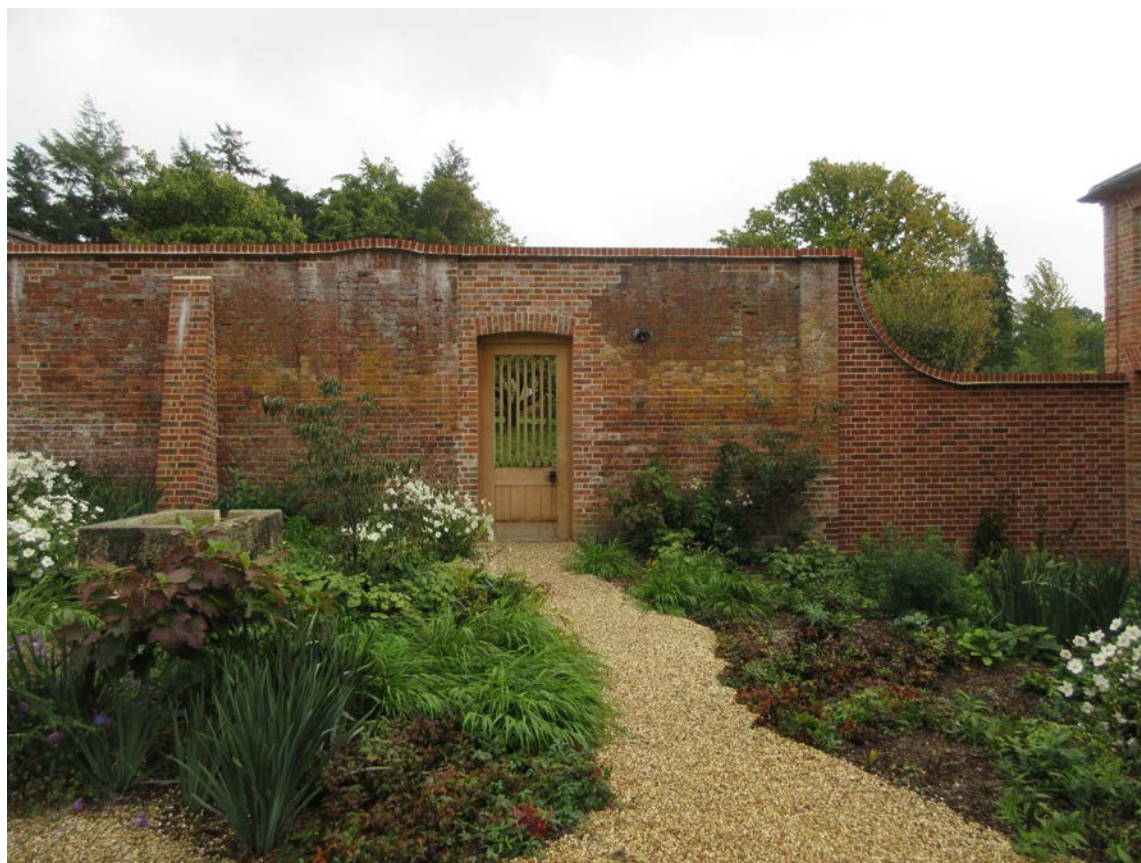
Figure 18. 2025 completed works to area north west of the main house, with a new single doorway

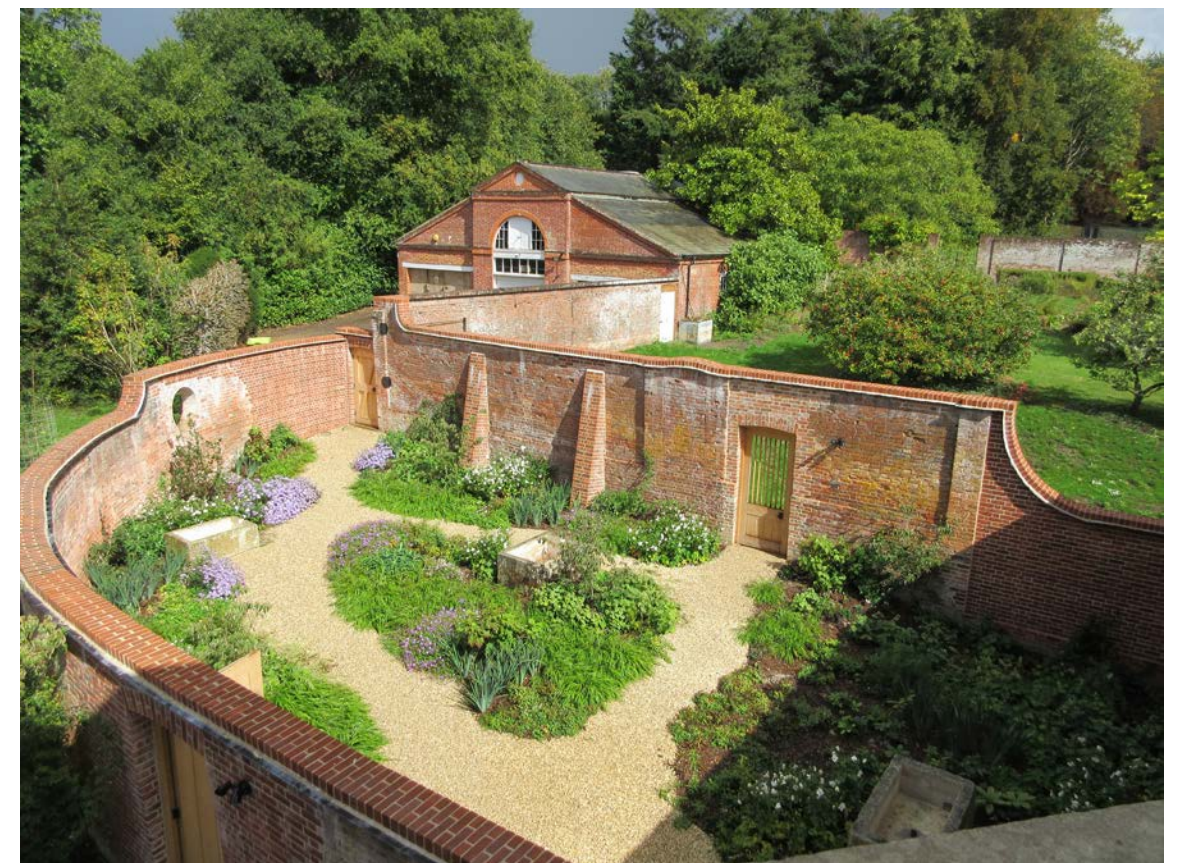
Figure 19. 2025 completed landscaping works to walled area north west of the main house

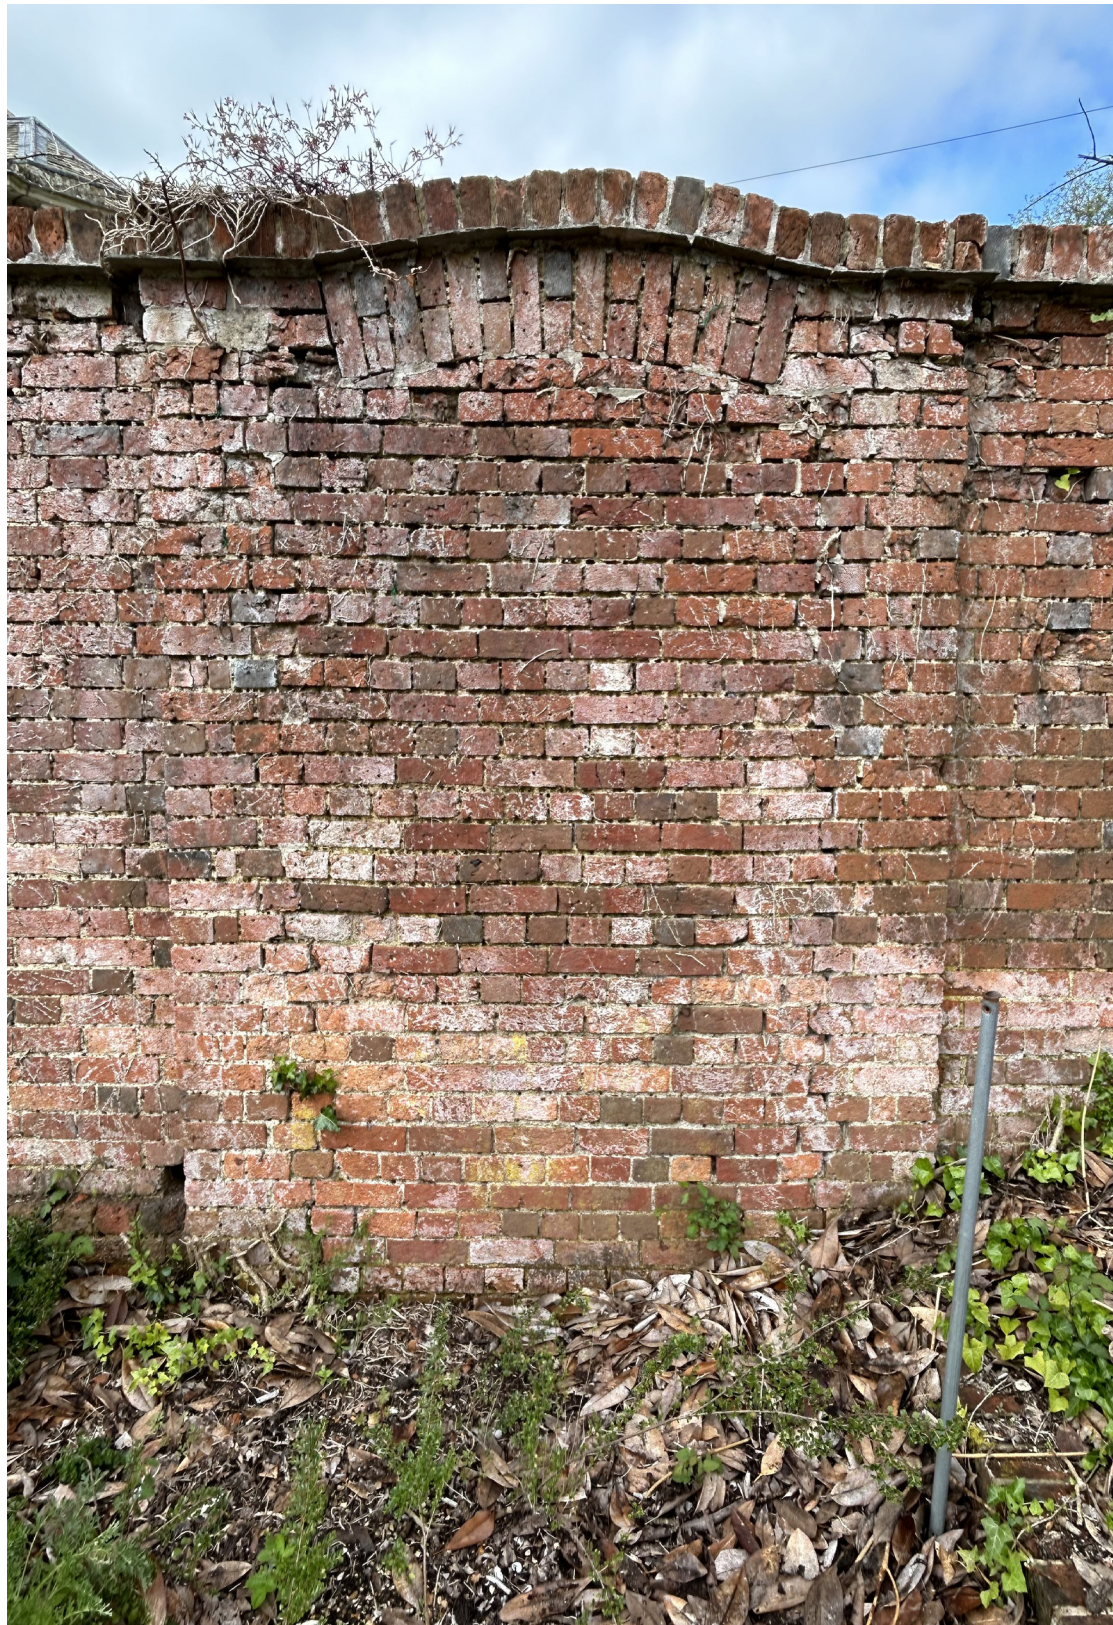
Figure 20. On the west face of the wall, the historic opening is closed by bonded brickwork

Elsewhere, there are hints of other original brick openings that have not been utilised, one of which remains on the west wall to the north of the main house service range (Figure 20). This opening would have made sense on plan but dramatic changes of level on site made it unachievable and this might have caused it to be abandoned mid-construction. And there are also later copies or re-openings of blocked openings, such as that in the south east corner of the walled garden, which appears to be a later opening (Figure 21). This opening is provided with a metal gate, which appears to be of C20th manufacture.

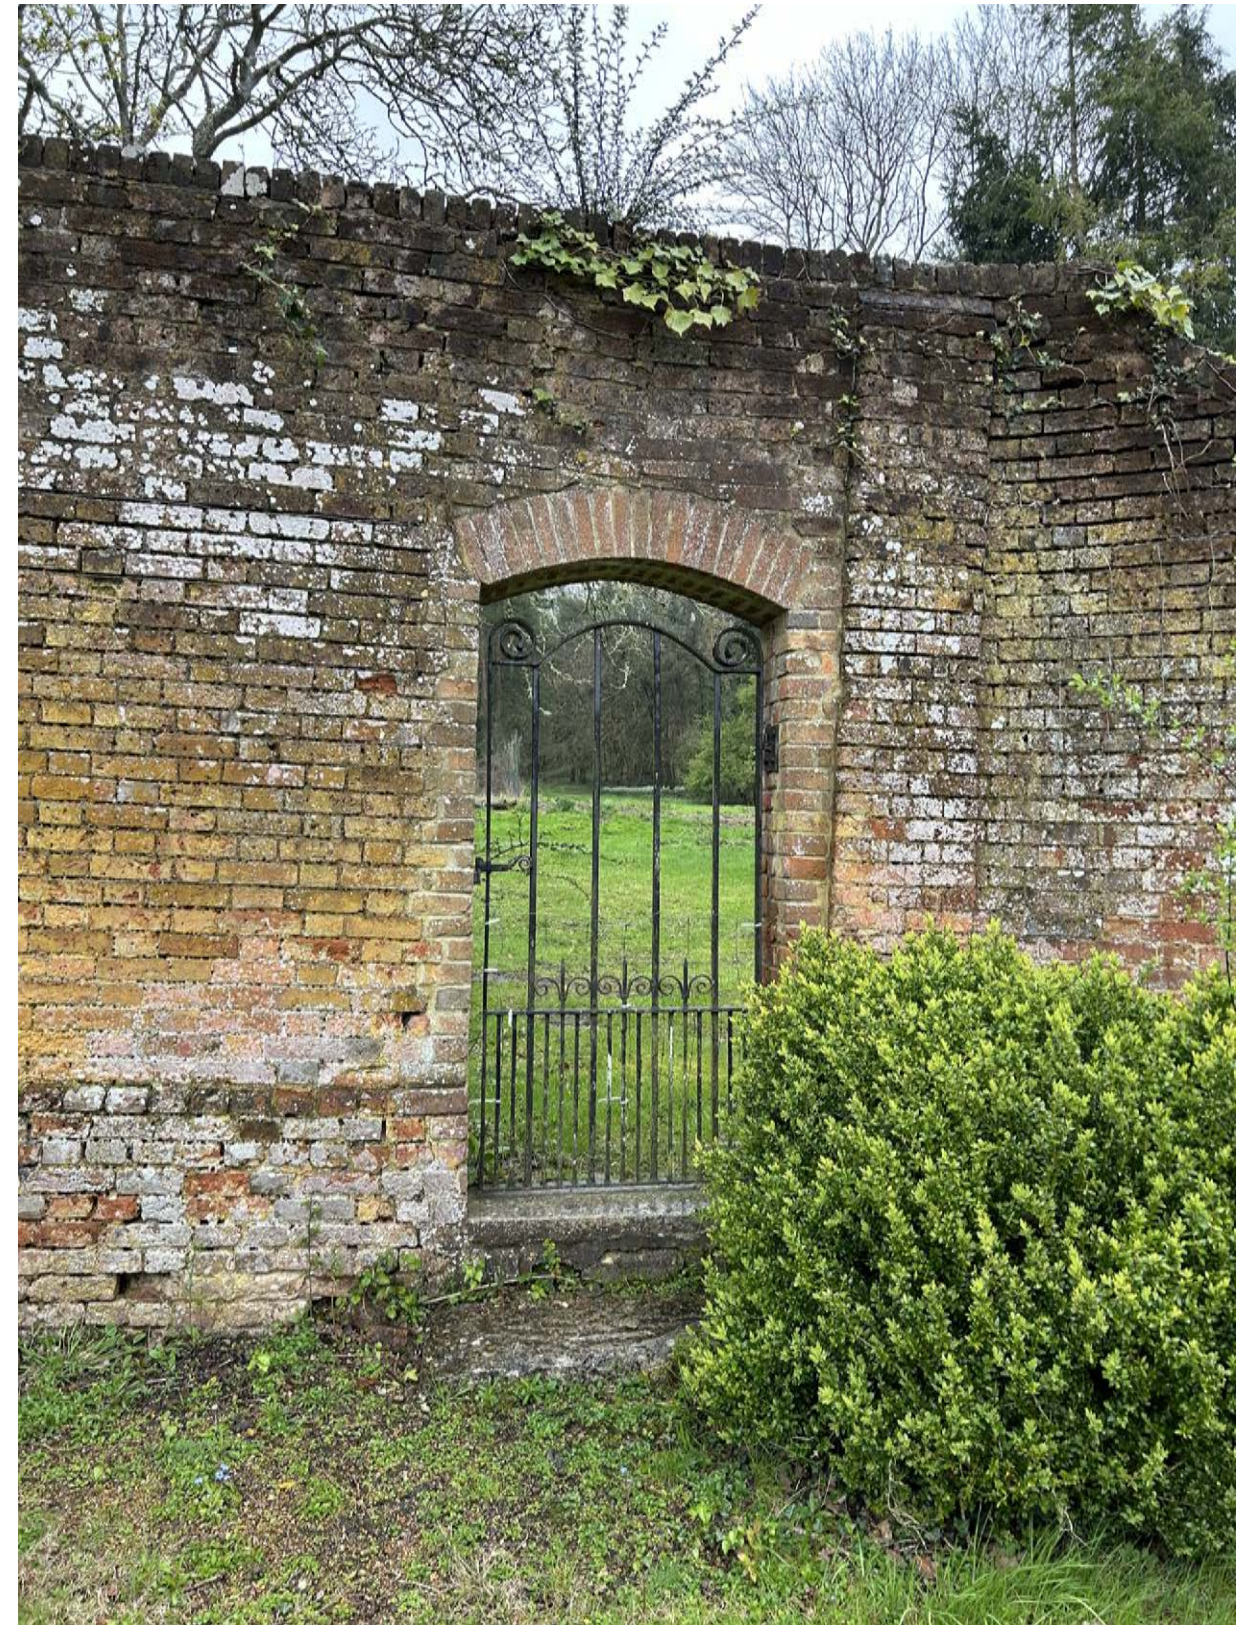
Figure 21. The opening in the S.E. corner of the walled garden which was evidently a later insertion

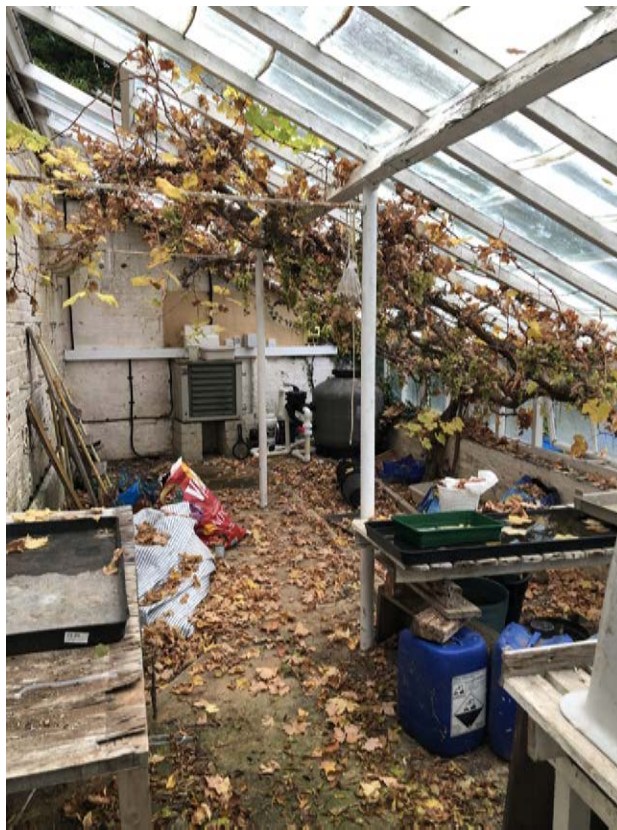
Figure 27. Glasshouse located east of the Coach house along the north garden wall.

The area to the north of the walled garden in the former service yard of the Coach house is more confused. An extensive glasshouse survives on its north wall, complete with vines (Figure 27). There is then the kidney shaped swimming pool from the 1970's surrounded by concrete paving, which is set at a higher level than the eastern front of the Coach house (Figure 28). The eastern elevation of the Coach house, although amended by C20th alteration is surprisingly grand, more so than any other aspect of the building, with its composed brick pediment and tripartite arrangement of ground floor openings (Figure 29). This rather suggests that this part of the building was intended to be seen, and that the walled service yard that was created to the east of it was a later afterthought, added during, or perhaps immediately after, construction.

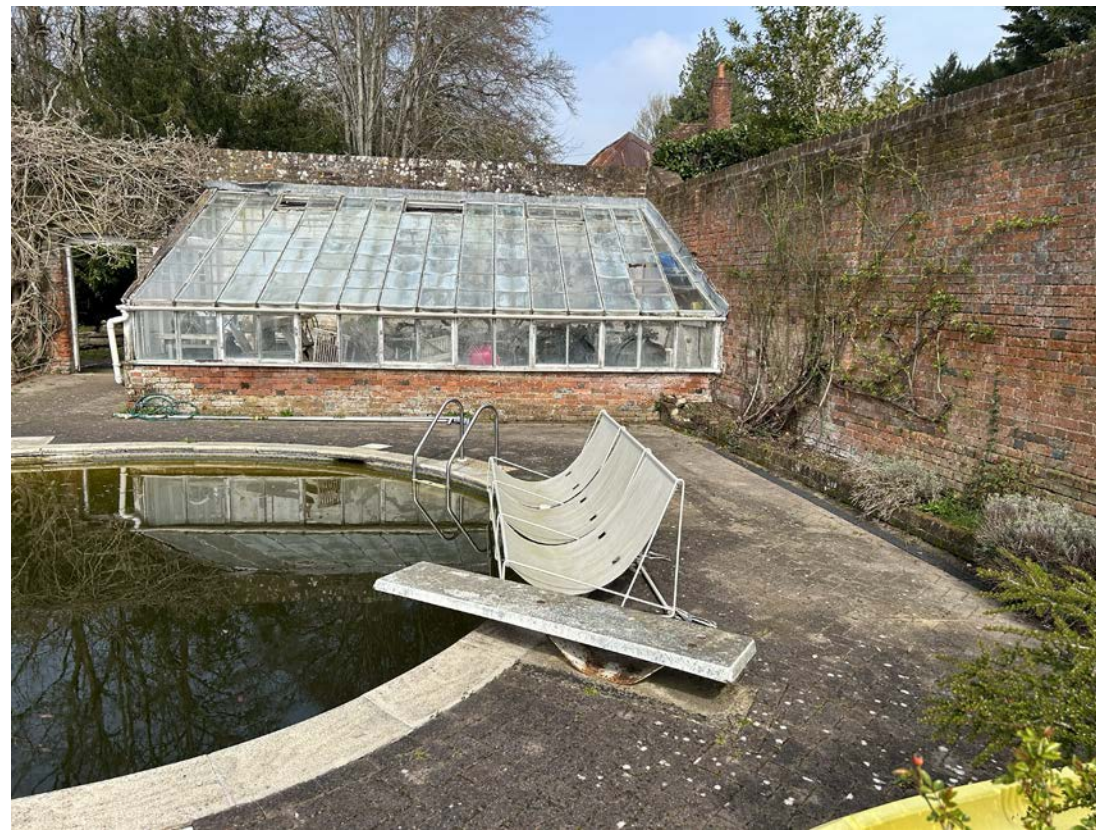
Figure 28. Walled area north of the walled garden with 'kidney' shaped pool and lean to glasshouse

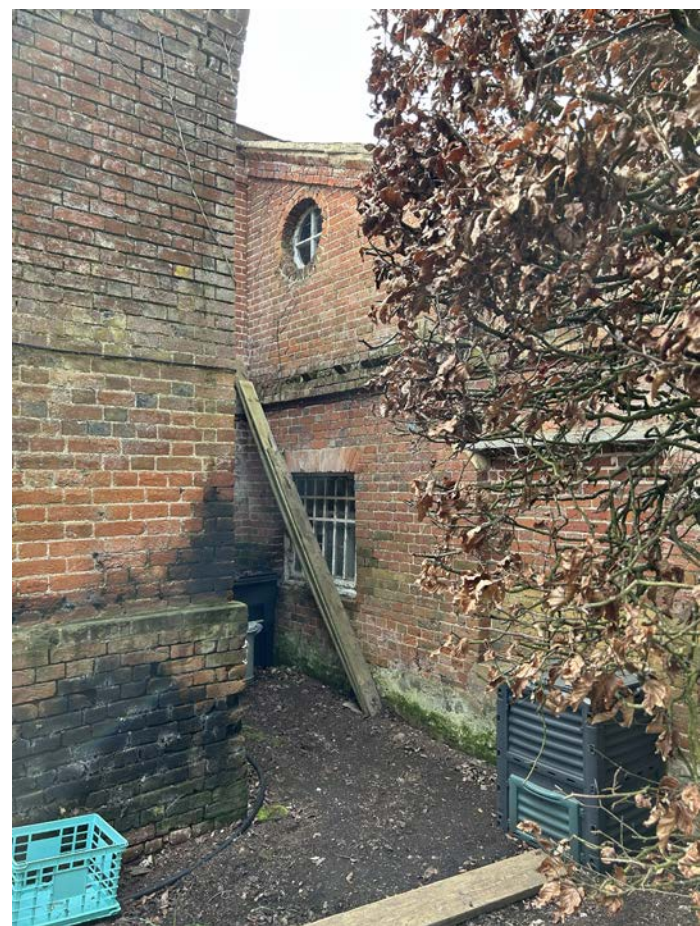
Figure 30. Unsatisfactory wall arrangement with the Coach House and north wall of the walled garden

This would explain the somewhat haphazard and not altogether satisfactory arrangement of walls where they meet the Coach House. Presently the north wall of the walled garden collides mid-way with the northern wing of the Coach House, splitting this elevation into two (Figure 30). Coupled with this, there are raised ground levels which are so high at this part that the brickwork appears very green and damp (Figure 31). Elsewhere, the eastern frontage of the Coach house appears somewhat truncated proportionately (Figure 32).

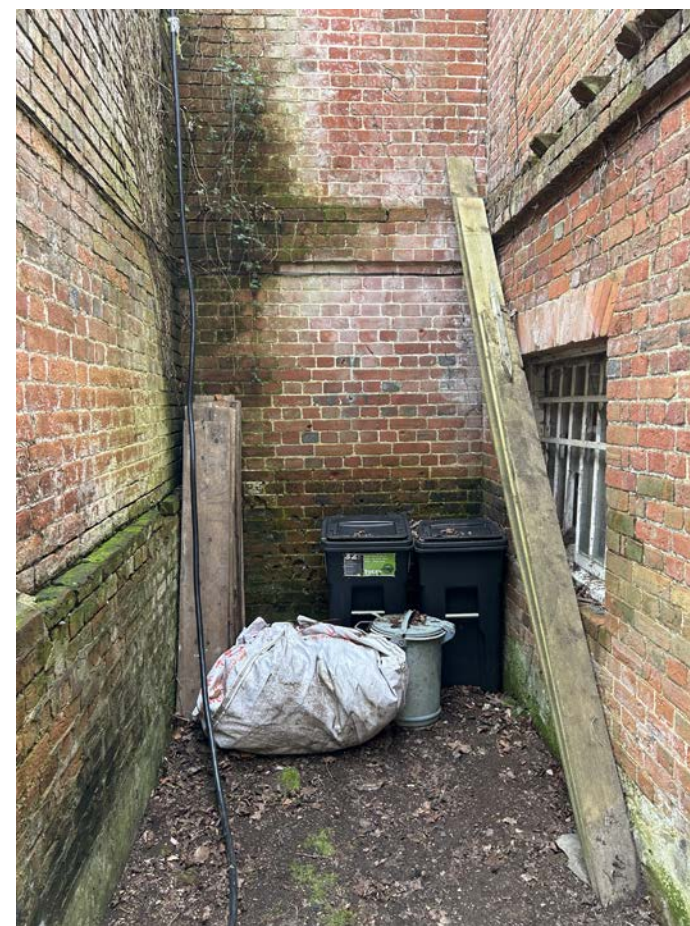
Figure 31. Unsatisfactory area created by the arrangement of the garden wall with the Coach House

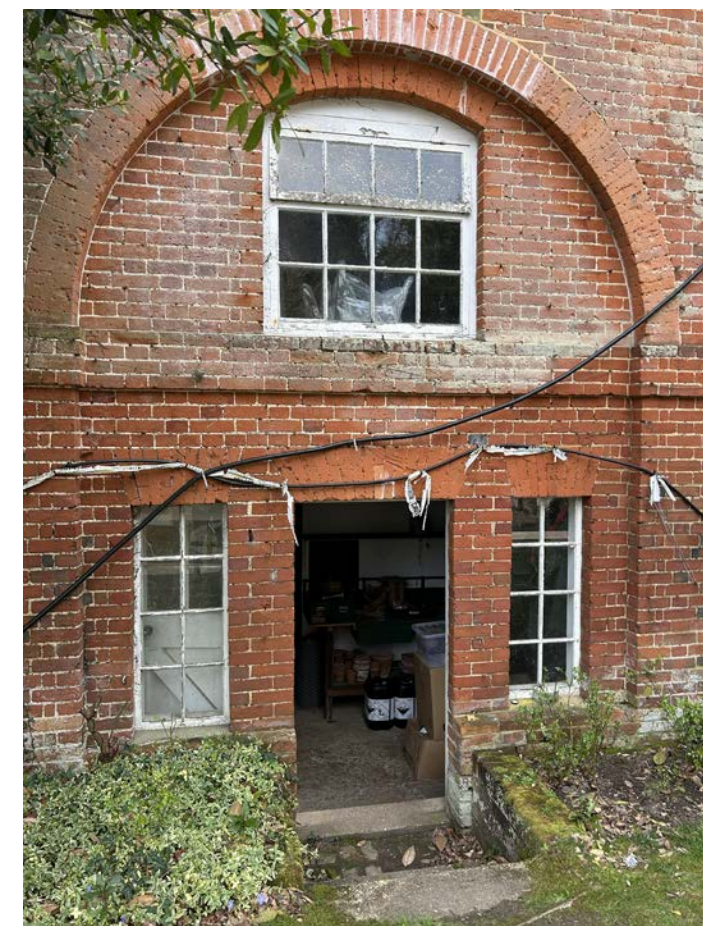
Figure 32. Raised ground levels to eastern side of Coach House, and truncated proportions

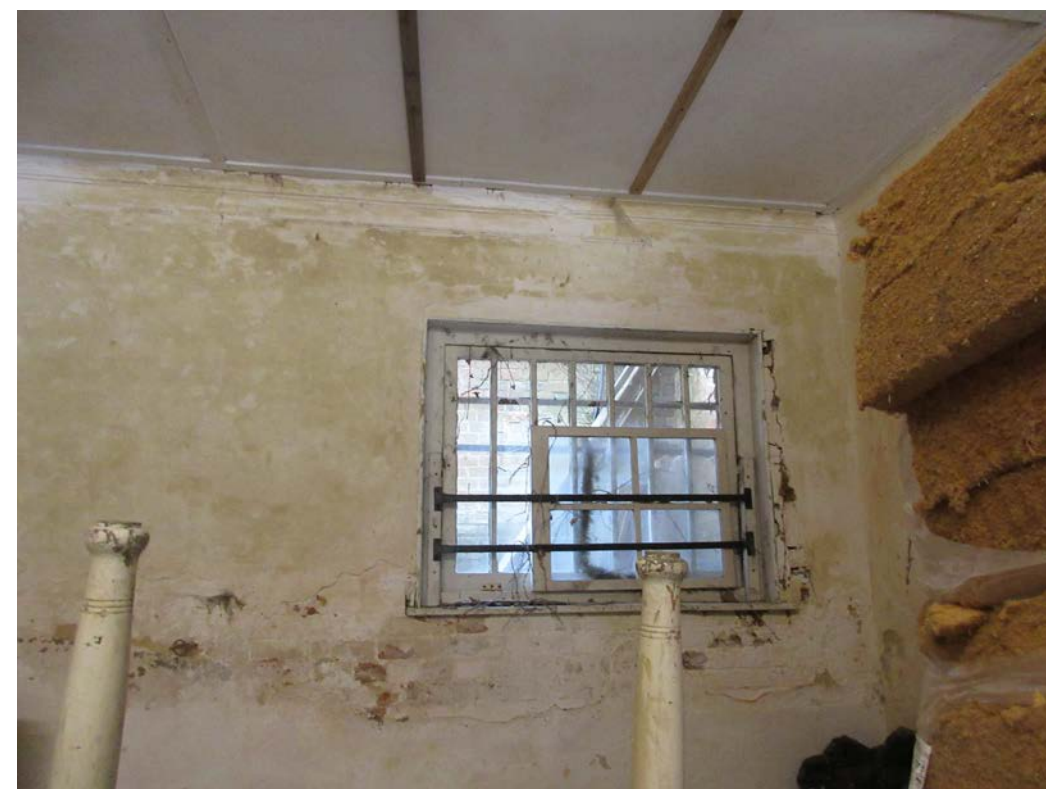
Figure 33. Dampness inside Coach House

This also gives rise to significant issues of dampness in the building itself (Figure 33). On the north side of the walled garden, earth has been mounded up in a semi-disused area where bins are stored (Figure 34). These arrangements, like those previously encountered to the north west corner of the walled garden, adjacent to the service range, rather suggests that the plan of the walled garden and Coach House was set out on paper, but amended to suit the more 'lively' topography that was found on site.

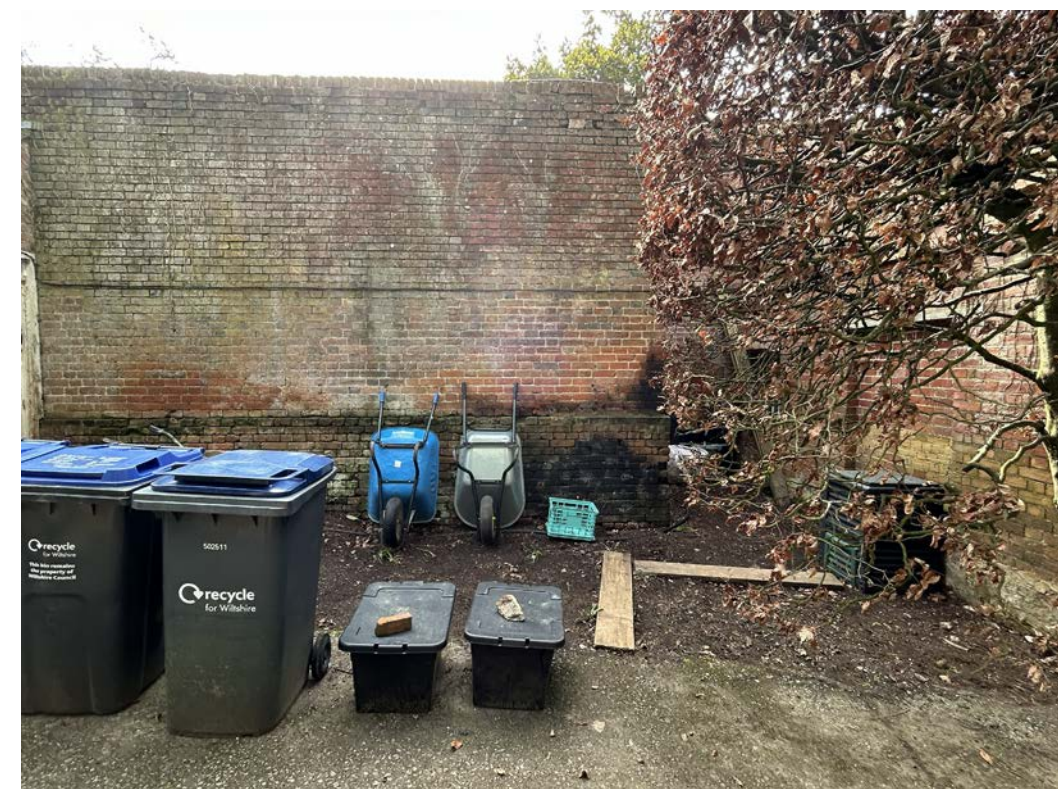
Figure 34. Area north east of the Coach House
