# ALDERBURY HOUSE, SALISBURY

## Proposal for changes to the walled garden

### Heritage Impact Assessment and Statement of Significance

Ptolemy Dean Architects

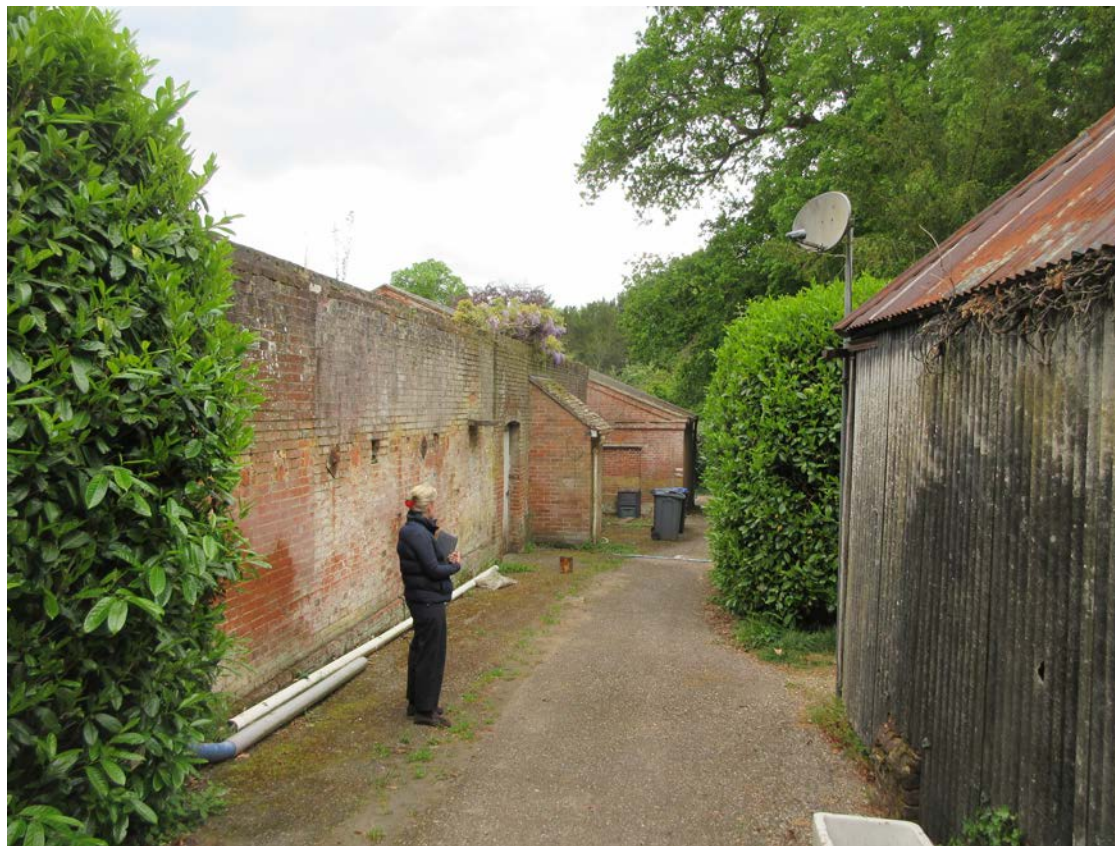
Figure 35. Area north of the Coach House walled garden with corrugated iron sheds

The wider area north of the Coach House and walled garden serves as a service area, which is helpful for storage of items and garden maintenance. There are scars from previous and now removed lean to additions to the walled garden north side which may have related to former potting sheds to service the glass houses (Figure 35). Also on this side is a more modern lean to which accommodates a gardeners WC (Figure 36).

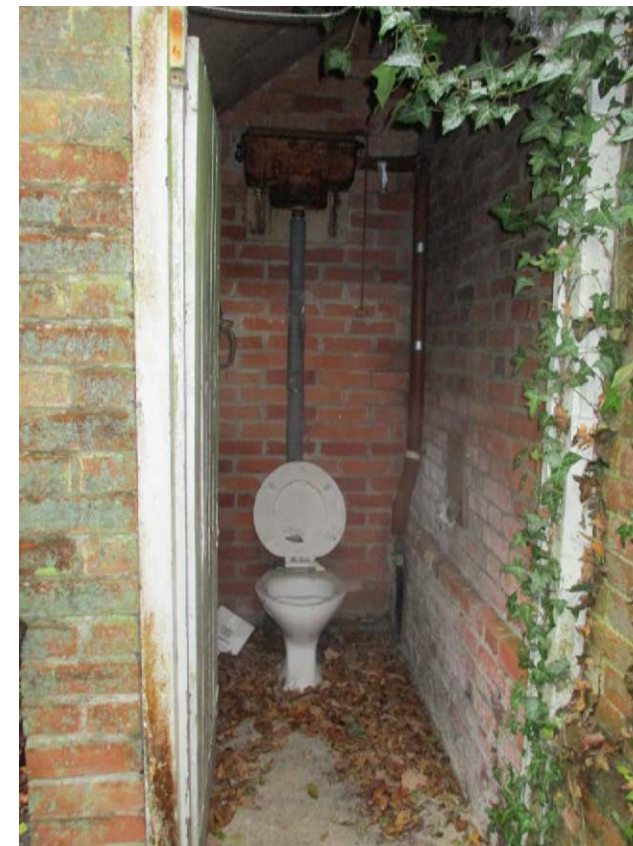
Figure 36. Gardeners WC along garden wall north of the Coach House

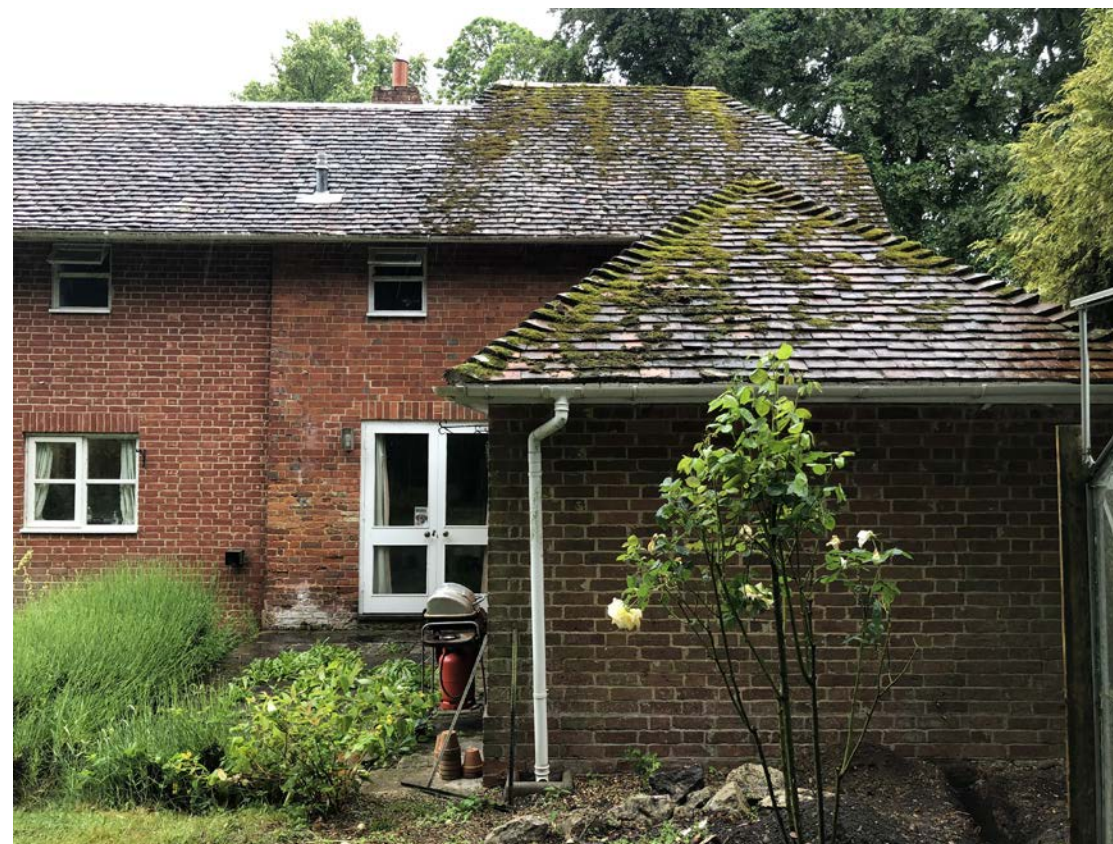
Figure 39. C20th works to Alderbury House lodge.

The rear south facing side of the listed lodge building is well shielded by planting and much altered by C20th extensions (Figure 39).

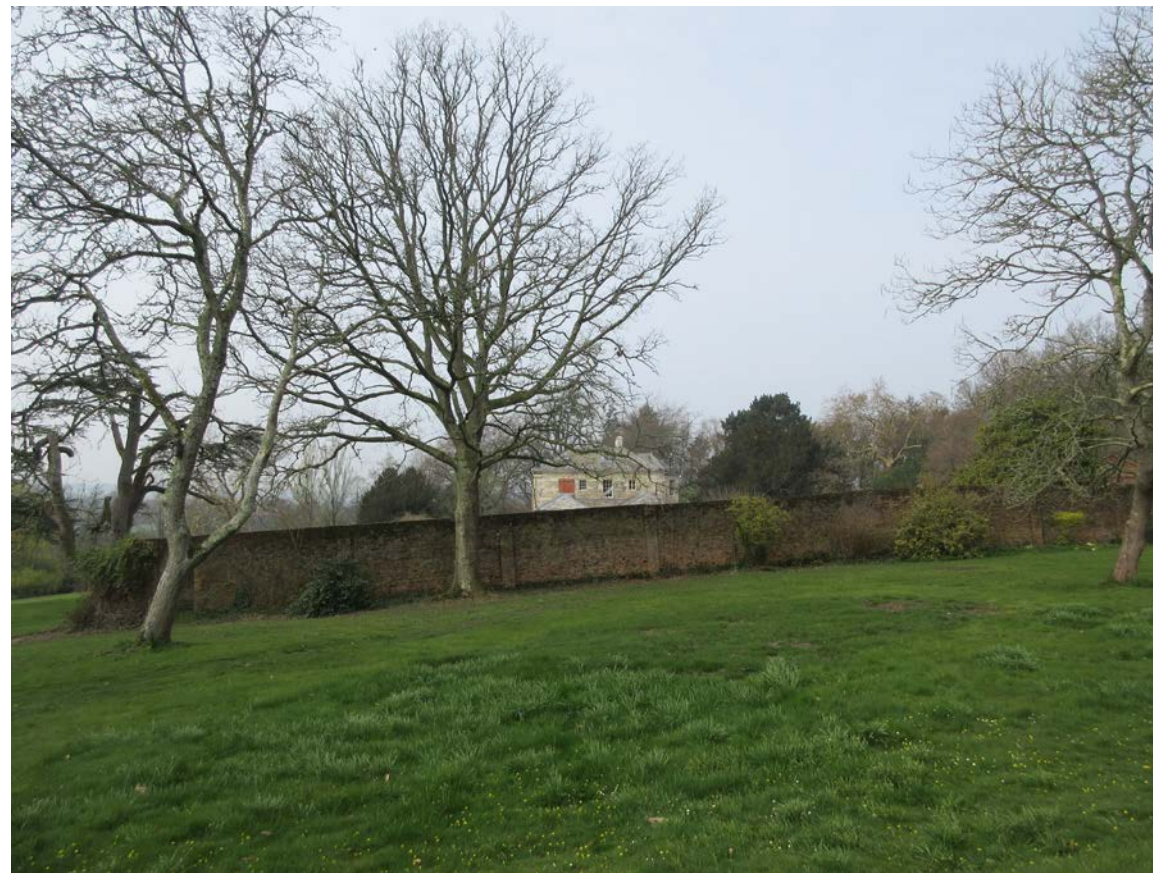
Figure 40. Walled garden following the significant slope in the landscape to the south

The eastern wall of the walled garden follows the topography of the ground which falls to the south (Figure 40). A section of it has been totally removed to allow for more convenient vehicle access (Figure 41). To the west of this is the modern tennis court, which represents a re-surfacing of one that was installed here in the 1960's (Figure 42). The connection of this area back to the walled garden was achieved by the vehicle entrance to the north and the smaller gateway to the south, both possibly inserted in the 1960's. The atmosphere of this part of the site is one of slight abandonment with poor connection back to the house and the rest of the gardens, although the distant view towards the house is attractive (Figure 43).

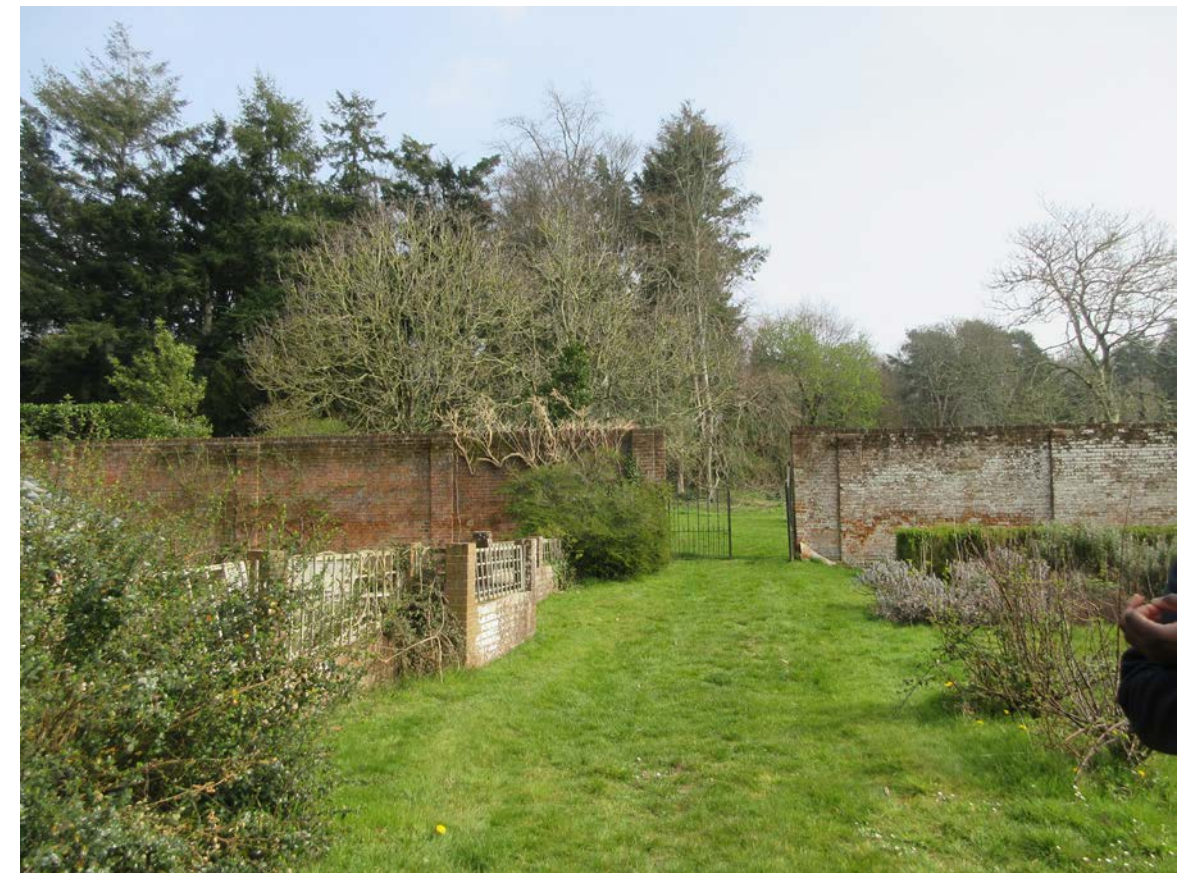
Figure 41. Section of wall removed for vehicular access

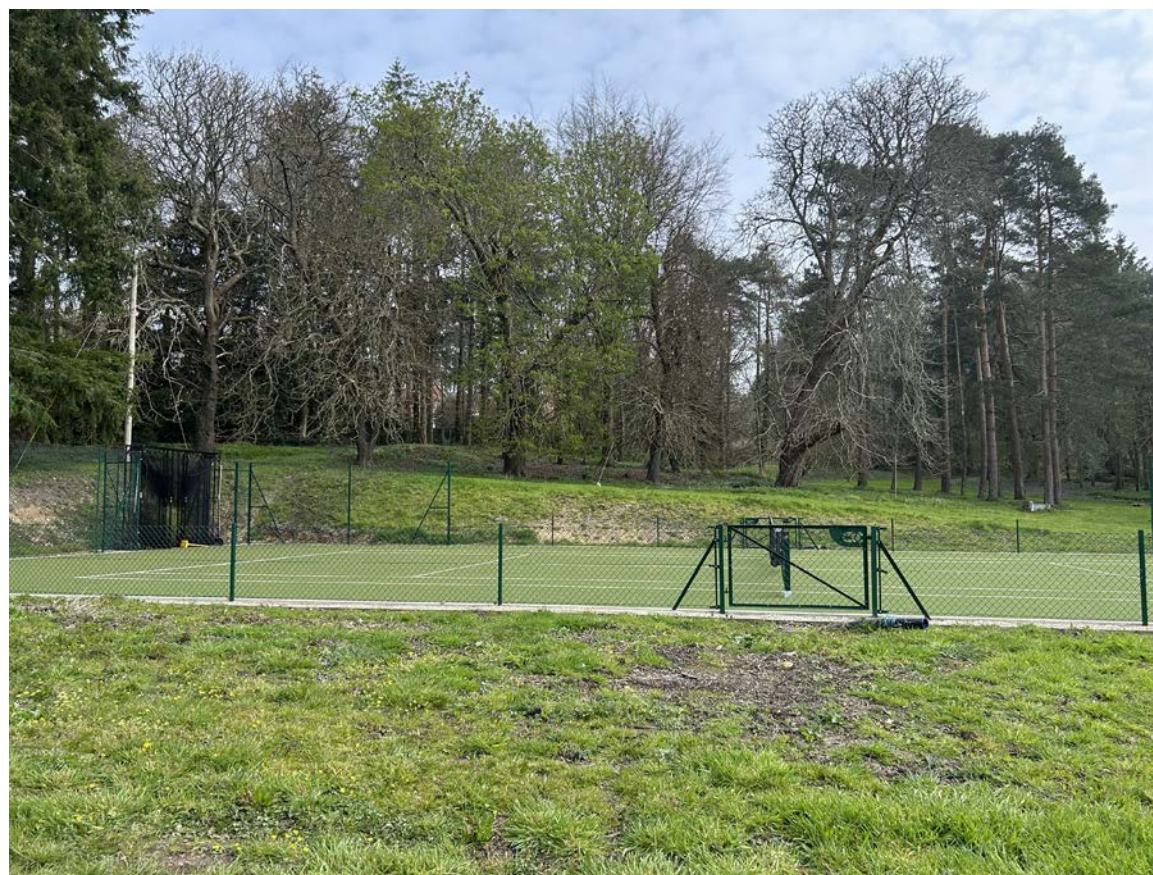
Figure 42. Tennis court located east of the walled garden
