**TECHNICAL NOTE ADDENDUM ON FLOOD RISK AND DRAINAGE**

| <b>PROJECT</b> | Eastleigh Court, Warminster | <b>PROJECT / REF</b> | S250204-TN01 |

**BACKGROUND**

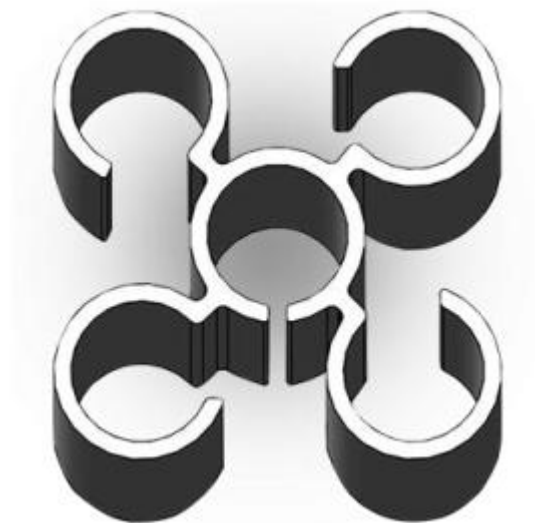
*Figure 02 – Cross-sectional view through the ECO-90*

The ECO90 drainage system uses a multiple open chamber system that creates both lateral and vertical water transfer into the varying soil stratum surrounding it. The system is particularly effective in soils of medium to low permeability and enables infiltration systems to be used in areas where normal soakaways are not considered suitable.

During operation, soils surrounding the ECO-90 'close in' and the system begins to work more efficiently. Through repeated wetting and drying of the soils, micro-fissures in the soil form that extend outwards of the ECO-90, improving infiltration in low permeability soils such as silty and sandy clays.

The ECO90 Drainage system was launched in the UK in 2012. It is installed vertically into the ground, terminating above the natural water table, in maximum lengths up of to 12m.

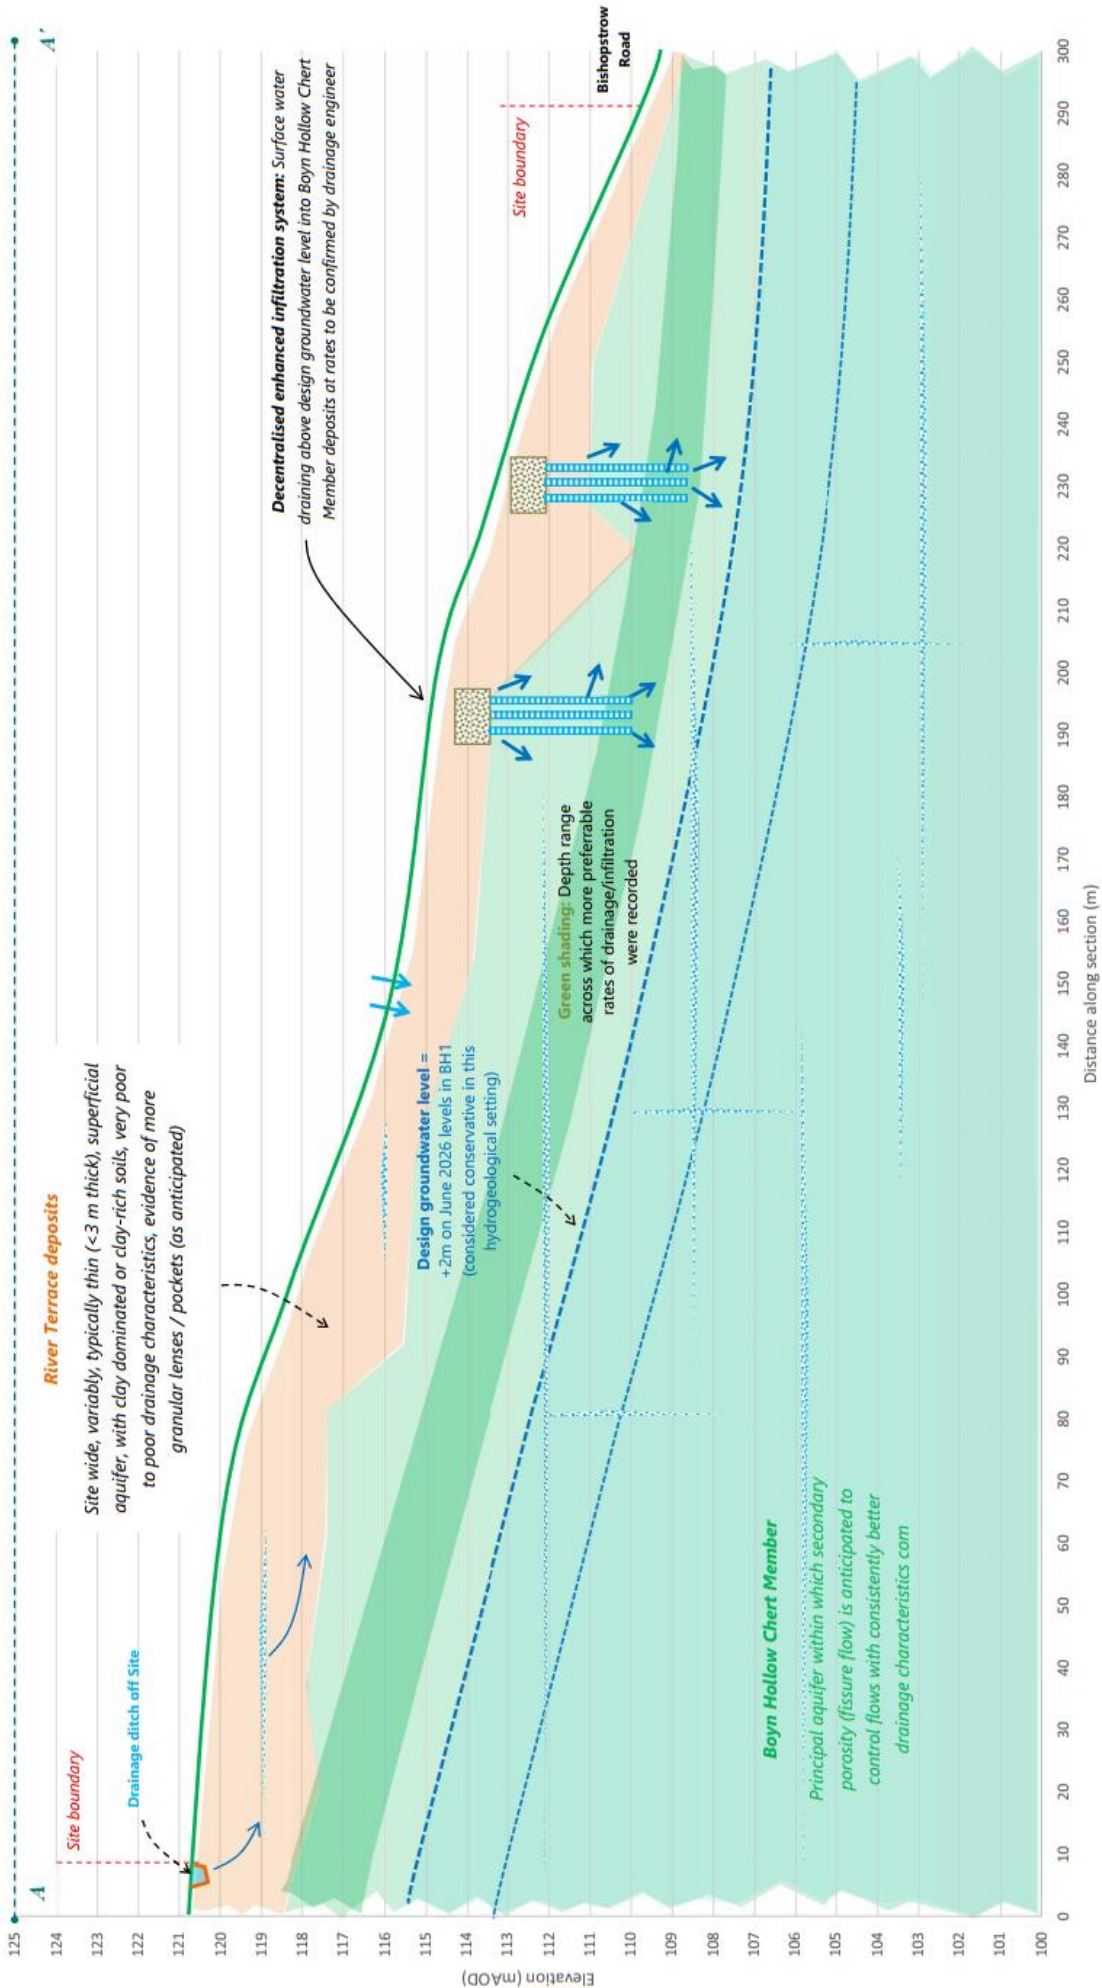
The below figure is taken from the Hydrogeological Assessment and provides a good representation of the identified ground, hydrological and hydrogeological conditions at the site:

Figure 04 – Ground and Groundwater Model (Soil and Structures Hydrogeological Assessment Extract)

EC49 have advised that the invert/depth of the ECO90 devices should be limited to 6mBGL (below ground level) to remain clear of groundwater (with 2m freeboard) as shown on Figure 04, discharging into the Boyn Hollow Chert Member where preferable rates of drainage/infiltration were recorded. The total length of the ECO90 devices will be approximately in 4.5m lengths, to cater for permeable car park construction and/or attenuation situated above the ECO90 units.

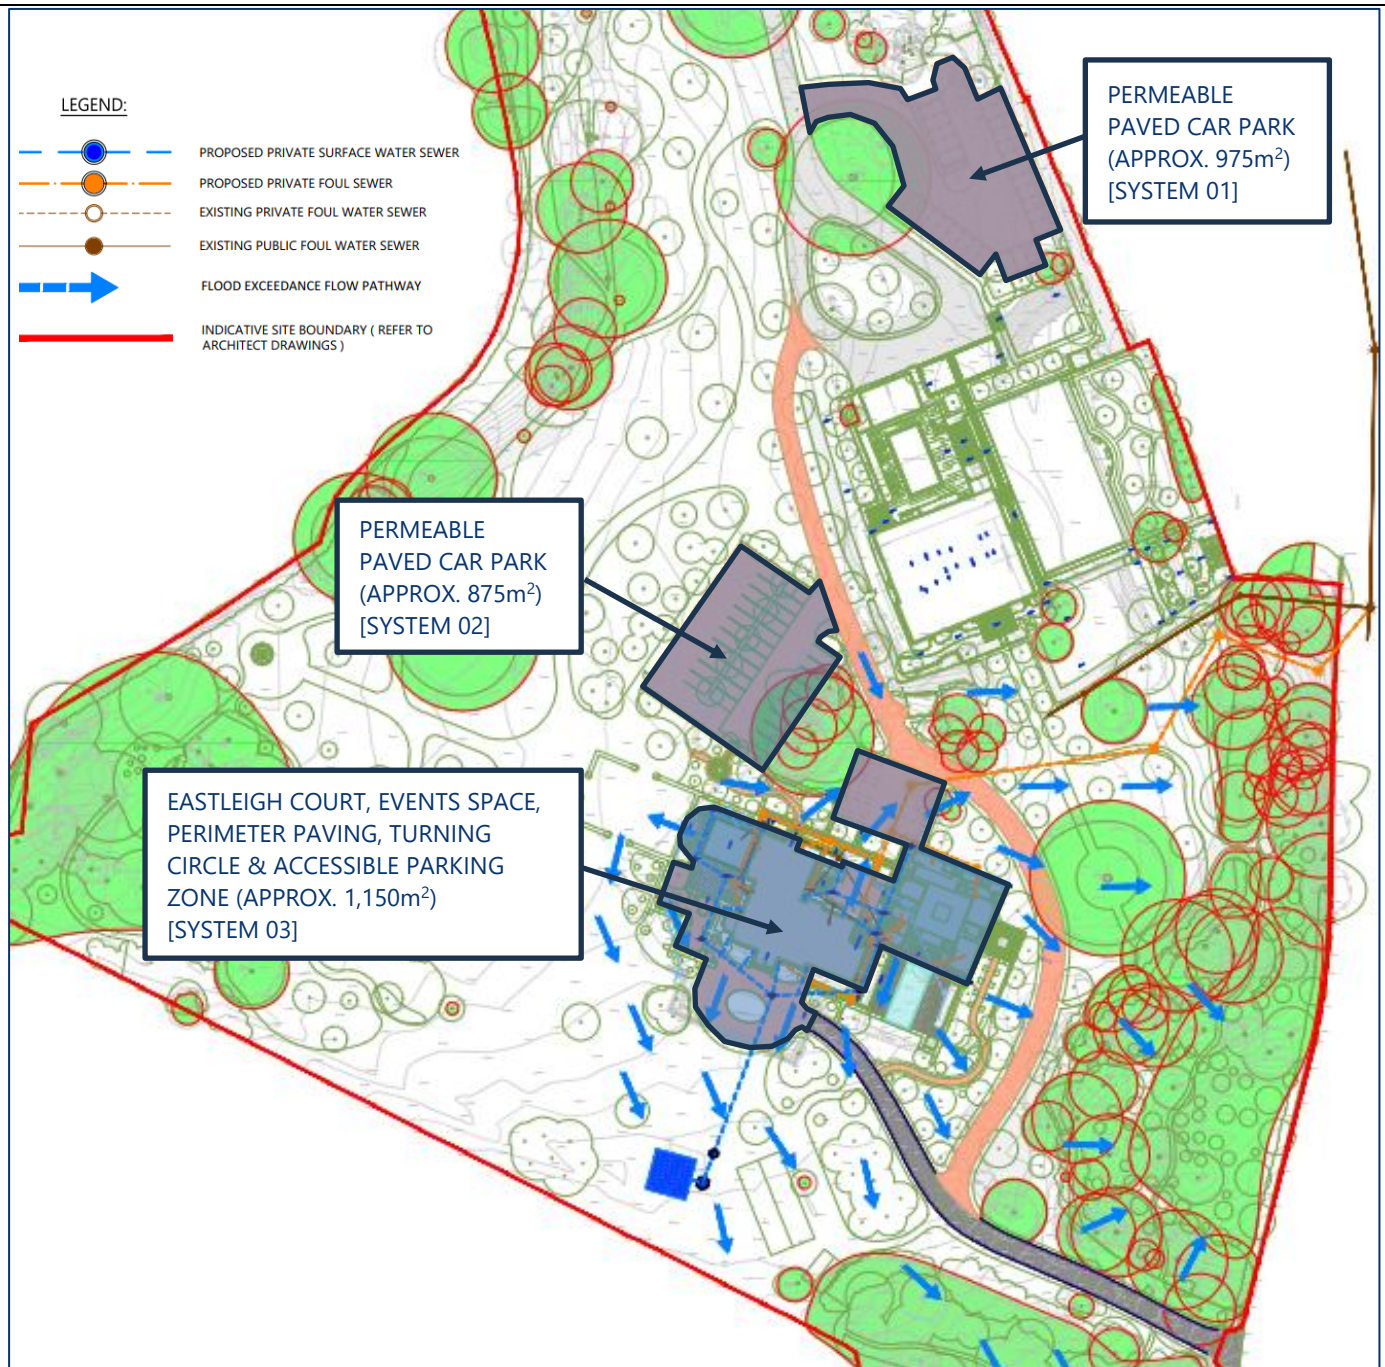
Figure 05 – Outline Drainage Masterplan Mark-Up

System 01 will utilise the soakage rates identified within TD01, System 02 will utilise TD02 infiltration rates and System 03 will utilise TD03 infiltration rates.

It is envisaged that Systems 01 and 02 will utilise storage attenuation within the porous subbase, with ECO90 units situated beneath the porous subbase, allowing for water to percolate through the surface paving and subbase, removing pollutants as water percolates before infiltrating into the ground via the ECO90 units. The exact detail will be determined during the detailed design by Groundwater Dynamics.

Storage estimates have been undertaken in Causeway Flow+ Software (V18.0) based on the areas depicted in Figure 05 to understand attenuation volumes required to ensure of no flooding up to and including the 100year + 45% climate change return period, utilising FEH rainfall data:

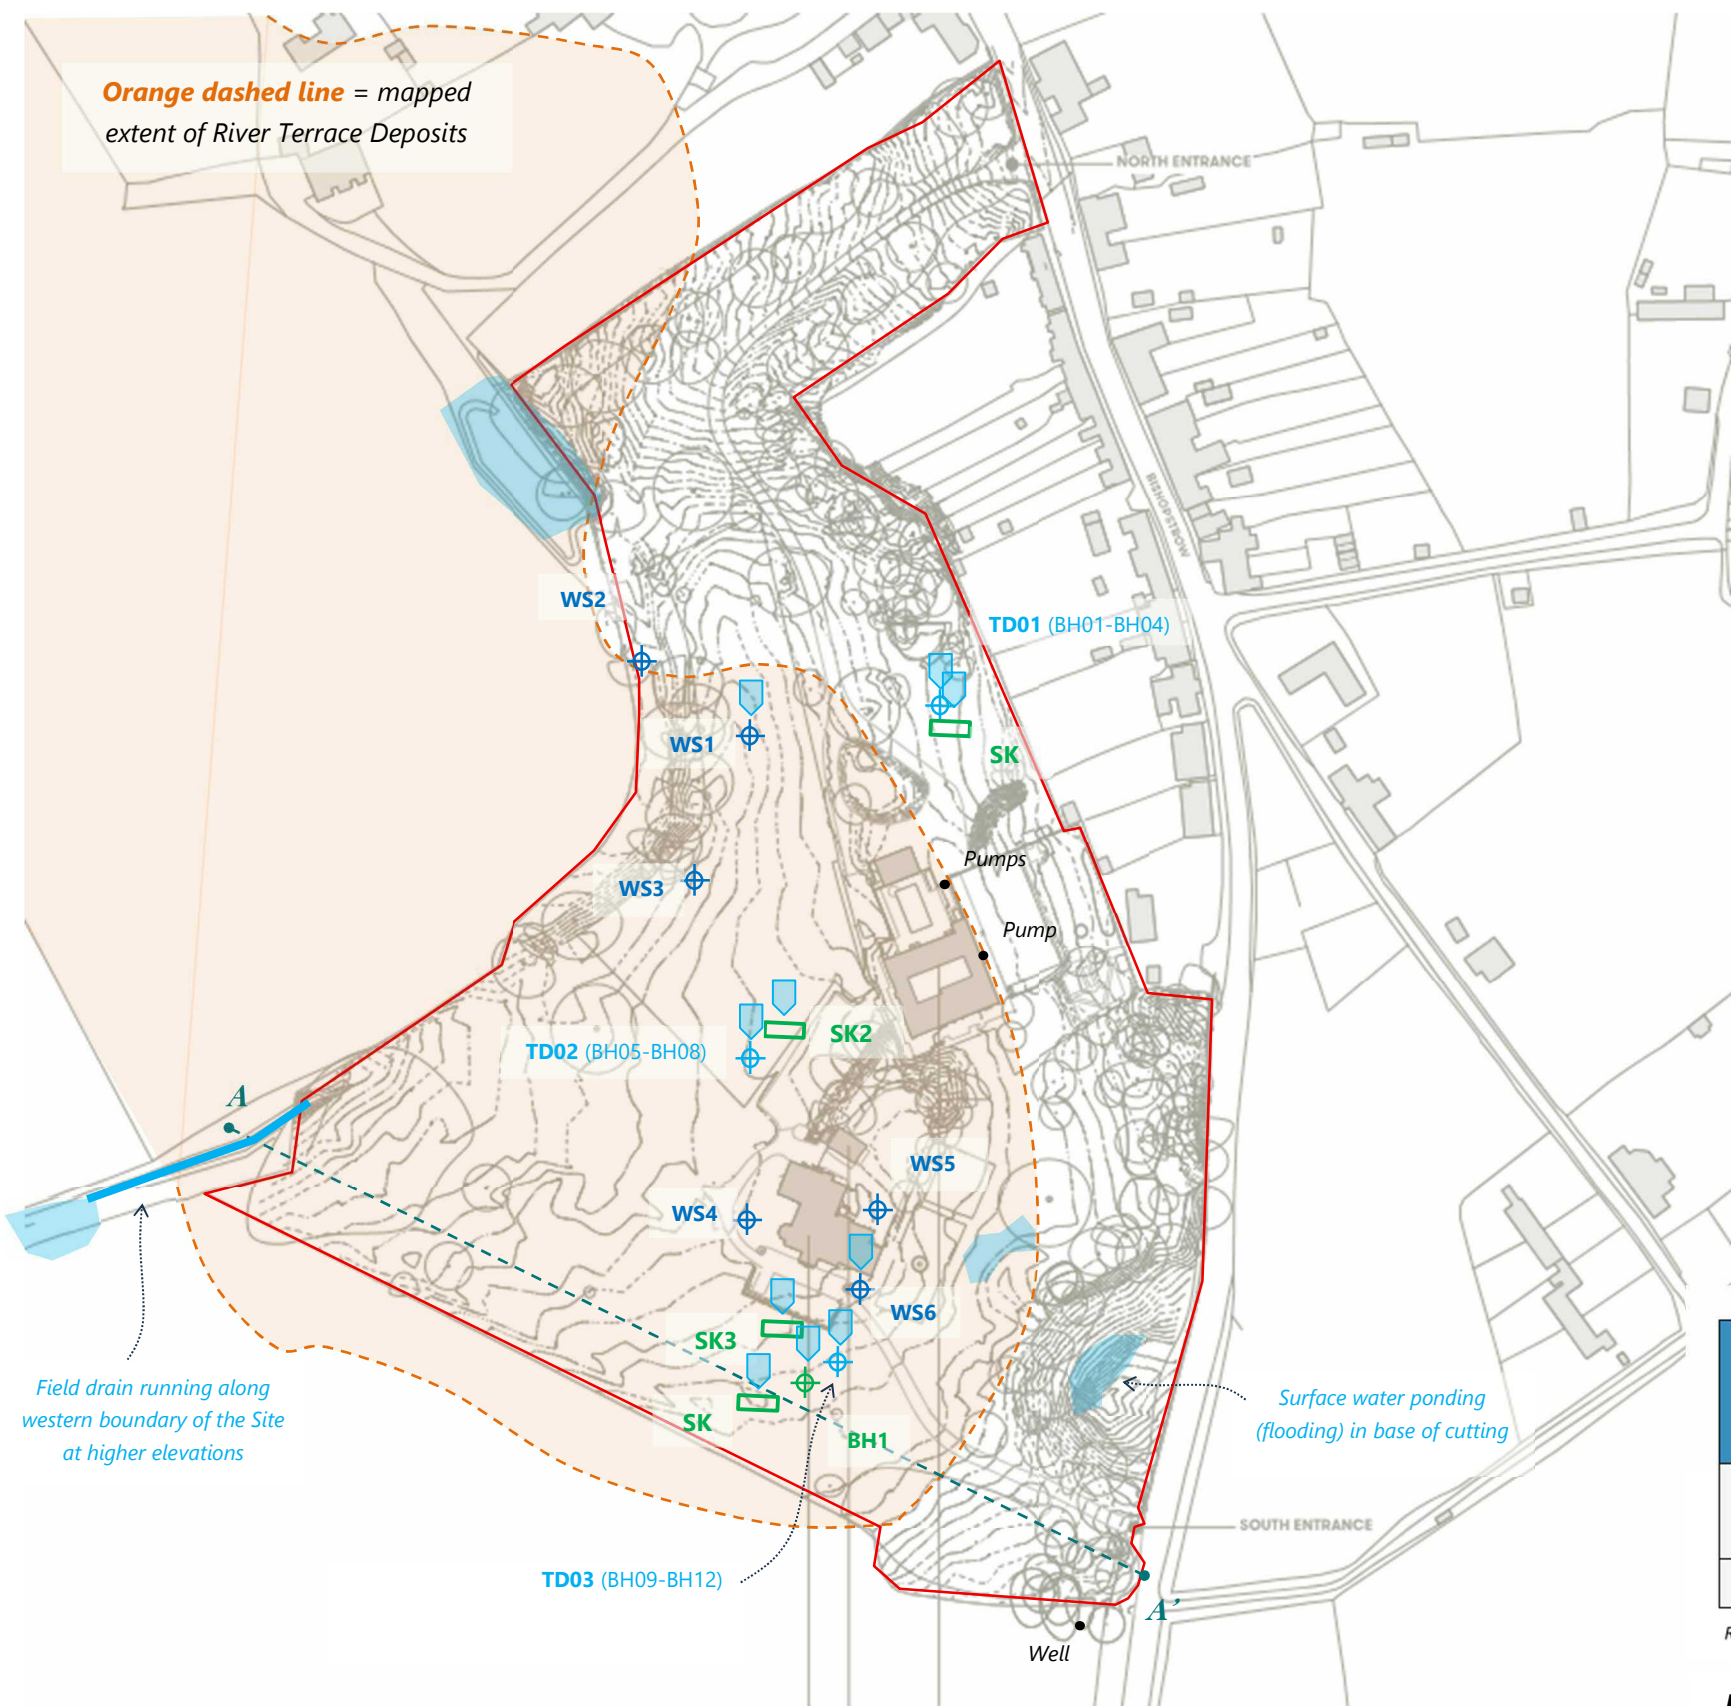
5.0 Ground and Groundwater Model – Baseline Plan – Site Scale

- Environment Agency mapped areas of surface water flooding
- Section line – refer to profile at end of Section 5.0
