## Preliminary Roost Assessment

2 Sharcott Pennings, Sharcott, Pewsey, Kennet, Wiltshire, SN9 5NJ

This report is prepared to inform a planning application with Wiltshire Council. The proposed development includes:

The stables will be converted into a self-contained annex. The stable conversion work will include internal renovations as well as additional windows and fascia boards on the gable ends.

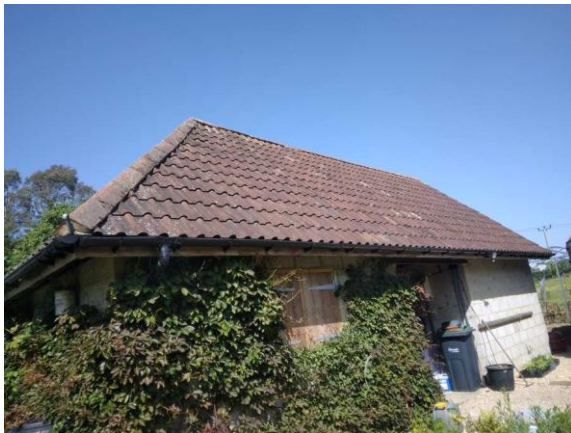
Building B1 is a (single-storey) stable with a double Roman (clay tile) roof. While the roof tiles themselves were in good condition, the gable end verges have missing mortar/verge gaps that allow access between the tiles and the lining. No other external or internal features were identified as offering roosting potential. No bat evidence was observed during the survey. In line with Good Practice Guidelines (Collins, J (Ed), 2023), B1 is assessed to have moderate habitat value for roosting bats due to the presence of suitable access points and roosting features.

*Building B1 - Eastern elevation*

Two bat emergence/re-entry surveys will be required on B1, requiring five survey positions to provide full coverage of the building's elevations. If bat roosts are confirmed in the building, one additional survey may be required to characterise the roost and to inform a licence application to Natural England.

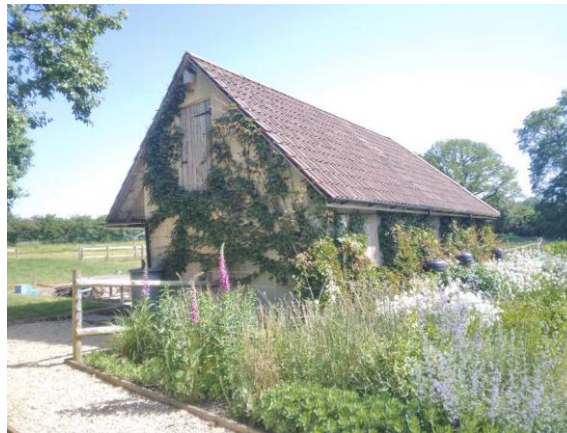
*Building B1 - South-western elevation*

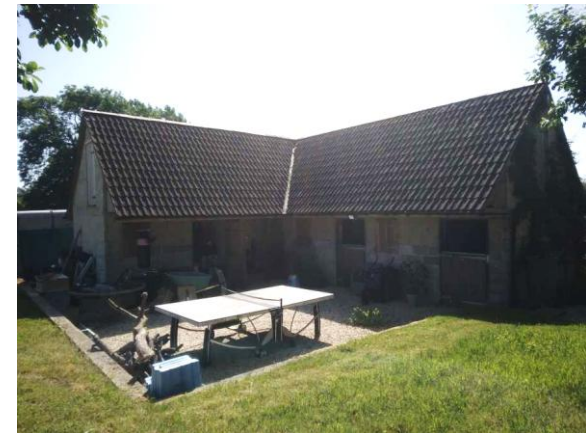
*Building B1 - Northern and western elevations*

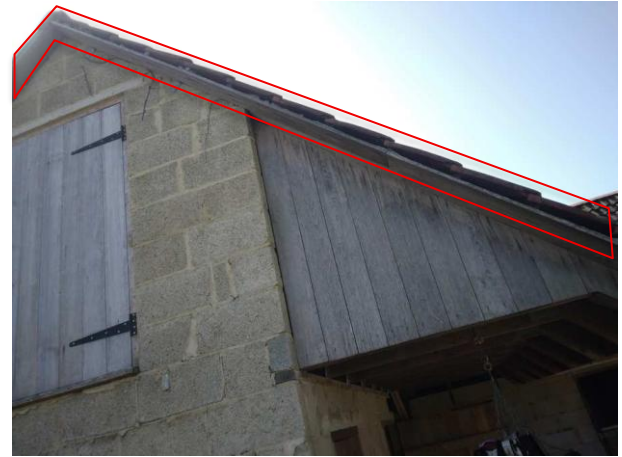
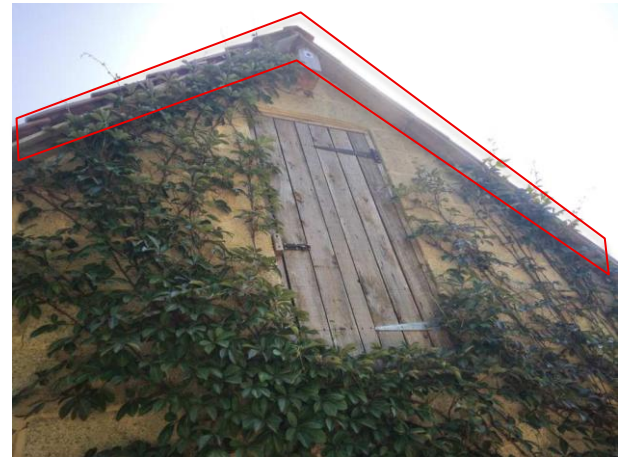
| Feature | Materials/Details | Condition/description/suitability | Photograph |
|---|---|---|---|
| Roof | Clay tiles | <p><b>Condition/description</b></p> <p>The roof tiles were in good condition. The roof had open eaves leading into the interior of the building on all elevations.</p> <p><b>Suitability/access/evidence of bats</b></p> <p>The gable-end verges have mortar/verge gaps that allow access between the tiles and the lining (highlighted in red).</p> | <p><i>B1 roof - Gable end gaps northern elevation</i></p> <p><i>B1 roof - Gable end gaps western elevation</i></p> |

The proposed plans include converting the stable (B1) into an annexe. The stable conversion work will include internal renovations as well as additional windows and fascia boards on the gable ends. Therefore, the existing gable end access points will be filled/blocked. This could result in the destruction of any bat roosts and cause disturbance, death, or injury to bats.

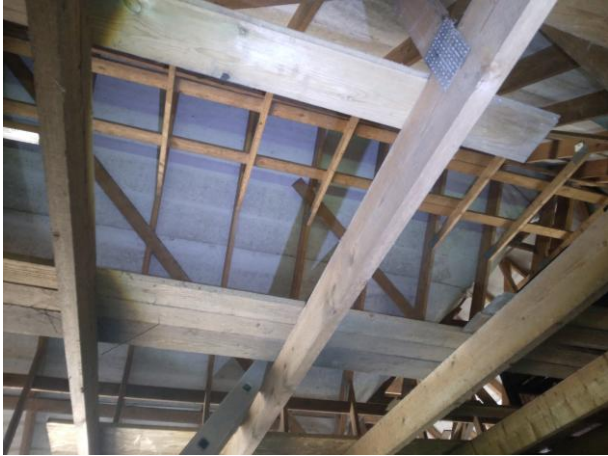
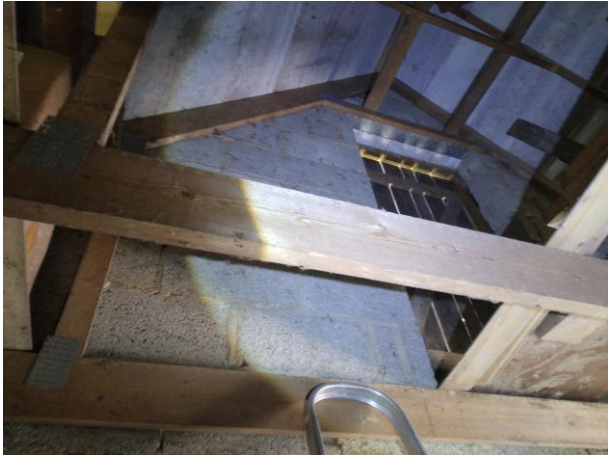
| Internal space | Breathable Roof Membrane (BRM) | <p>The building has no internal voids (vaulted). No evidence of bats was identified during the internal inspection. The interior of the roof was lined with Breathable Roof Membrane (BRM), which was in good condition. The interior of the building was well-sealed with no internal crevices.</p> | <p><i>B1 – Internal space</i></p> <p><i>B1 - Gable end</i></p> |
