**Preliminary Roost Appraisal & Barn Owl Survey (Final Report)  
Hill Cottage, Stop Street, Fonthill Gifford, Tisbury, Wiltshire SP3 6QW**

**Prepared for:** Mr and Mrs A Bagnall

**Prepared by:** Louise Lowans BSc. (Hons), MCIEEM

**Prepared on:** 15/09/2026

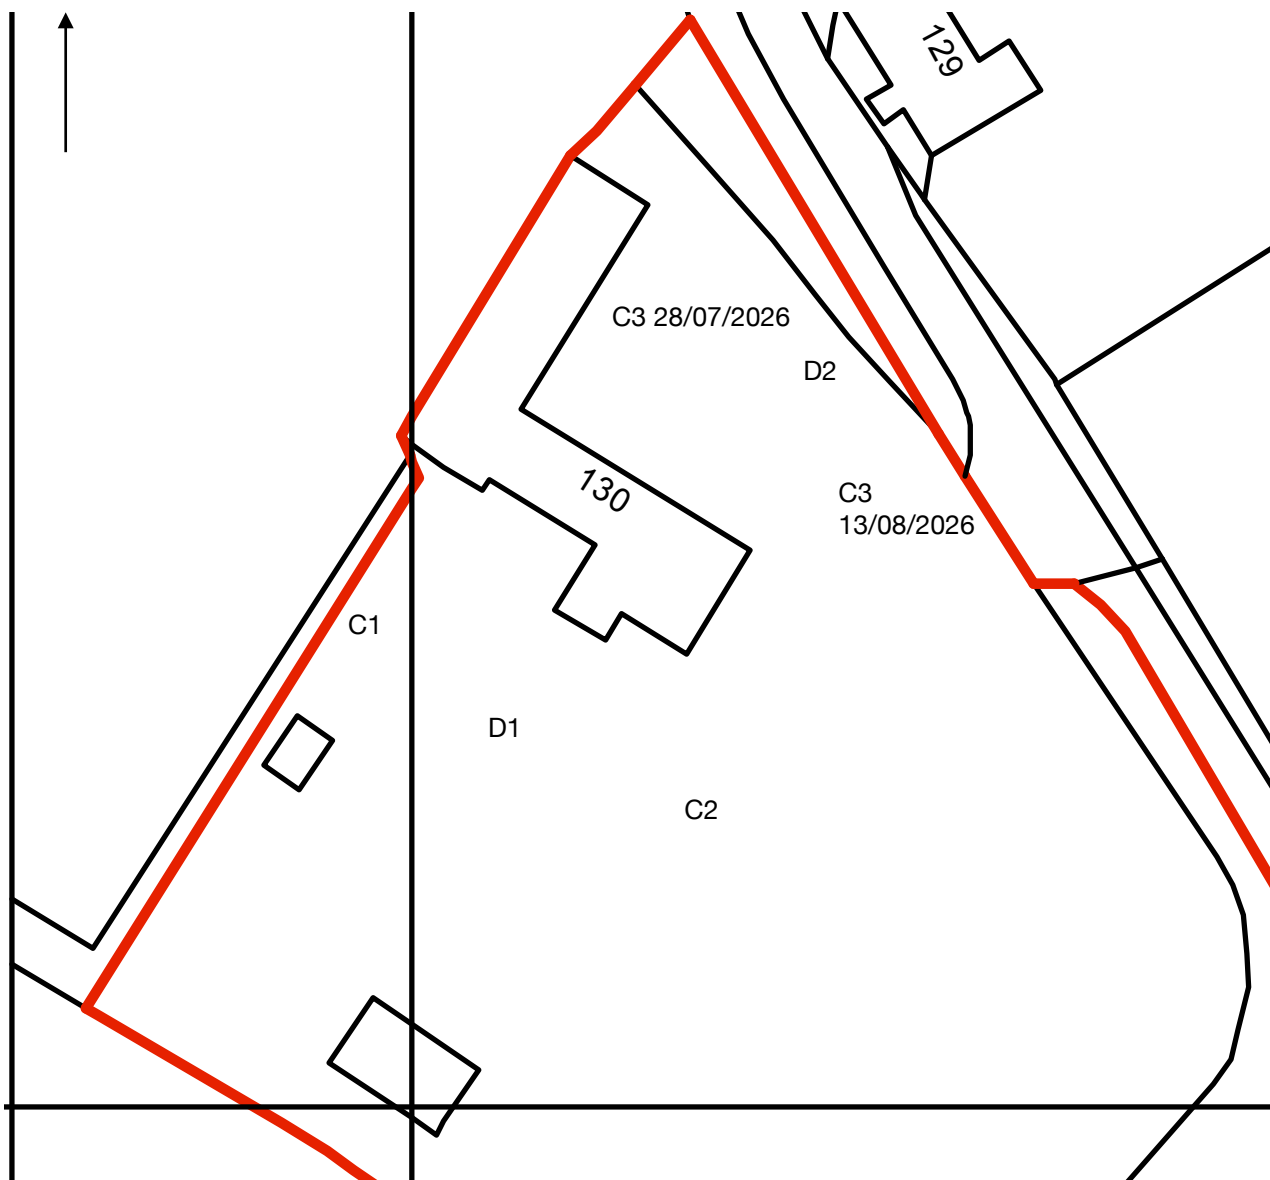
Plan 8 - Position of IR cameras, Song Meter Bat Detectors and surveyor during dusk emergence surveys 28/07/2026 & 13/08/2026

- C1 = Camera 1 Northwest and southwest elevations of cottage
- C2 = Camera 2 Southeast and southwest elevations of cottage
- C3 = Camera 3 Northwest and northeast elevations of cottage (28/07/2026)
- C3 = Camera 3 Southeast and northeast elevations of cottage (13/08/2026)
- D1 = Song Meter Mini Bat detector 1 was placed on the southwest side of the cottage
- D2 = Song Meter Mini Bat detector 2 was placed on the northeast side of the cottage
- S = Surveyor walked around the cottage throughout the survey

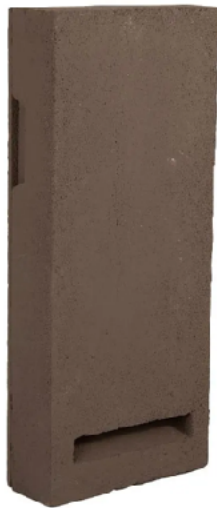
Example of Vivara Pro Build-in Woodstone® Bat Tube (external dimensions: H500mm x W210mm x D77mm)

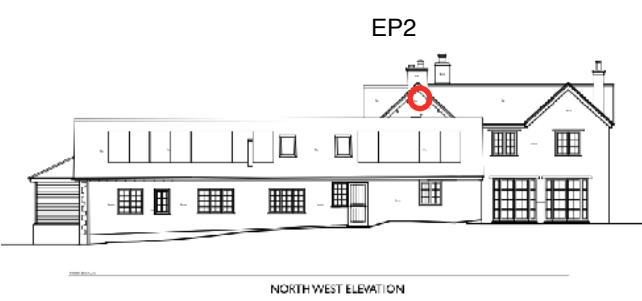
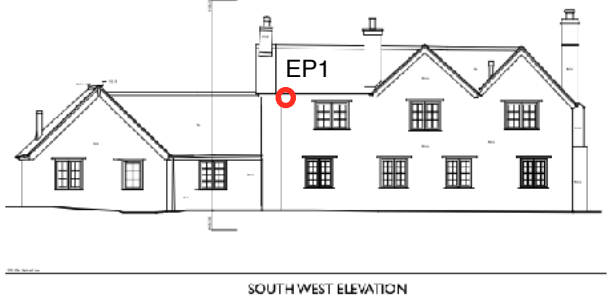
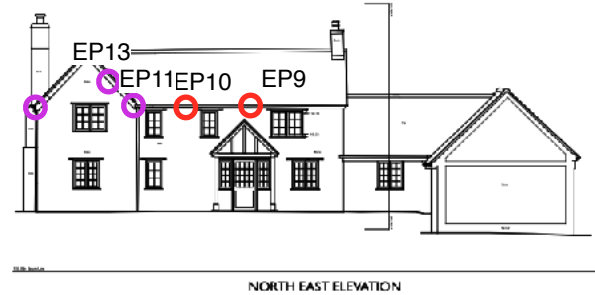
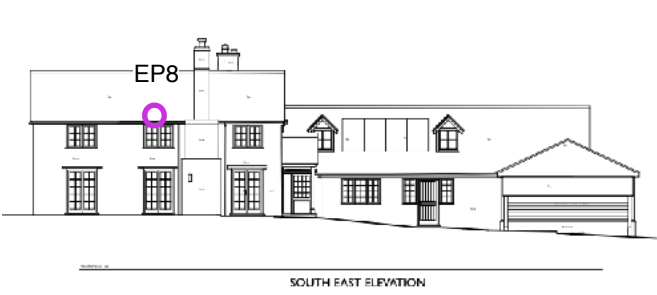
Plan 10 - Scaffold that is to be erected will not block the access points that are to be retained

- Soprano pipistrelle access point to be retained
- Serotine access point to be retained

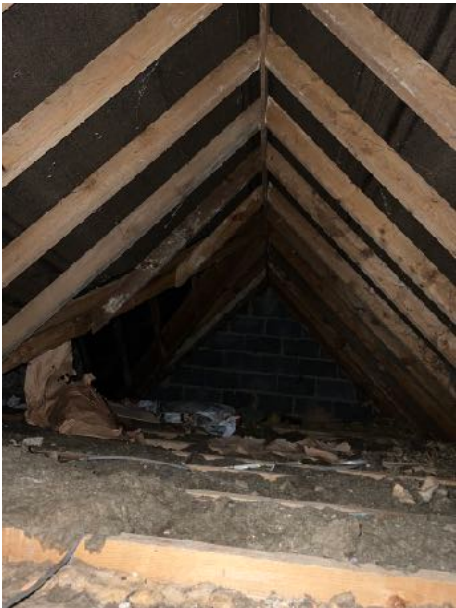
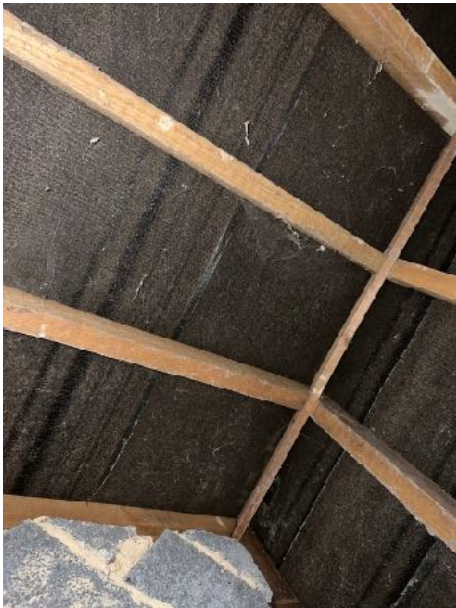
The ridge beam was covered in cobwebs; there were no gaps between the rafters that could be used by crevice-dwelling bats. No evidence of bats (staining, bat droppings, feeding remains and live or dead bats) was found within the loft space.

Figure 28 - Loft 1 no evidence of bats

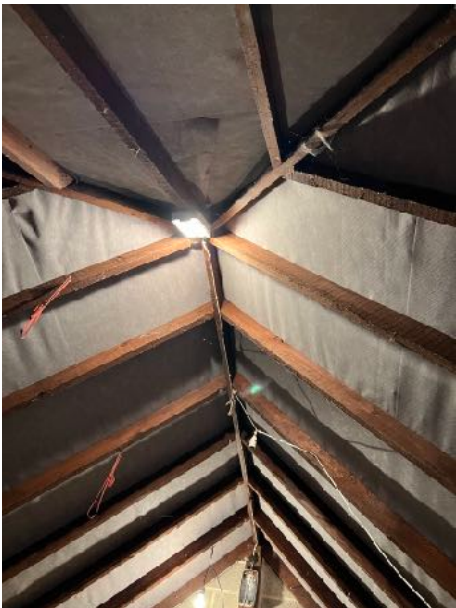
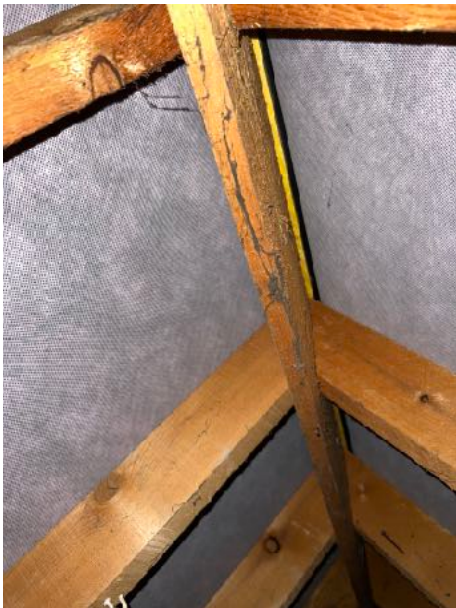
The ridge beam was covered in cobwebs; there were no gaps between the rafters that could be used by crevice-dwelling bats. There was no staining on the breathable membrane. No evidence of bats (staining, bat droppings, feeding remains and live or dead bats) was found within the loft space.

Figure 30 - Loft 2 no evidence of bats

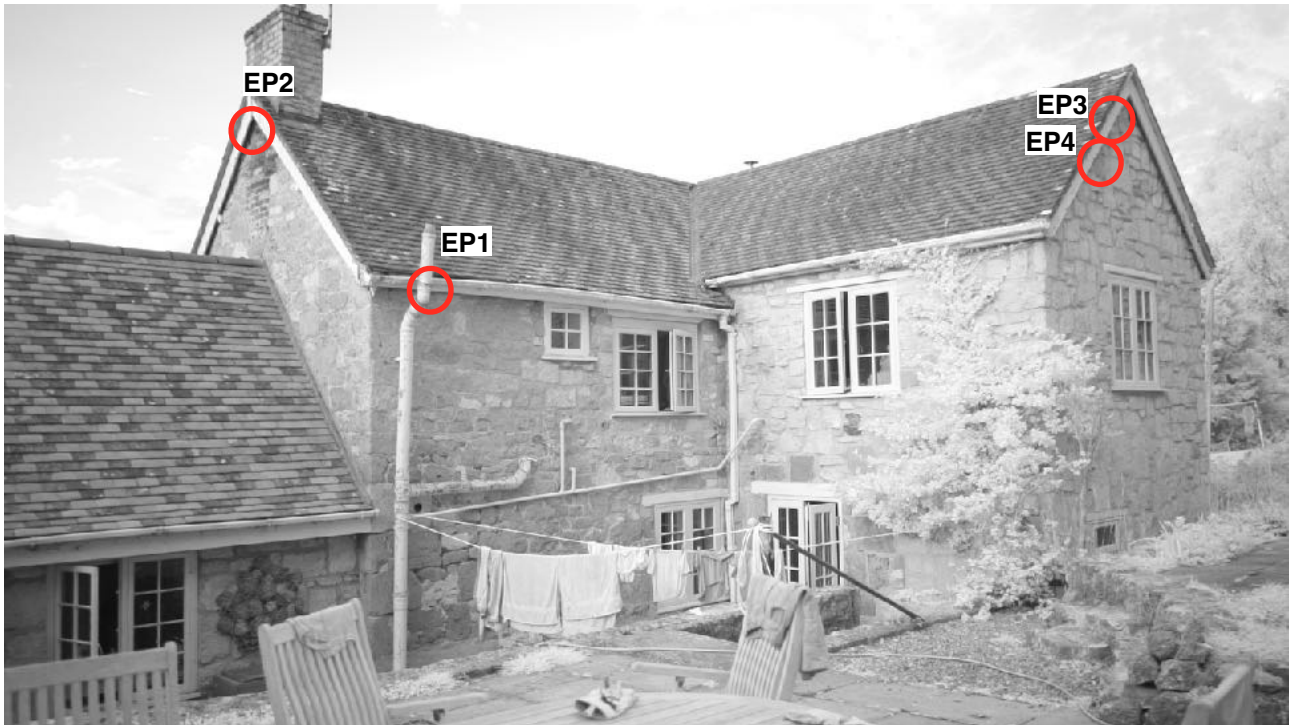
Figure 32 - Cottage NW & SW elevations - Exit points 1 to 4, 28/07/2026 (Red circle: soprano pipistrelle bats)

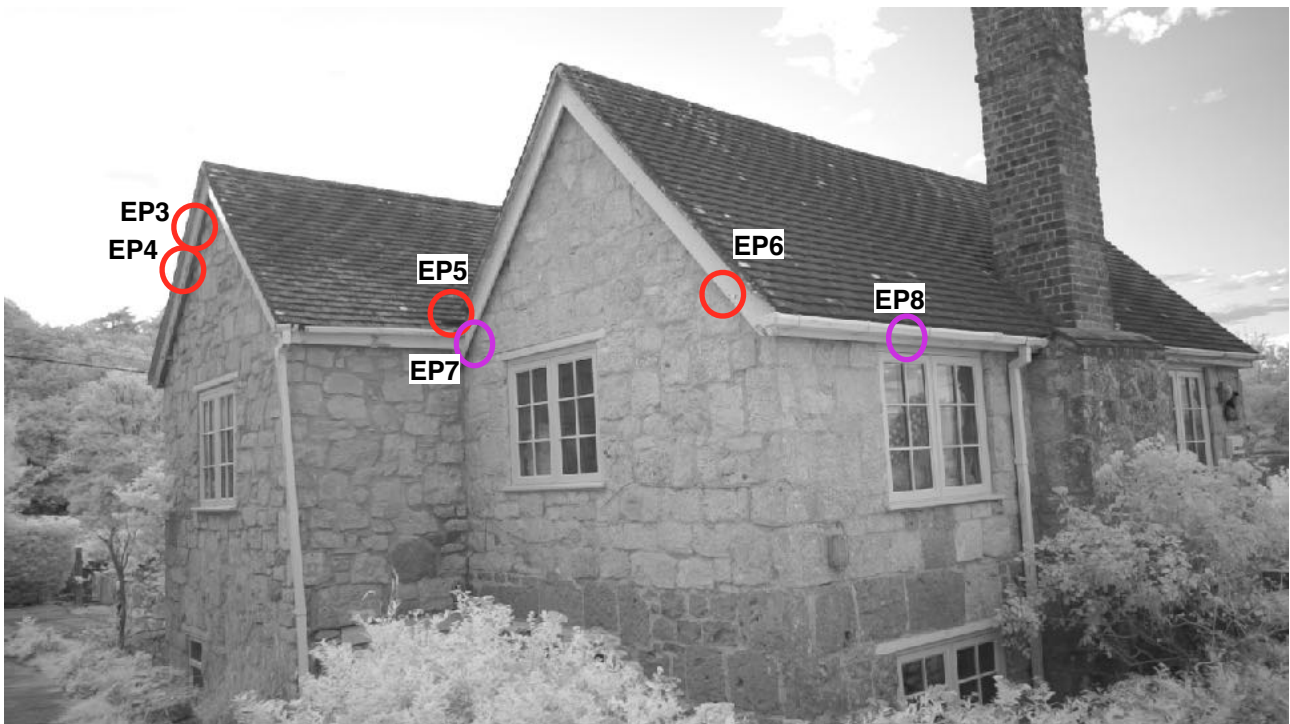
Figure 33 - Cottage SW & SE elevations - Exit points 3 to 8, 28/07/2026 (Red circle: soprano pipistrelle bats. Purple circle: serotine bats)

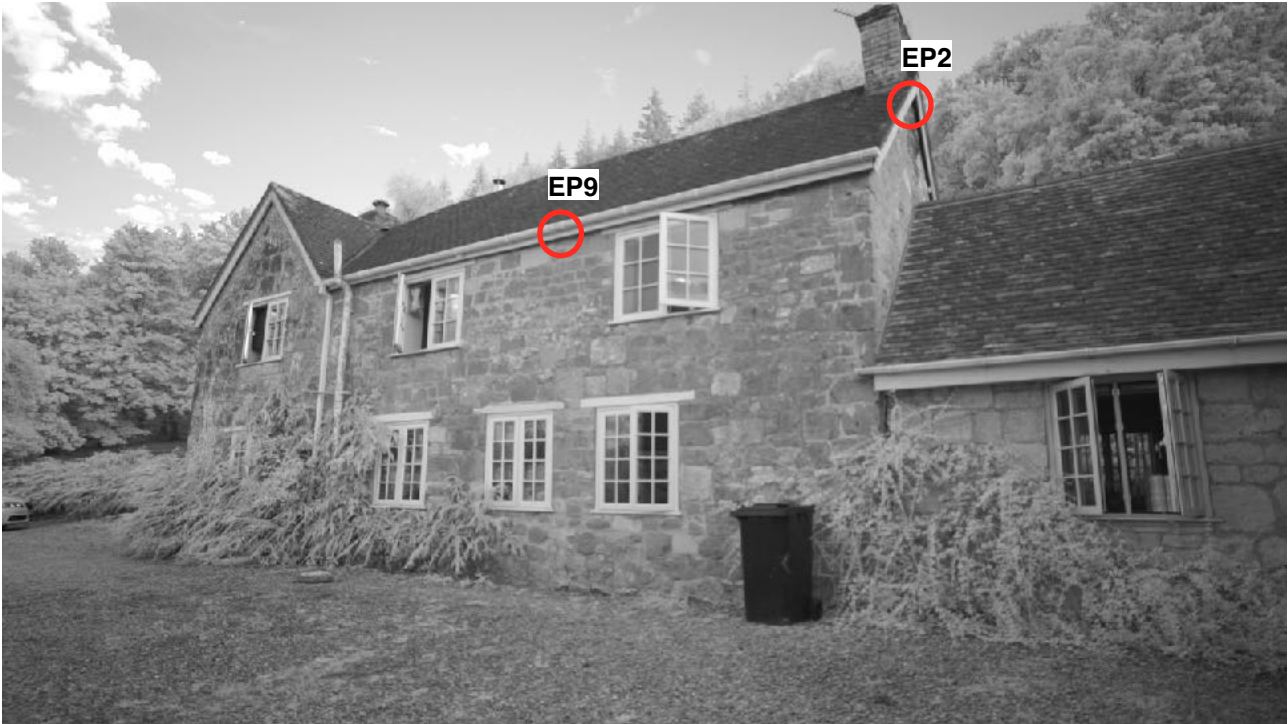
Figure 34 - Cottage NE and NW elevations - Exit points 2 and 9. 28/07/2026 (Red circle: soprano pipistrelle bats)

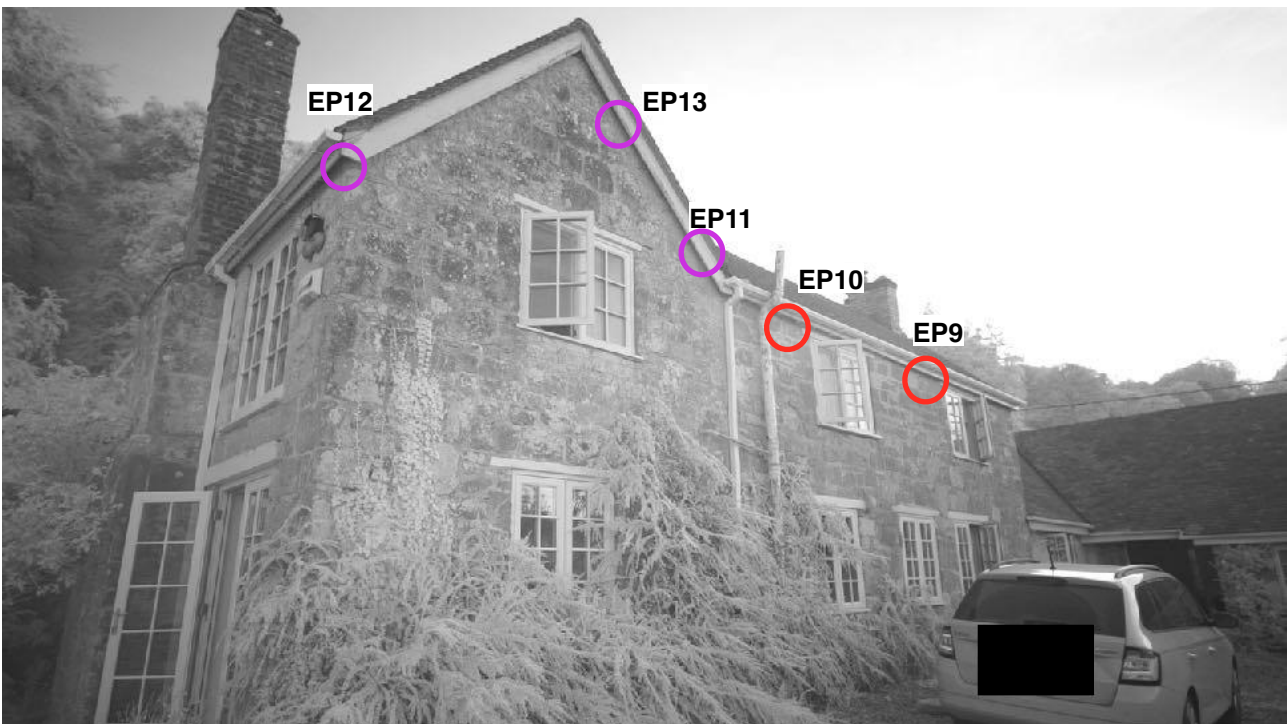
Figure 35 - Cottage SW & SE elevations - Exit points 9 to 13. 13/08/2026 (Red circle: soprano pipistrelle bats. Purple circle: serotine bats)

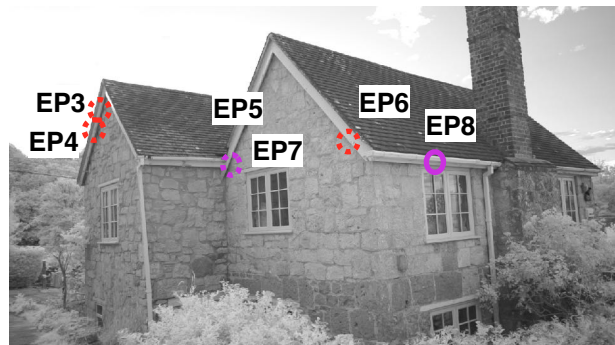
Cottage SW & SE elevations - Exit points 3, 4, 5, 6 & 7 (Red dashed circle: soprano pipistrelle bats. Purple dashed circle: serotine bats) to be lost. Exit point 8 (Purple circle: serotine bat) to be retained

Four of the eight access points into the Soprano pipistrelle day roost and four of the five access points into the serotine day roost will be retained. In addition, two bat tubes will be built into the proposed southwest elevation.

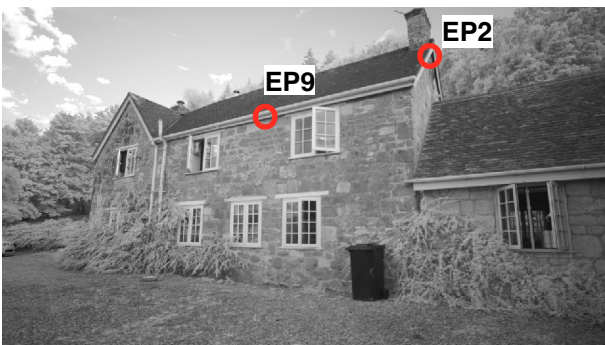
Cottage NE and NW elevations - Exit points 2 and 9. (Red circle: soprano pipistrelle bats) to be retained

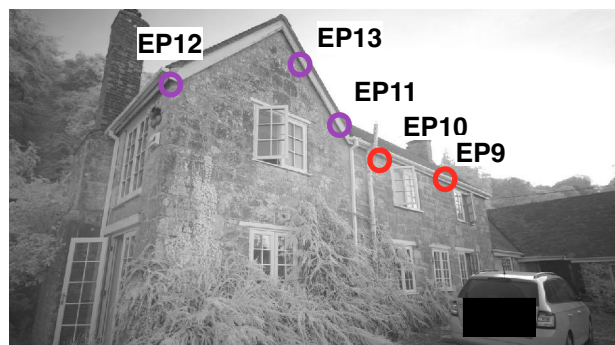
SW & SE elevations - Exit points 9 to 13 (Red circle: soprano pipistrelle bats. Yellow circle: serotine bats) to be retained
