# Ringbourne, Longhedge, Corsley

## Ecological Impact Assessment

July 2026

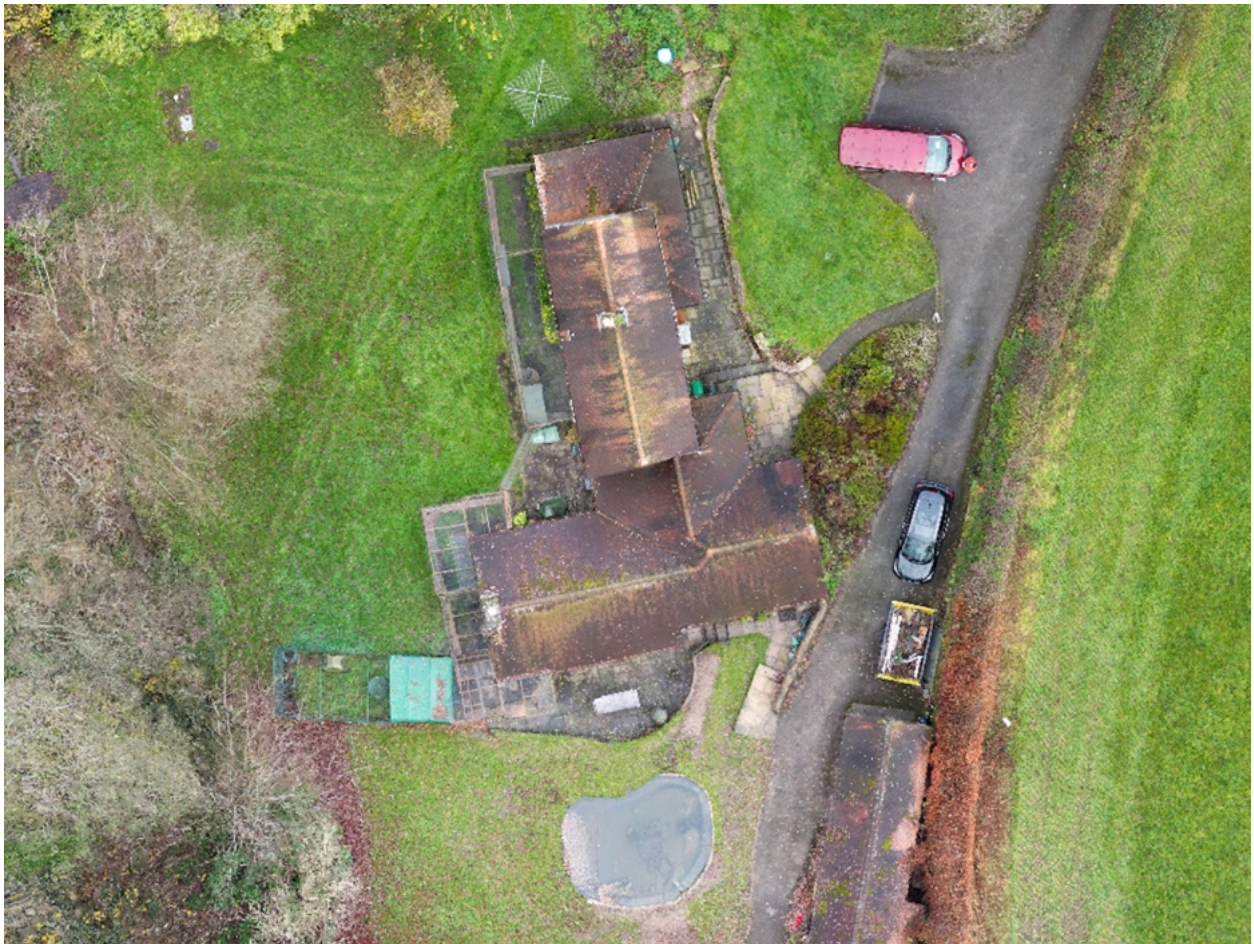
**Figure 1 – Aerial view of the Structure 'Ringbourne Drone Orthophoto'**

24. The Structure comprises a number of main construction sections, resulting in a complex roof layout with a variety of gable ends, valleys and hips. This also means there are numerous loft spaces. The Structure is a mix of material construction types with rendered areas (either block or brick), as well as exposed and painted brick and stone sections. A ground floor extension with hipped roof wraps around the building from the northern elevation and around the northern end of the eastern elevation. A small section of this extension forms a lean-to which currently serves as a woodstore (hereby referred to as the "woodstore").
25. Caged enclosures extend from the Structures western elevations.

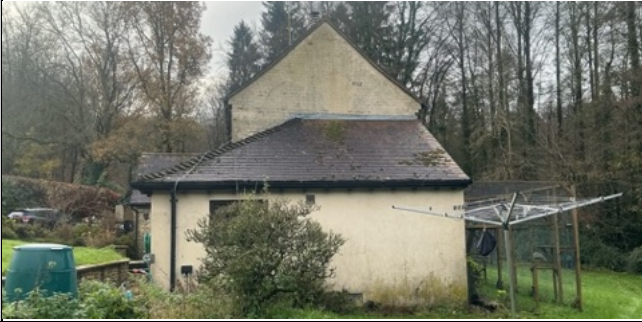
| Structure Reference | Photo | Descriptions |
|---|---|---|
| Northern extension | | no PRFs identified |

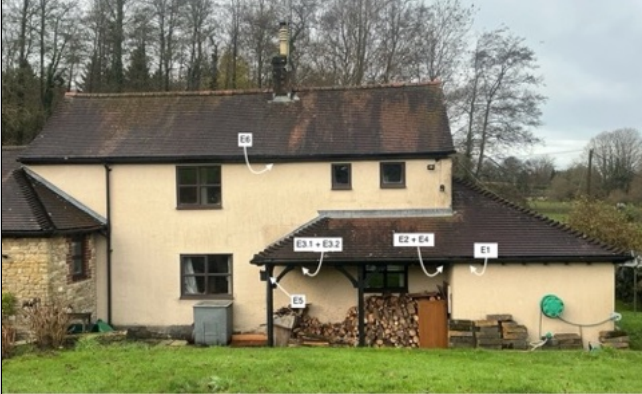
| Structure Reference | Photo | Descriptions |
|---|---|---|
| Eastern elevation (Two-storey section) | | Northern extension eastern elevation (PRF: E1), Woodshed (PRFs: E2 – E5) and main structure eastern elevation (PRF: E6) |

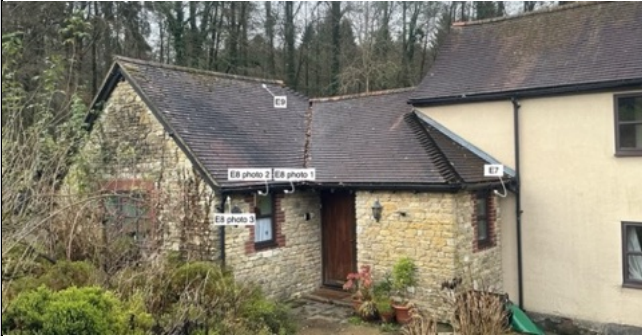
| Structure Reference | Photo | Descriptions |
|---|---|---|
| Eastern elevation (Entrance) | | PRFs - E7 – E9 |

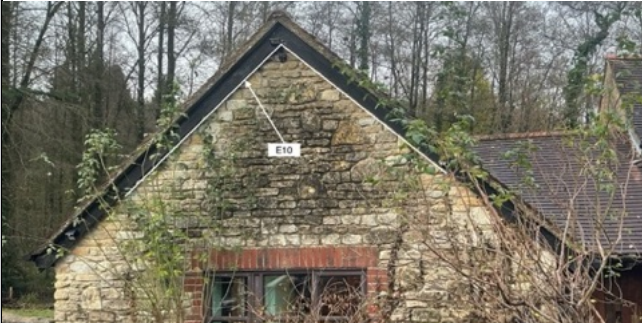
| Structure Reference | Photo | Descriptions |
|---|---|---|
| Eastern gable (Southern extension) | | PRFs - E10 |

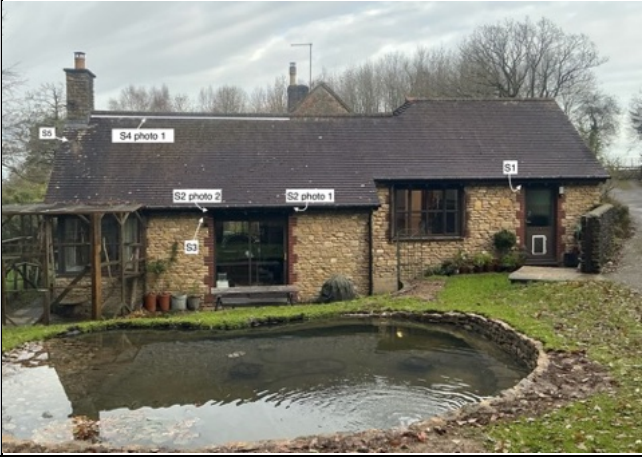
| Southern Elevation<br>(Southern extension) | | PRFs - S1 – S5 |

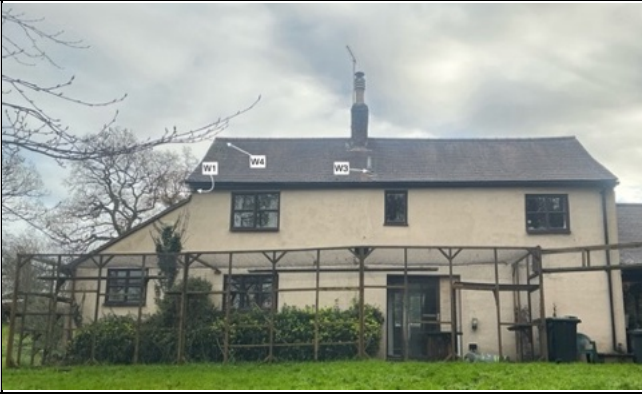
| Western elevation<br>(Two-storey section) | | PRFs - W1, W3 and W4 |

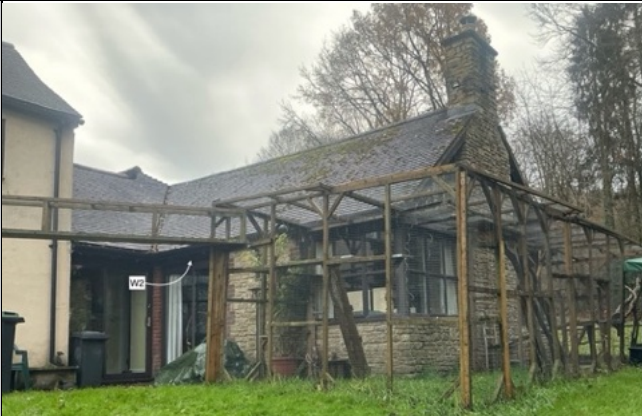
| Western and northern elevation<br>(Southern extension) | | PRF - W2 |

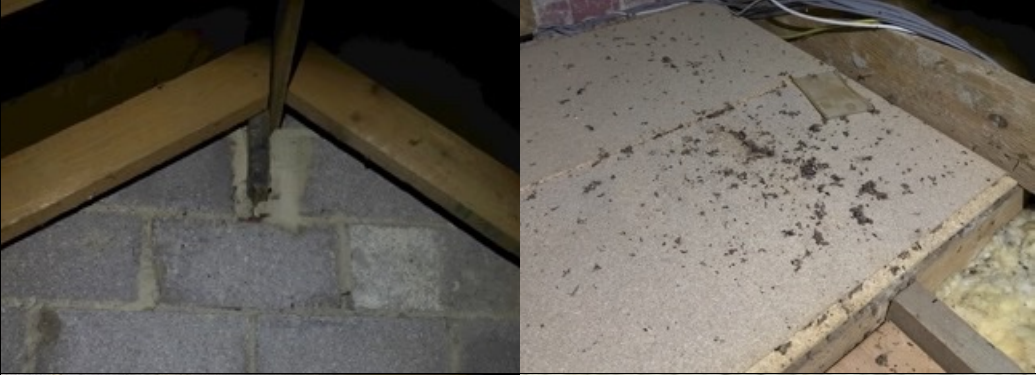
33. Loft one measured approximately 3m x 2m and 1.7m high at the apex.
34. Approximately 300-400 brown long-eared bat droppings were identified on the loft floor below the ridge beam (confirmed by eDNA analysis). Due to the number and location of the droppings, this likely represents a day roost.

| Structure Reference | Photo/s | | Survey Ref | Survey Date | Species & numbers | Roost Type | Roost Location | Access Point(s) & no. | Dimensions of existing roosts / Explanation of where roost is |
|---|---|--|---|---|---|---|---|---|---|
| Loft 1 – Location 1 | | | PEA | 05/12/2025 | ~300- 400 Brown Long-eared droppings | Likely day roost | Internal void above the main entrance on the eastern elevation | Unknown - Potential access at feature E7, E8 and E9 | The void was approximately 3m x 2m and 1.7m high. |

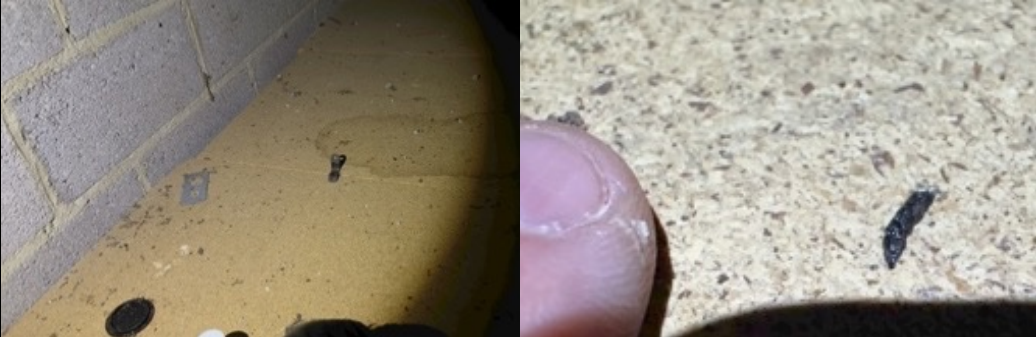
35. Loft two measured approximately 3m x 4m. There were six scattered bat droppings throughout. These were identified to likely be *Pipistrellus* species. Due to the low number and scattered distribution of droppings this is likely to represent occasional usage by non-roosting bats and does not constitute a bat roost.

| Structure Reference | Photo/s | | Survey Ref | Survey Date | Species & numbers | Roost Type | Roost Location | Access Point(s) & no. | Dimensions of existing roosts / Explanation of where roost is |
|---|---|--|---|---|---|---|---|---|---|
| Loft 2 | | | PEA | 05/12/2025 | Six scattered bat droppings (Likely pipistrellus species) | Unknown – Likely represents occasional usage by non-roosting bats and does not constitute a bat roost. | Loft 2 – internal void above the existing kitchen on in the southern extension | Unknown – Potential access via E8, E9, E10, and S1 | The void was approximately 4m x 3m. |

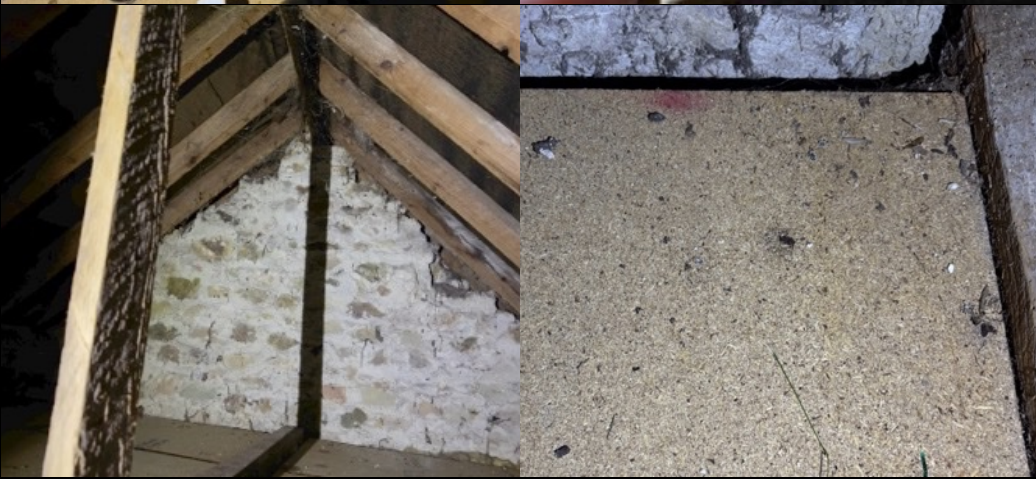
36. Loft three measured approximately 5m x 6m. Loft 3 was not able to be fully accessed due to a water tank partially blocking access, however, it was able to be visually surveyed.
37. Four likely *Pipistrellus* bat droppings were identified scattered throughout the loft. Due to the low number and scattered distribution of droppings this is likely to represent rare access by non-roosting bats and is not considered to indicate the presence of a bat roost.
38. Six degraded bat droppings were identified at the base of the southern wall. These were considered to have come from a “big bat” species, likely Serotine bat (low confidence). Due to the number of droppings, this is likely to represent an occasional day roost. eDNA analysis of these droppings was unsuccessful due to degradation.

| Structure Reference | Photo/s | | Survey Ref | Survey Date | Species & numbers | Roost Type | Roost Location | Access Point(s) & no. | Dimensions of existing roosts / Explanation of where roost is |
|---|---|--|---|---|---|---|---|---|---|
| Loft 3 – Location 2 | | | Additional Site visit | 01/07/2025 | Unknown (Likely big bat sp.) – Six droppings (Below the ridge beam at the southern external wall) | Day roost | Internal void above the southern section of the two-storey section of the structure | Unknown – Potential access via E6, W1, W3, and W4. | The void was approximately 5m x 6m |

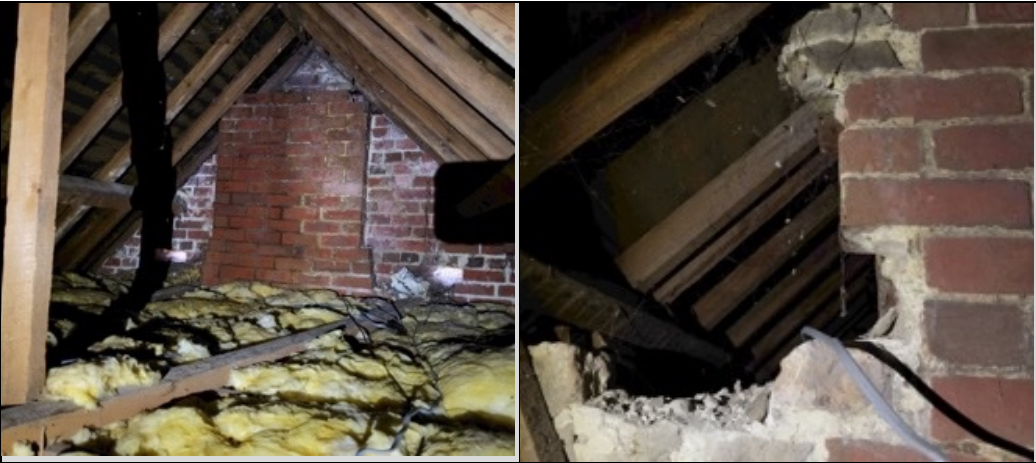
39. Loft four measured approximately 4m x 5m.  
Five likely *Pipistrellus* bat droppings were identified scattered throughout the loft. Due to the low number and scattered distribution of droppings this is likely to represent rare access by non-roosting bats and is not considered to indicate the presence of a bat roost.

| Loft 4 | | | | 05/12/2025 | Unknown (Likely Pipistrellus species– 6x droppings (scattered)) | Unknown – Likely represents occasional usage by non-roosting bats and does not constitute a bat roost | Internal void above the Northern section of the two-storey section of the structure | Unknown – Potential access via E6, W1,W3, and W4. Large opening in internal wall provides fly through access between Loft 3 and 4. | |

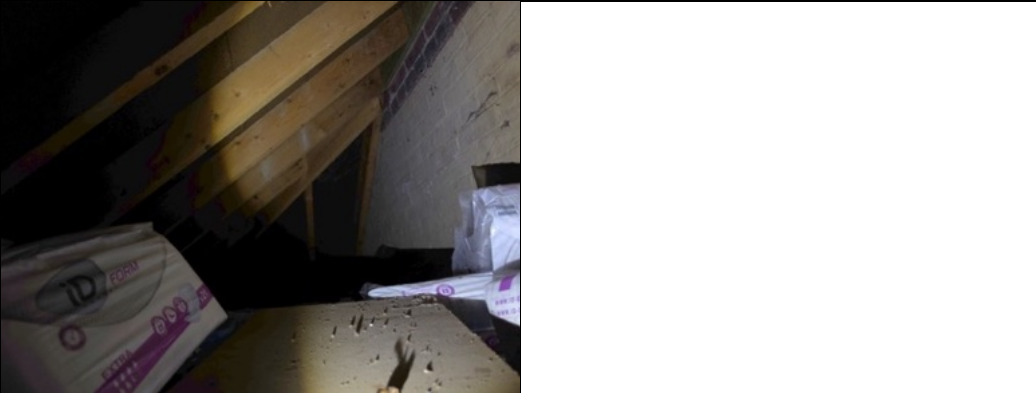
41. Eight likely *Pipistrellus* bat droppings were scattered throughout. Due to the size of the void and the number of droppings present, this was considered to represent a day roost.

| Loft 5 – Location 5 | | PEA | | 05/12/2025 | Unknown (Likely pipistrelle sp.)<br>Eight scattered droppings | Day roost | Internal void above the northern extension | Unknown - Potential access via E1, E2 and E4. | Void was approximately 4m x 1m |

| Loft 5 – Location 3 | Likely common pipistrelle day roost (up to 3 bats)<br>Low CS | Loss of access<br>Roost destruction<br>Disturbance | See 'E2 Avoidance' above | See 'E2 Mitigation' above | Temporary pre-erected bat box erected pre-dismantling and during construction;<br>Replacement roosting feature within roof structure |

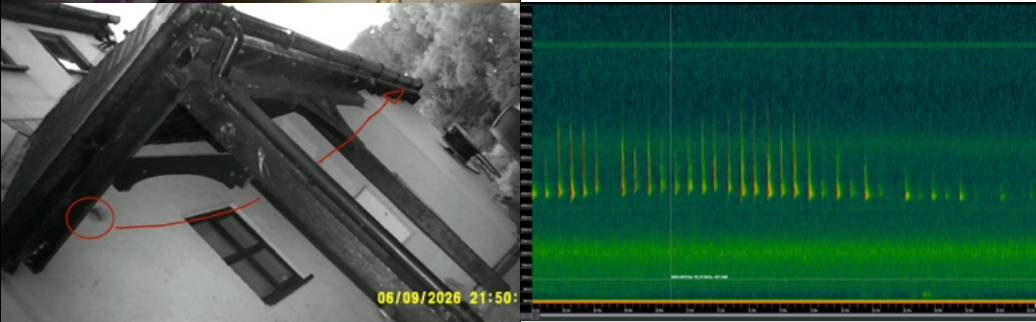
48. One common pipistrelle bat emerged from under the southeast corner of the woodstore (**E3.2**).

| E3.2 | | BE3 | | 09/06/2026 | Common pipistrelle | Day roost | Eastern elevation - Under the Southwest corner of the woodstore | Gap between wall and timber beam (~2cmX1m) | Gap between wall and timber beam (~2cmX1m) |

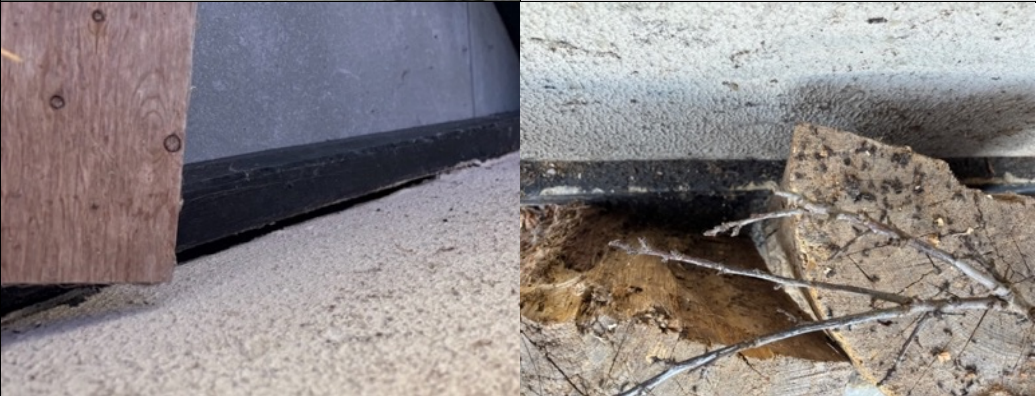
49. During a site meeting on 1st July 2026, approximately 400-500 likely *Pipistrellus* droppings were identified beneath the **E3.2** roost access (previously identified as a common pipistrelle day roost). The sudden appearance of these droppings indicates that this roost had recently been used by a large number of bats.

50. Between the 3<sup>rd</sup> bat emergence survey (9<sup>th</sup> June 2026) and the site meeting (1<sup>st</sup> July 2026), an extreme heatwave had occurred. The **E3.2** roost is sheltered from the sun during the afternoon, while the **E10** roost is exposed to the sun both earlier in the day and for most of the remaining day.

51. It is therefore considered most likely that the **E10** maternity roost temporarily utilised the **E3.2** roost during the extreme heatwave. As such, the **E3.2** roost is considered to be a maternity roost.

| E3.2 | | Additional Site visit | | 01/07/2026 | Approximately 400-500 bat droppings (Likely Common Pipistrelle). | Considered likely maternity roost | Eastern elevation - Under the Southwest corner of the woodstore | Gap between wall and timber beam (~2cmX1m) | Gap between wall and timber beam (~2cmX1m) |

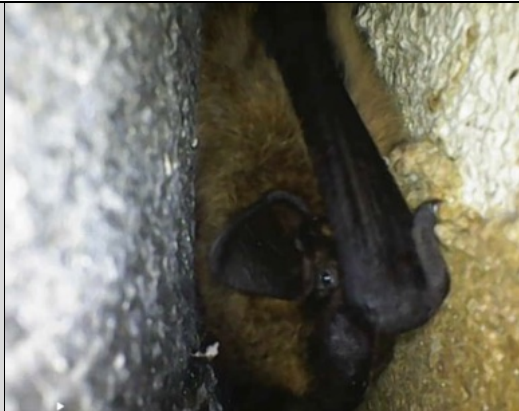
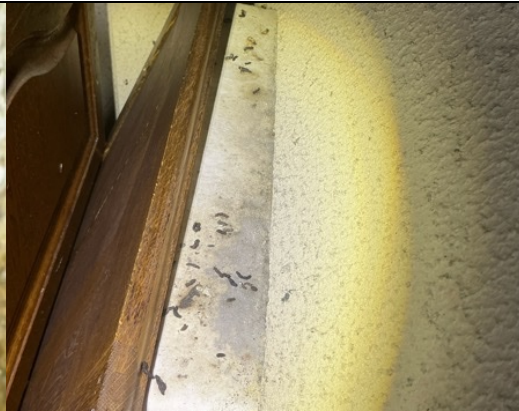
29. At the woodstore, a single common pipistrelle bat was identified by endoscope, roosting between the northernmost roof rafter and the rendered wall (feature E2) at the woodstore roof eaves. Approximately 35 common pipistrelle droppings were recorded beneath the access point (confirmed by eDNA analysis).
30. The gap between the roof rafter and the rendered wall tapered from 3cm at the lower roof edge up to approximately 50cm from the eastern wall. At this upper 50cm section, the wall render did not extend beyond the point where it met the rafter, forming a narrow “tunnel” for this upper 50cm long section. This 50cm section is considered to be the roost.
31. The roost was accessed via the wider 2-3 gap section within the approximately central third of the roof rafter-wall gap.

| E2 | | | PEA | 05/12/2025 | Common pipistrelle (1) | Winter roost | Eastern elevation – woodstore roof in northwest corner (see | Gap between woodstore roof timber and adjacent northern extension wall (approximately 2-3cm x 30cm) Location – E2 | Between woodstore roof timber and adjacent northern extension wall – internal space is unknown due to the possibility of access to a void between the woodstore ceiling boards and roof tiles. |

| Structure reference | Roost Character & Conservation Significance | Potential Effects | Avoidance | Mitigation | Compensation |
|---|---|---|---|---|---|
| E2 | Common pipistrelle winter (hibernation) roost (1 bat)<br>Low CS | Loss of access<br>Roost destruction<br>Disturbance during construction | Works will be undertaken between September and mid-November or mid-March and April.<br><br>Construction works will finish at least 30 minutes before sunset and start no earlier than 30 minutes after sunrise.<br><br>Where required, lighting will be directional to avoid illuminating retained or replacement bat roost features. | ToolBox Talk; Precautionary Approach to dismantling / demolition; Level 2 licenced bat worker present during works; | Temporary pre-erected bat box erected pre-dismantling and during construction;<br>Retained roost space in situ;<br>Modification of access to enable continued new access |

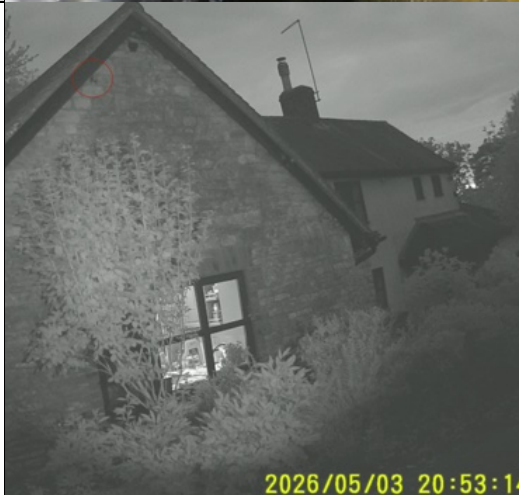
44. 12 common pipistrelle bats and three non-echolocating bats were observed emerging from a fascia board at the eastern gable (**E10**). All three non-echolocating bats were considered to be common pipistrelle due to emergence location and visual observation of the individuals.

| E10 | | | BE2 | 04/05/2026 | Common pipistrelle (12)<br><br>Unknown (4)<br>Considered to be likely Common pipistrelle due emergence location and visual observation of the individuals | Maternity roost | South east gable - Between the southern fascia board and the wall with potential access into the void (Loft 2). | Behind the southern fascia board, approximately 1m – 2m from the gable apex. | Between the southernmost fascia board and wall (approximately 3cm widest). |

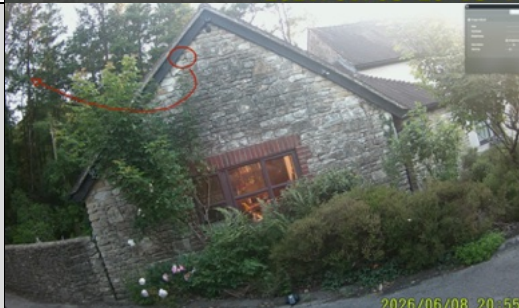
46. 40 common pipistrelle bats were observed emerging from the southern section of fascia board at the eastern gable (**E10**). From 22:08 to 22:54, 23 common pipistrelle bats were observed re-entering into the same location (**E10**) and continued to re-enter after the survey ended.

| E10 | | | BE3 | 09/06/2026 | Common pipistrelle (40) | Maternity roost | See above 'Location E10' BE2 | See above 'Location E10' BE2 | See above 'Location E10' BE2 |

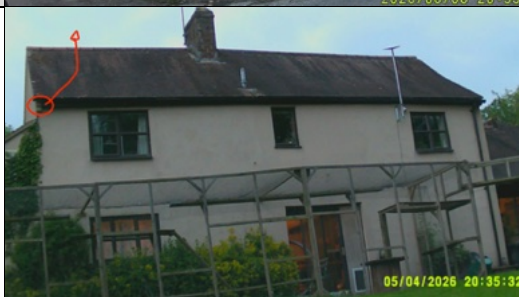
45. One common pipistrelle emerged from the northwest corner (**W1**) of the Structure from a small gap where the lower corner of the roof met with the wall.

| W1 | | | BE2 | 04/05/2026 | Common pipistrelle (1) | Day roost | Northwestern corner of the two-storey section of the Structure | A gap where the northern wall meets the western timber fascia. | Gap is at least 5cmx2cm. It is unknown if the void extends/ gives access to a void between the woodstore ceiling boards and roof tiles. |

| W1 | Common pipistrelle day roost (1 bat)<br>Low CS | Loss of access<br>Roost destruction<br>Disturbance during construction | See 'E2 Avoidance' above | See 'E2 Mitigation' above | Temporary pre-erected bat box erected pre-dismantling and during construction;<br>Replacement roosting feature within roof structure |

A single crevice dwelling bat box will be installed onto the external wall of the northern elevation gable at 0.5m below the gable apex.

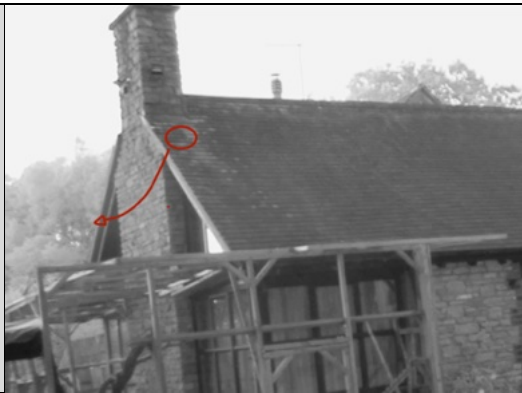
47. One soprano pipistrelle bat was observed emerging from the southern roof elevation (**S5**).

| S5 | | | BE3 | 09/06/2026 | Soprano<br>pipistrelle | Day roost | Southern<br>roof<br>elevation ~ 4<br>tiles from the<br>western roof<br>edge ~3 tiles<br>down from<br>the chimney<br>base. | At roost location: From<br>under a tile | Gap is approximately 2cmx2cm. It is<br>unknown if there is access into Loft 2. |
