Ecological Enhancement Plan

EC1932-09

Salisbury NHS Foundation Trust

September 2026

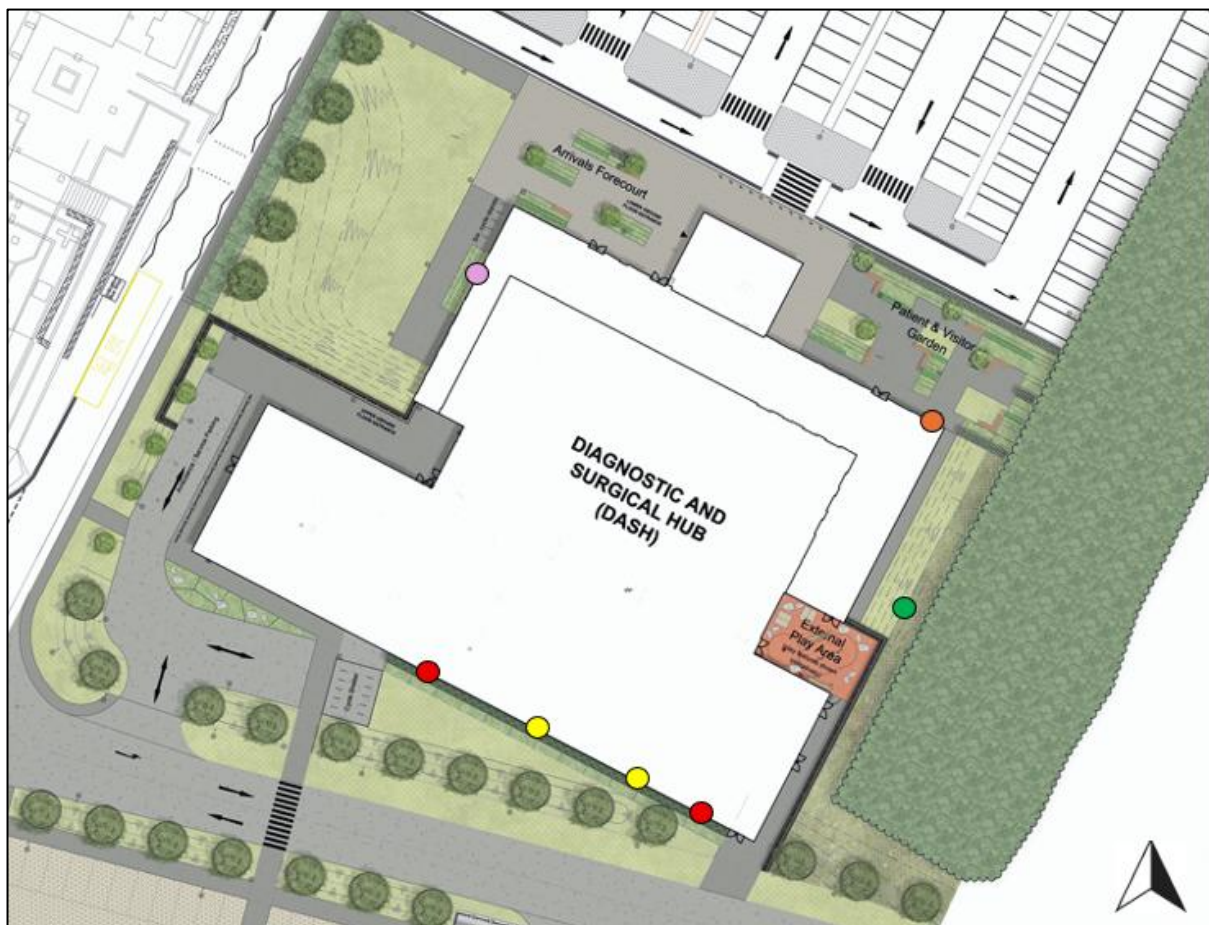
Figure 1. Location of ecological features: bat boxes (red), sparrow nest terrace (orange), swift nest bricks (purple), insect bricks (yellow) and standing log pile (green).

The specifications of the ecological enhancement features and their management are set out below. The locations of the ecological enhancement features detailed below are shown in Figures 1 - 5, Appendix A. Examples of the enhancement features detailed below are shown in Figures 6 – 10, Appendix B.

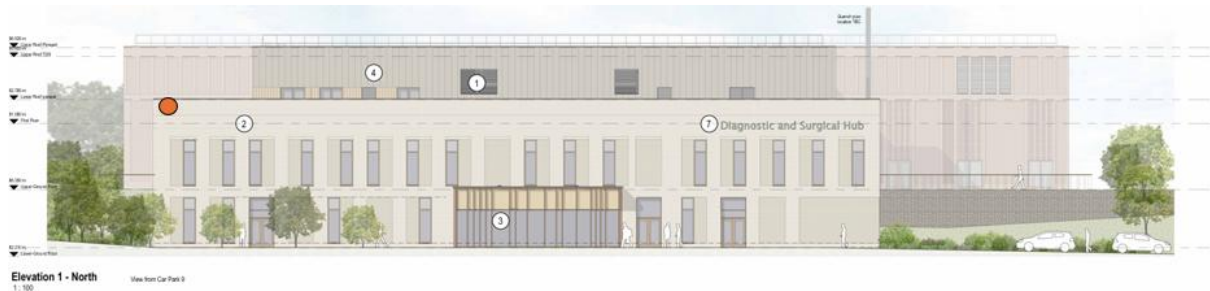
Figure 2. North elevation showing indicative positioning of sparrow terrace (orange).

One Habitat Sparrow Terrace (<https://www.habibat.co.uk/integrated-bird-products399f8204>), or similar alternative, will be built into the Lower Roof Parapet of the new building, to provide safe and secure nesting place for this species. As house sparrow prefer to nest in colonies, a terrace box type provides three nesting chambers together.

The sparrow terrace will be installed on a northern elevation to avoid overheating the nest. The boxes will be installed as high as possible into the top of the wall of the Lower Roof Parapet to ensure maximum distance between the ground level and the box entrances, thus providing a clear flight path for birds.

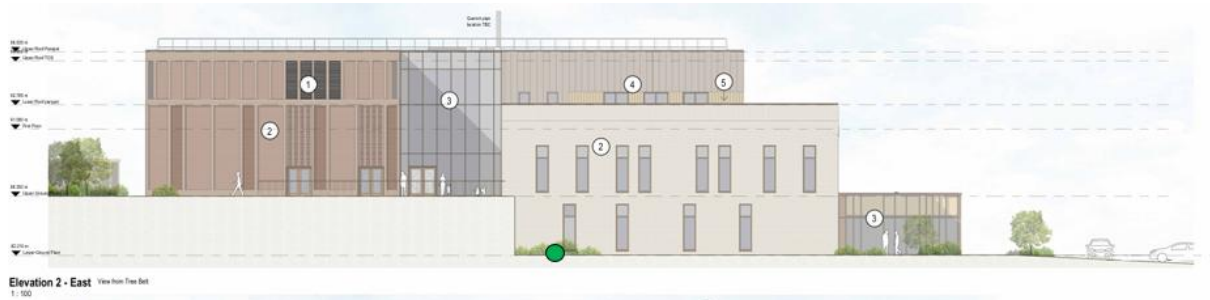
Figure 3. East elevation showing indicative positioning of standing log pile (green).

One standing wood pile will be installed to the east of the building, in the greenspace adjacent to the tree line. At least ten logs will be used to create the habitat, stood vertically and partially buried to approximately 50cm deep. Above the ground, the logs will be at varied heights. Untreated logs from broadleaved tree species will be used and be at least 10cm in diameter.

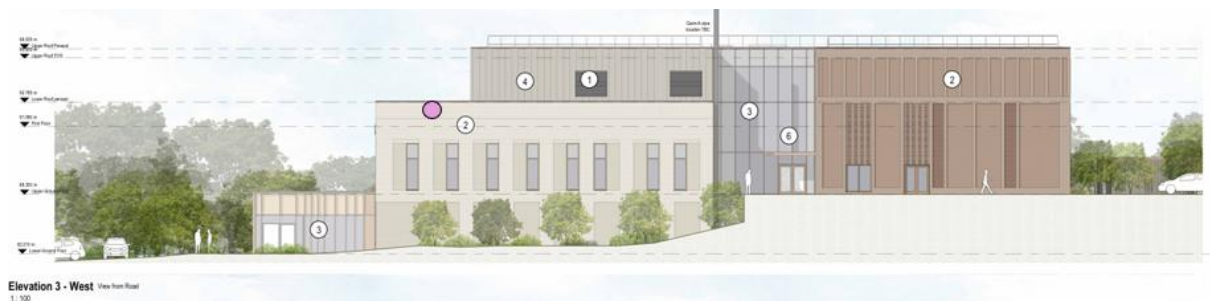
Figure 5. West elevation showing indicative positioning of three swift bricks grouped together (purple).

Three specialist nest bricks will be grouped together to provide colony nesting space for swifts on the Lower Roof Parapet of the new building. Examples of suitable bricks include Action for Swifts Integrated 'S Brick' - Double Brick Length, Ibstock Eco Habitat Built-In Swift Nest Box and Genesis Built-In Swift Nest Box (<https://www.wildcare.co.uk/wildlife-nest-boxes/bird-boxes/swifts.html>). The three bricks will be positioned close to one another, but with at least a 40cm distance between entrance holes.

The boxes will be installed into a western elevation to avoid overheating the nest. The boxes will be installed as high as possible into the top of the wall of the Lower Roof Parapet to ensure maximum distance between the ground level and the box entrances, thus providing a clear flight path for birds.

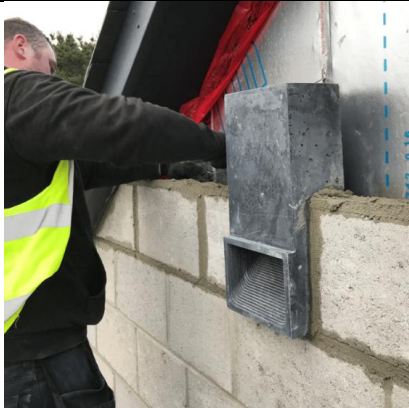
Figure 6: Green&Blue BatBlock Built-In Bat Box  
(<https://www.wildcare.co.uk/greenblue-batblock.html>)

Two bat boxes will be installed on the Upper Roof Parapet of the new building to provide roosting opportunities for crevice dwelling species such as common pipistrelle. The boxes installed will be Green&Blue BatBlock Built-In Bat Box (<https://www.wildcare.co.uk/greenblue-batblock.html>), or a similar alternative, built into the exterior wall during construction.

Built in bat boxes/bricks are constructed of concrete or concrete and wood mixes. They are long-lasting, breathable and maintain a consistent temperature inside for roosting bats.

The bat boxes are designed so that droppings fall out freely, therefore eliminating the need for cleaning out.

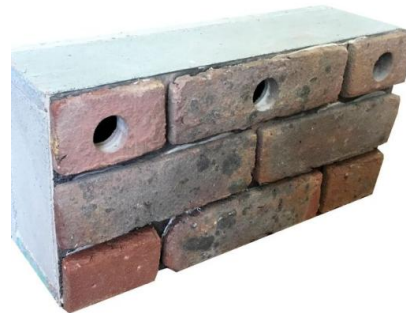
Figure 7: Habibat Sparrow Terrace  
(<https://www.habibat.co.uk/integrated-bird-products399f8204>)

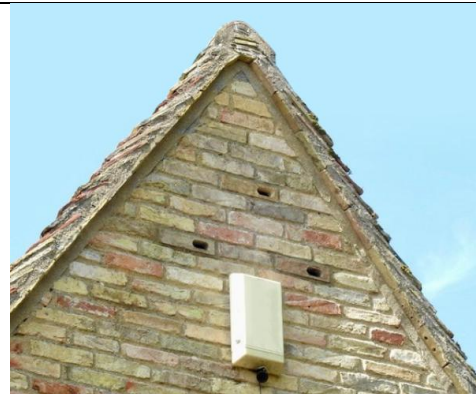
Figure 9: Example showing three swift bricks grouped together  
(<https://www.actionforswifts.com/>)

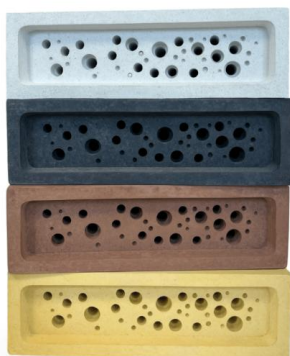
Figure 10: Green&Blue Bee Brick  
(<https://www.wildcare.co.uk/greenblue-bee-brick.html>)

Two insect bricks will be installed into the walls of the Lower Roof Parapet of the new building. The bricks contain moulded cavities where the bees can lay their eggs. Examples include Green&Blue Bee Brick (<https://www.wildcare.co.uk/greenblue-bee-brick.html>) and Habibat Solitary Bee Box (<https://www.habibat.co.uk/habibat-solitary-bee-box>).

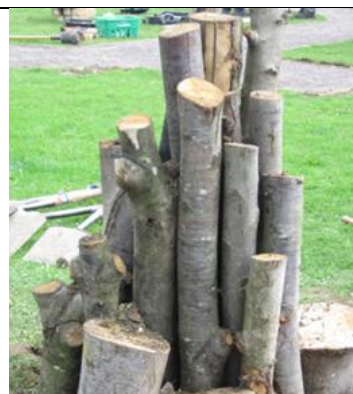
Figure 10: Standing wood pile example  
(<https://ptes.org/wp-content/uploads/2016/11/Build-a-log-pile-for-stag-beetles.pdf>)
