Land at Gate Farm, High  
Street, Sutton Benger  
Flood Risk Assessment &  
Drainage Strategy

## Flood Risk Assessment & Drainage Strategy

P25-317

25317-RLL-25-XX-RP-C-0001

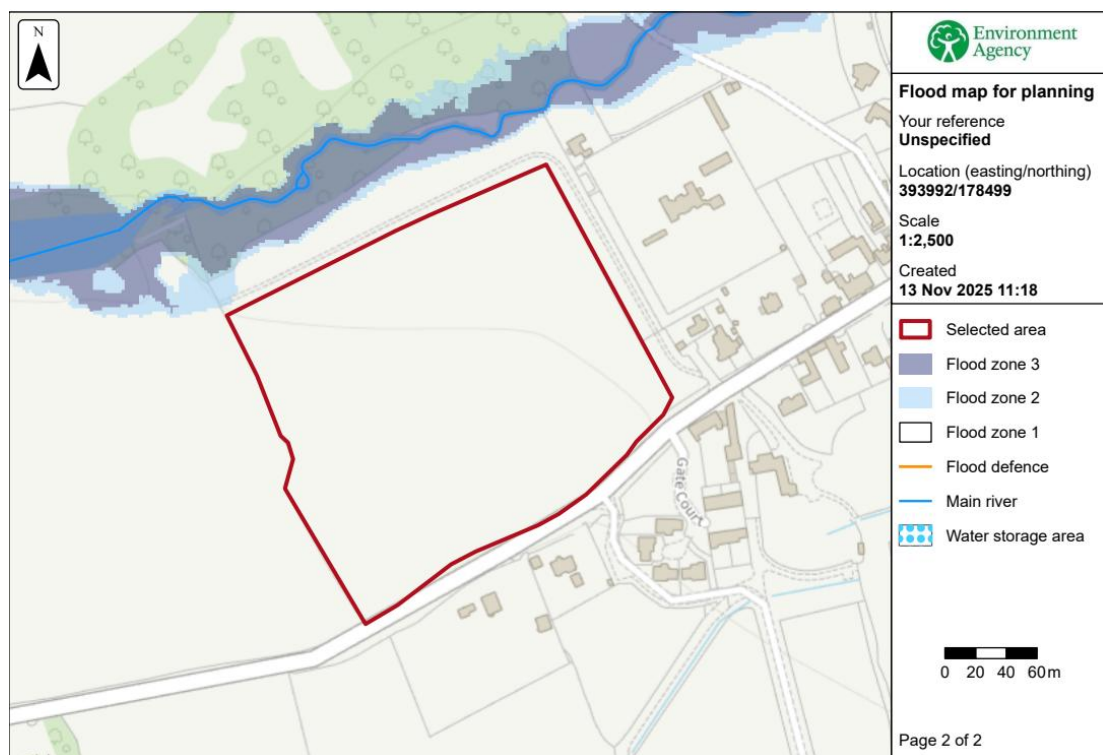
- 3.1.1 The application site lies wholly within Flood Zone 1, indicating a low probability of fluvial flooding. Flood Zones 2 and 3 are restricted to land immediately north of the site boundary and are associated with the adjacent main river. No part of the proposed built development encroaches into these higher-risk areas, ensuring that residential and other vulnerable uses remain entirely within Flood Zone 1. A snapshot of the Environment Agency Flood Map for Planning is provided in Figure 3.1.

- 3.1.2 As such the site is not considered to be at risk of flooding from fluvial sources. Full product 4 data can be found in **Appendix I**.

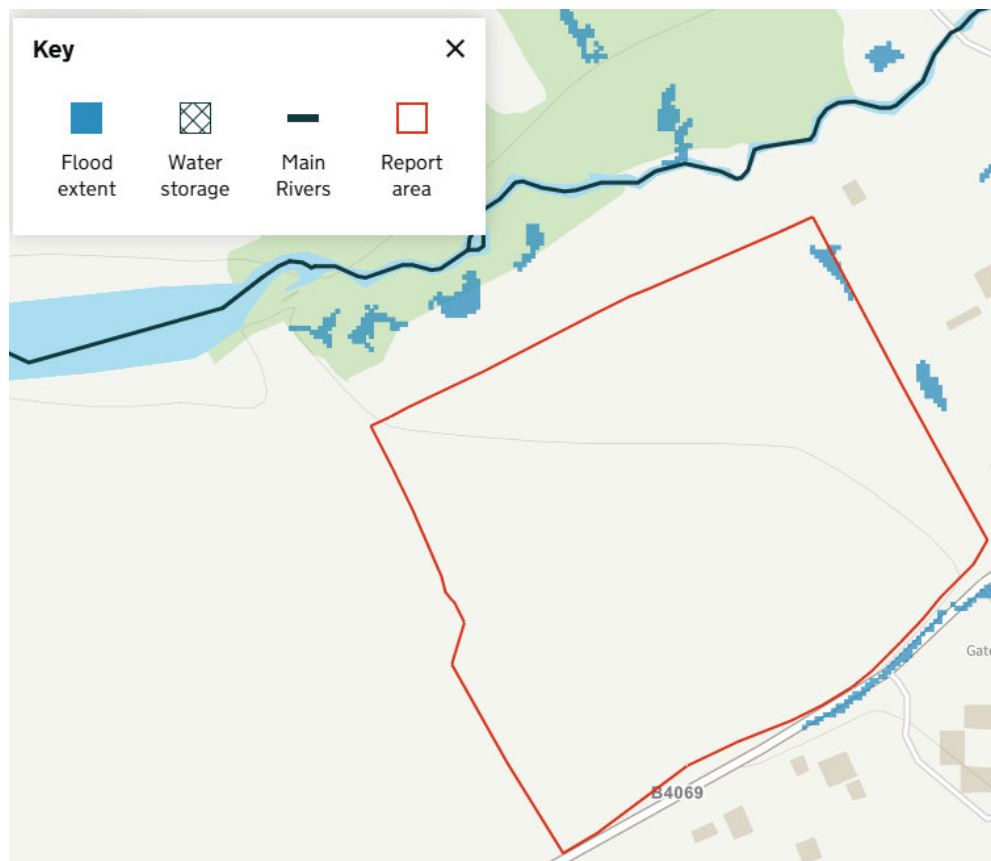
Figure 3.4 EA Surface Water Flood Risk Map

- 3.4.1 A review of the Environment Agency's mapping indicates that the site is predominantly at low risk of surface water flooding in the 1 in 1000-year event. Mapping of the extent of surface water flood risk is shown in Figure 3.4.

- 3.4.2 The Environment Agency surface water flood mapping shows that the site is predominantly at low risk of surface water flooding.
- 3.4.3 Mapped surface water ponding and flow paths are limited to off-site areas along the adjacent main river corridor and isolated low points within the Sutton Benger settlement, with no overland flow routes directed towards the site or its boundaries.

- 3.4.4 A small, isolated area of minor surface-water flood risk is shown on EA mapping at the southern site boundary within the B4069. This represents shallow, low-hazard ponding associated with the existing road corridor rather than overland flow routes towards the site. A further very small patch of shallow surface-water ponding is also shown within the north-eastern corner of the site boundary; this lies within open land and does not coincide with any proposed built development or internal access routes.

risk for the lifetime of the development. The minor mapped areas of surface water risk do not affect the developable area, do not pose a hazard to safe access/egress, and are mitigated through the proposed positive drainage and exceedance routing, without increasing flood risk elsewhere. On this basis, no further mitigation or sequential testing is required in relation to these isolated features.

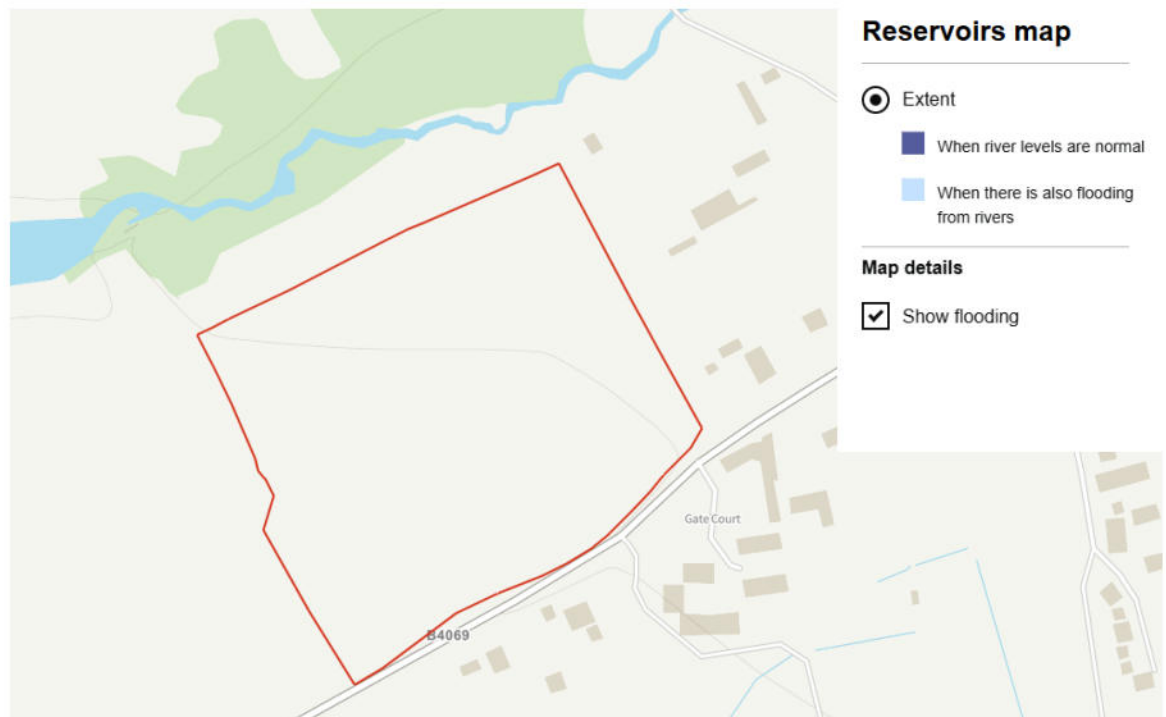
Figure 3.5 EA Reservoir Flood Risk Map

- 3.6.1 The Environment Agency's online flood mapping shows that the site is outside of the area at risk of flooding from reservoirs. An extract of the mapping is shown in Figure 3.5 below.

- 3.6.2 Based on the above, the site is considered to be at low risk of flooding from the failure of infrastructure.

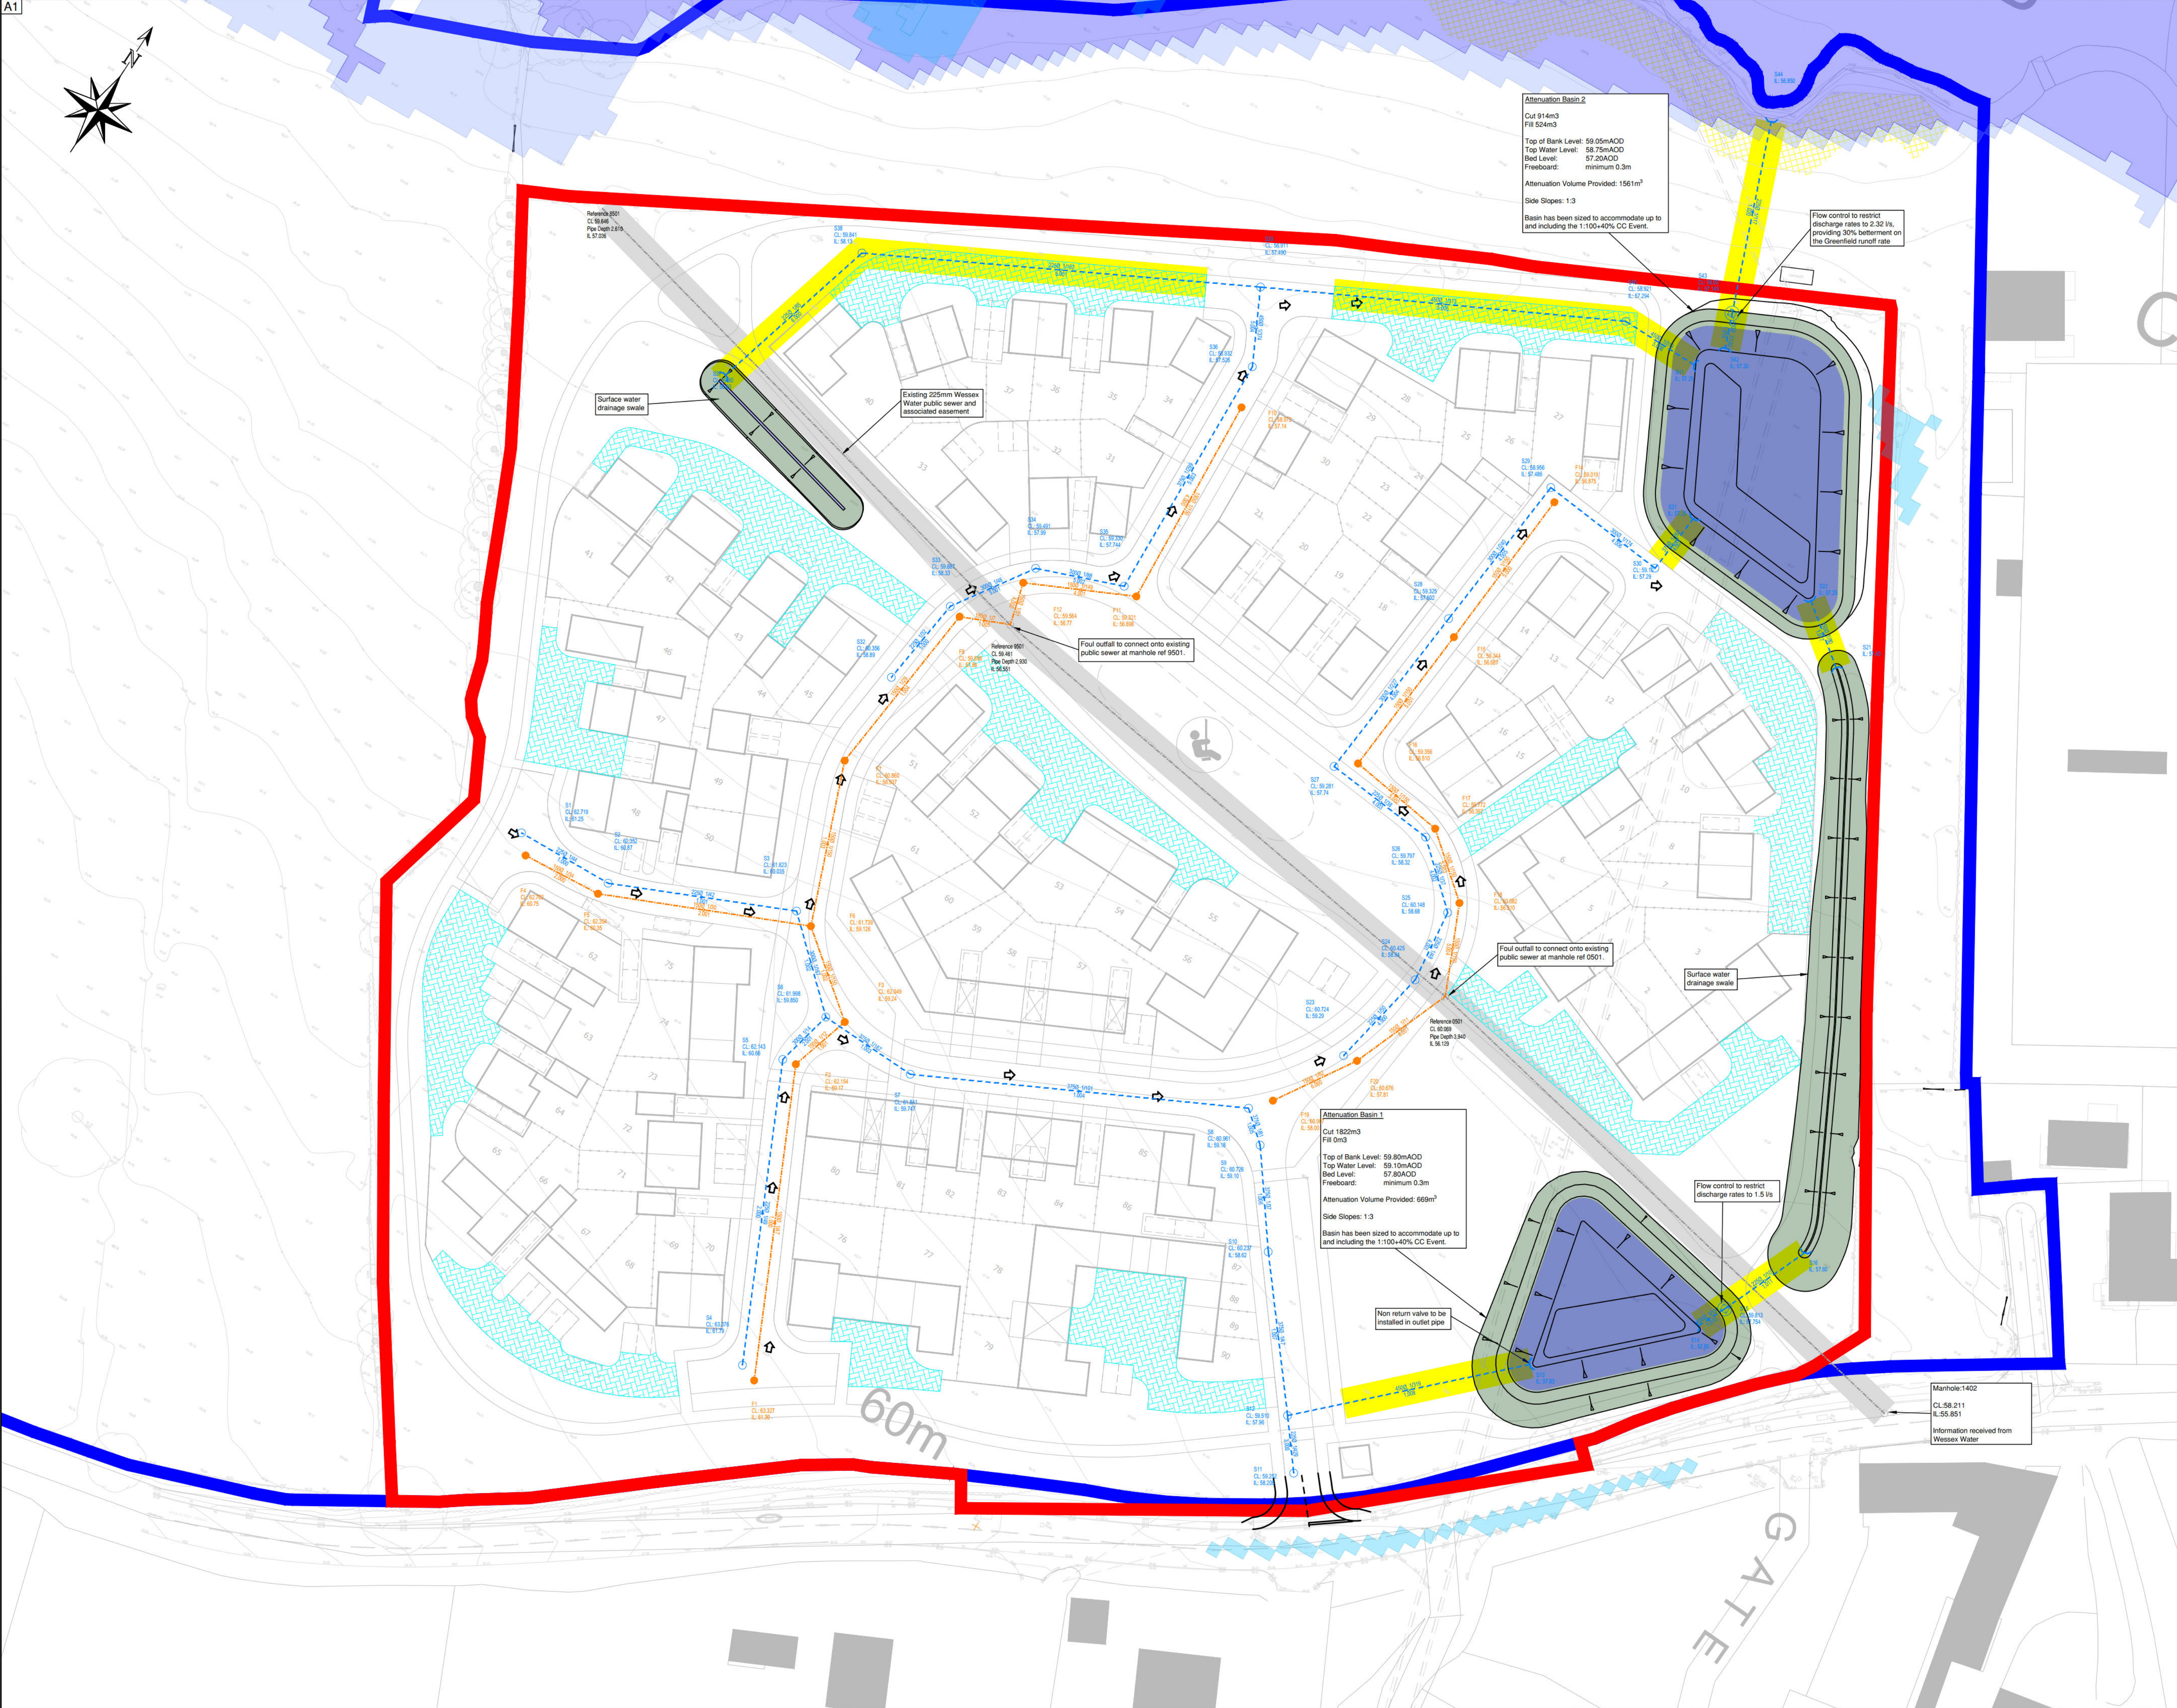
## Appendix C – Drainage Strategy Plan

- 6.1.6 A copy of the proposed drainage strategy plan indicating the schematic foul water sewer design and outfall points can be found in **Appendix C**.

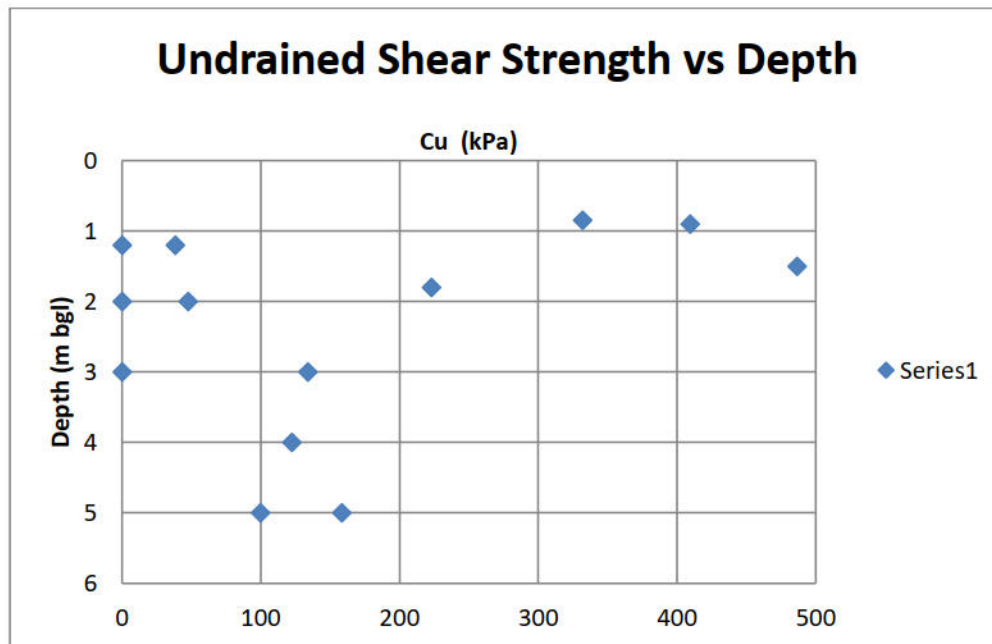
Figure.2 – Showing undrained shear strength with depth.

$$c_u = N_{60} f_1 \text{ (kN/m}^2\text{)} \quad [1]$$

Where  $c_u$  is the undrained shear strength,  $N_{60}$  is the corrected SPT N value and  $f_1$  is an empirical correlation factor based on the soil plasticity index. Derived  $C_u$  values are presented against depth in the accompanying figure.

The Kellaways Sand Member predominately exhibits low strength cohesive soils (<30Kpa), within WS04 located in the southwest of the site. This is confirmed in with field observations in trial pits TP07 to TP11 where soft clay was observed.

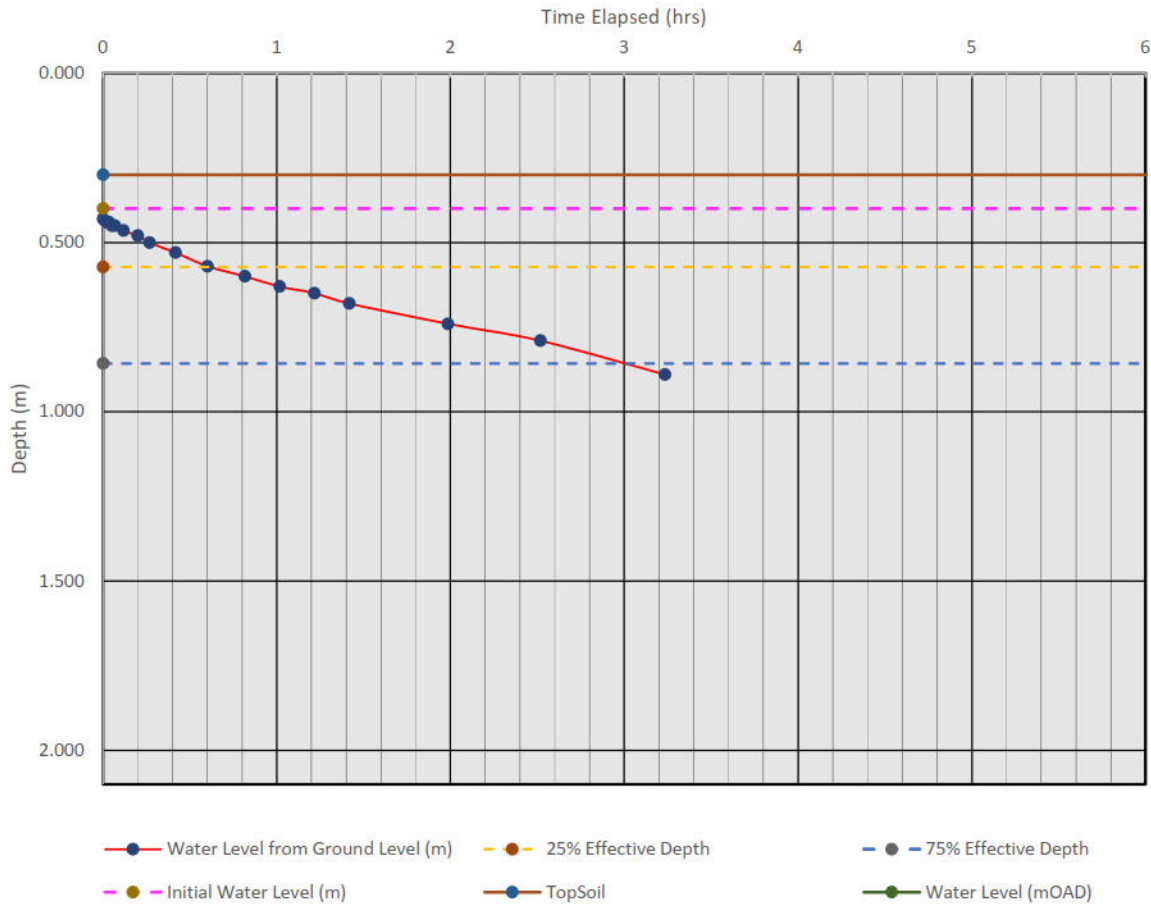
P25-317 Sutton Benger SA01 T1

| <b>Time for outflow between 75% and 25% effective depth (secs):</b> | 9000.00 |

| <b>vol between 75% and 25% (m3):</b> | 0.52 |

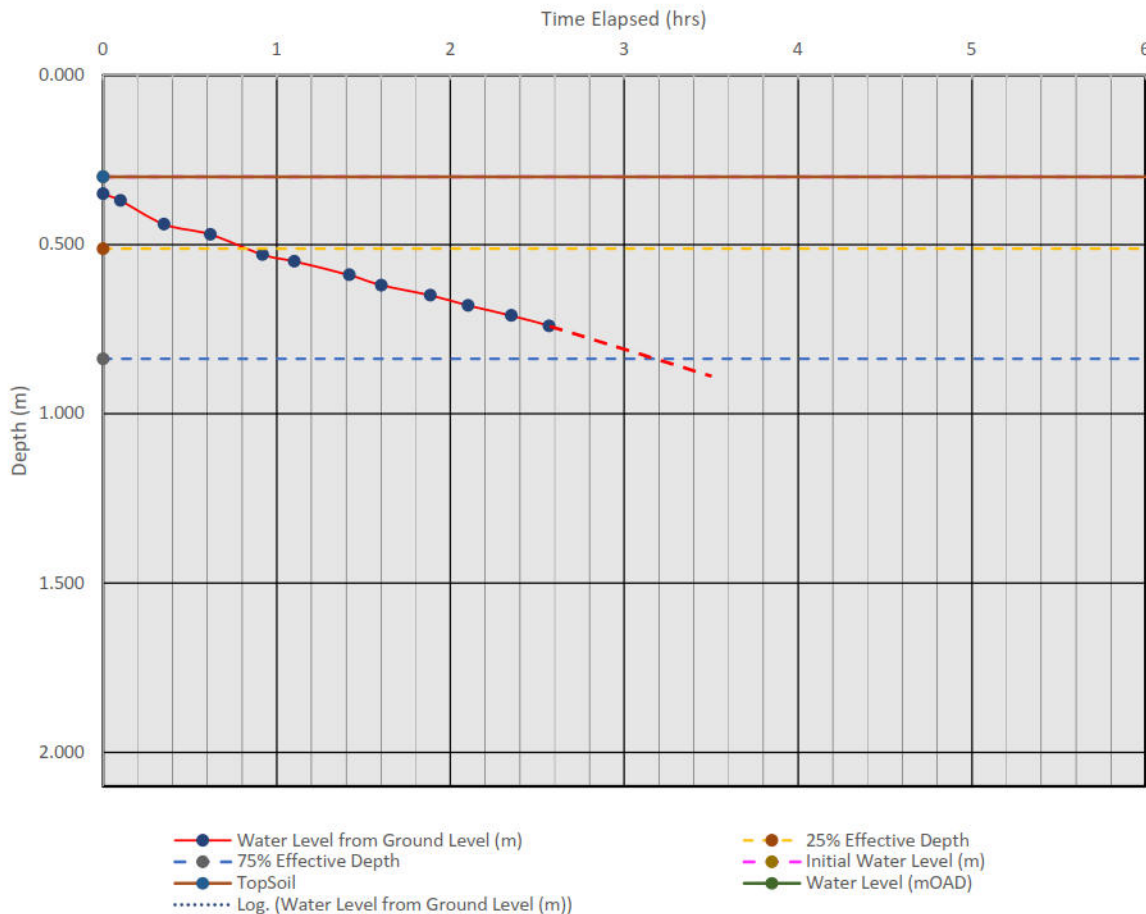
P25-317 Sutton Benger SA01 T2

| <b>Time for outflow between 75% and 25 % effective depth (secs):</b> | 9120.00 |

| <b>vol between 75% and 25% (m3):</b> | 0.59 |

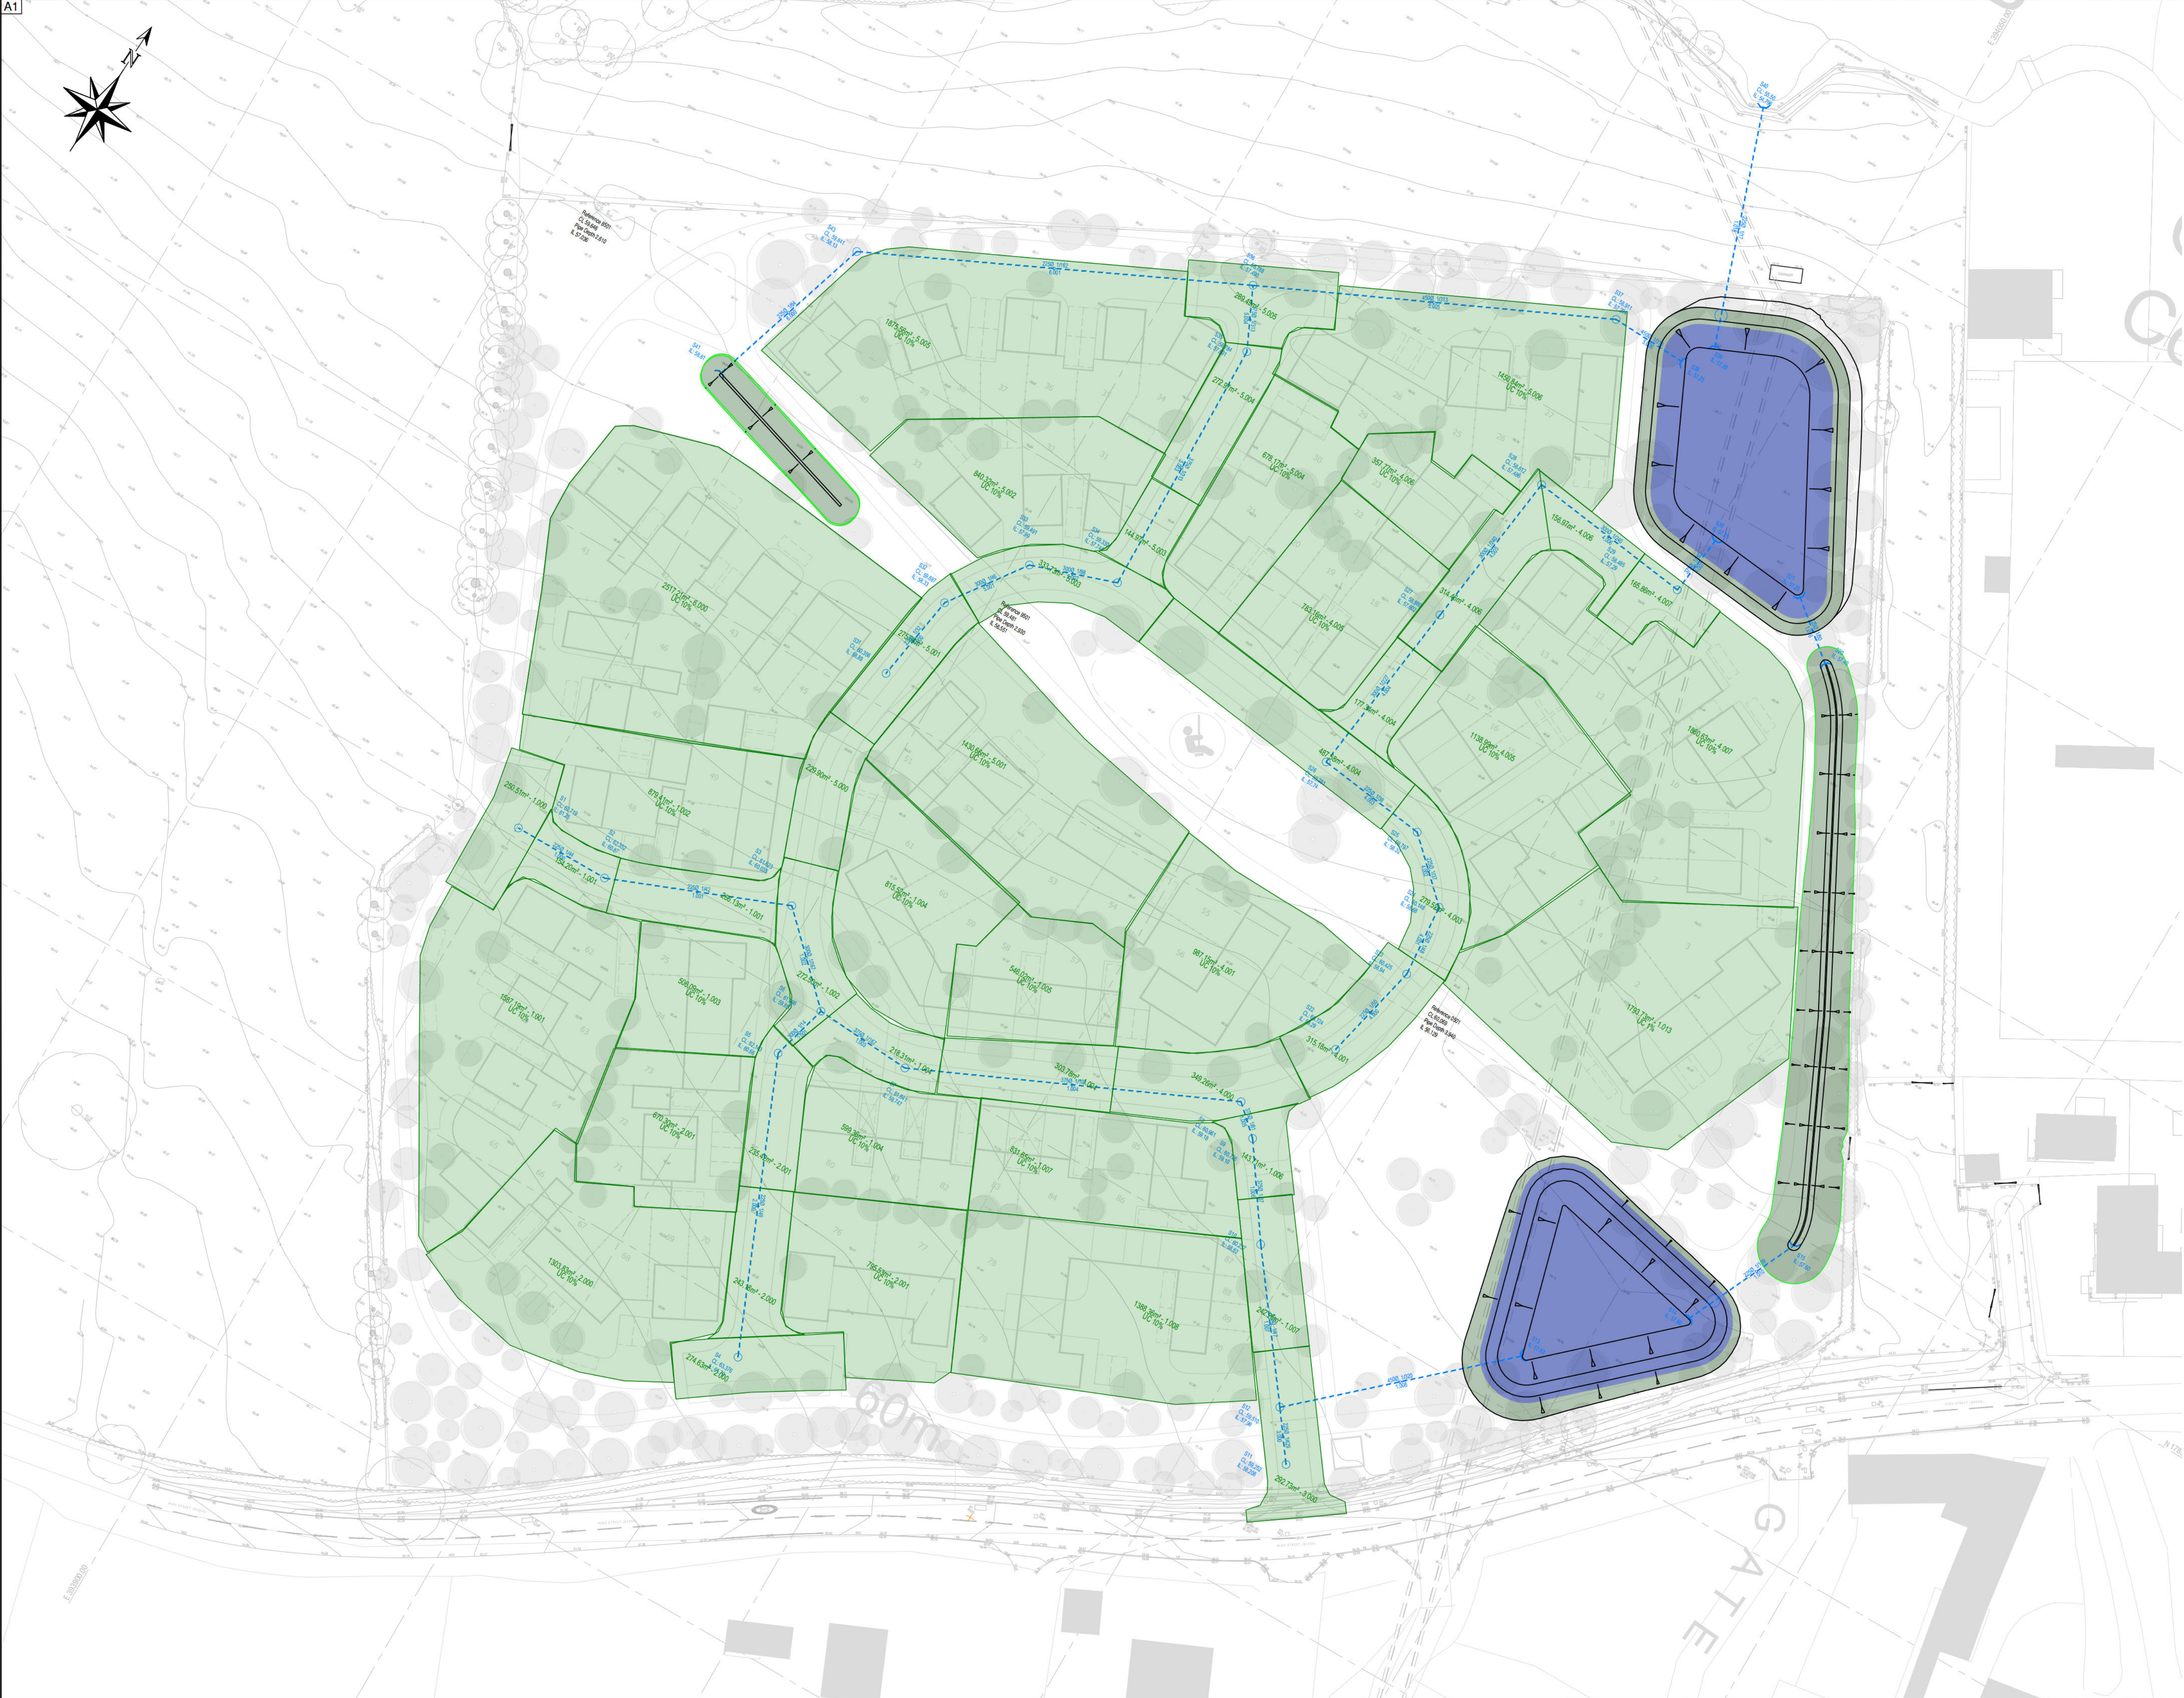
## **Appendix H – Surface Water Drainage Area Plan**

- 4.4.5 A surface water drainage area plan can be found in **Appendix H**.
- 4.4.6 The attenuation basins form the primary SuDS features for the development, providing a significant amount of storage. The basins have been sized to accommodate runoff from storm events up to and including the 1 in 100-year + 40% climate-change allowance. Flows from the southern half of the development will be restricted from basin 1 at a controlled discharge rate of 1.5 l/s. Final discharge into the main river will be restricted to 2.32 l/s.

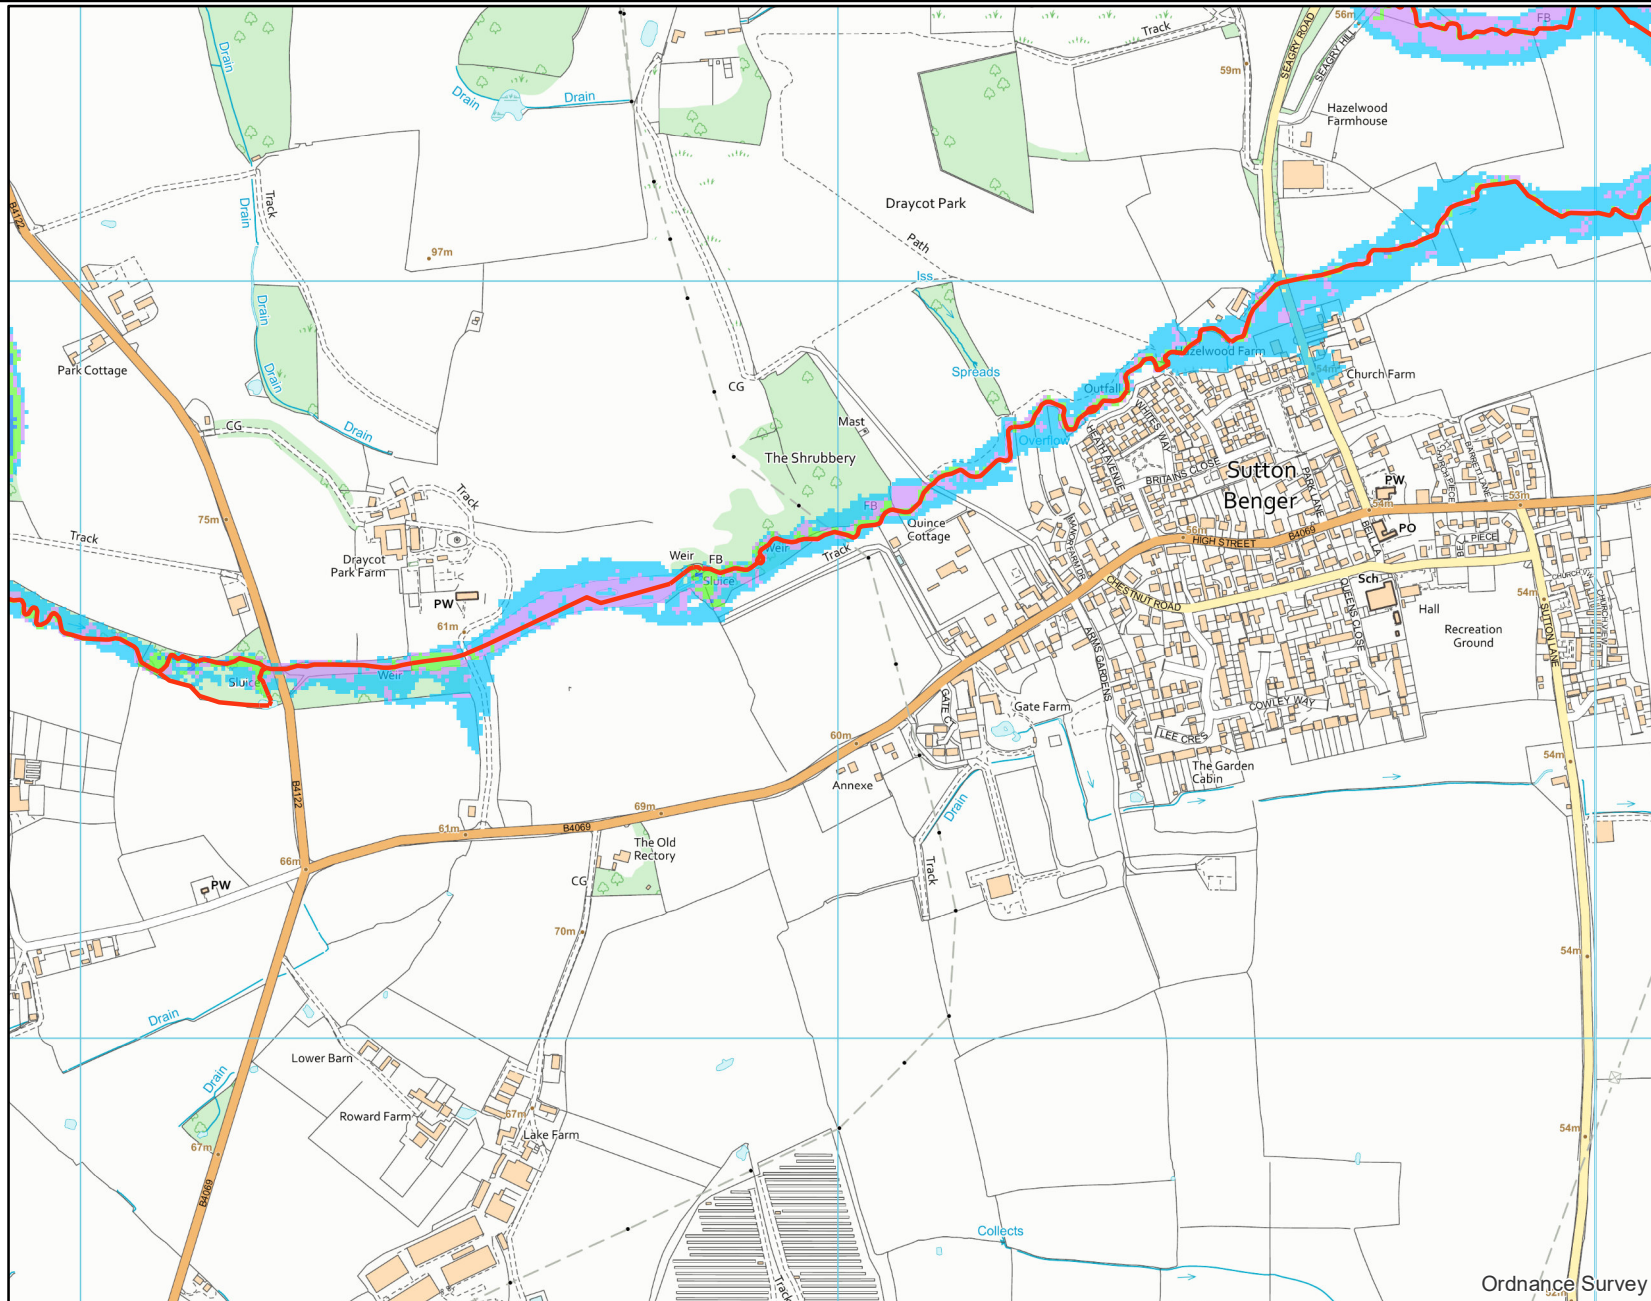
EIR2025/41803 - JFLOW Fluvial Water depths (m) Without Flood Defences. 100 year (1% AEP)  
Centred on land at ST 93995 78506. Created 28/11/2025.

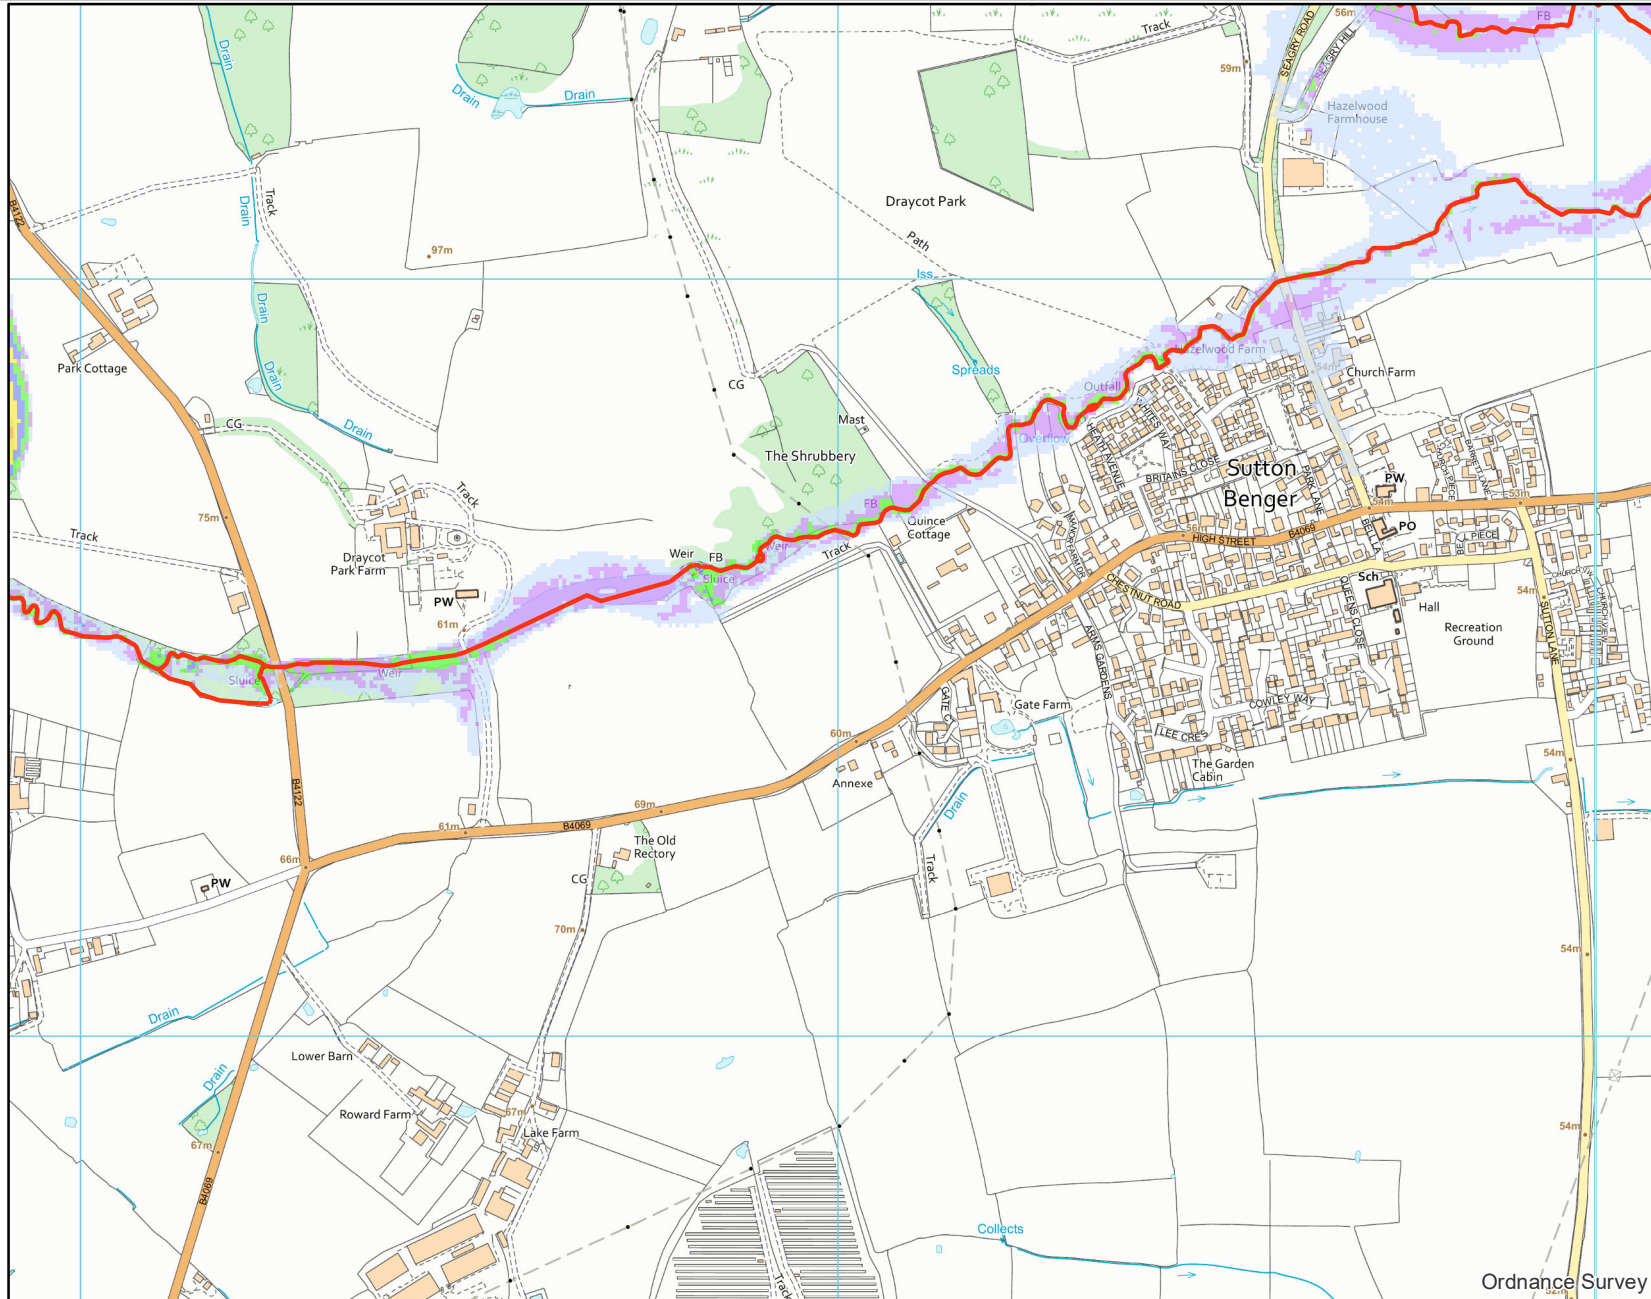
EIR2025/41803 - JFLOW Fluvial Water depths (m) Without Flood Defences. 1000 year (0.1% AEP)  
Centred on land at ST 93995 78506. Created 28/11/2025.
