## **Fireplace at 13 Wilcot Green, Pewsey, SN9 5NN**

**A Historic Buildings Study**

**March 2026**

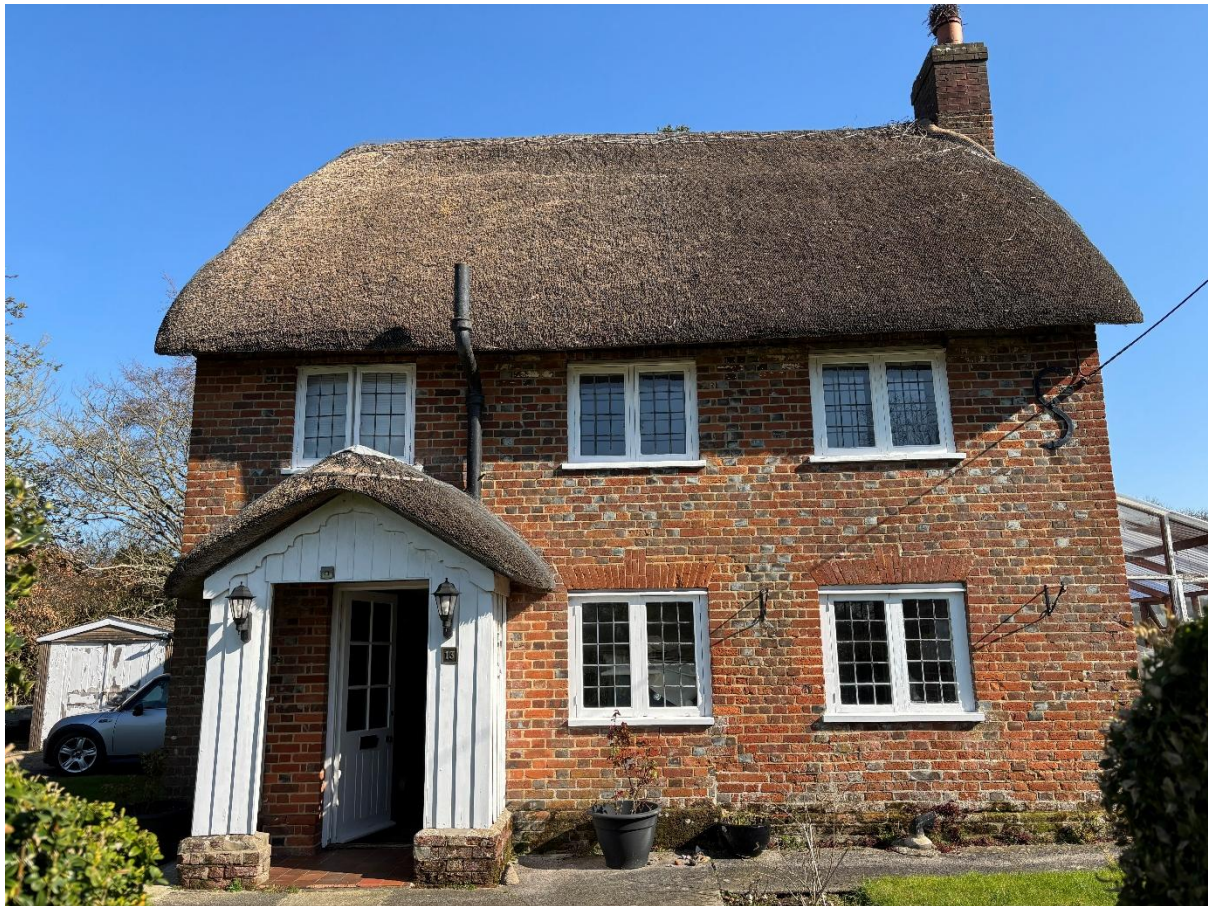
**Fig.2 Main elevation**

A Flemish bond brick cottage of two full storeys under a gabled thatch roof, with former central entrance on the **main road elevation**, now a window (**fig.2**). Some brickwork has been replaced, but the right-hand vertical joint of the former doorway largely remains. There is a single brick chimney to the hearth in the main room on south-east gable end. The lower windows have flat gauged arches with prominent keyblocks. There is some slight evidence that the upper floor may have been set under a long dormer from the lighter brick corners at first floor level, and a possibility that the wall has been raised by one or two courses (**fig.3**).

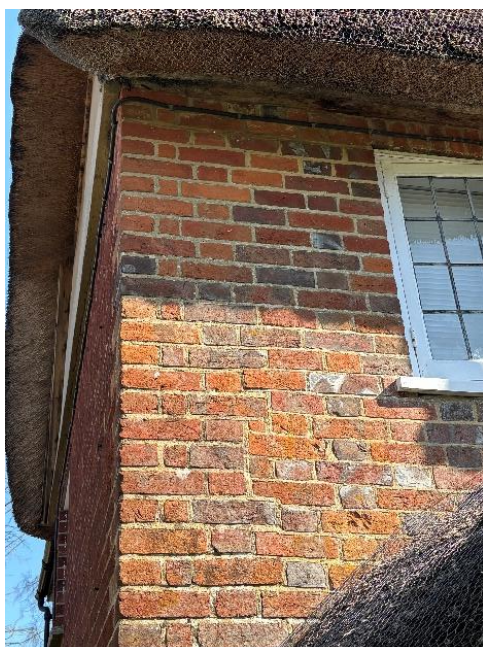
**Fig.3 South-west corner showing discontinuity in brickwork due to the rebuilding of the north-east gable wall**

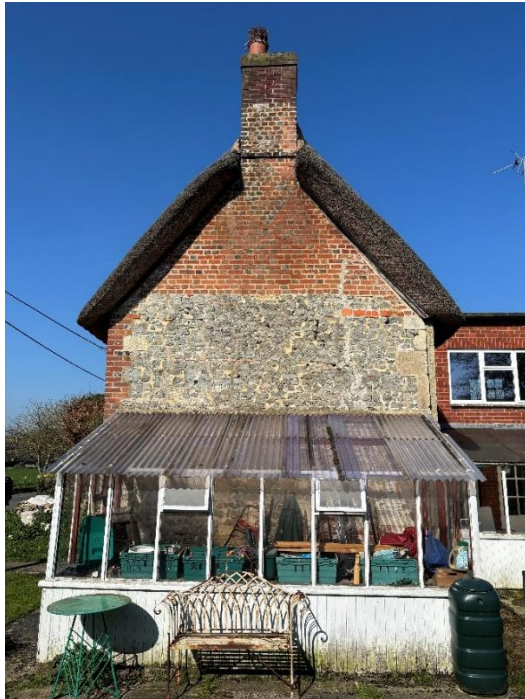
**Fig.4 South-east gable**

The **south-east gable wall** is of greensand rubble with limestone quoins. There are brick returns to the front elevation, and limestone to the rear elevation, which is obscured by a rear range, and a facing of concrete block. The upper gable is in Flemish bond brickwork, continuing to the chimney (**fig.4**).

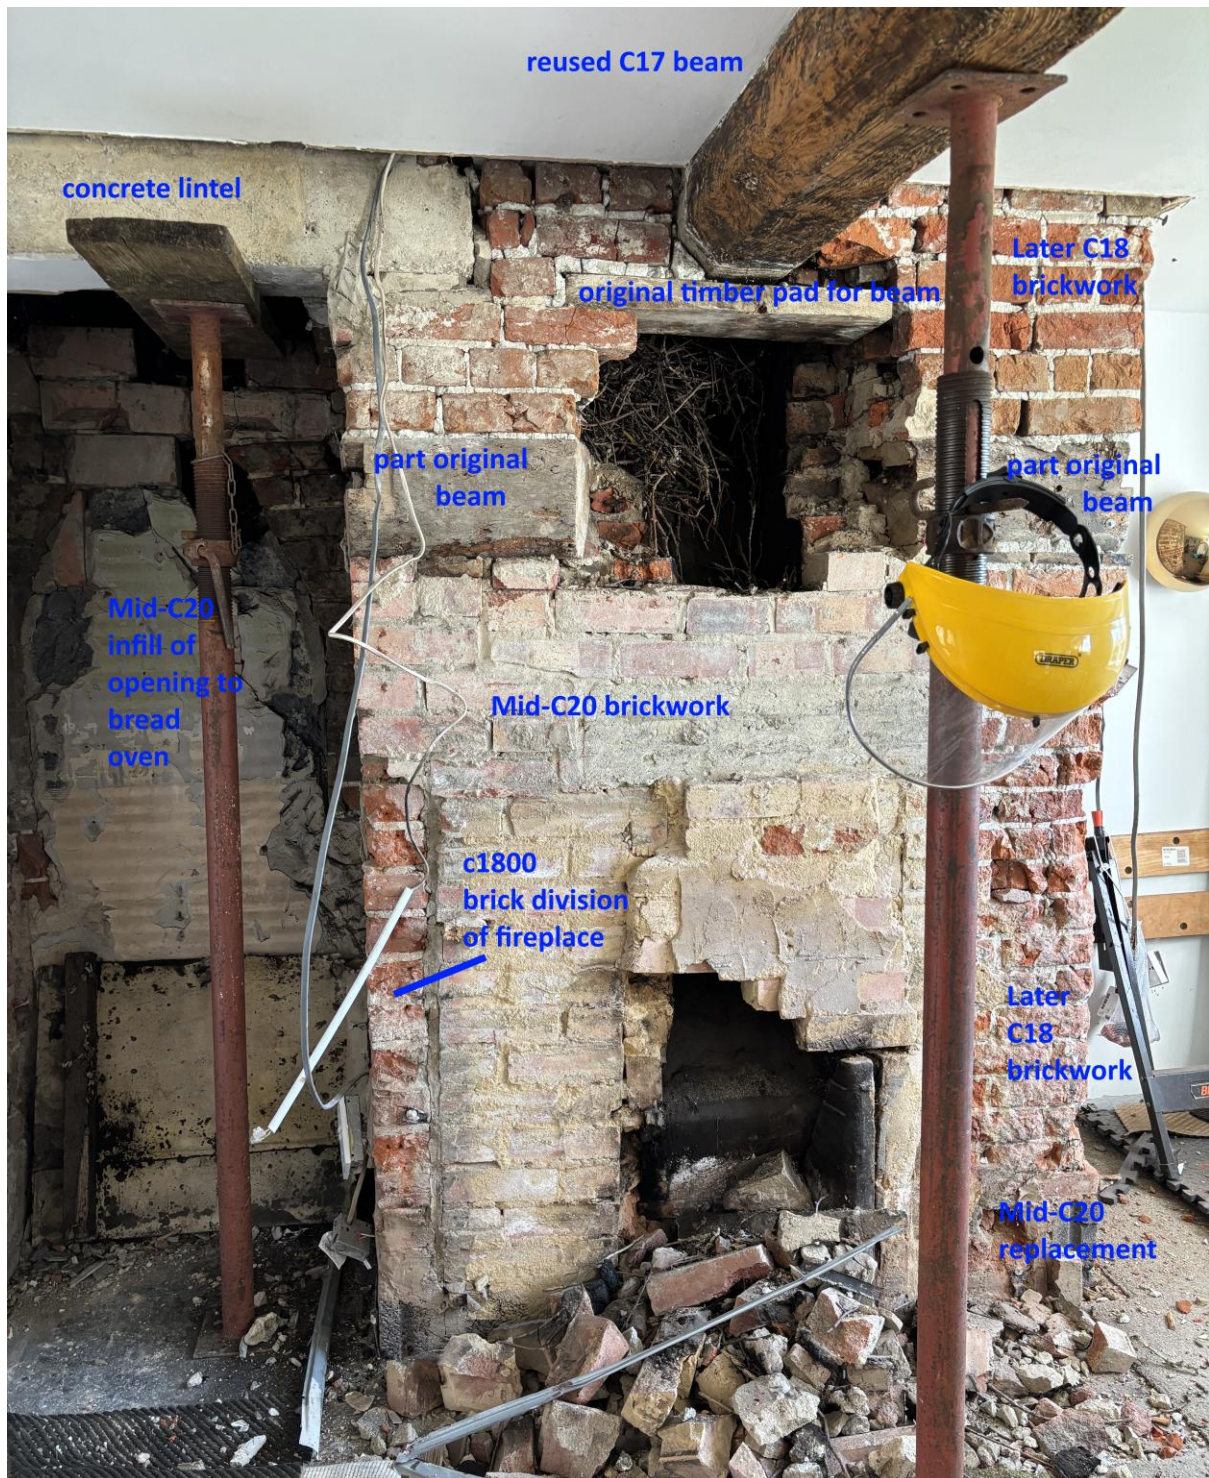
**Fig.6 Main hearth at ground floor level**

- The same cinder block infill is seen in the bread oven opening, suggesting that a refurbishment of the hearth in the 1950's or 60's took place at the same time that a Baxi boiler or heater was said to have been installed. The surrounding replacement brickwork contemporary with this latest phase is of Flettons in a cement mortar (**fig.6**).

- The original north-east wall of the fireplace retains a single timber lacing course in the original brickwork (**fig.11**).
- At the time of the visit, remains of a mid-20<sup>th</sup> century corrugated Newtonite lath was seen at the return with the rear wall. At the head of the recess is a substantial concrete lintel (**fig.6**).

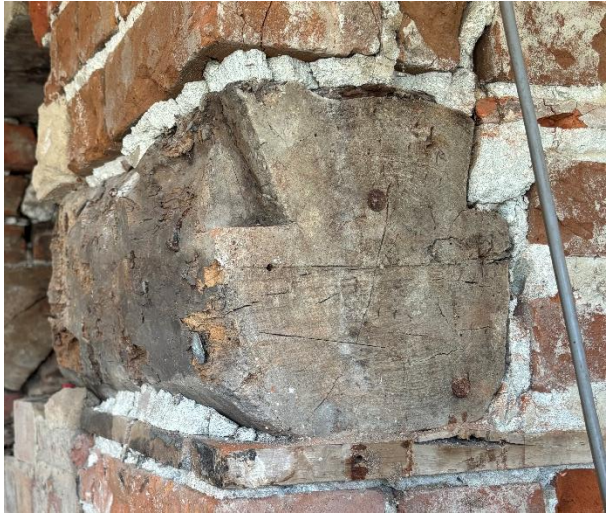
The exterior entry and stairs are now in what was the former unheated service end of the cottage. There were no older features to note here. All the interest is in the main living room, with a newly-opened fireplace against the south-east wall, and a much-weathered 17<sup>th</sup> century axial beam with a 3" chamfer. At the south-east end it is propped on a flat-laid board in the chimney breast. At the north-west end it is lodged in the partition wall. Due to its weathered state, and the wide chamfer, it is likely that the beam is reused.

***Fig.7 South-west end of beam showing cuts from a former use***

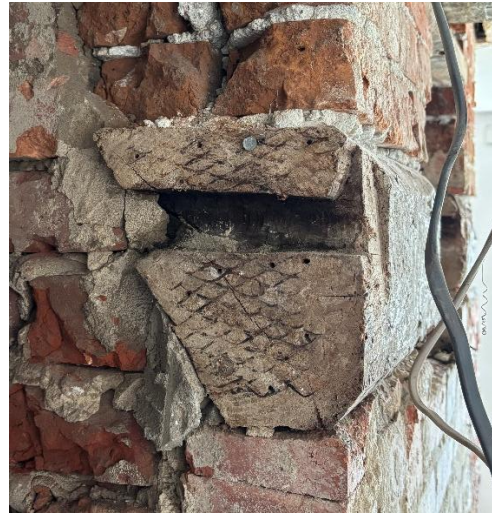
***Fig.8 North-east end of beam showing a possible redundant joist pocket***

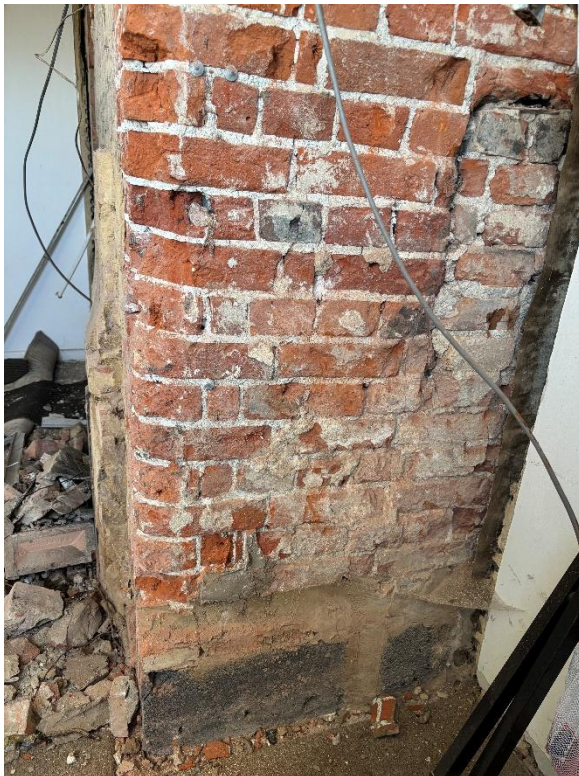
- If a newel stair once existed in the righthand recess, it was removed to house a copper boiler. A tall thin recess was made in the existing brickwork to facilitate a low-set flue to vent the smoke from the boiler. Note that the original brickwork return has been rounded off to the height of the flue, possibly for ease of access. At the base of this return wall is a patch repair in what appears to be cinder block (**fig.9**).

***Fig.9 South-west return of fireplace with narrow recess of 6 bricks' height cut in for a flue***

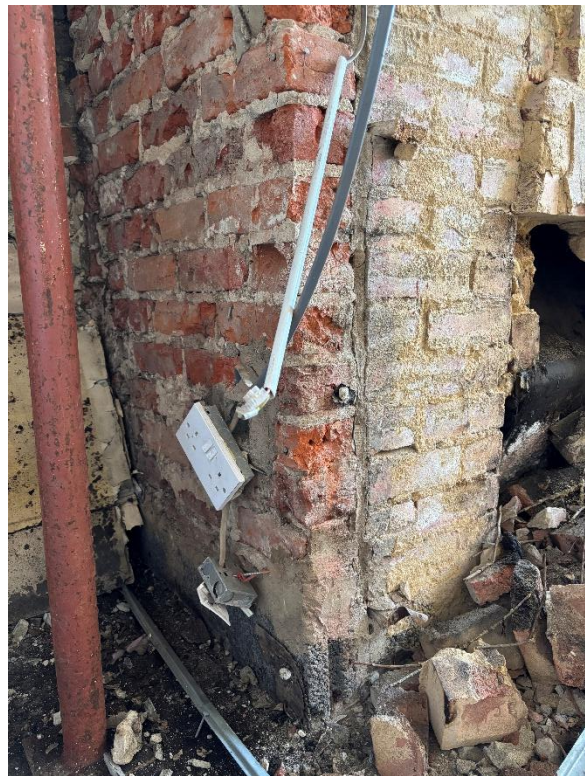
- In c1800 the fireplace was shortened to the present proportions using slightly wider bricks (9"x 2½-¾) in a harder lime mortar. The wall is not bonded into the back of the hearth (**figs.10 & 16**) This function may have become housed in a rear outbuilding or detached kitchen.

***Fig.10 North-east return showing stretcher bond brickwork partition of c1800 which reduced the width of the fireplace***

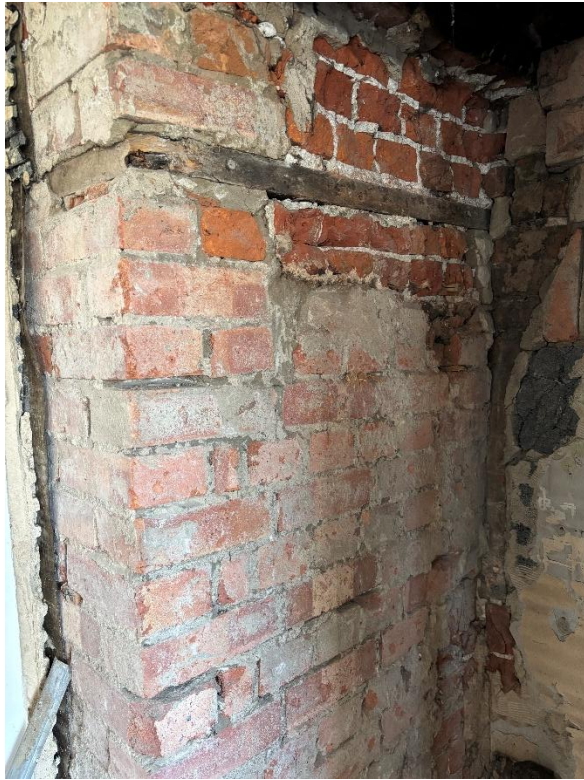
***Fig.11 The original north-east wall of the fireplace, showing a remaining timber levelling course***

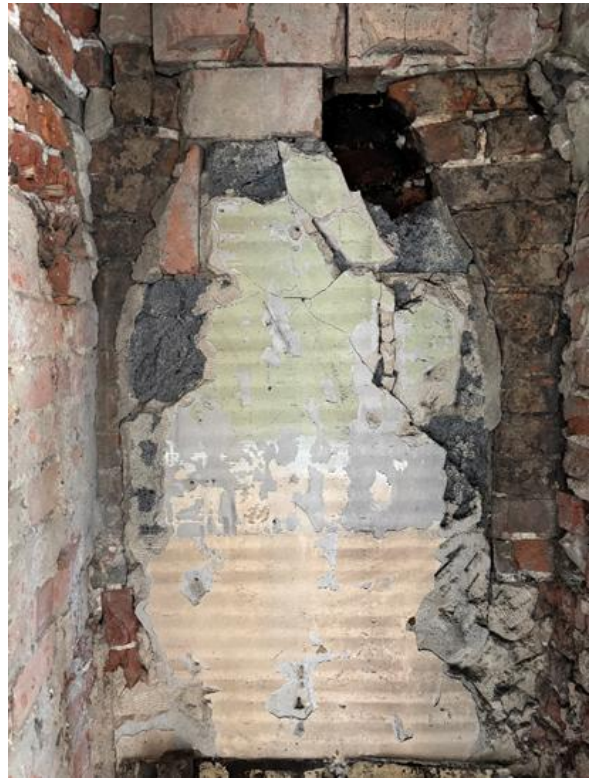
- Fireplace brickwork is of 9"x 2¼-½" x 4" soft orange bricks based on English garden wall bond (1 row of headers to 3 rows of stretchers)
- The tapered recess recently uncovered to the left of the fireplace was the front of a bread oven which once opened into the main flue (**figs.12, 17 & 18**)

***Fig.12 The soot-blackened, tapered top of a bread oven infilled with cinder block***

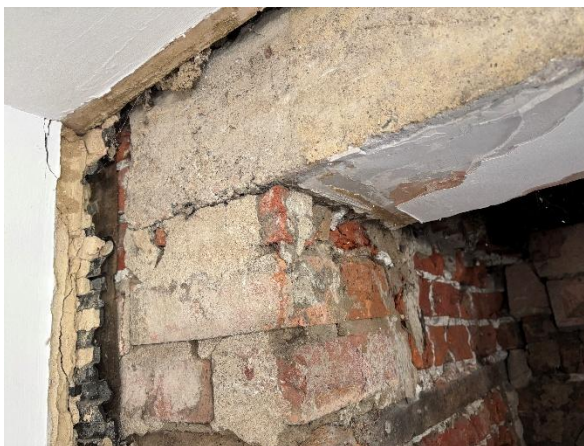
***Fig.13 Concrete lintel with edge of Newtonite lath lining to left***

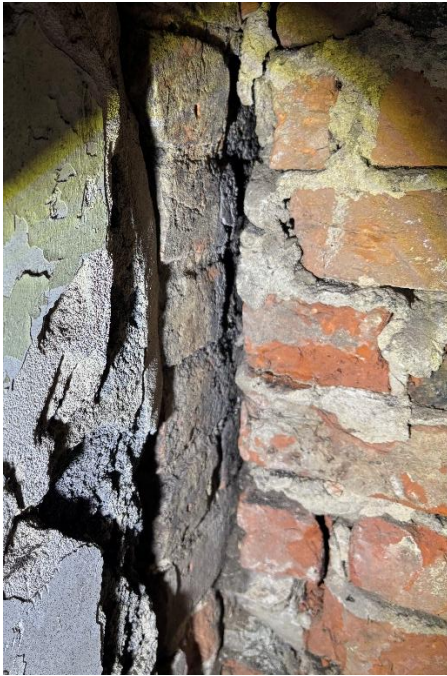
***Fig.15 Junction of later partition with back wall of hearth***

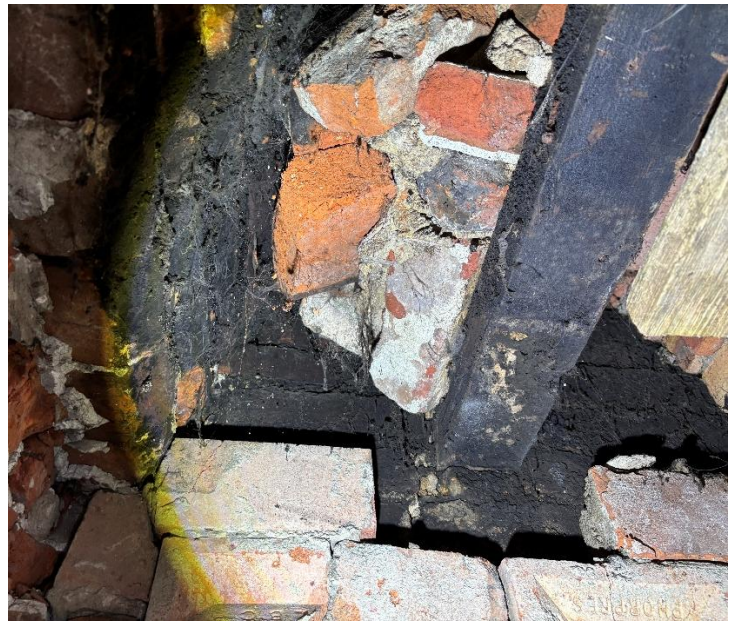
***Fig.16 Sooted flue blocked with original loose brickwork***

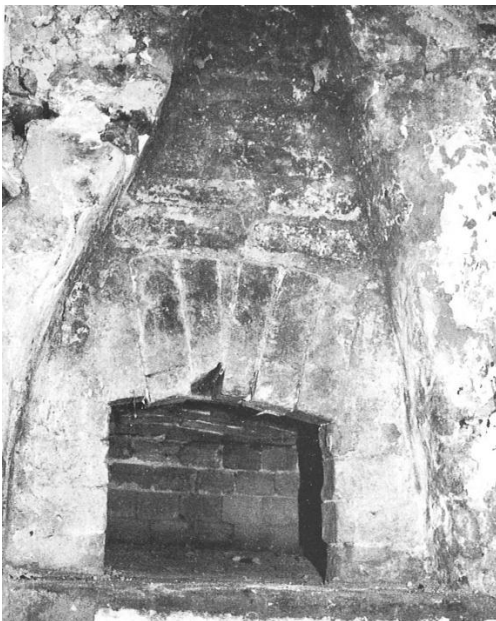
***Fig.17 Bread oven in tapered recess in a farmhouse in Semington***

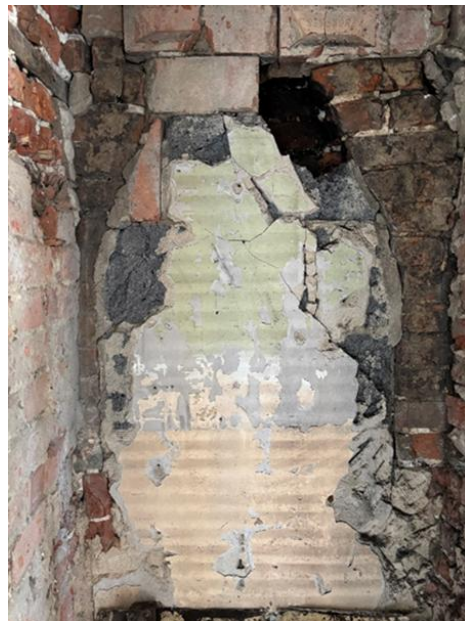
***Fig.18 Remains of bread oven opening at 13 Wilcot Green***
